STATE OF CALIFORNIA
CALIFORNIA NATURAL RESOURCES AGENCY
DEPARTMENT OF WATER RESOURCES
DIVISION OF SAFETY OF DAMS

INSPECTION OF DAM AND RESERVOIR IN CERTIFIED STATUS

Name of Dam Santiago Creek Dam No. 75 County Orange
 Type of Dam Earth Type of Spillway Open Channel
 Water is 10.6 feet below spillway crest and 30.6 feet below dam crest.
 Water Surface Elevation El. 779.4'
 Weather Conditions Sunny
 Contacts Made Danielle Drake with IRWD and Steve Sweeney with Serrano Water District
 Reason for Inspection Periodic Maintenance Inspection

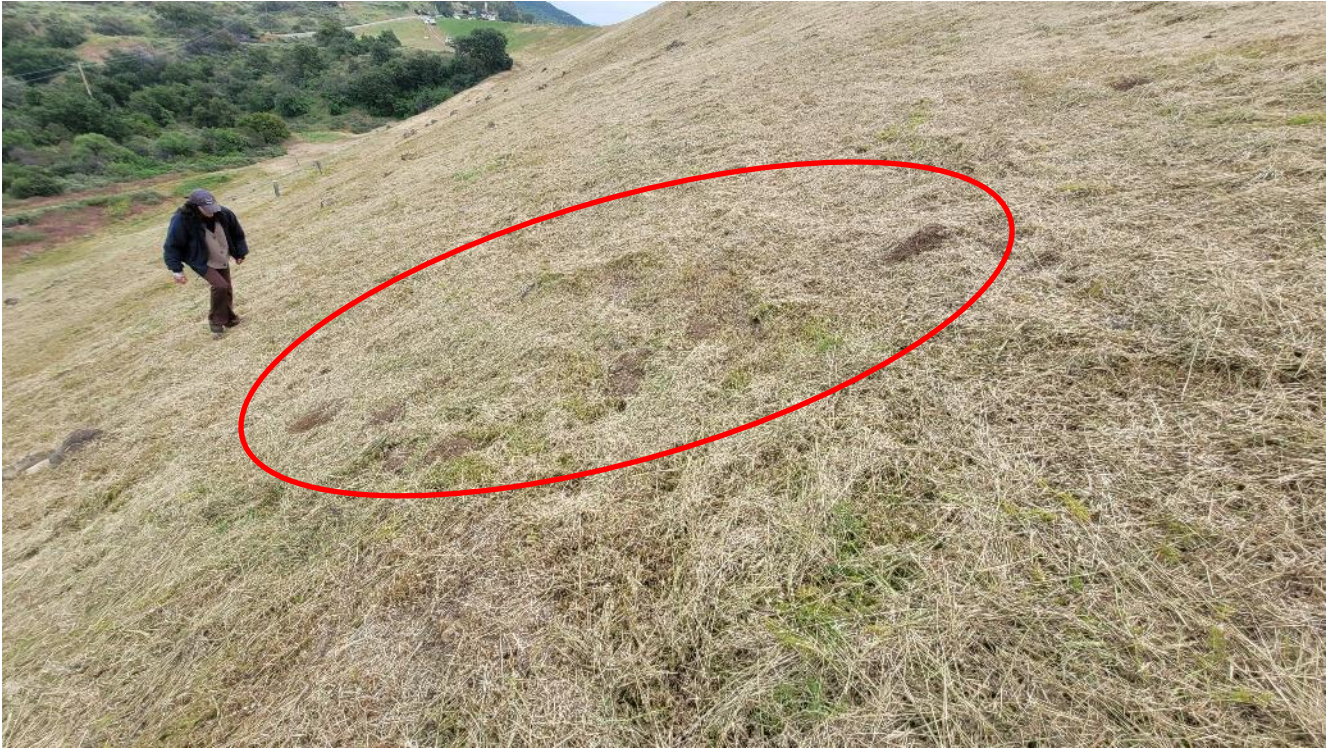
The crest appeared level and well-aligned. The visible portion of the upstream slope, and the downstream slope appeared uniform, stable, and in satisfactory condition. The groins, toe, and abutments appeared satisfactory with no signs of instability or distress. Overall, the vegetation is well managed with periodic vegetation control from the owner. During the inspection, there was significant vegetation growth throughout the concrete lined upstream slope. The owner plans to cut down the vegetation by May 3, 2023. Generally, the rodent control is satisfactory with minimal signs of rodent activity. The owner has bait traps around the dam and needs to continue rodent abatement. The owner needs to collapse, backfill, and compact the rodent holes with suitable material as an ongoing maintenance item.

Photo 1: View of new rodent activity along the downstream slope.

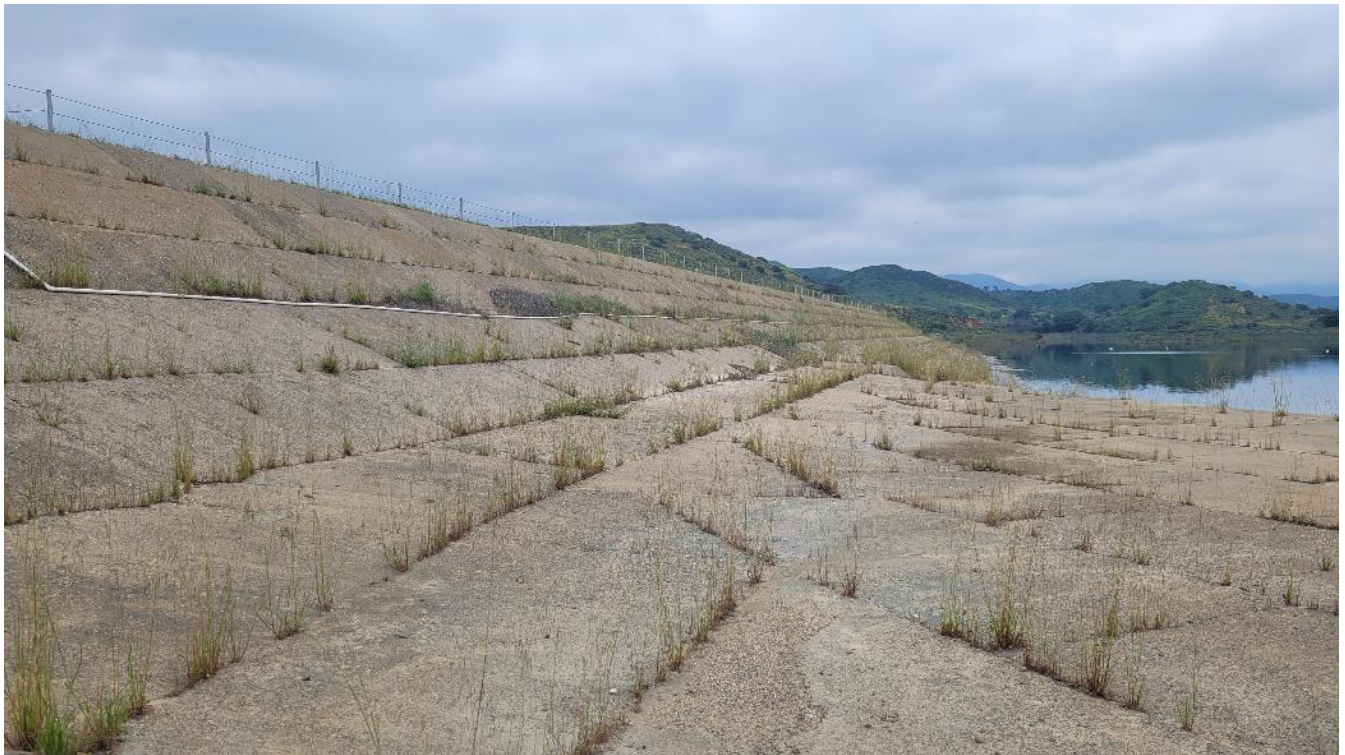
Photo 2: View of the upstream slope with weed growth.

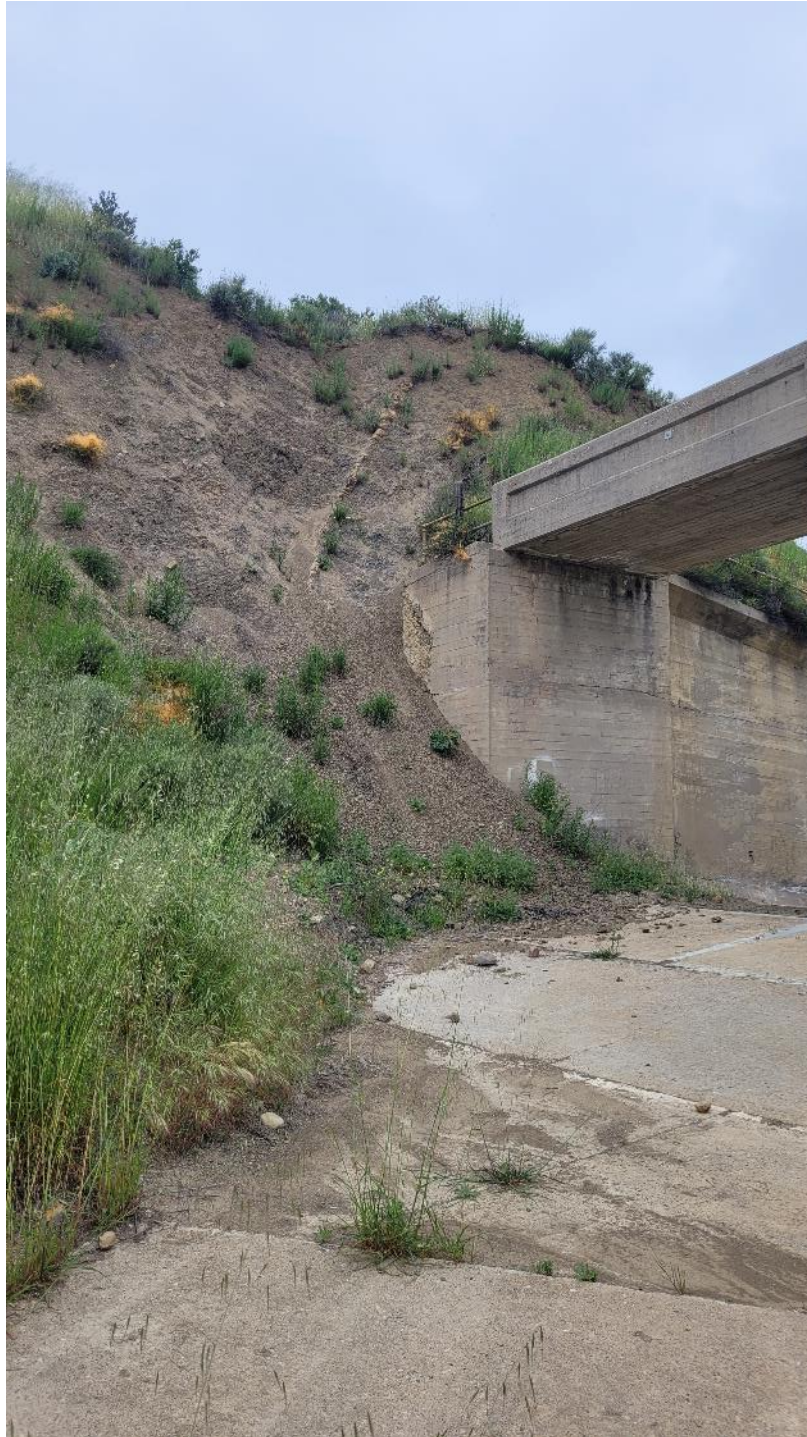
Generally, the spillway approach, control section, and channel were clear of debris. The spillway approach had a buildup of vegetation and sediment that the owner needs to remove by November 1, 2023. Overall, the concrete elements of the spillway appeared to be in satisfactory condition. However, the concrete at the spillway has continuous spalling from expansion and contraction and the owner repairs the spalling as an ongoing maintenance, which is acceptable. The longstanding erosion at the left abutment contact with the spillway appears unchanged since the previous inspection. The owner has submitted an enlargement application filed on December 17, 2021, and is currently in review by DSOD's design engineering branch. The enlargement application work includes a new spillway and outlet works, which will also address the ongoing erosion left of the spillway.

Survey Monuments: The vertical displacements show negligible changes since December 1989 with a max settlement of 0.058' at BM-4. The max horizontal movement measured from January 1994 to December 2022 is 0.9 inches at BM-5. This survey monument is at the left end of the spillway where there has been erosion left of the spillway. There appears to be no concerning trends or conditions in the data. The owner has submitted an enlargement application to replace the spillway as well.

Photo 3: View of the erosion left of the spillway.

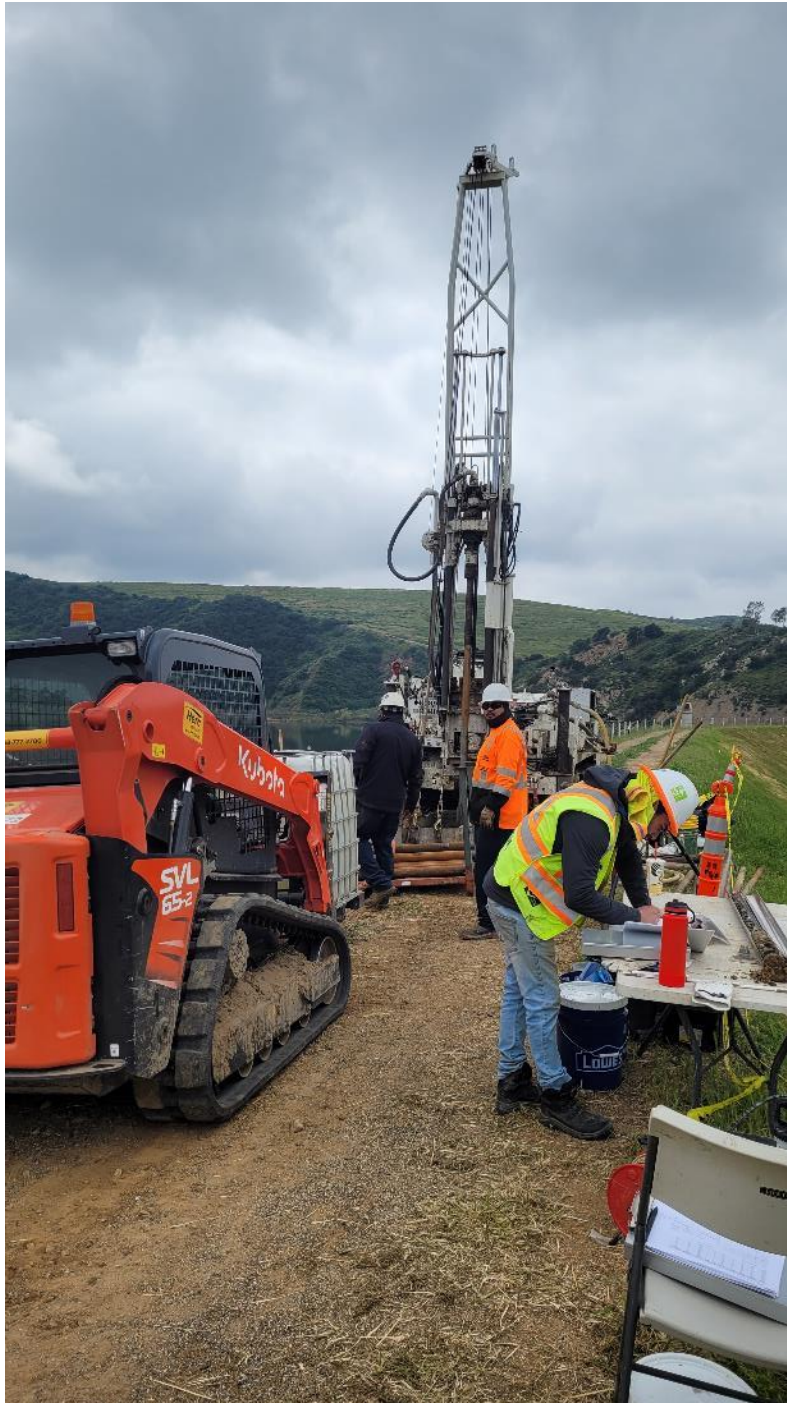
There is work ongoing at the dam affiliated with an alteration application filed on June 24, 2020, and approved on September 21, 2020. The ongoing work includes geotechnical investigations to support the design of a new outlet and spillway.

Photo 4: View of the ongoing geotechnical investigation.

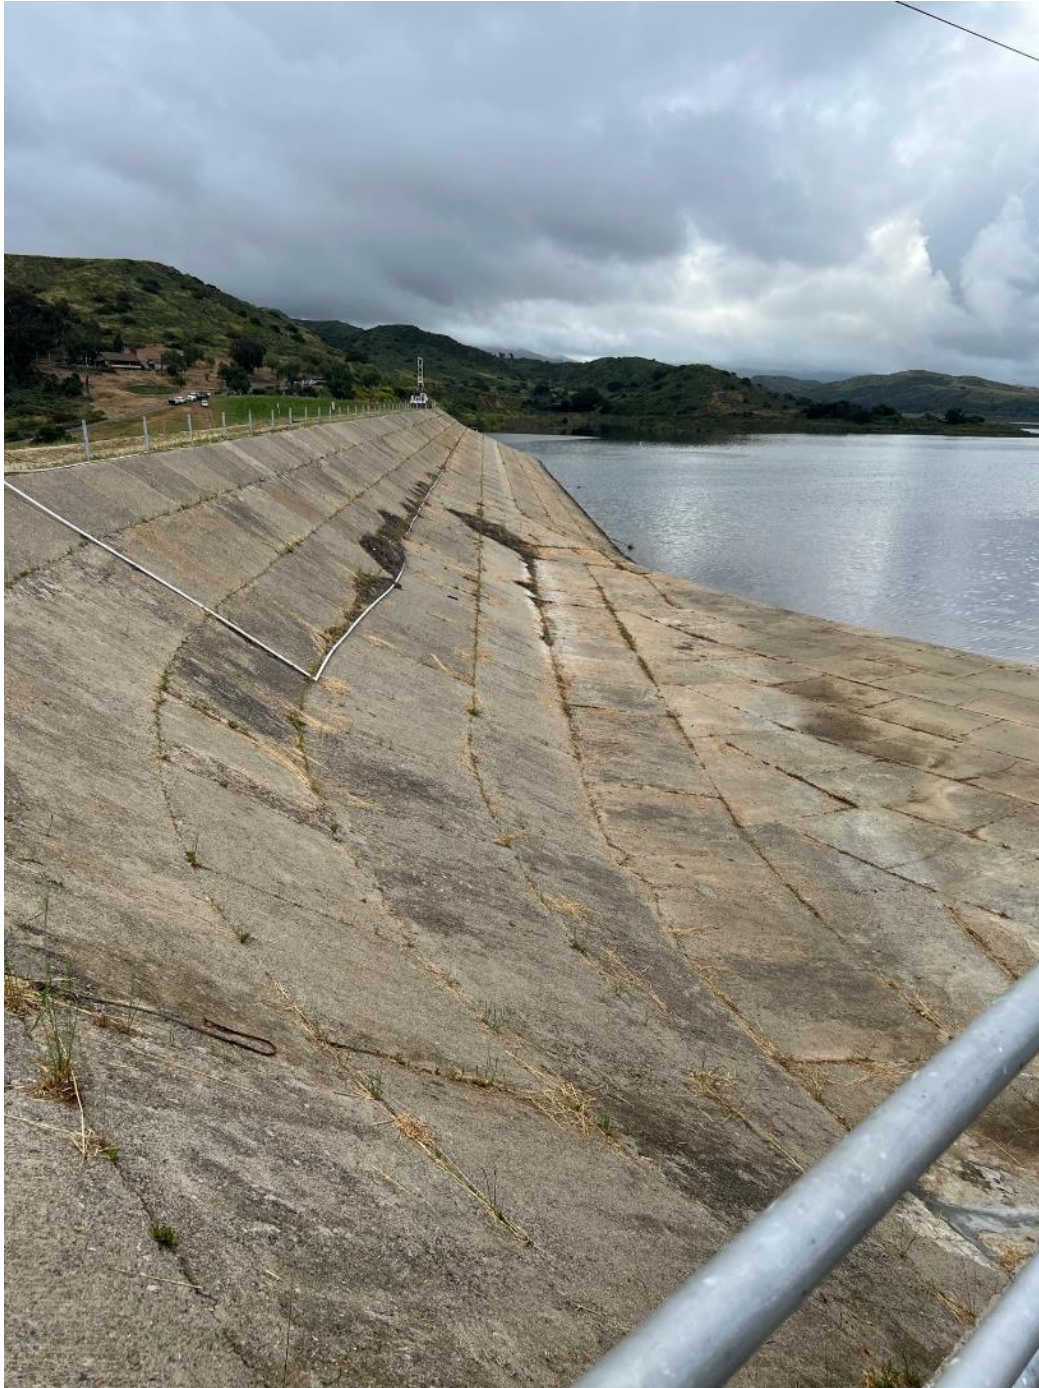
Photo 5: View of the cleared upstream slope. (Supplied by owner after inspection [5/3/2023]).

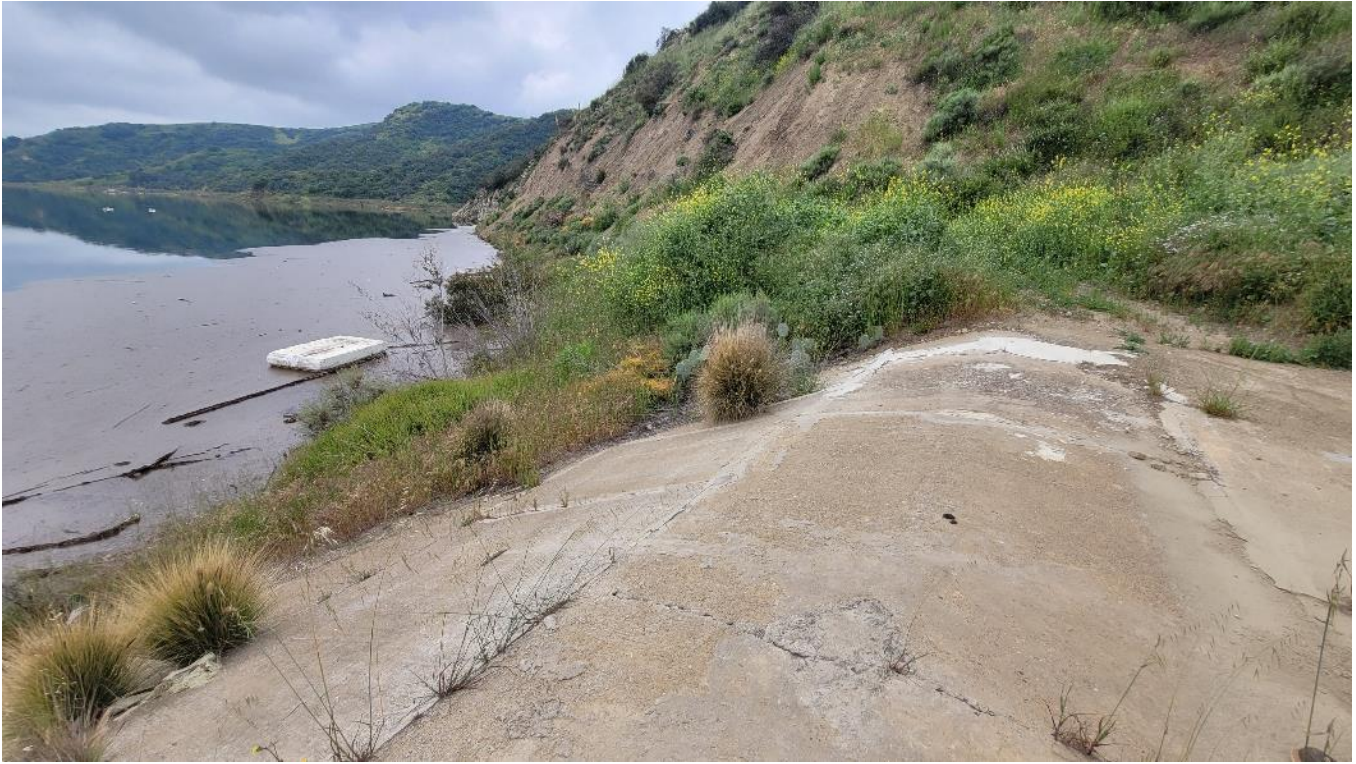
Photo 6: View of the spillway approach with sediment and vegetation buildup.

- The owner needs to continue the following as ongoing maintenance items:
 - Collapse, backfill, and compact the rodent holes with suitable material.
 - Repair the spillway spalling as it appears.
- The owner needs to remove the sediment and vegetation buildup at the spillway approach by November 1, 2023 (Photo 6).
- For future instrumentation reports, rain data needs to be incorporated into the piezometer data plots.
