STATE OF CALIFORNIA
CALIFORNIA NATURAL RESOURCES AGENCY
DEPARTMENT OF WATER RESOURCES
DIVISION OF SAFETY OF DAMS

INSPECTION OF DAM AND RESERVOIR IN CERTIFIED STATUS

Name of Dam Syphon Canyon Dam No. 1029-4 County Orange
 Type of Dam Earth Type of Spillway Open Channel
 Water is 32 feet below spillway crest and 39 feet below dam crest.
 Water Surface Elevation EI. 346'
 Weather Conditions Sunny
 Contacts Made Danielle Drake with IRWD
 Reason for Inspection Periodic Maintenance Inspection

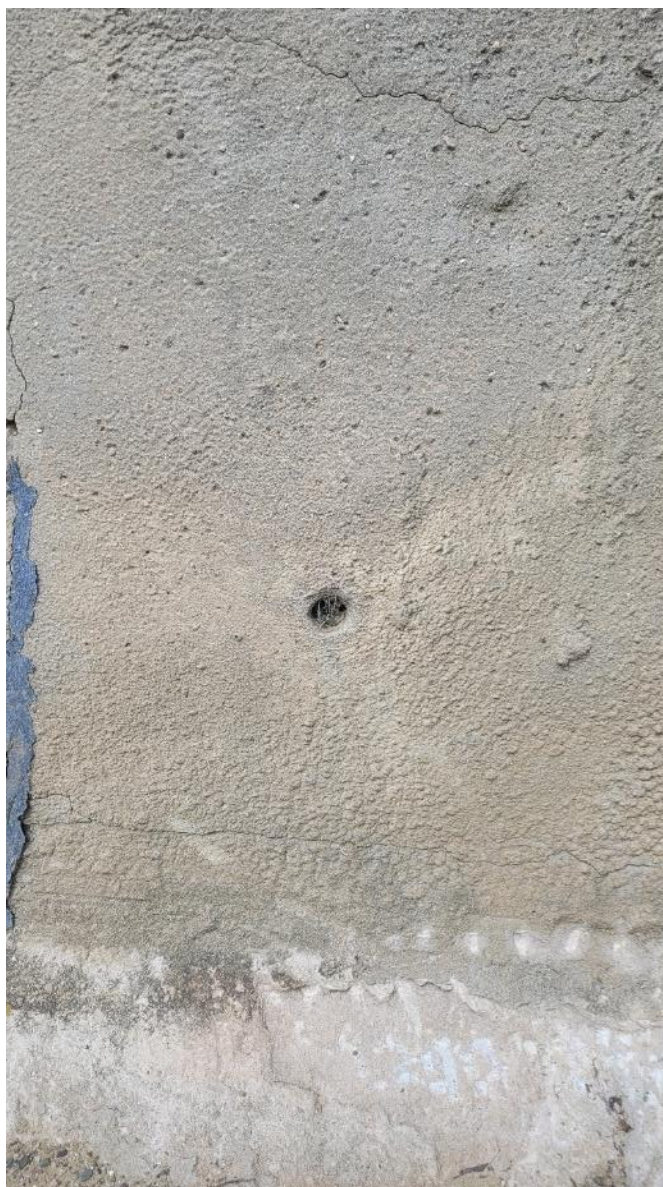
Photo 1: View of debris in one of the spillway weepholes.

- The owner needs to collapse, backfill, and compact the rodent holes with suitable material as an ongoing maintenance item.
- The owner needs to remove the debris from the spillway weepholes by November 1, 2023.
- The owner needs to investigate and determine the condition of Piezometers VBW/2-A and VBW/2-B.
- For future instrumentation reports, rain data needs to be incorporated into the piezometer data plots.

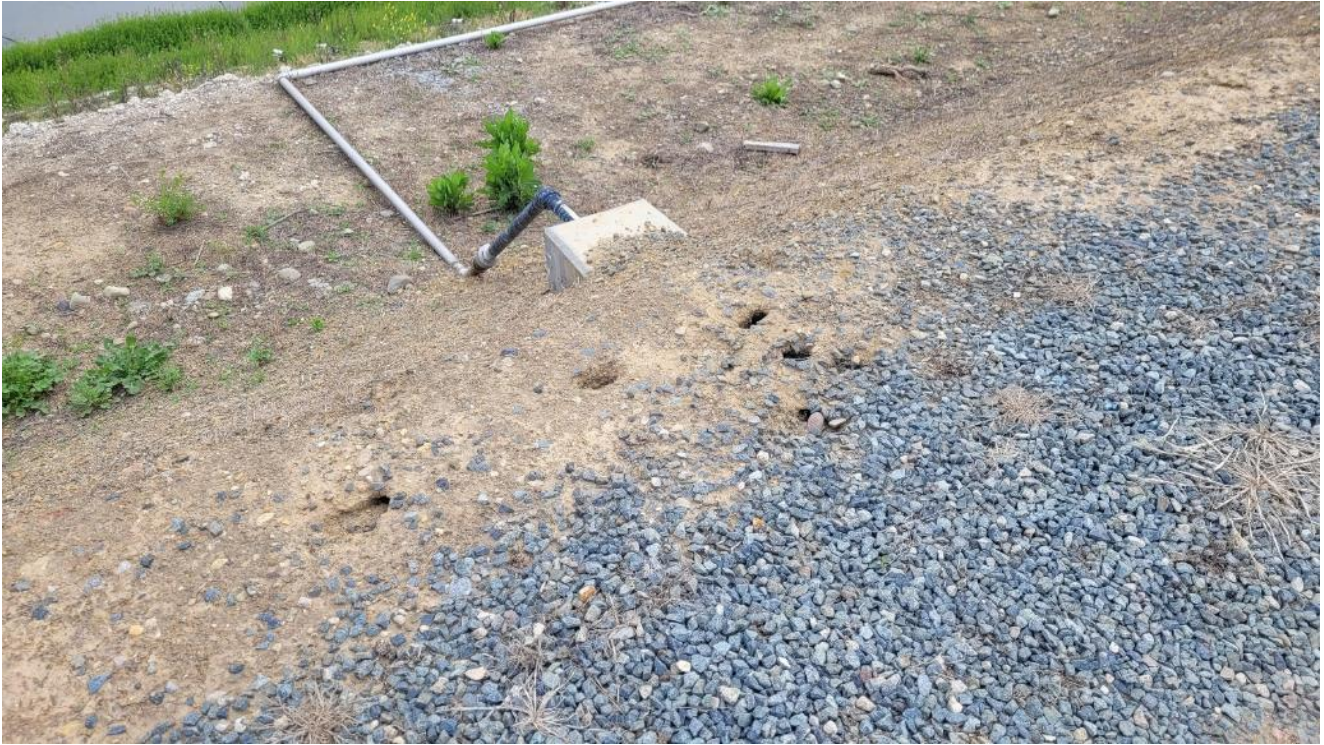
Photo 2: View of minor rodent activity along the crest.

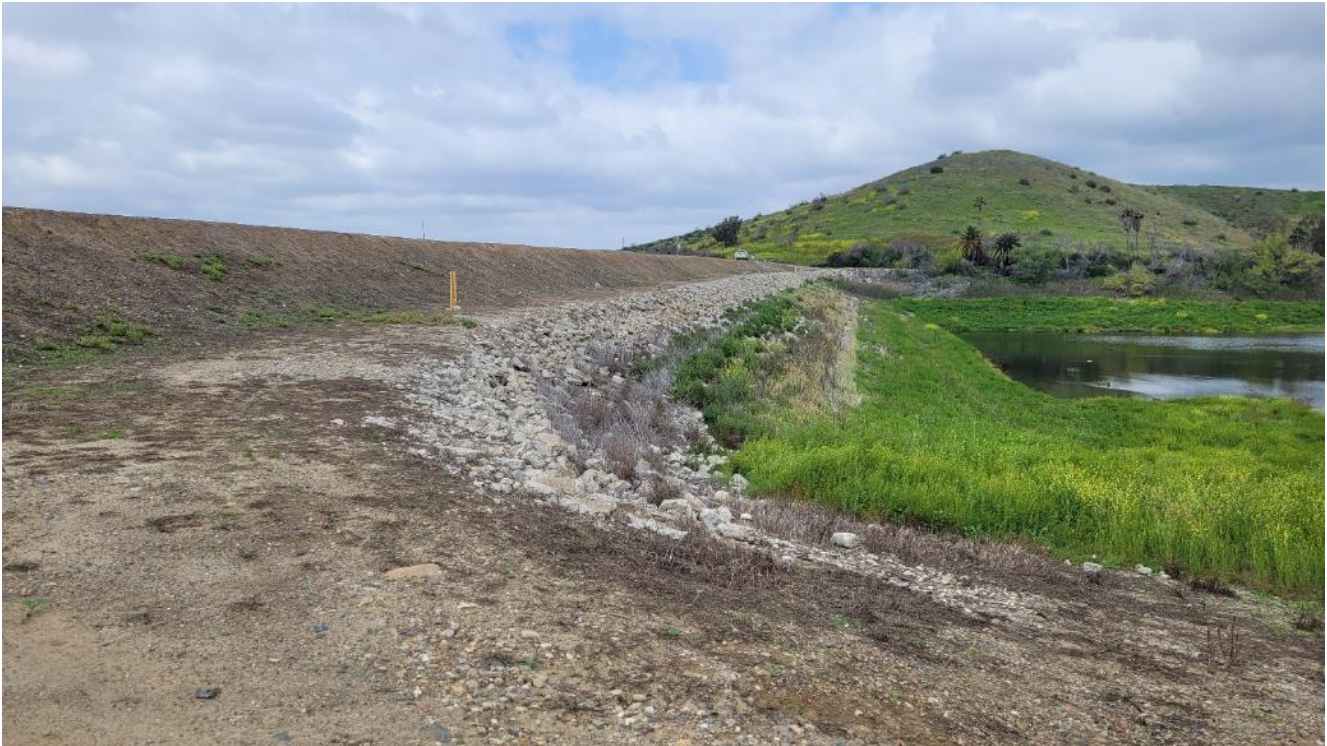
<u>Dam</u>	The crest appeared level and well-aligned. The visible portion of the upstream slope, and the downstream slope appeared uniform, stable, and in satisfactory condition. The groins, downstream toe, and abutments appeared satisfactory with no signs of instability or distress. The vegetation is well managed with periodic vegetation control from the owner. Generally, the rodent control is satisfactory with minimal signs of rodent activity. The owner needs to collapse, backfill, and compact the rodent holes with suitable material as an ongoing maintenance item.
<u>Spillway</u>	The spillway approach, control section, and channel were clear of debris. The concrete elements of the spillway appeared to be in satisfactory condition. Several weepholes in the spillway had debris built up. The owner needs to remove the debris by November 1, 2023.
<u>Outlet</u>	The outlet consists of one upstream 12-inch butterfly valve and two downstream 16-inch butterfly valves. The owner fully cycled all three valves during this inspection with no issues. The exit of the outlet that enters the underground storm drain was clear of debris.

Photo 3: View of the upstream slope from the left abutment.
