STATE OF CALIFORNIA
CALIFORNIA NATURAL RESOURCES AGENCY
DEPARTMENT OF WATER RESOURCES
DIVISION OF SAFETY OF DAMS

INSPECTION OF DAM AND RESERVOIR IN CERTIFIED STATUS

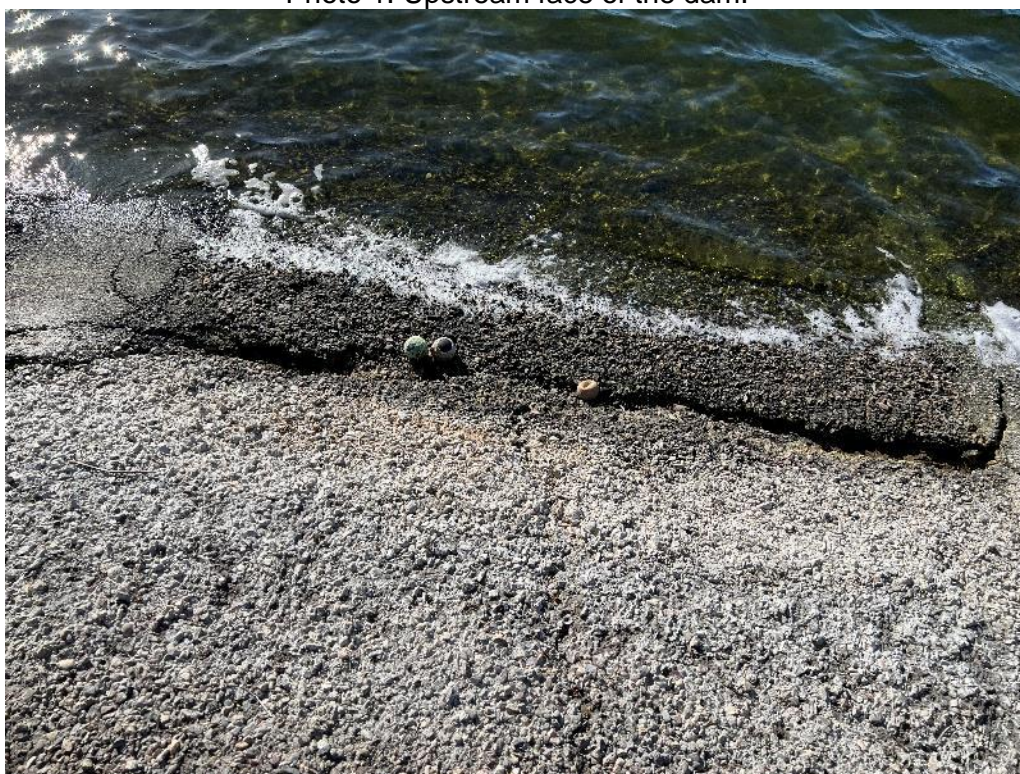
Photo 2. Example of cracks in upstream liner that will be repaired.
