STATE OF CALIFORNIA
CALIFORNIA NATURAL RESOURCES AGENCY
DEPARTMENT OF WATER RESOURCES
DIVISION OF SAFETY OF DAMS

INSPECTION OF DAM AND RESERVOIR IN CERTIFIED STATUS

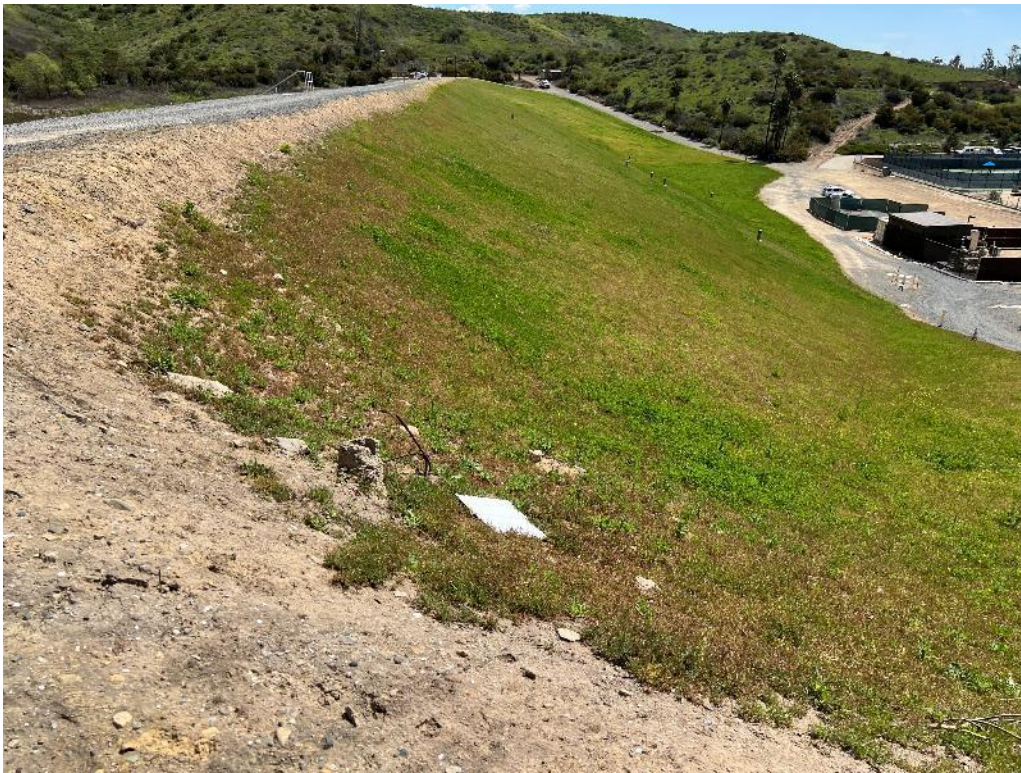
Photo 1. Downstream face of the dam.
