STATE OF CALIFORNIA
CALIFORNIA NATURAL RESOURCES AGENCY
DEPARTMENT OF WATER RESOURCES
DIVISION OF SAFETY OF DAMS

INSPECTION OF DAM AND RESERVOIR IN CERTIFIED STATUS

Name of Dam Santiago Creek Dam No. 75 County Orange
Type of Dam Earth Type of Spillway Concrete weir and open channel
Water is 26 feet below spillway crest and 46 feet below dam crest.
Weather Conditions Sunny
Contacts Made Danielle Drake with IRWD and Steve Sweeney with Serrano Water District
Reason for Inspection Maintenance Inspection

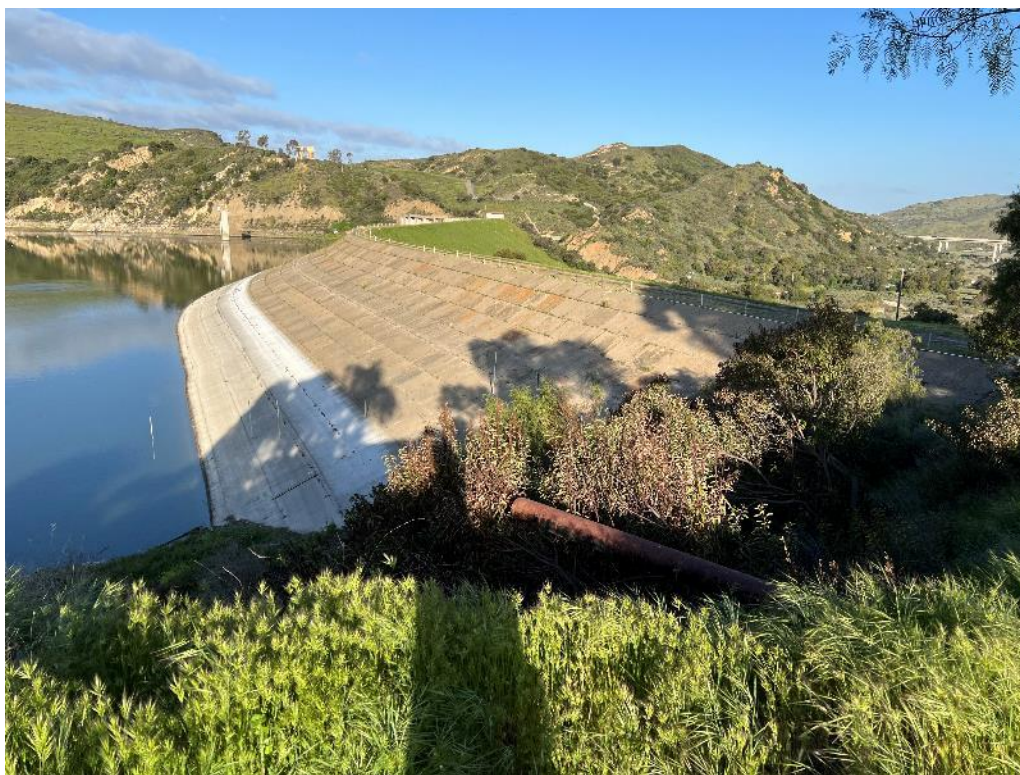
Photo 1. Right side of the upstream face of the dam.

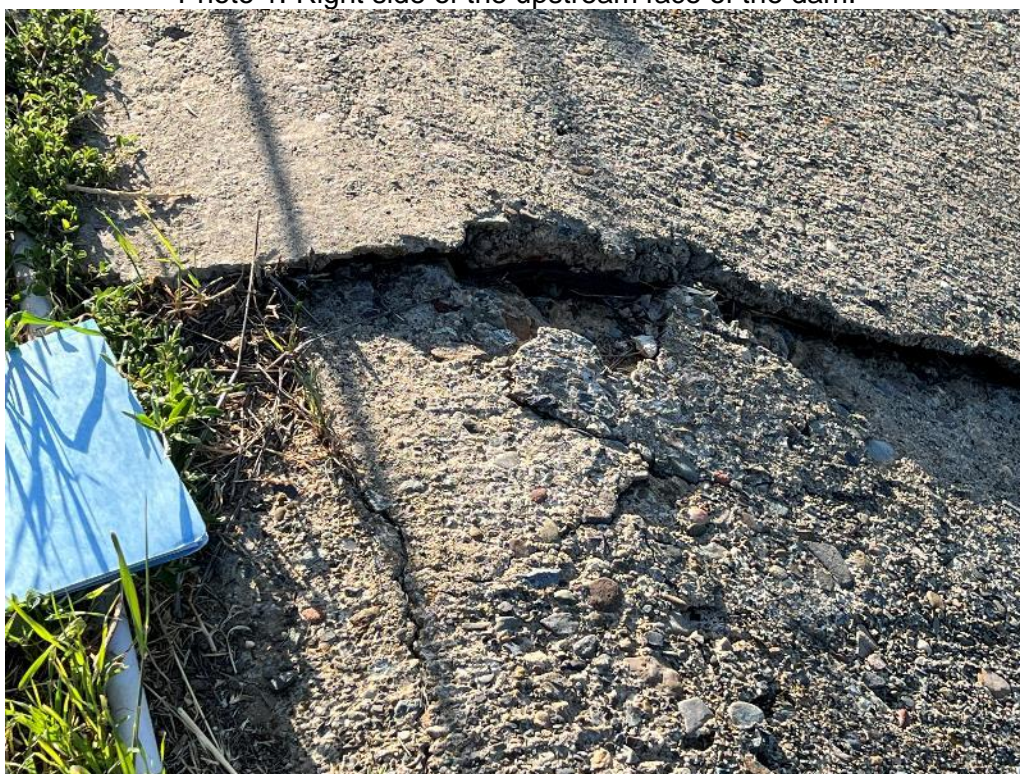
<u>Dam</u>	The crest appeared to be level and well-aligned. The crest narrows to ~9 feet near the right end of the embankment (Photo 4). The visible portions of the upstream concrete-lined face and groins appeared uniform and stable. A significant crack was observed on the upstream face near the crest hinge point, located between Piezometers R1 and R6. As part of the enlargement application, the crest is being widened with an MSE wall, which will include demolishing this area of cracked concrete. However, if the application work is significantly delayed, the crack will need to be repaired
------------	--

Photo 2. Crack in the upstream concrete liner.

- Repair the crack in the concrete liner on the upstream face, located between Piezometers R1 and R6 (Photo 2).
- Repair spalls with exposed concrete and damaged section of concrete in the spillway (Photo 9).
- Remove sediment and vegetation from the left side of the spillway approach.

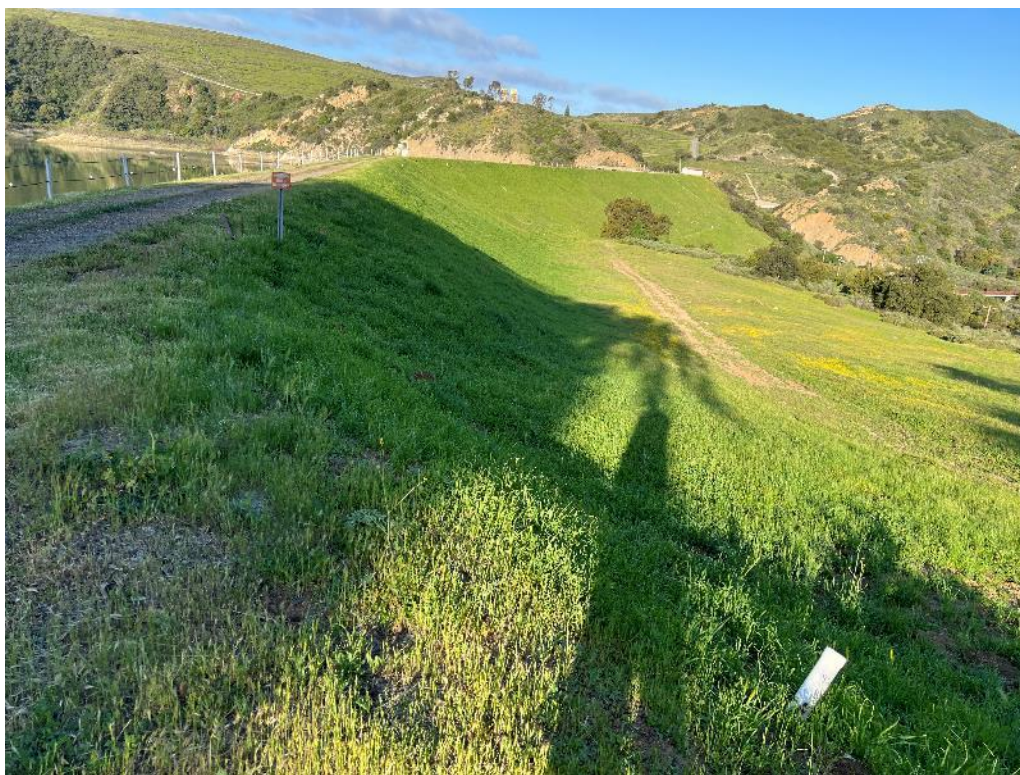
Photo 3. Downstream face of the dam.

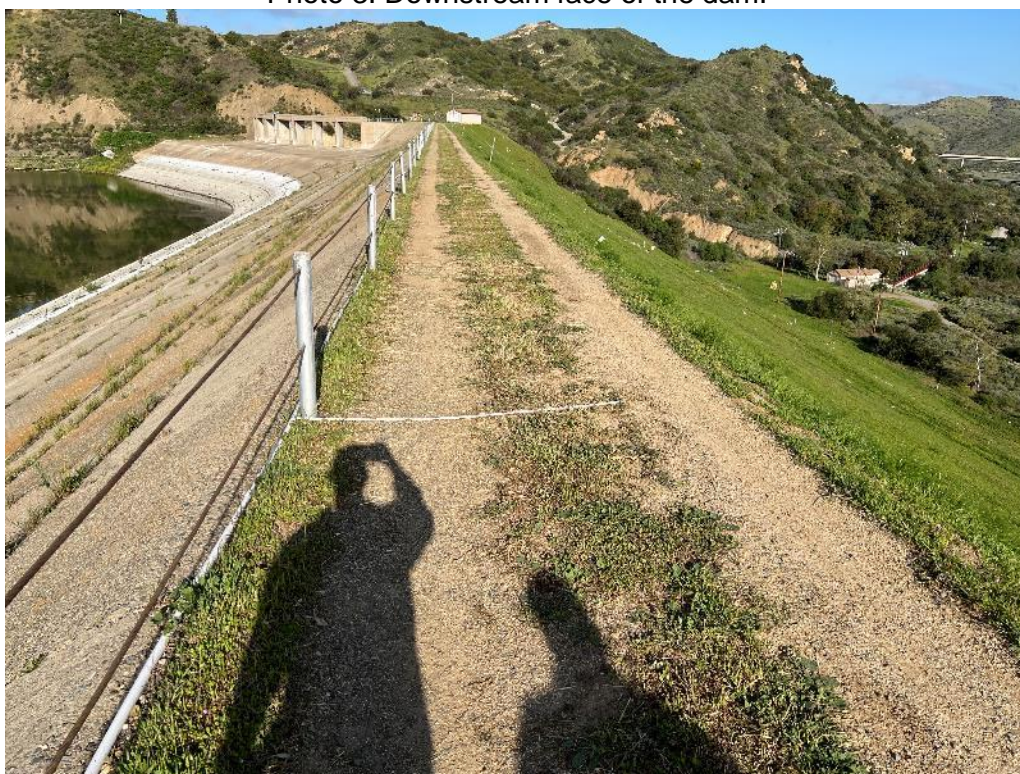
Photo 4. Thin section of the crest.

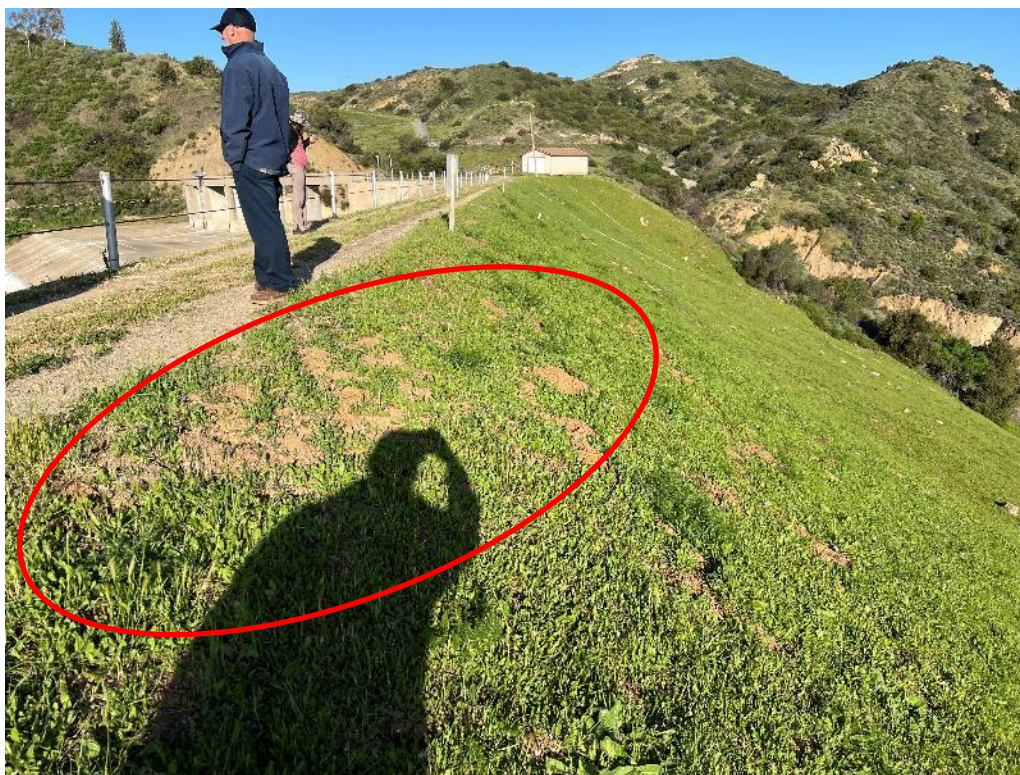
Photo 5. Example of rodent activity.

- Longstanding erosion rills on the downstream face of the dam need to be repaired during routine maintenance work (Photo 6).
- Existing rodent burrows need to be collapsed, backfilled, and compacted (Photo 5).

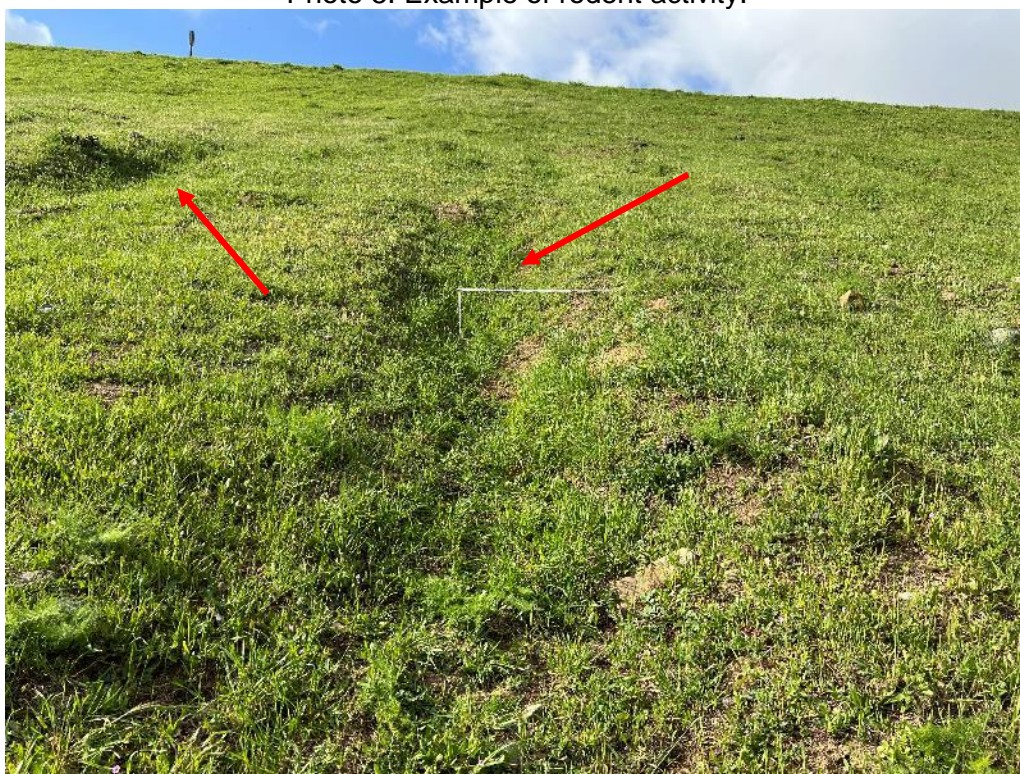
<p>during routine maintenance. The downstream face has several erosion rills that have developed over time near the lower half of the embankment. While it has taken several years for the erosion rills to develop, the expectation is that they will only increase in size. The erosion rills need to be repaired during routine maintenance work.</p>
<u>Spillway</u>	<p>The approach, control section, and downstream channel were clear and unobstructed. The concrete surfaces show signs of age with longstanding diagonal cracking on the right wall, spall locations with exposed rebar, and a damaged section of concrete near the downstream end of the left wall. The spillway appears to be in serviceable condition and is going to be replaced as part of the enlargement application mentioned above. However, if the project is significantly delayed, repairs will need to be made to the spalls and damaged sections of concrete during routine maintenance work.</p>

Photo 6. Example of erosion rills on the downstream face of the dam.

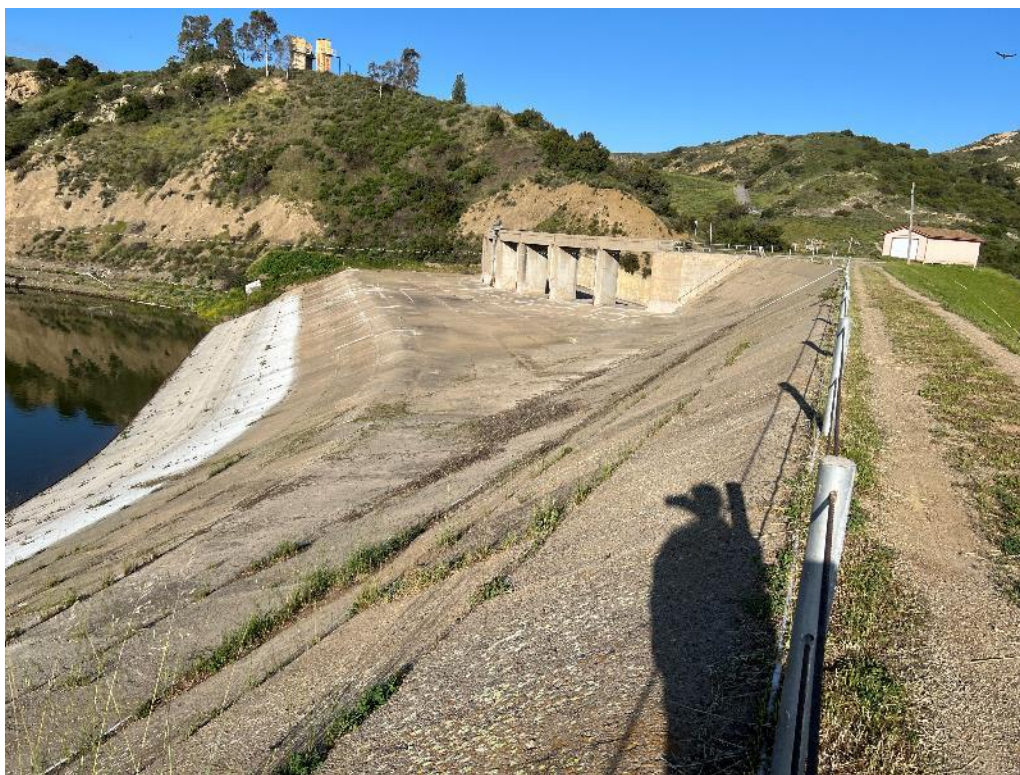
Photo 7. Spillway approach and control section.

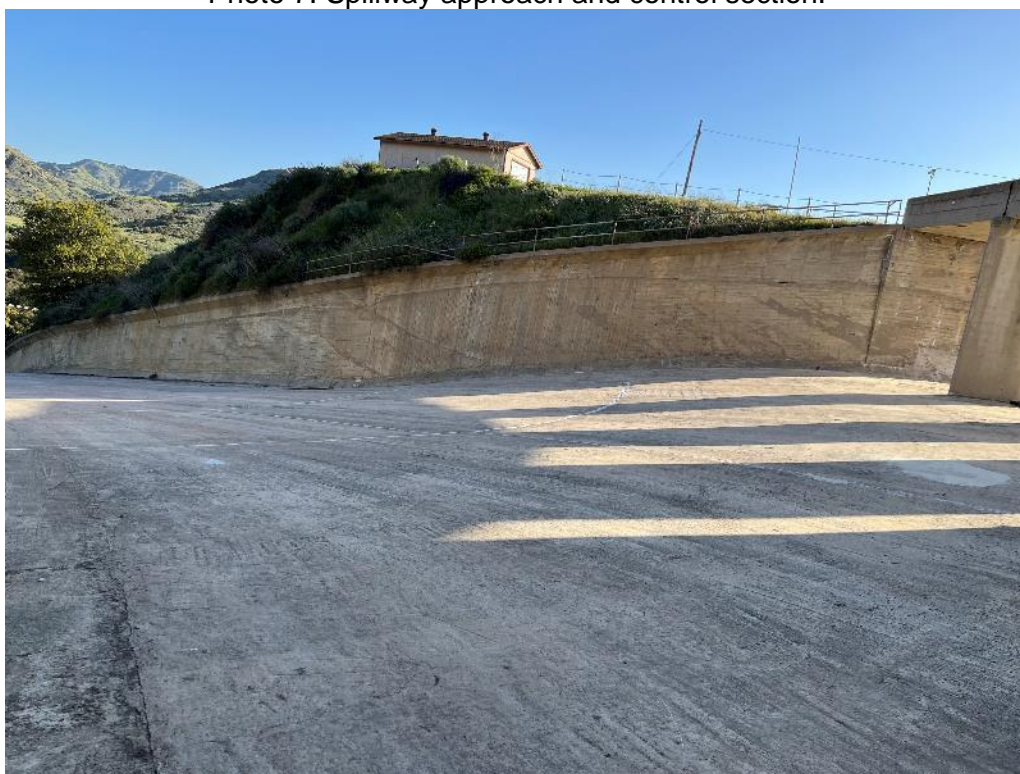
Photo 8. Diagonal cracks in the right spillway wall.

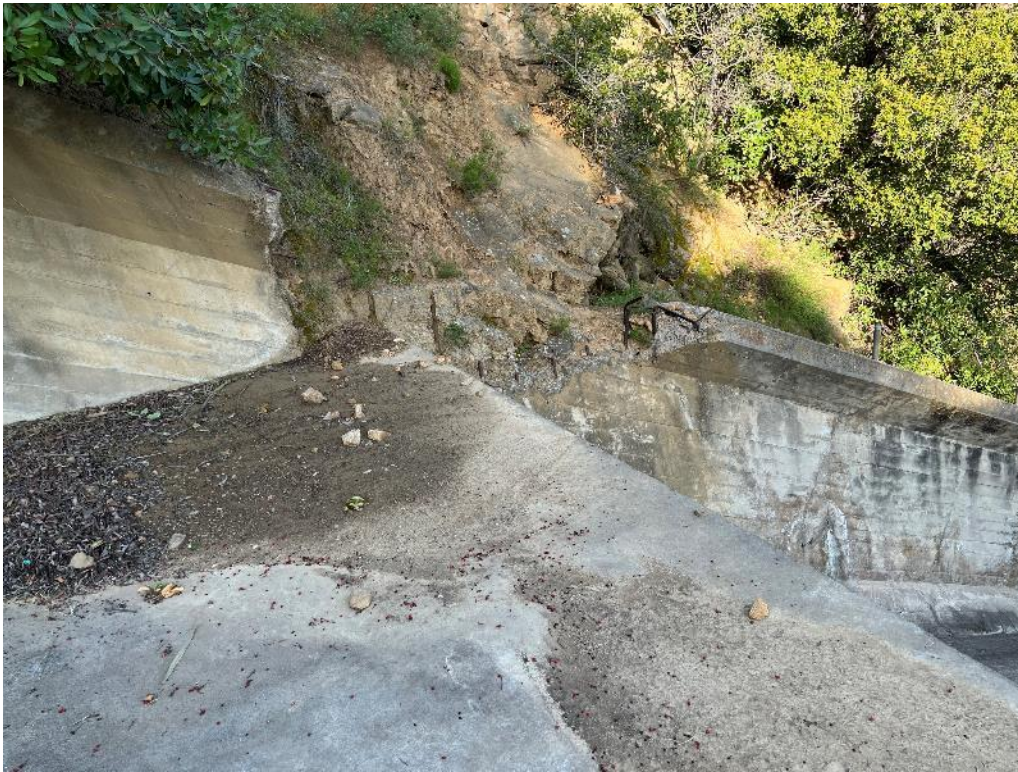
Photo 9. Missing section of concrete at the downstream end of the spillway chute and flip bucket.
