Annual Surveillance Report
January 2017 through December 2017
Syphon Canyon Dam
DSOD Dam No. 1029-004
Irvine, CA
December 19, 2018

Project No. 397D-IRW

Subject: Syphon Canyon Dam, DSOD Dam No. 1029-004,
Annual Surveillance Report from January 2017 through December 2017

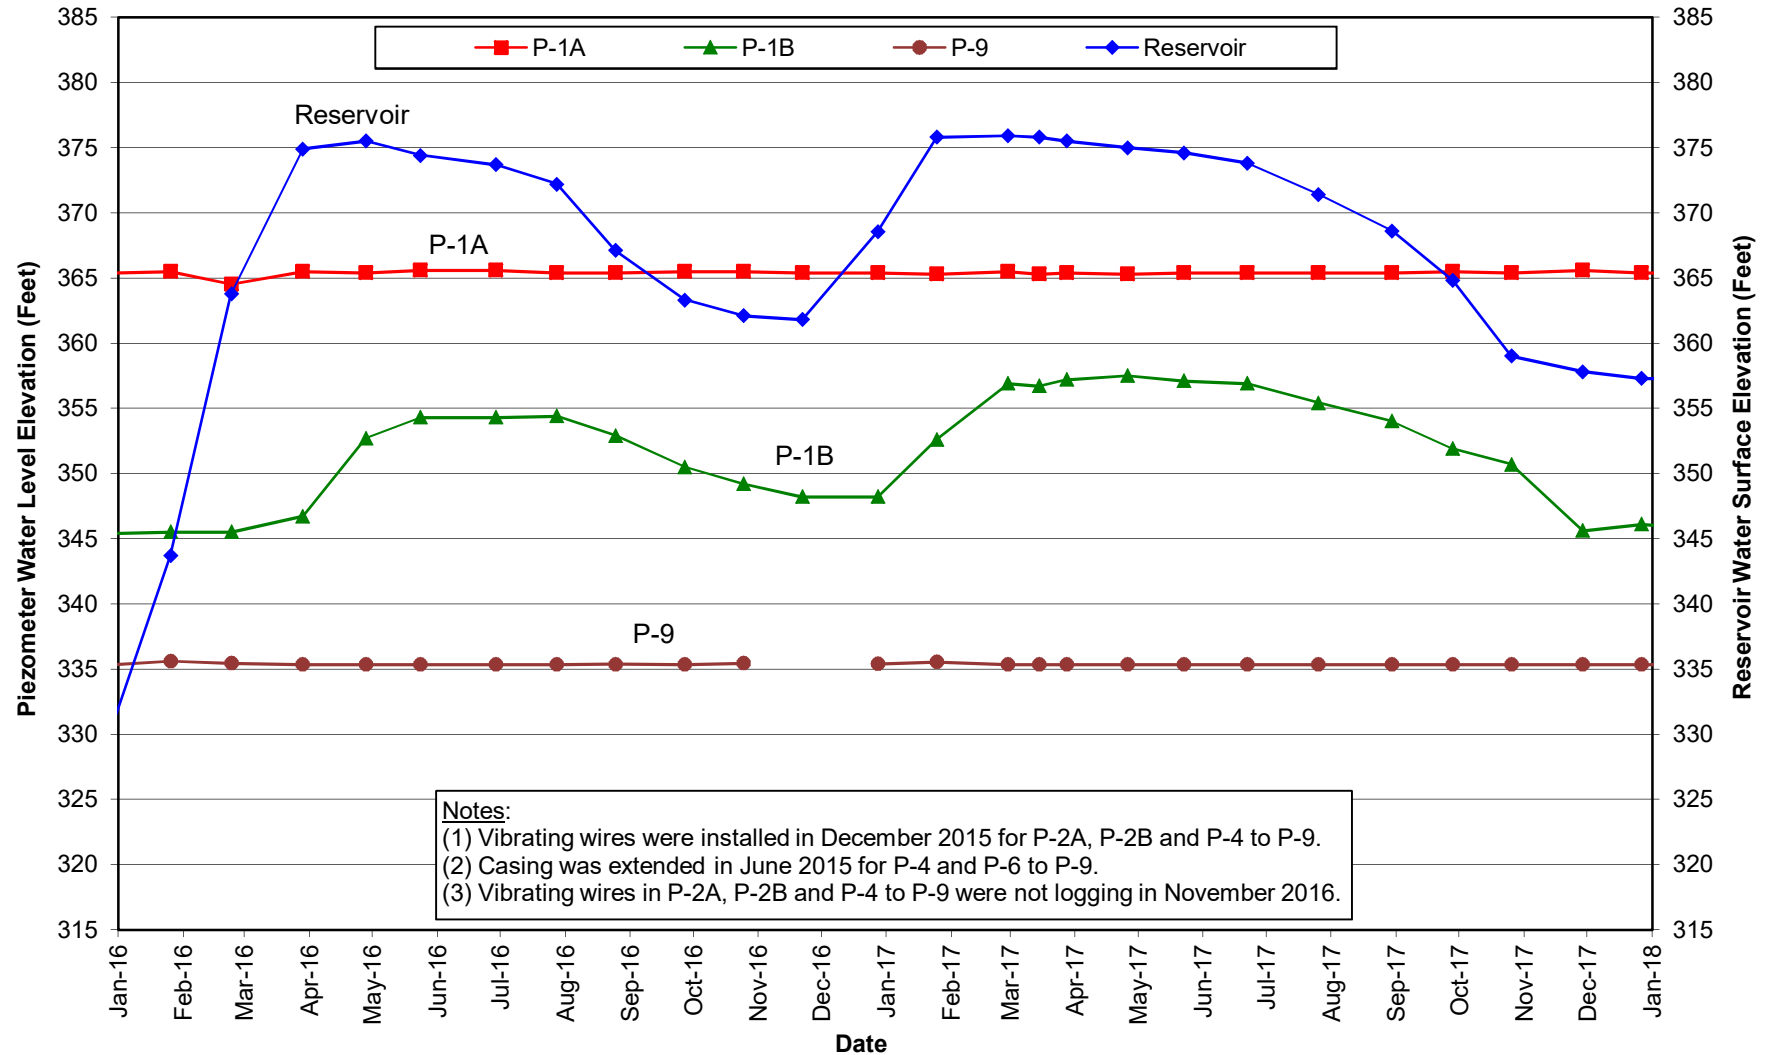
**SYPHON CANYON DAM
2-YR PIEZOMETER AND RESERVOIR WATER SURFACE ELEVATIONS
PIEZOMETERS P-1A, P-1B, AND P-9
JANUARY 2016 THROUGH DECEMBER 2017**

Nested Piezometers P-1, P-2 and P-3 are located on the crest of the dam, P-2 is located near the maximum section of the dam, P-1 is located on the right side of the crest, and P-3 is located on the left side of the crest. Piezometer P-1A is nested in the same well as Piezometer P-1B located on the right most portion of the crest of the dam. The tip of P-1A is located within the dam embankment at Elevation 365.7 feet, while P-1B has a tip within the dam foundation at Elevation 345.7 feet. Piezometer P-1A remained nearly dry. The water levels in P-1B generally responded to reservoir water surface fluctuations and were within historical water levels during the review period (Figures 3A and 4A).

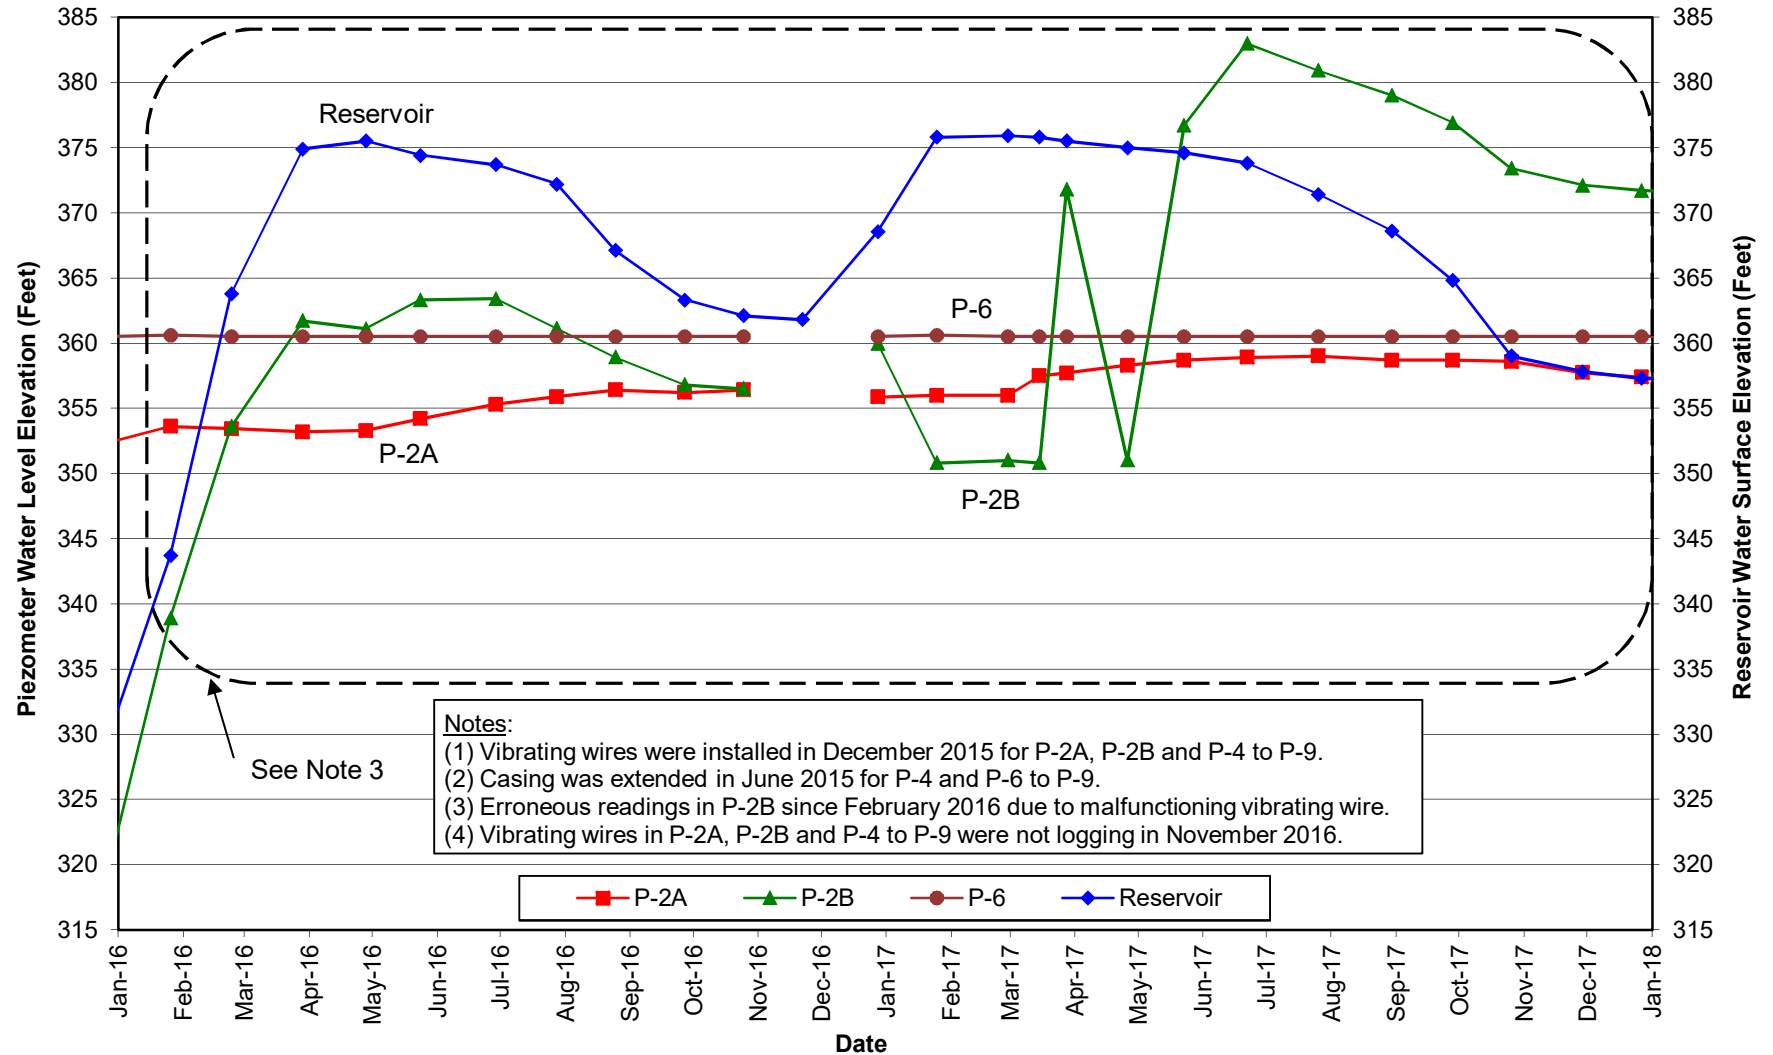
**SYPHON CANYON DAM
2-YR PIEZOMETER AND RESERVOIR WATER SURFACE ELEVATIONS
PIEZOMETERS P-2A, P-2B, AND P-6
JANUARY 2016 THROUGH DECEMBER 2017**

Piezometer P-2A is nested in the same well as Piezometer P-2B on the crest of the dam, near the maximum section of the dam. The tip of P-2A is located within the dam embankment at Elevation 342.2 feet, while P-2B has a tip within the dam foundation at Elevation 309.4 feet. Piezometer P-2A had showed little response to the fluctuations in the reservoir, prior to emptying the reservoir and after refilling the reservoir (Figure 4B). In July 2015, the District performed a maintenance cleaning of P-2A. Since the reservoir was refilled, the water level reading in P-2A have been gradually increasing, within the historical range. During the review period, water levels in P-2A showed some response to the reservoir water level fluctuations (Figure 3B).

The District took two manual readings in P-2B during this review period (taken on February 28, 2017 and April 26, 2017) which indicated a new historical high-water level at Elevation 351.0 feet (Figures 3B and 4B). The vibrating wire instrument was providing higher readings than what was measured manually, and the District should attempt to recalibrate and see its performance. If needed, the District will need to replace the vibrating wire instrument in P-2B.

instruments were installed in December 2015 for P-6, P-7 and P-8, water level readings have not fluctuated at all. P-6 should be investigated because water level in P-6 cannot be higher than crest piezometers.

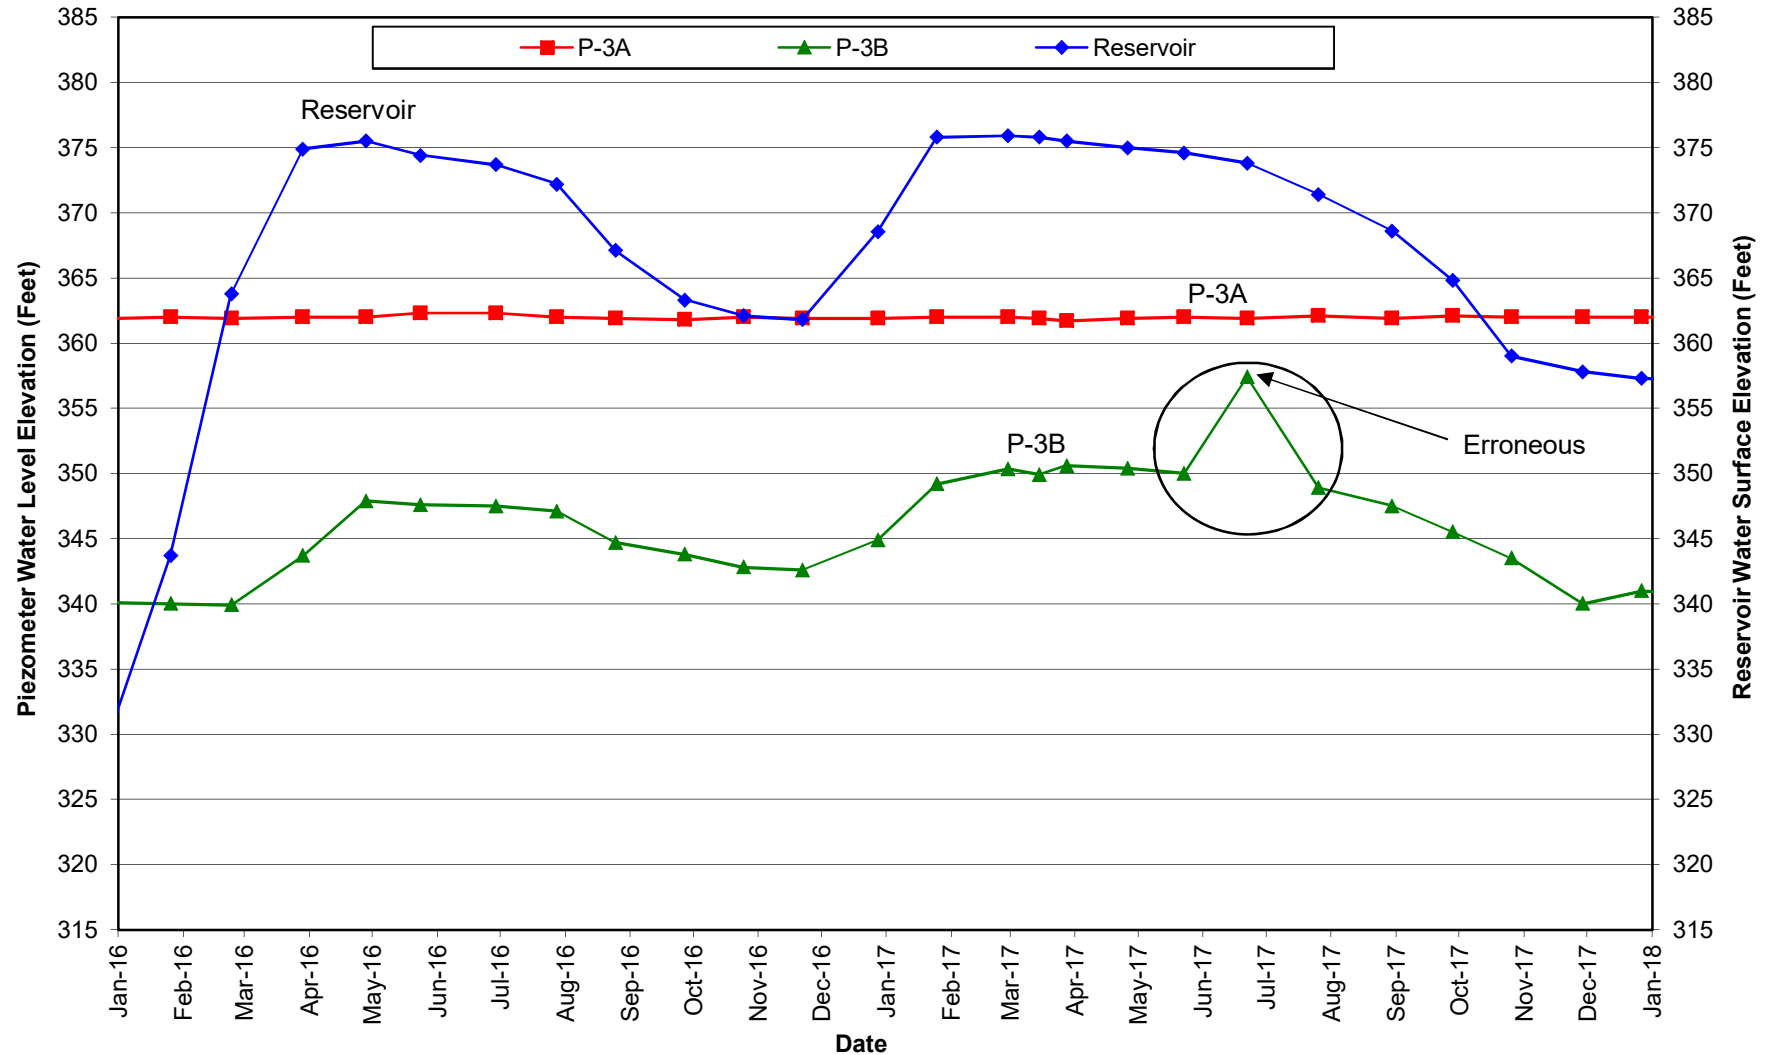
**SYPHON CANYON DAM
2-YR PIEZOMETER AND RESERVOIR WATER SURFACE ELEVATIONS
PIEZOMETERS P-3A AND P-3B
JANUARY 2016 THROUGH DECEMBER 2017**

Piezometer P-3A is nested in the same well as Piezometer P-3B located on the far left portion of the crest of the dam. The tips of both P-3A and P-3B are located within the dam embankment at Elevations 362.3 and 340.3 feet, respectively. Water levels in P-3A remained nearly dry throughout the review period, while P-3B showed water levels that generally responded to reservoir water surface fluctuations (Figures 3C and 4C). A reading taken on June 22, 2017 in P-3B showed a sudden increase in the water level that was higher than historical levels. Following the high reading the water levels returned below Elevation 350 feet. This single measurement is likely erroneous but this piezometer should be closely observed in the future.

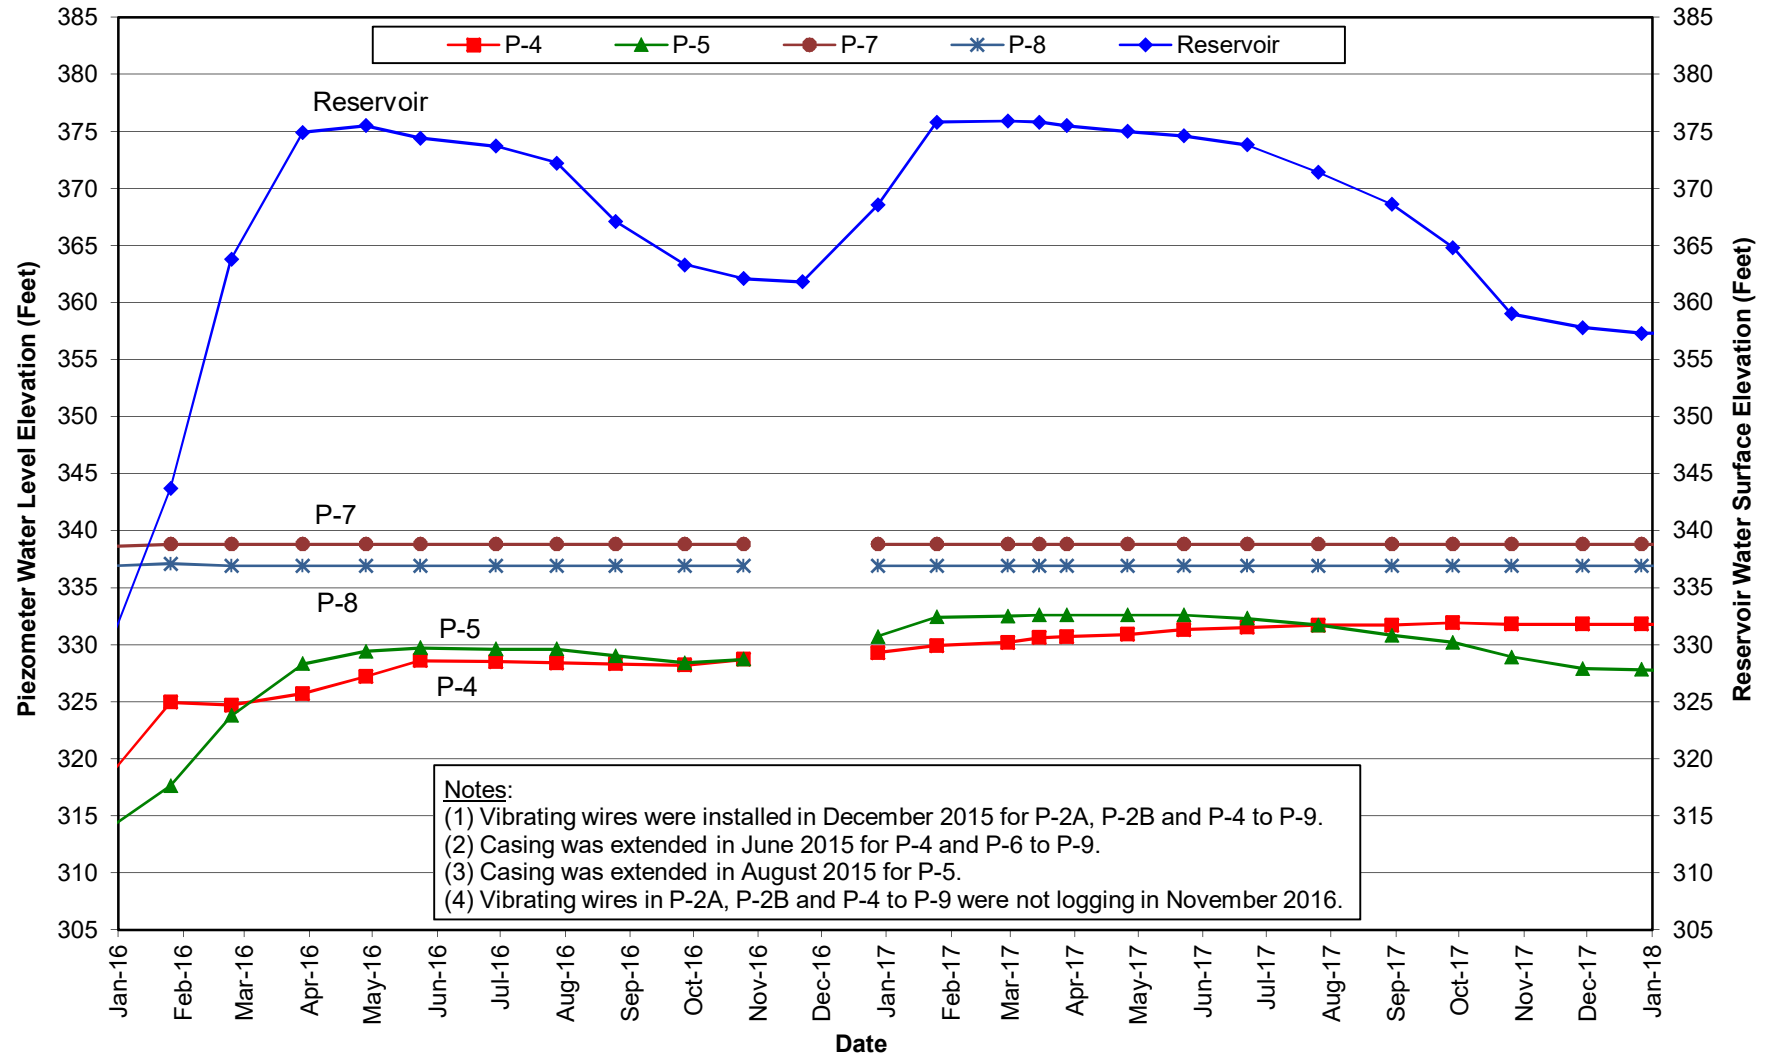
**SYPHON CANYON DAM
2-YR PIEZOMETER AND RESERVOIR WATER SURFACE ELEVATIONS
PIEZOMETERS P-4, P-5, P-7, AND P-8
JANUARY 2016 THROUGH DECEMBER 2017**

Piezometer P-4 is located on the downstream face, near the maximum section of the dam. P-5 is located at the downstream toe, also near the maximum section of the dam. The tips of both P-4 and P-5 are located within the dam foundation at Elevations 314.7 and 314.0 feet, respectively. Water levels in P-4 and P-5 showed general responses to reservoir water surface fluctuations and responded to the reservoir being refilled in early 2016. During the months of June, July and August 2012, Mr. Ken Pfister of the District indicated that Piezometer P-4 was missing its top cap. As a result, water and other debris could have entered the piezometer and caused the abnormal high readings during those months. The cap was replaced in August 2012, and the readings returned to the previously recorded range (Figures 3D and 4D). The top of casings for P-4 and P-5 were raised on June 23, 2015 and August 25, 2015, respectively (Table 2). During the review period, both P-4 and P-5 reported new historical high-water levels of Elevations 331.9 and 332.6 feet, respectively. Since the vibrating wire instruments were installed in December 2015 for P-4 and P-5, water level readings have continued to rise to new historical levels.

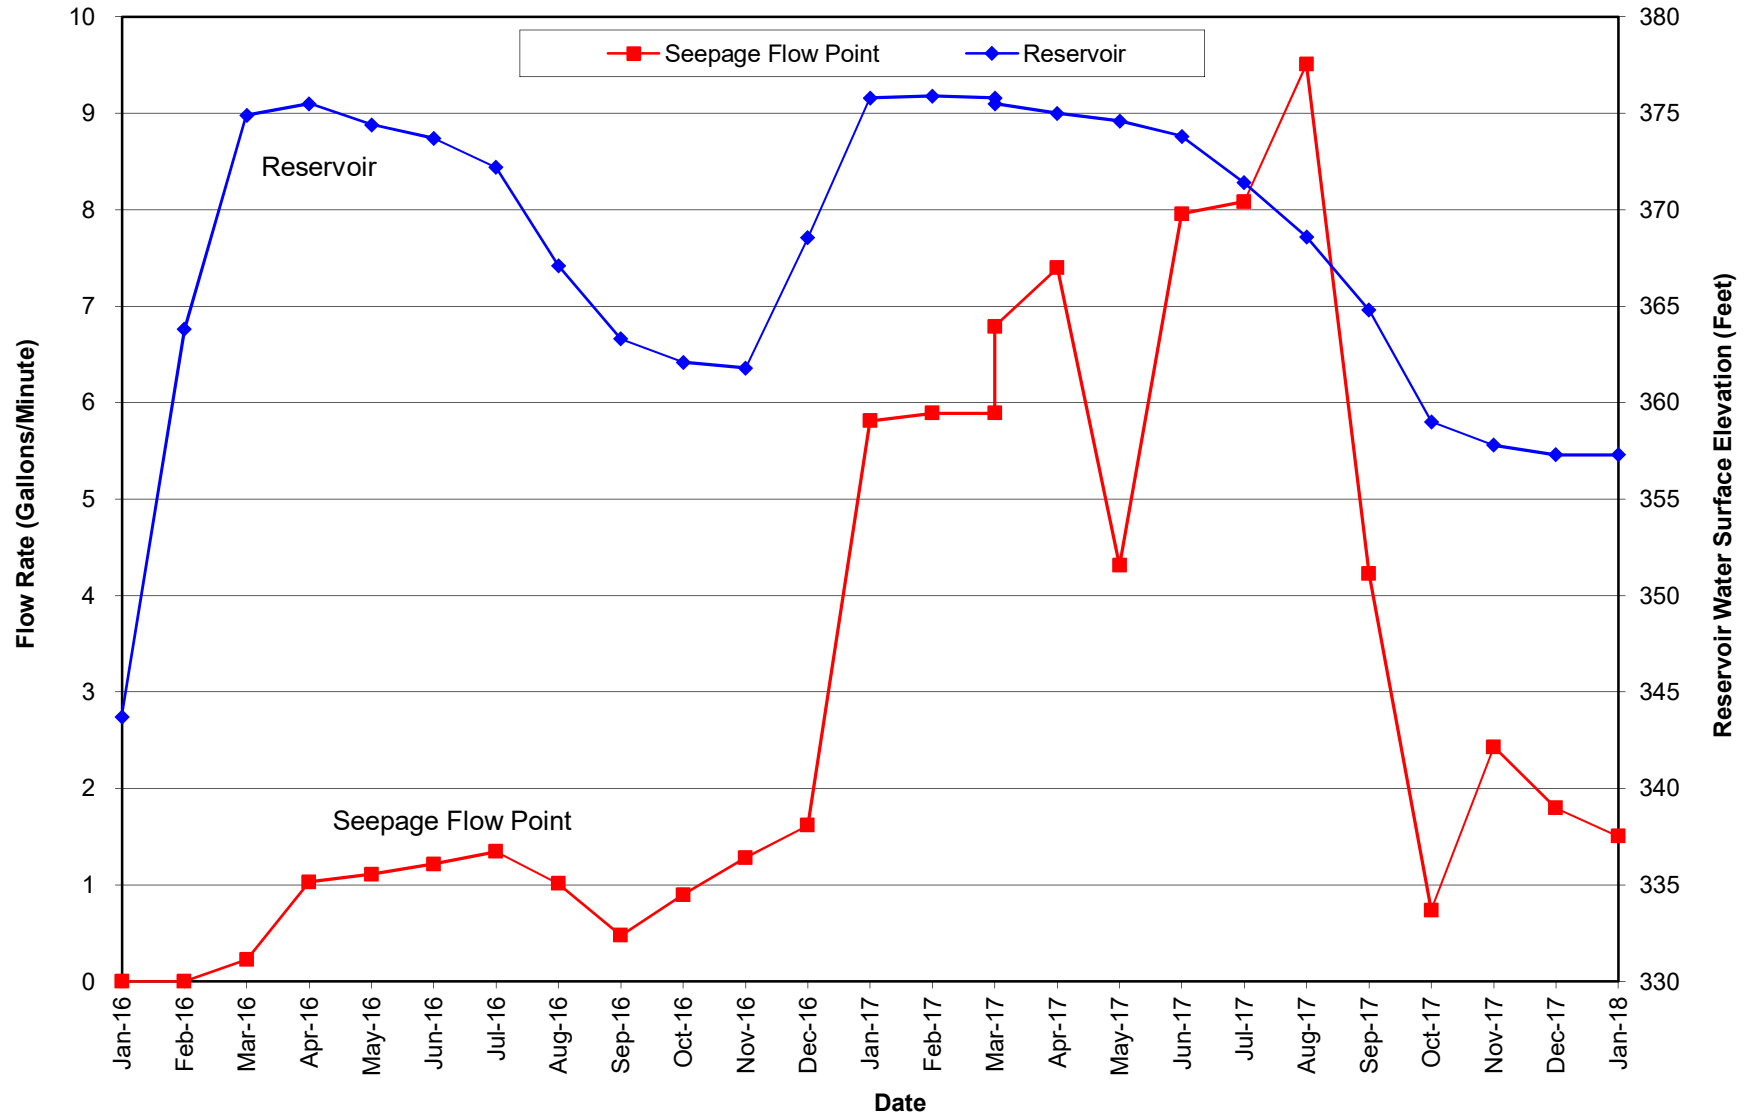
**SYPHON CANYON DAM
2-YR SEEPAGE MEASUREMENTS
SEEPAGE FLOW POINT
JANUARY 2016 THROUGH DECEMBER 2017**

Seepage flow rates have decreased to little or no flow when the reservoir water surface is below approximate Elevation 355 feet. During the 12-month review period, the seepage flow rate ranged from a low of 0.7 gallons per minute on October 26, 2017 to a high of 9.5 gallons per minute on August 30, 2017 (Figure 5).
