**Annual Surveillance Report**  
**January 2018 through December 2018**  
**Sand Canyon Dam**  
**DSOD Dam No. 1029-002**  
**Irvine, CA**  
**June 14, 2019**

**Project No. 397B-IRW**

Subject: Sand Canyon Dam, DSOD Dam No. 1029-002  
Annual Surveillance Report from January 2018 through December 2018

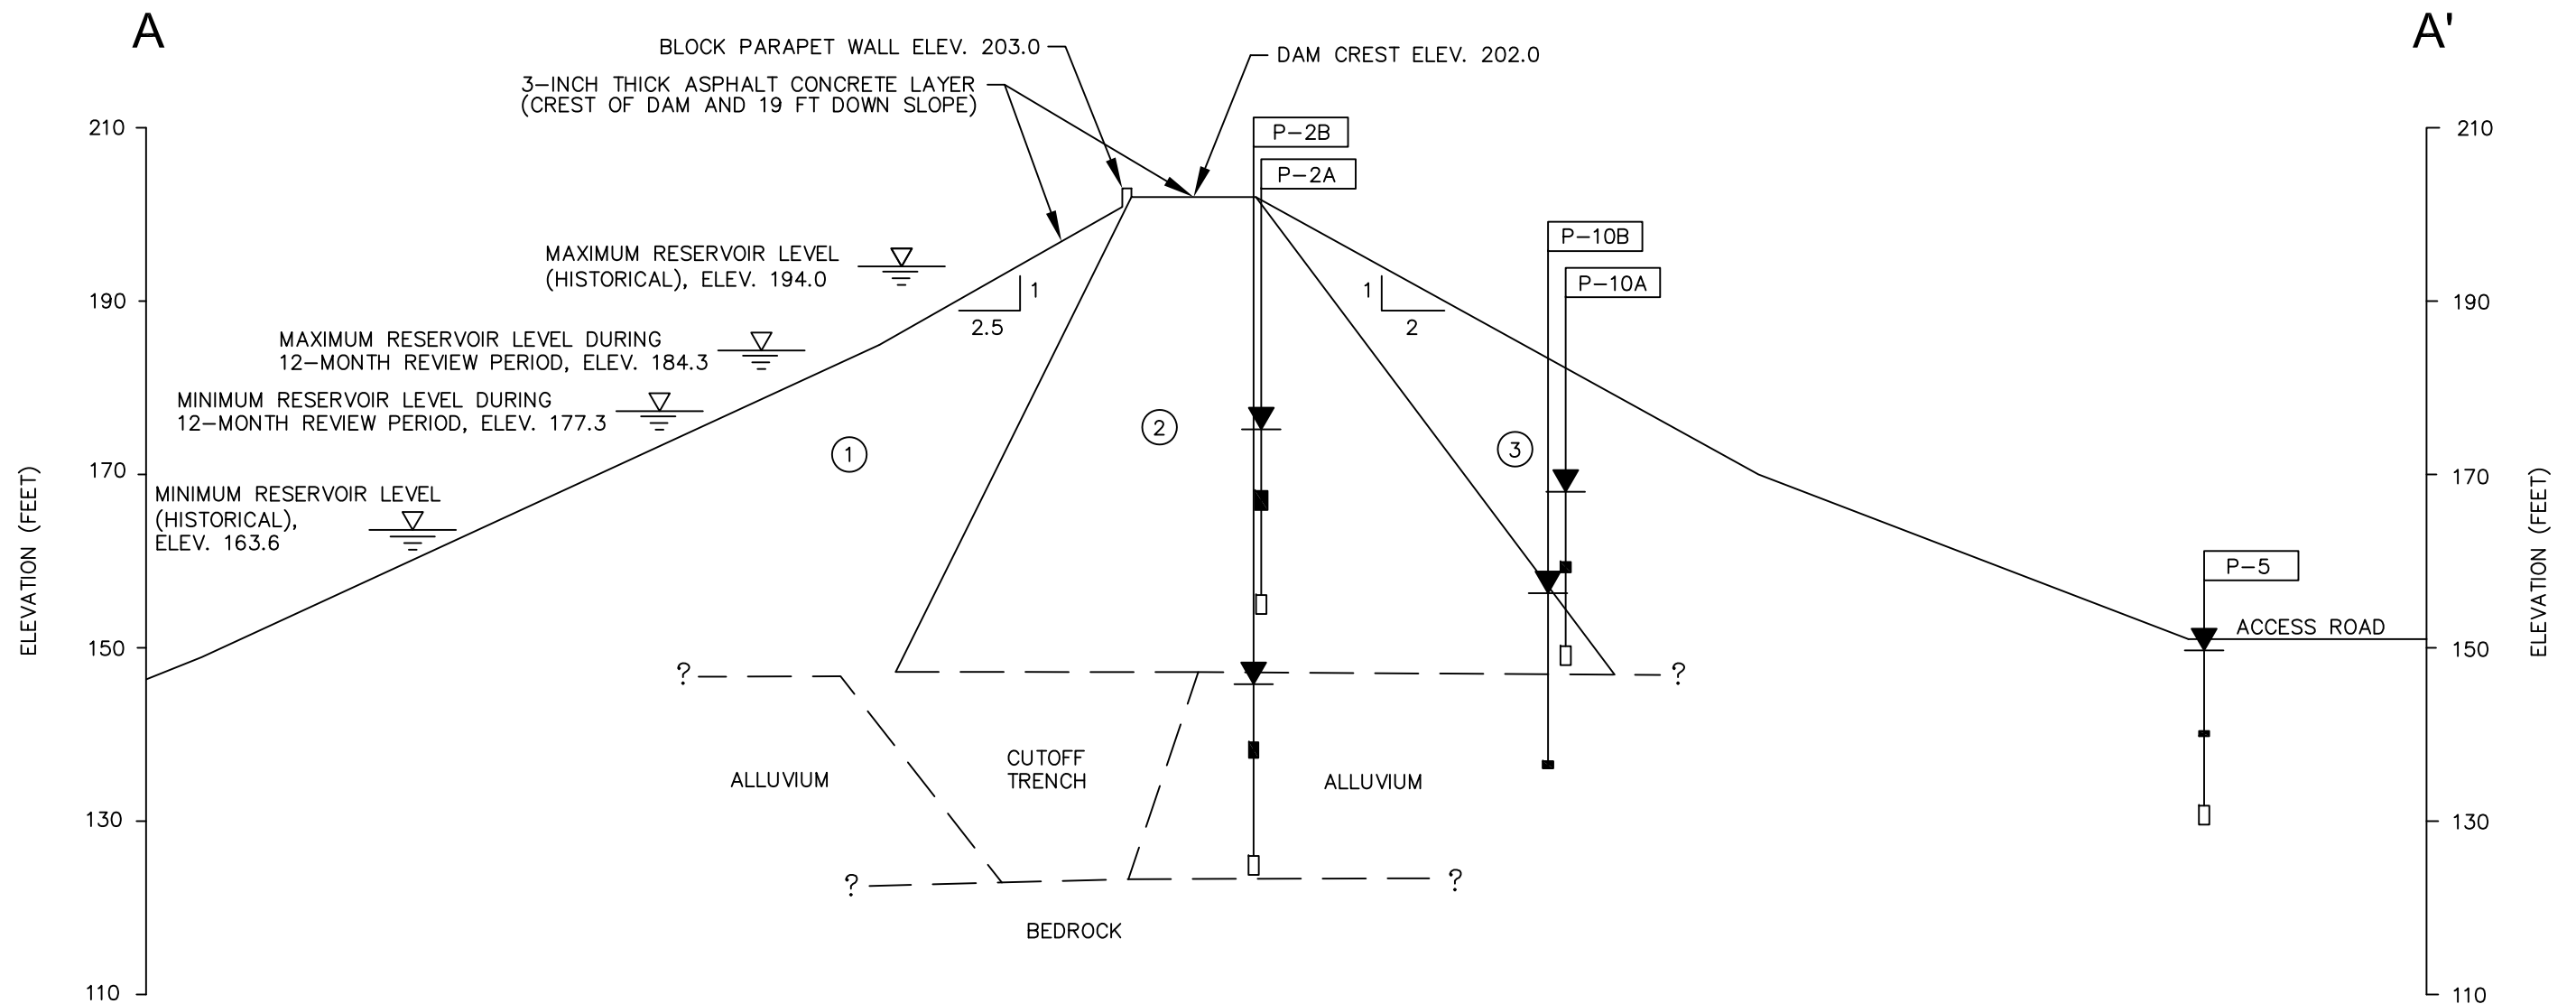
PROJECT NO.	DATE	FIGURE
397B-IRW	JUNE 2019	2

Piezometers P-2A, P-2B, P-5, P-10A, and P-10B are located at or near the section of the dam overlying the maximum depth of the foundation alluvium (Section A-A' on Figure 2). Piezometer P-2A is nested in the same well as Piezometer P-2B and they are situated on the crest of the dam. During July through September 2017 period, water level in P-2A was temporarily higher than the water surface elevation of the reservoir. This temporary condition occurred because, during the period starting from April to July 2017, the elevation of the reservoir water surface had been lowered

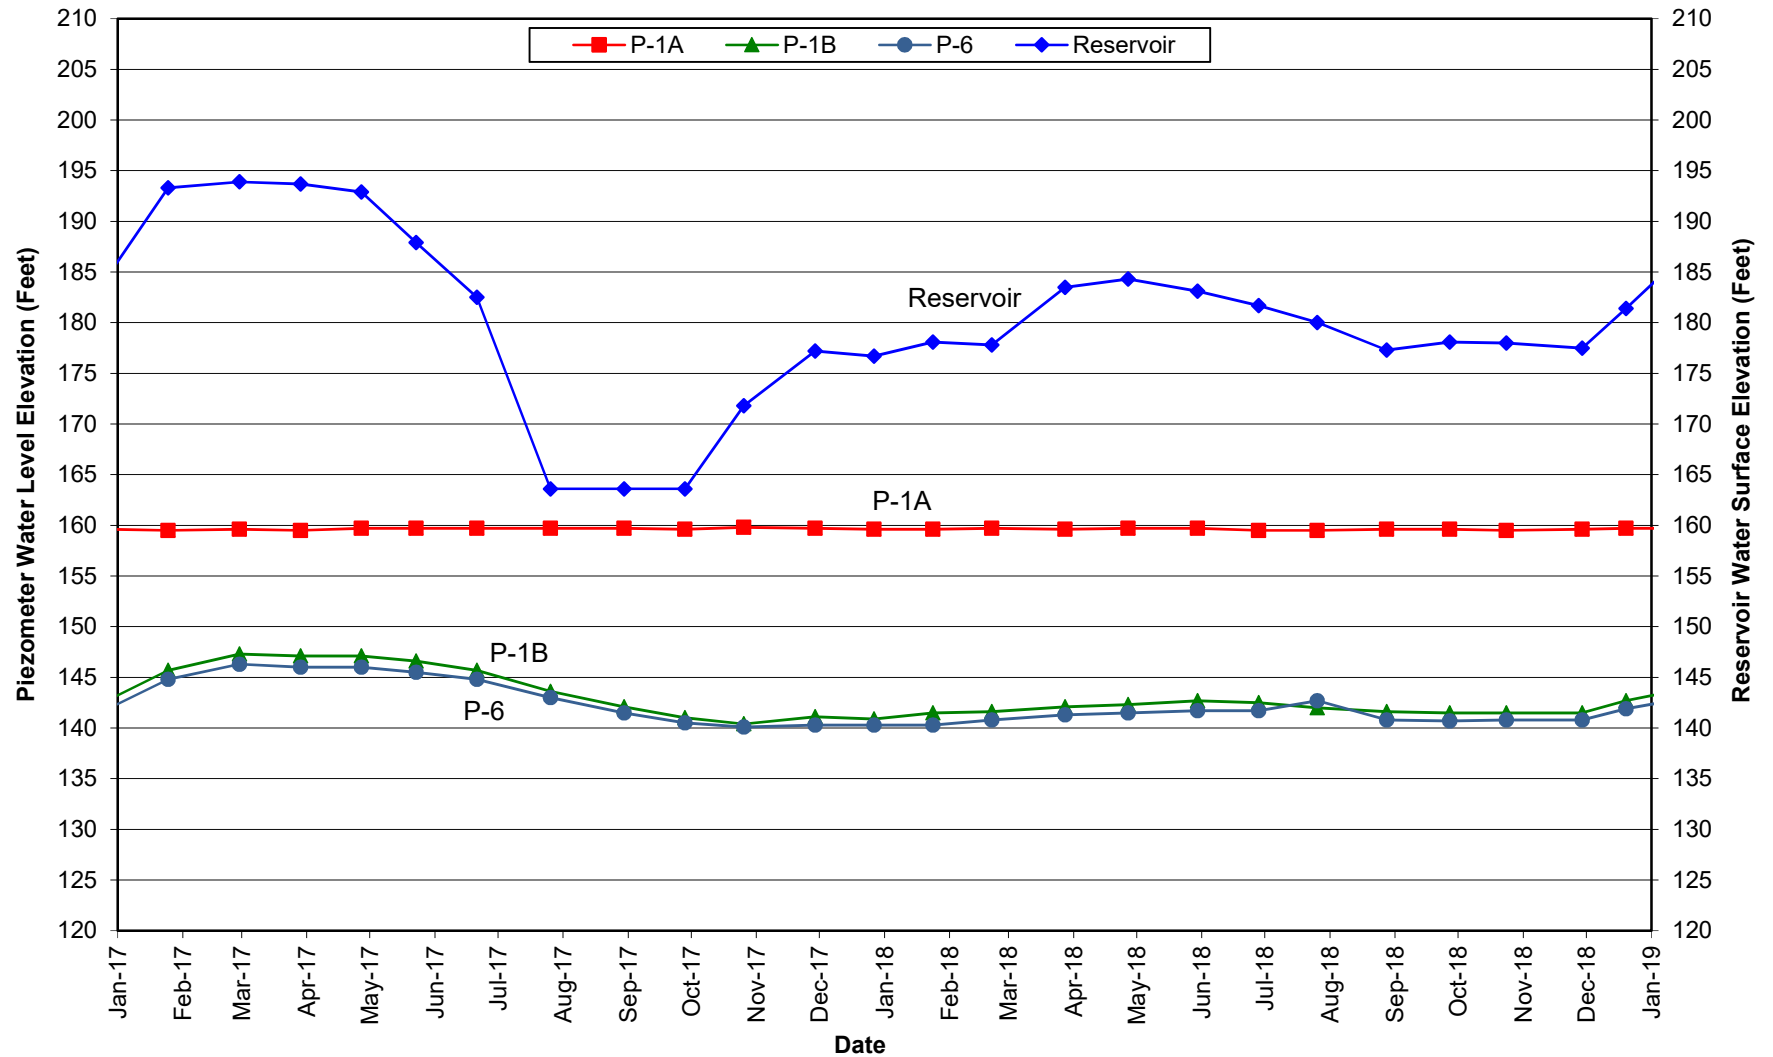
**SAND CANYON DAM  
2-YR PIEZOMETER AND RESERVOIR WATER SURFACE ELEVATIONS  
PIEZOMETERS P-1A, P-1B, AND P-6  
JANUARY 2017 THROUGH DECEMBER 2018**

Piezometers P-1A, P-1B, and P-6 are located in the right portion of the dam. Piezometer P-1A is nested in the same well as Piezometer P-1B on the crest of the dam, while Piezometer P-6 is near the toe. The tip of Piezometer P-1A is located within the dam embankment downstream from the cutoff trench, while Piezometers P-1B and P-6 have tips within the foundation alluvium. Graphs of the water levels during the two-year period from January 2017 through December 2018 are shown on Figure 4A, and those for a 10-year historical period from January 2009 through December 2018 are shown on Figure 5A. Piezometer P-1A has historically shown little to no response to reservoir water surface fluctuations and the water levels tend to stay within a small range. A reading taken on June 28, 2016 is below the reported bottom of the piezometer and is therefore considered as erroneous. During the 12-month review period, the water levels in P-1A remained fairly consistent. Piezometers P-1B and P-6 respond to reservoir water surface fluctuations and the range during the 12-month review period was within the historical water levels. Fluctuations in these two piezometers appear to indicate that water levels within the alluvium do show some response to changes in reservoir water levels.

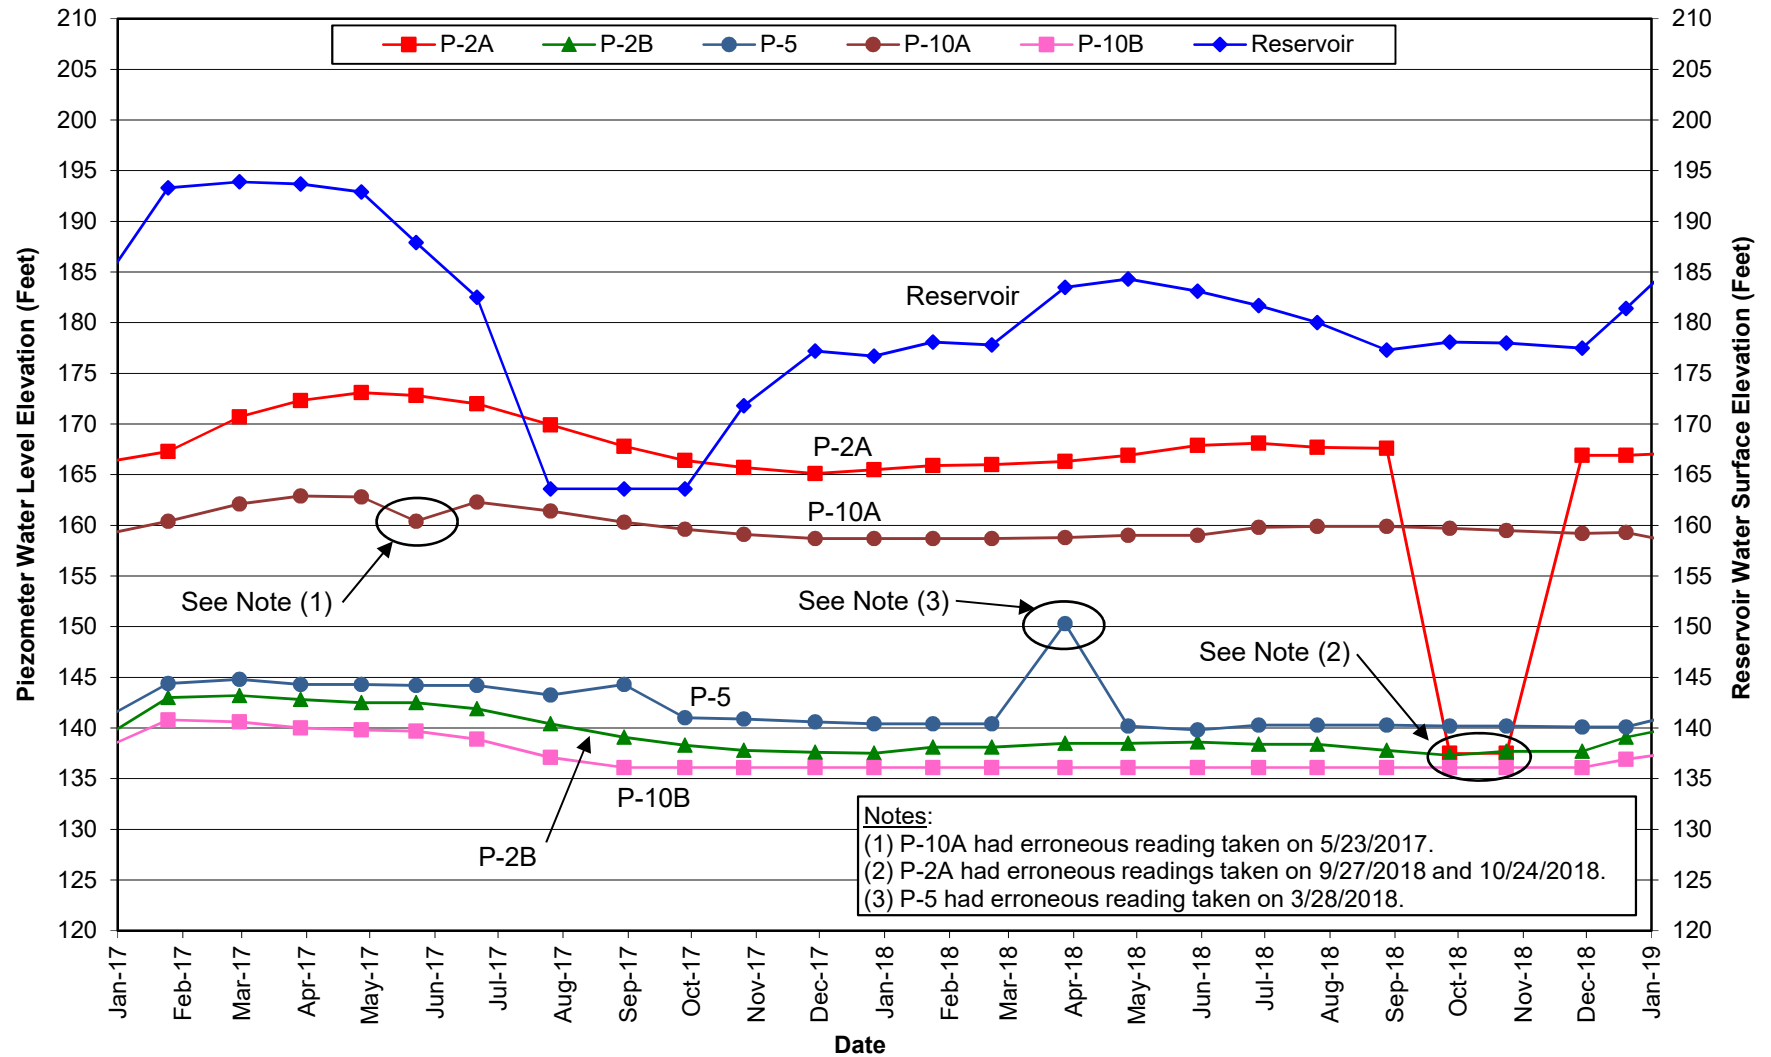
**SAND CANYON DAM  
2-YR PIEZOMETER AND RESERVOIR WATER SURFACE ELEVATIONS  
PIEZOMETERS P-2A, P-2B, P-5, P-10A, AND P-10B  
JANUARY 2017 THROUGH DECEMBER 2018**

Piezometers P-2A and P-10A are installed in the dam embankment, and generally respond to reservoir water surface fluctuations. A reading of the water level in Piezometer P-2A taken on April 4, 2010 showed a sudden increase, followed by the water level readings returning to below Elevation 173 feet. This single measurement is likely erroneous. A reading taken on May 23, 2017 in Piezometer P-10A showed a sudden decrease, followed by higher water level readings. This single measurement is likely erroneous. The water levels observed in these piezometers during this 12-month review period were consistent with historical levels.

Piezometers P-2B, P-5, and P-10B are installed in the foundation alluvium. Piezometers P-2B and P-10B show little response to reservoir water surface fluctuations, while Piezometer P-5 shows very little if any correlation. Readings taken on October 29, 2013, August 26, 2014, March 26, 2015, April 29, 2015, August 26, 2015, and November 24, 2015 in Piezometer P-10B indicated sudden increases in the water level in that piezometer. Following those high readings however, the water level returned to below Elevation 140 feet. Therefore, those measurements were likely erroneous. The water levels observed in these piezometers during this 12-month review period were generally consistent with historical levels.

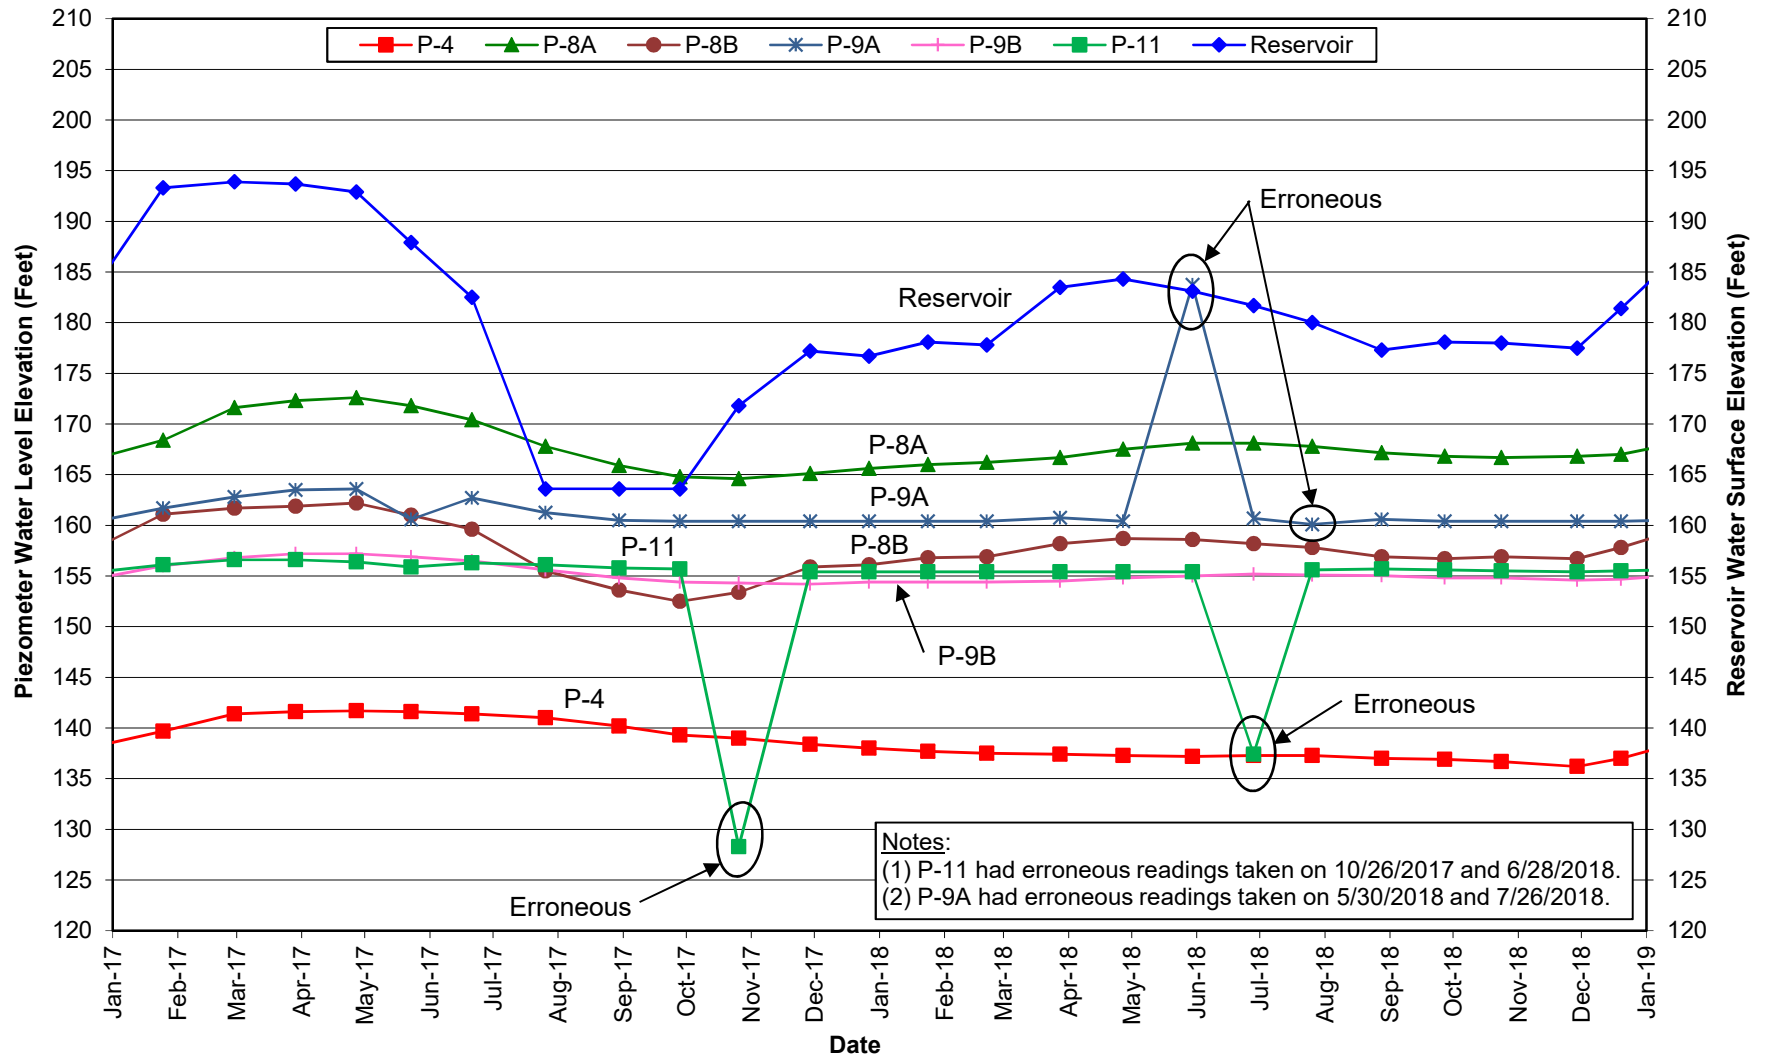
**SAND CANYON DAM  
2-YR PIEZOMETER AND RESERVOIR WATER SURFACE ELEVATIONS  
PIEZOMETERS P-4, P-8A, P-8B, P-9A, P-9B, AND P-11  
JANUARY 2017 THROUGH DECEMBER 2018**

Piezometers P-4 and P-8B are installed in foundation bedrock, and P-9B is installed in foundation alluvium. Piezometers P-8B and P-9B generally respond to reservoir water surface fluctuations, while increases and decreases in Piezometer P-4 may be related to rainwater. On August 26, 2014, a sudden decrease to a dry reading was reported in Piezometer P-9B, followed by water level readings returning to Elevation 155 feet. This single measurement is likely erroneous. The water levels observed in these piezometers during this 12-month review period were consistent with historical levels.

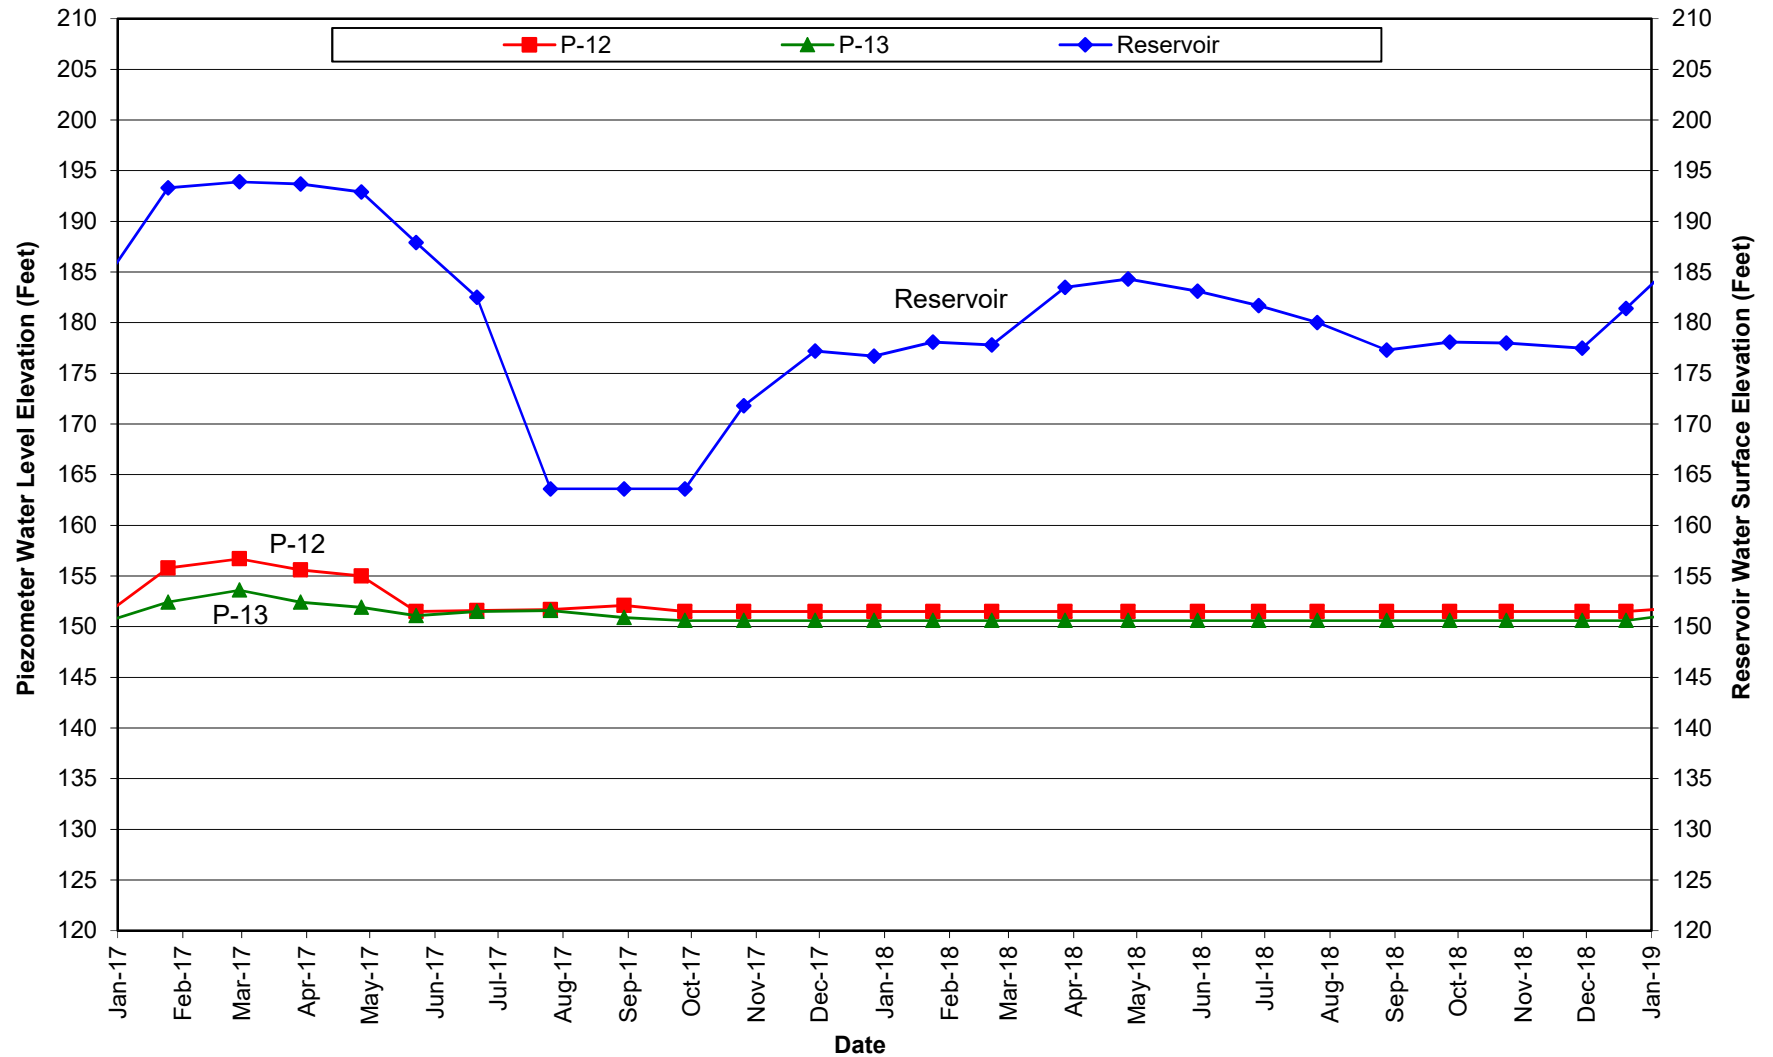
**SAND CANYON DAM  
2-YR PIEZOMETER AND RESERVOIR WATER SURFACE ELEVATIONS  
PIEZOMETERS P-12 AND P-13  
JANUARY 2017 THROUGH DECEMBER 2018**

Piezometers P-12 and P-13 are located on the downstream face of the dam near the toe between Sections A-A' and B-B'. Graphs of the water levels during the two-year period from January 2017 through December 2018 are shown on Figure 4E, and those for a 10-year historical period from January 2009 through December 2018 are shown on Figure 5E. The tip elevation of these two piezometers is believed to be in the dam embankment. Water levels observed in these piezometers show some response to reservoir water surface fluctuations, and they are at about the same elevation (approximately 153 feet) as that of the invert of the Right Subdrain. On October 26, 2010, a dry

reading was reported in Piezometer P-12 that corresponds to a water level approximately 2 feet above the reported bottom of the piezometer. This reading is considered as erroneous. A reading taken on August 29, 2012 was below the reported bottom elevation of the piezometer and was therefore considered as erroneous. The water levels observed in these piezometers during this 12-month review period were consistent with historical levels.

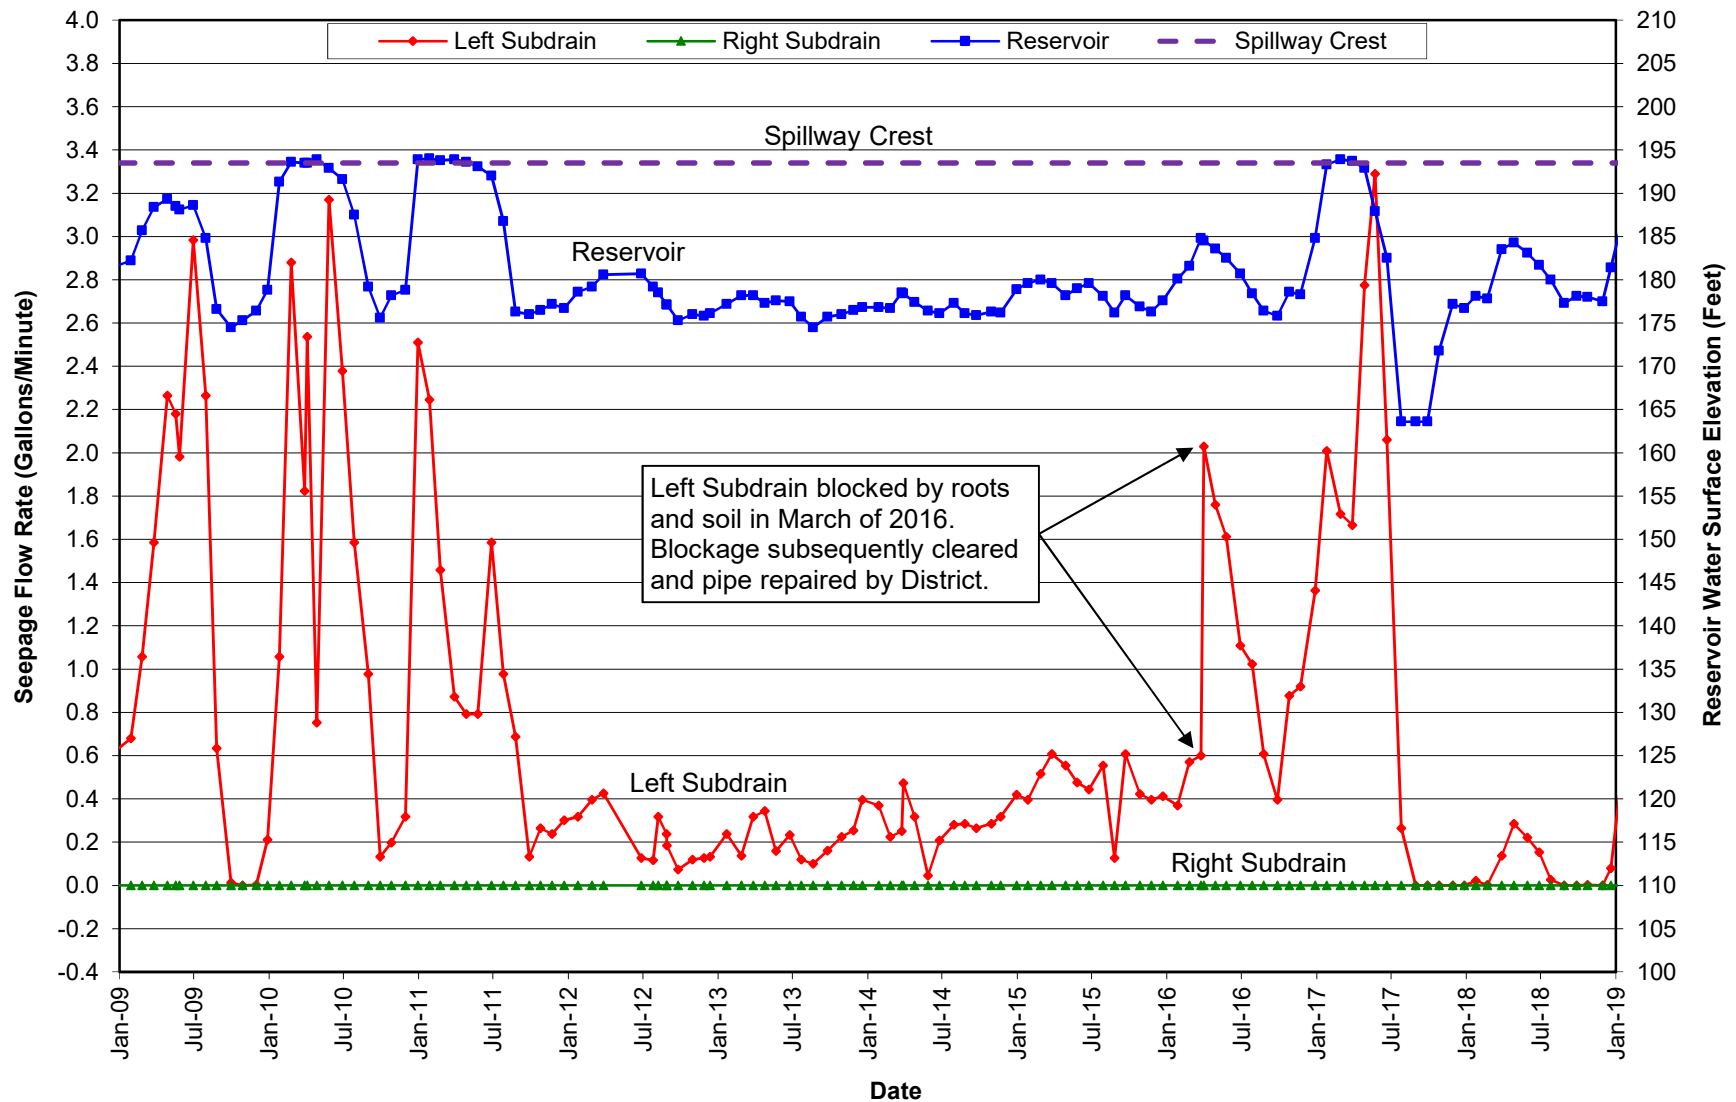
**SAND CANYON DAM**  
**10-YR HISTORICAL SEEPAGE FLOW RATES AND RESERVOIR WATER SURFACE ELEVATIONS**  
**JANUARY 2009 THROUGH DECEMBER 2018**

on Figure 7 shows that the seepage flow rate through the Left Subdrain tends to increase when the reservoir water surface is above an elevation of approximately 180 feet. The flow rate then decreases to less than 0.5 gallons per minute (gpm) when the reservoir water surface remains below Elevation 180 feet. As noted in Section 2.2 of this report, it is likely that a semi-pervious zone on top of the bedrock remains in place beneath the left portion of the dam. If present, such a zone would account for much of the seepage that is intercepted by the Left Subdrain. The flows should continue to be observed for clarity to check for the presence of any suspended solids that might indicate a potential piping condition.

During this 12-month review period, the Right Subdrain was dry, and the Left Subdrain flow rate ranged from no flow from August through November 2018, to a maximum flow rate of 0.29 gpm on April 27, 2018. Based on historical data, the maximum flow rate of 3.96 gpm was measured from the Left Subdrain on June 28, 2000. Based on GENTERRA's review of the subdrain data, the flow rates appear to be consistent with historical flow rates and there are no indications of any adverse conditions.

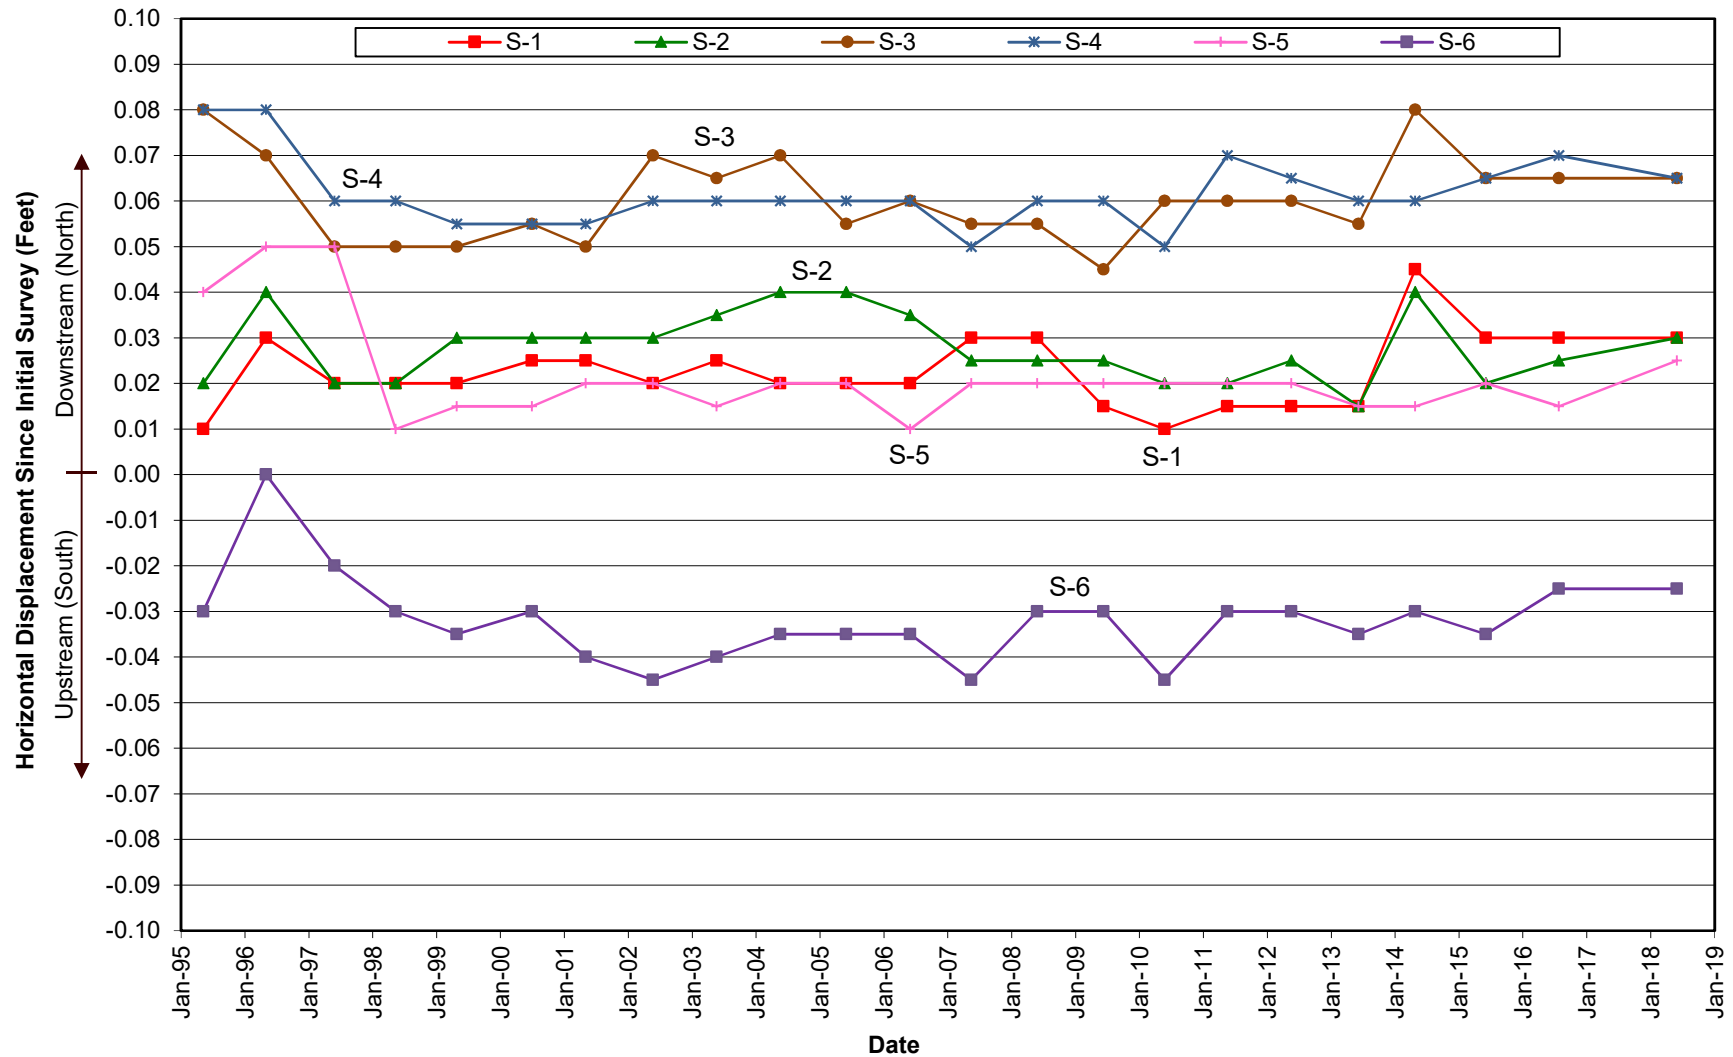
FIGURE 8

Based on GENTERRA's review of the survey data, the horizontal and vertical displacements of survey monuments appear to be minimal and consistent with historical surveys. There are no indications of any adverse conditions as determined from data obtained through 2018.
