Annual Surveillance Report
January 2018 through December 2018
Santiago Creek Dam
DSOD Dam No. 75-000
Irvine, CA
June 26, 2019

**ANNUAL SURVEILLANCE REPORT
JANUARY 2018 THROUGH DECEMBER 2018
FOR
SANTIAGO CREEK DAM
DSOD DAM NO. 75-000
IRVINE, CALIFORNIA**

Subject: Santiago Creek Dam, DSOD Dam No. 75-000,
Annual Surveillance Report, January 2018 through December 2018

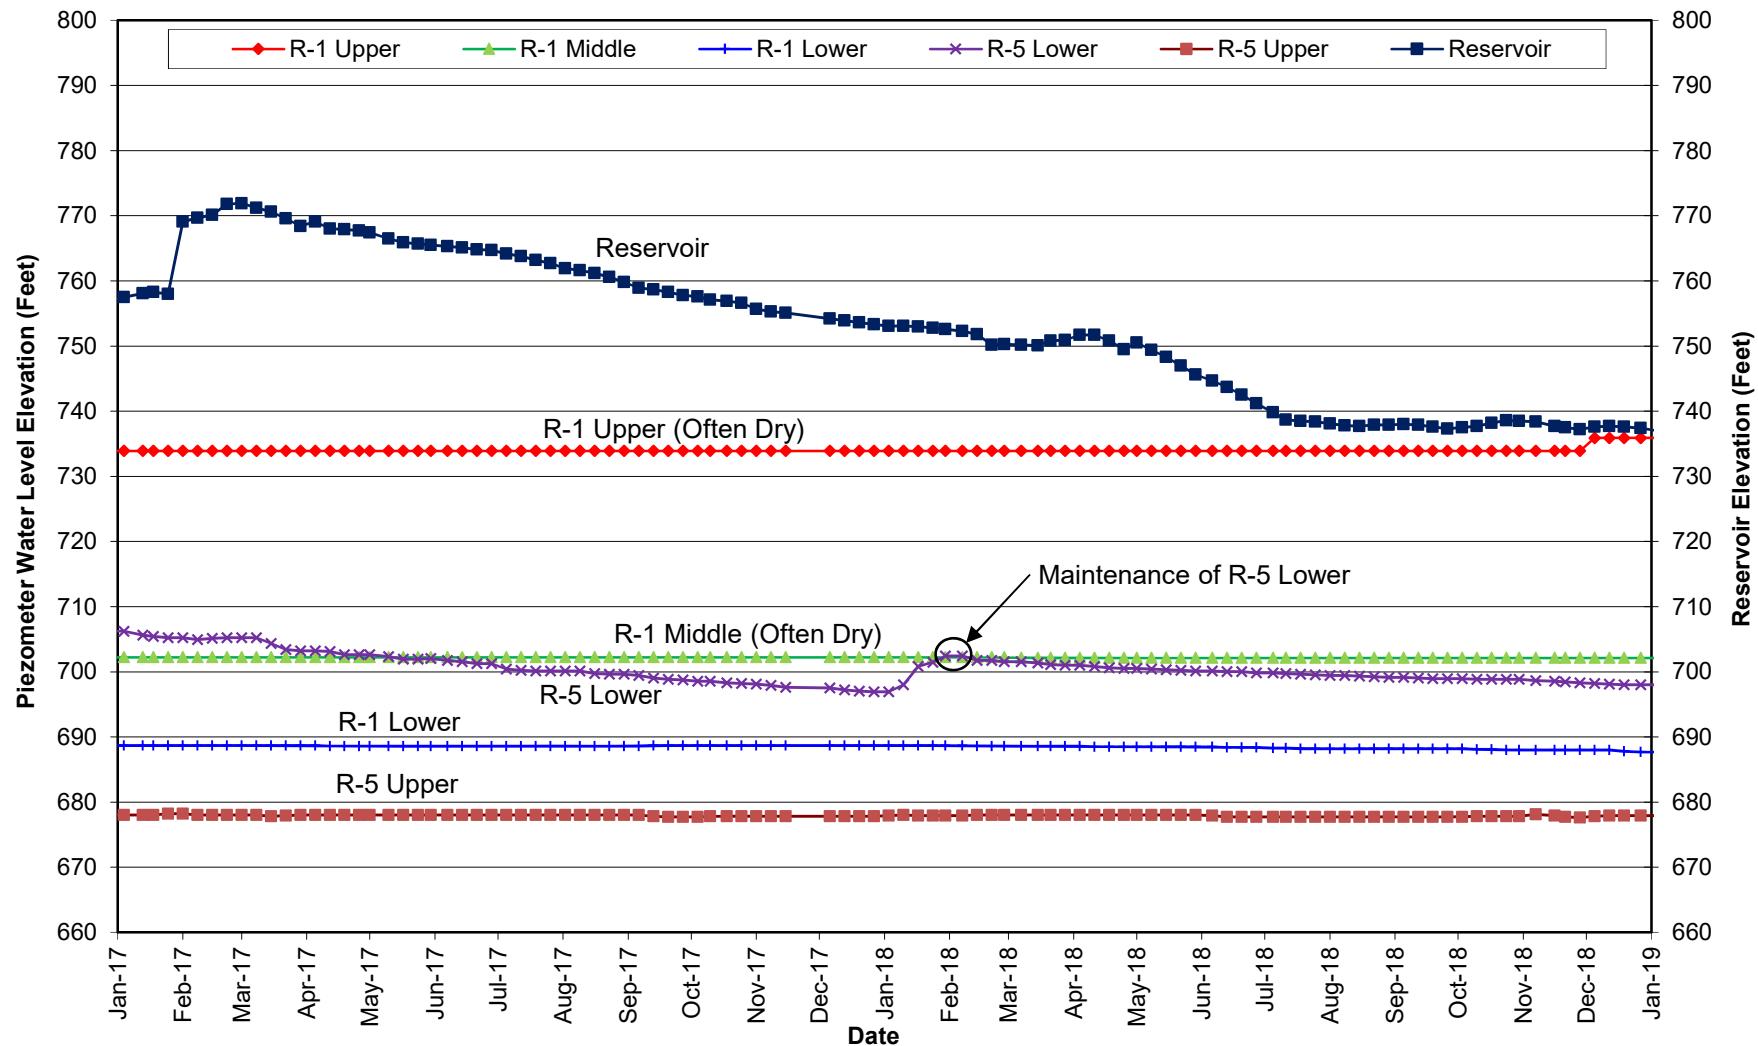
**SANTIAGO CREEK DAM
2-YR PIEZOMETER LEVELS
PIEZOMETERS R-1 AND R-5
JANUARY 2017 THROUGH DECEMBER 2018**

Piezometer R-1 is located on the dam crest near Station 6+00. Figures 2A and 3A present time-series graphs of the water levels measured in Piezometers R-1 Upper, R-1 Middle, and R-1 Lower. Piezometer R-1 Upper was installed in the pervious shell material and was dry throughout the review period, except for a reported water level increase in December 2018. Piezometer R-1 Middle has its tip near the base of the pervious shell material and was dry throughout the review period. Piezometer R-1 Lower was installed in the underlying bedrock foundation. It should be noted that the cross-sections shown on Figures 1B, 1C, and 1D are approximate, and that the contact lines

Lower. Piezometer R-5 Upper was installed in foundation alluvium and showed water levels that remained relatively constant throughout the review period. Piezometer R-5 Lower has its tip in bedrock, and water levels generally declined during the review period. A maintenance cleaning was reportedly performed on Piezometer R-5 Lower in July 2015, and the resulting effects can be seen on Figure 3A as an increase in the water level of approximately 8.4 feet in this piezometer. The water levels in this piezometer have gradually lowered since the cleaning was performed. Based on a review of historical data, it is likely that this piezometer was plugged starting in late 2010. Attempts at clearing the blockage had not resulted in the piezometer's water levels returning to historical levels, which are around an elevation of 670 feet. GENTERRA performed bailing and cleaning of Piezometer R-5 Lower on February 8, 2018 to evaluate the condition of the piezometer. GENTERRA was not able to remove the blockage that is present at a depth of 15 feet.

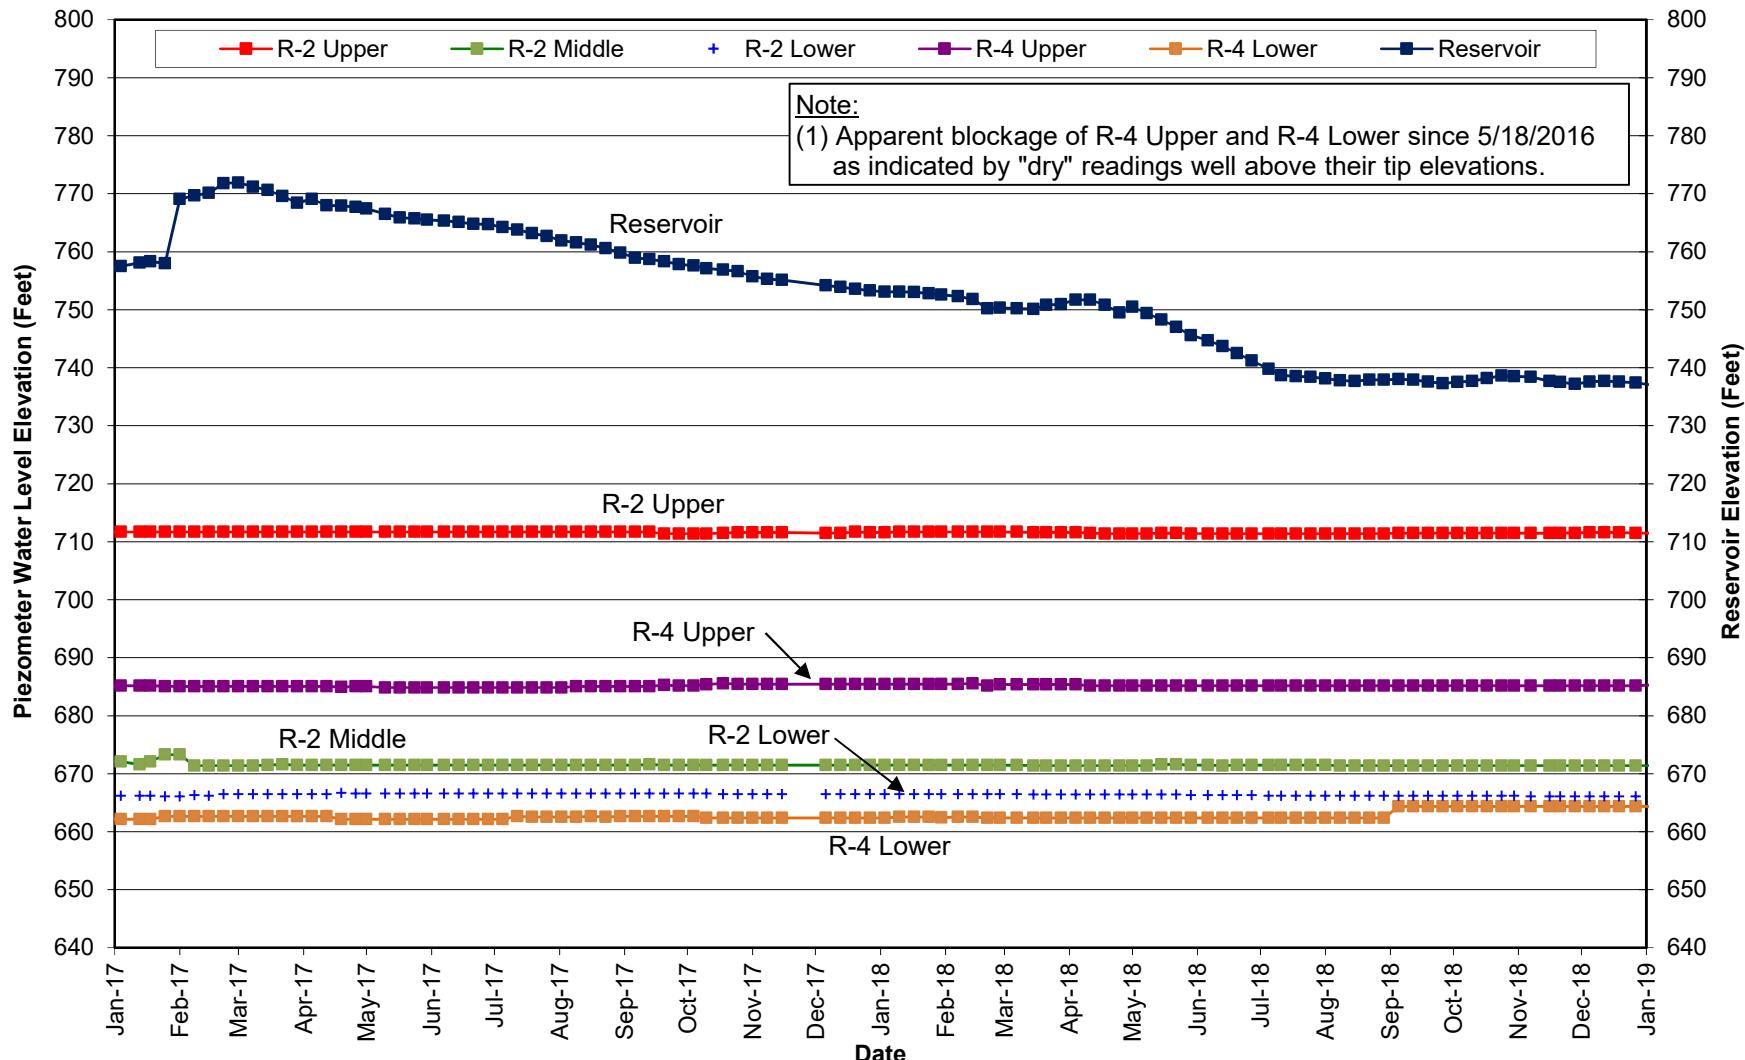
**SANTIAGO CREEK DAM
2-YR PIEZOMETER LEVELS
PIEZOMETERS R-2 AND R-4
JANUARY 2017 THROUGH DECEMBER 2018**

Piezometer R-2 is located on the dam crest near Station 2+50. Figures 2B and 3B present plots of the water levels measured in Piezometers R-2 Upper, R-2 Middle, and R-2 Lower. Piezometer R-2 Upper was installed in the pervious shell material, and the water level in this piezometer did not respond to reservoir fluctuations since September 2012. Water levels in R-2 Upper tend to respond to reservoir fluctuations following periods when the reservoir pool is at or above an elevation of approximately 775 feet. Piezometer R-2 Middle was installed in the foundation alluvium underlying the dam embankment and was fairly constant throughout the review period. In review of previous years recorded readings, there may be 1 to 1.5 feet of sediment accumulated in the piezometer. It is possible that the perforated zone is blocked and is therefore resulting in no response to reservoir water level changes. GENTERRA recommends a maintenance cleaning of Piezometer R-2 Middle to further evaluate the condition of the piezometer. Piezometer R-2 Lower is in the foundation bedrock, and the water level generally has not responded to reservoir water level changes since May 2013.

Piezometer R-4 is located on the downstream bench of the dam, downstream of Piezometer R-2. Figures 2B and 3B are plots of the water levels measured in Piezometers R-4 Upper and R-4 Lower. Piezometer R-4 Upper was installed in foundation alluvium. A maintenance cleaning of R-4 Upper was performed in July 2015, resulting in the water levels in this piezometer dropping by approximately 10 feet. After the cleaning, the water levels in Piezometer R-4 Upper remained between an elevation of 682 feet and 686 feet. Water levels in Piezometer R-4 Upper showed very little fluctuation throughout the current review period. Piezometer R-4 Lower was installed in the underlying bedrock and was reported during this review period as being dry from March 7, 2018 through the end of December 2018.

- 4.2.4** GENTERRA recommends that the Districts perform a maintenance cleaning of Piezometers R-2 Upper, R-2 Middle and R-3 Middle to further evaluate the condition of these piezometers. GENTERRA also recommends cleanings of Piezometer R-4 Lower, R-4 Upper, Piezometer R-7 Upper, and Piezometer No. 3 to remove accumulated debris and sediment from the bottom portions of these piezometers.

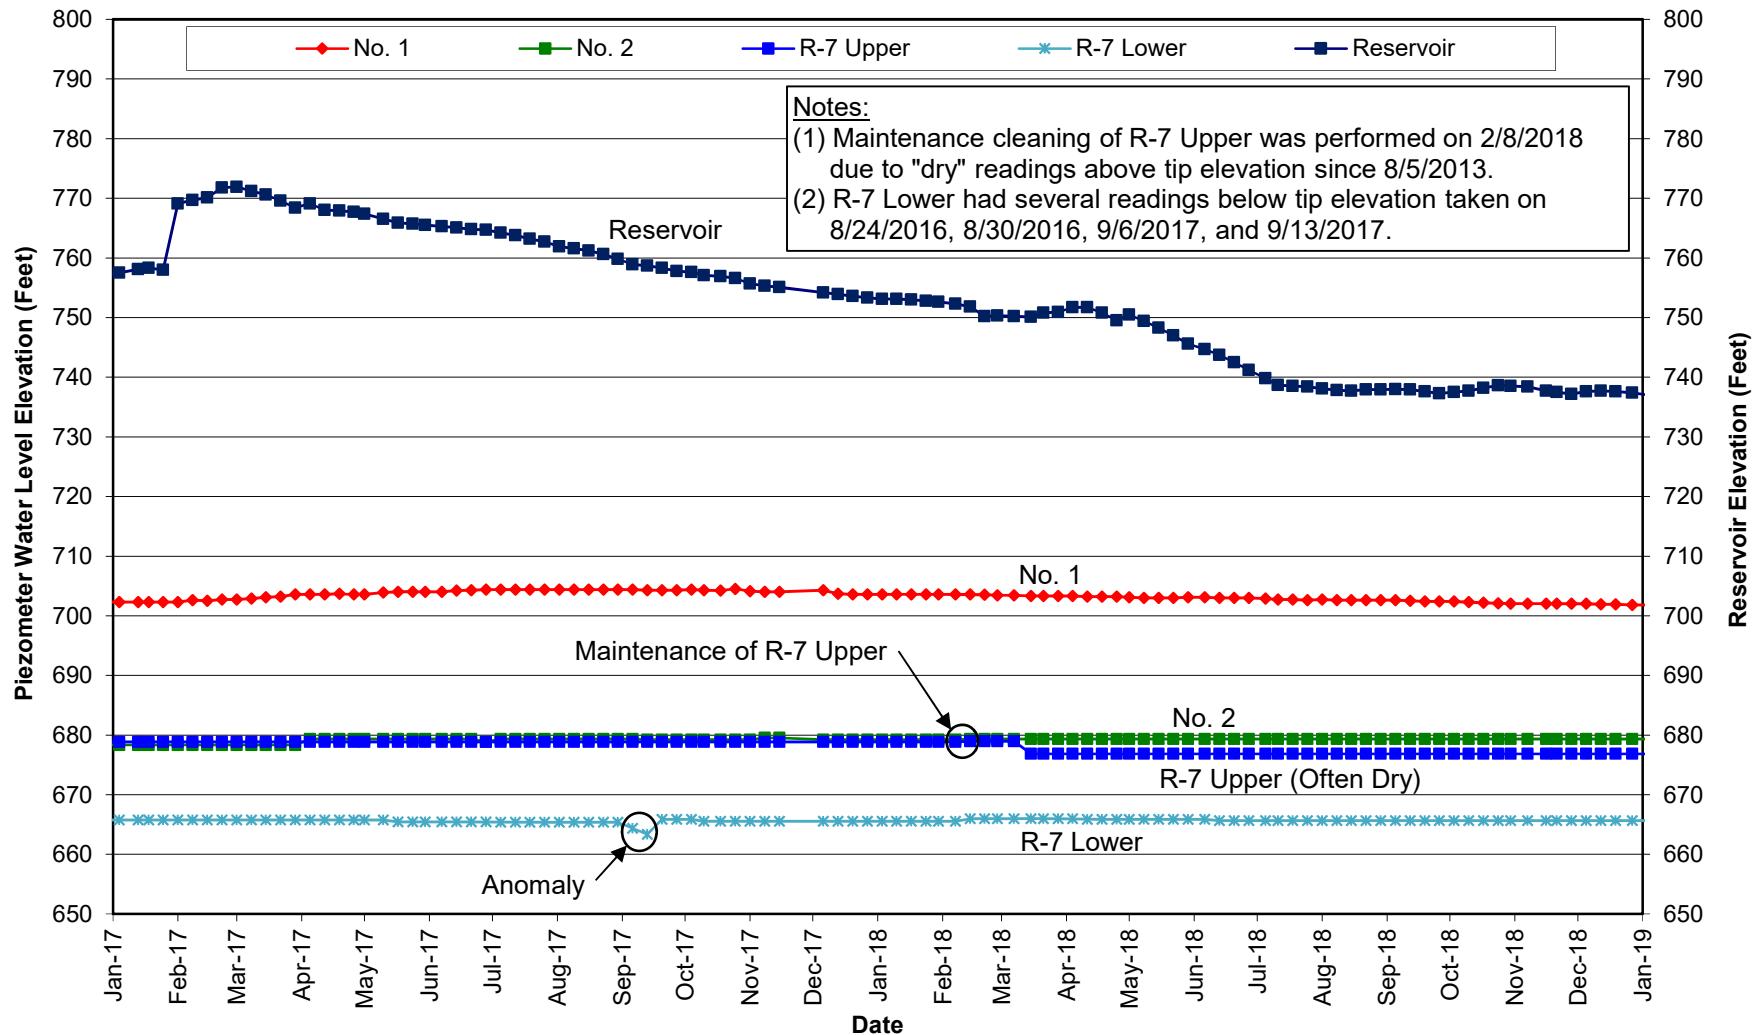
**SANTIAGO CREEK DAM
2-YR PIEZOMETER LEVELS
PIEZOMETERS No. 1, No. 2, AND R-7
JANUARY 2017 THROUGH DECEMBER 2018**

Piezometer No. 2 is located at the downstream toe of the dam, downstream of Piezometer No. 1. Figures 2E and 3E are graphs of water levels measured in Piezometer No. 2. This piezometer, installed in the foundation alluvium, showed little variation, and no discernable response to reservoir

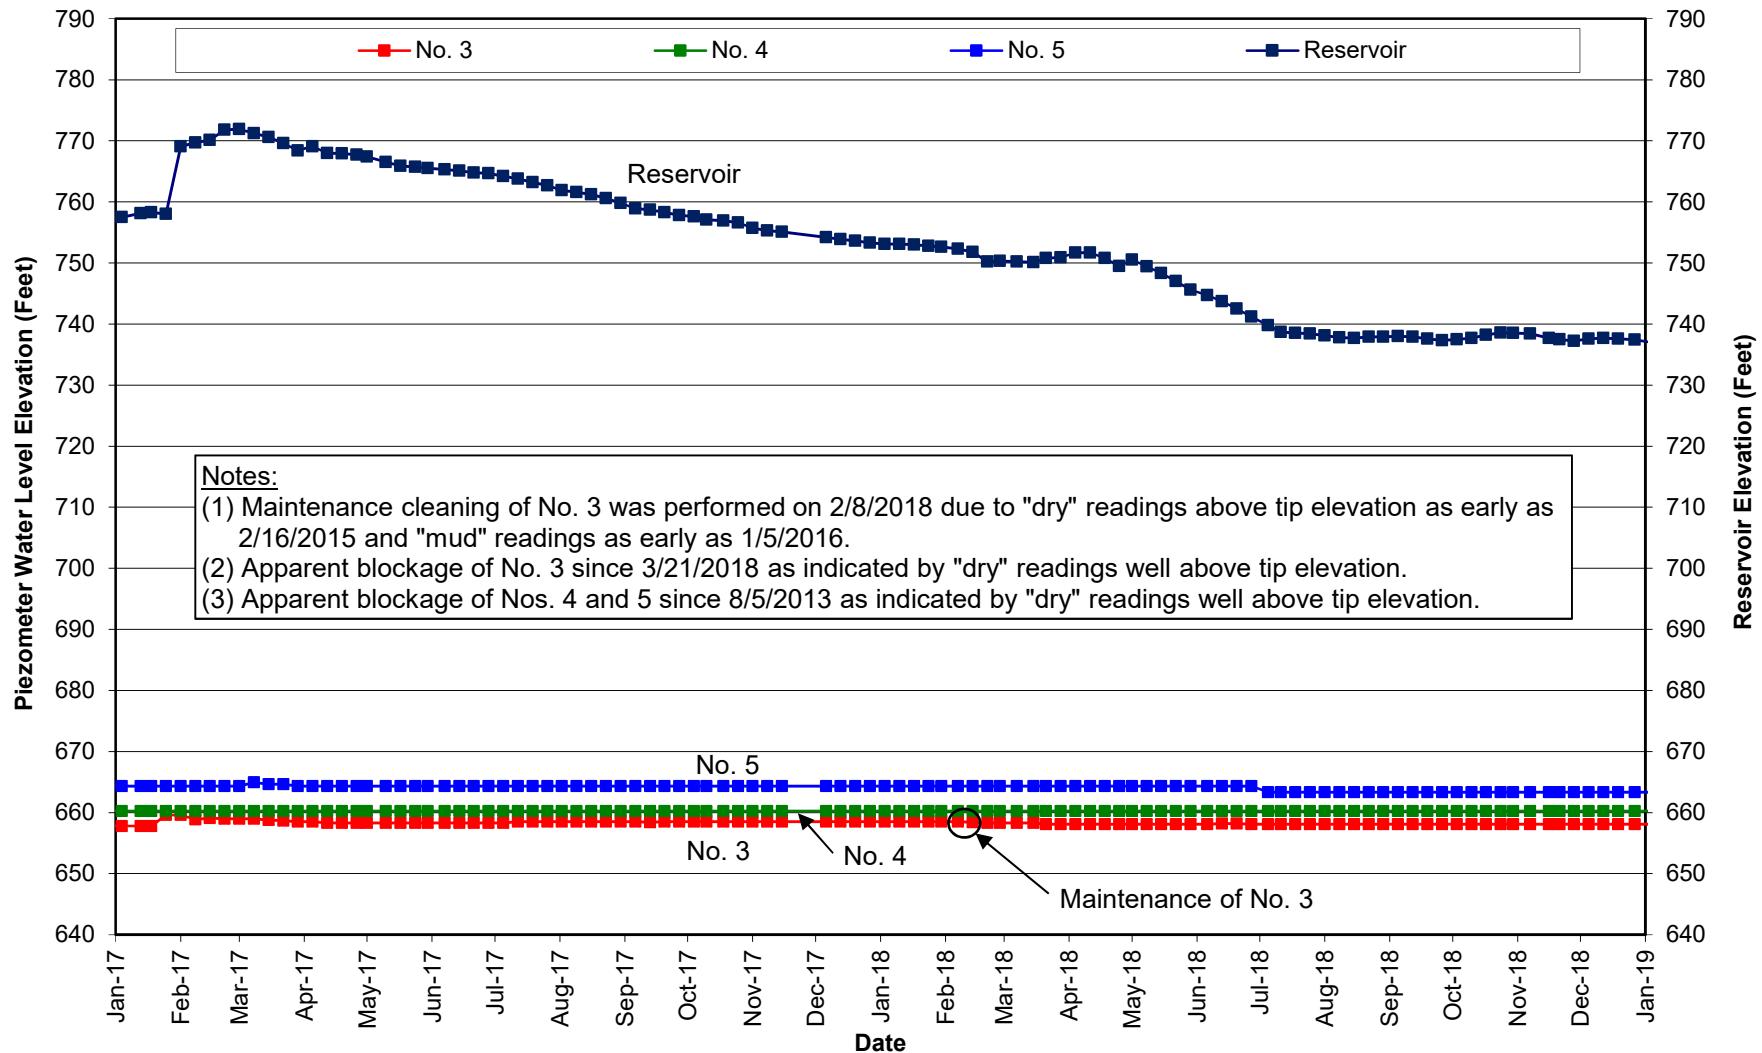
**SANTIAGO CREEK DAM
2-YR PIEZOMETER LEVELS
PIEZOMETERS No. 3, No. 4, and No. 5
JANUARY 2017 THROUGH DECEMBER 2018**

According to the Irvine Ranch Water District, Piezometers No. 3, No. 4, and No. 5 are two-inch-diameter piezometers that were installed along the downstream toe of the dam by GeoPentech. These piezometers were installed in boreholes that had been drilled during an investigation into the alluvial deposits below the dam's foundation as part of GeoPentech's liquefaction evaluation. No adverse conditions or trends were observed in the piezometers' readings during the current reporting period. The first recorded reading of these piezometers took place on November 5, 2011. The data are plotted in Figures 2F and 3F. There were minor variations in the piezometers' water levels during the current reporting period. An accumulation of mud had been encountered by Serrano personnel in the bottom of Piezometer 3 during the previous reporting period. GENTERRA performed a careful maintenance cleaning of Piezometer No. 3 on February 8, 2018. The cleaning succeeded in removing a substantial amount of the mud that had built up at the bottom of the piezometer, the District should consider performing another round of cleaning. Piezometer No. 4 was reported as being dry throughout the 12-month review period.

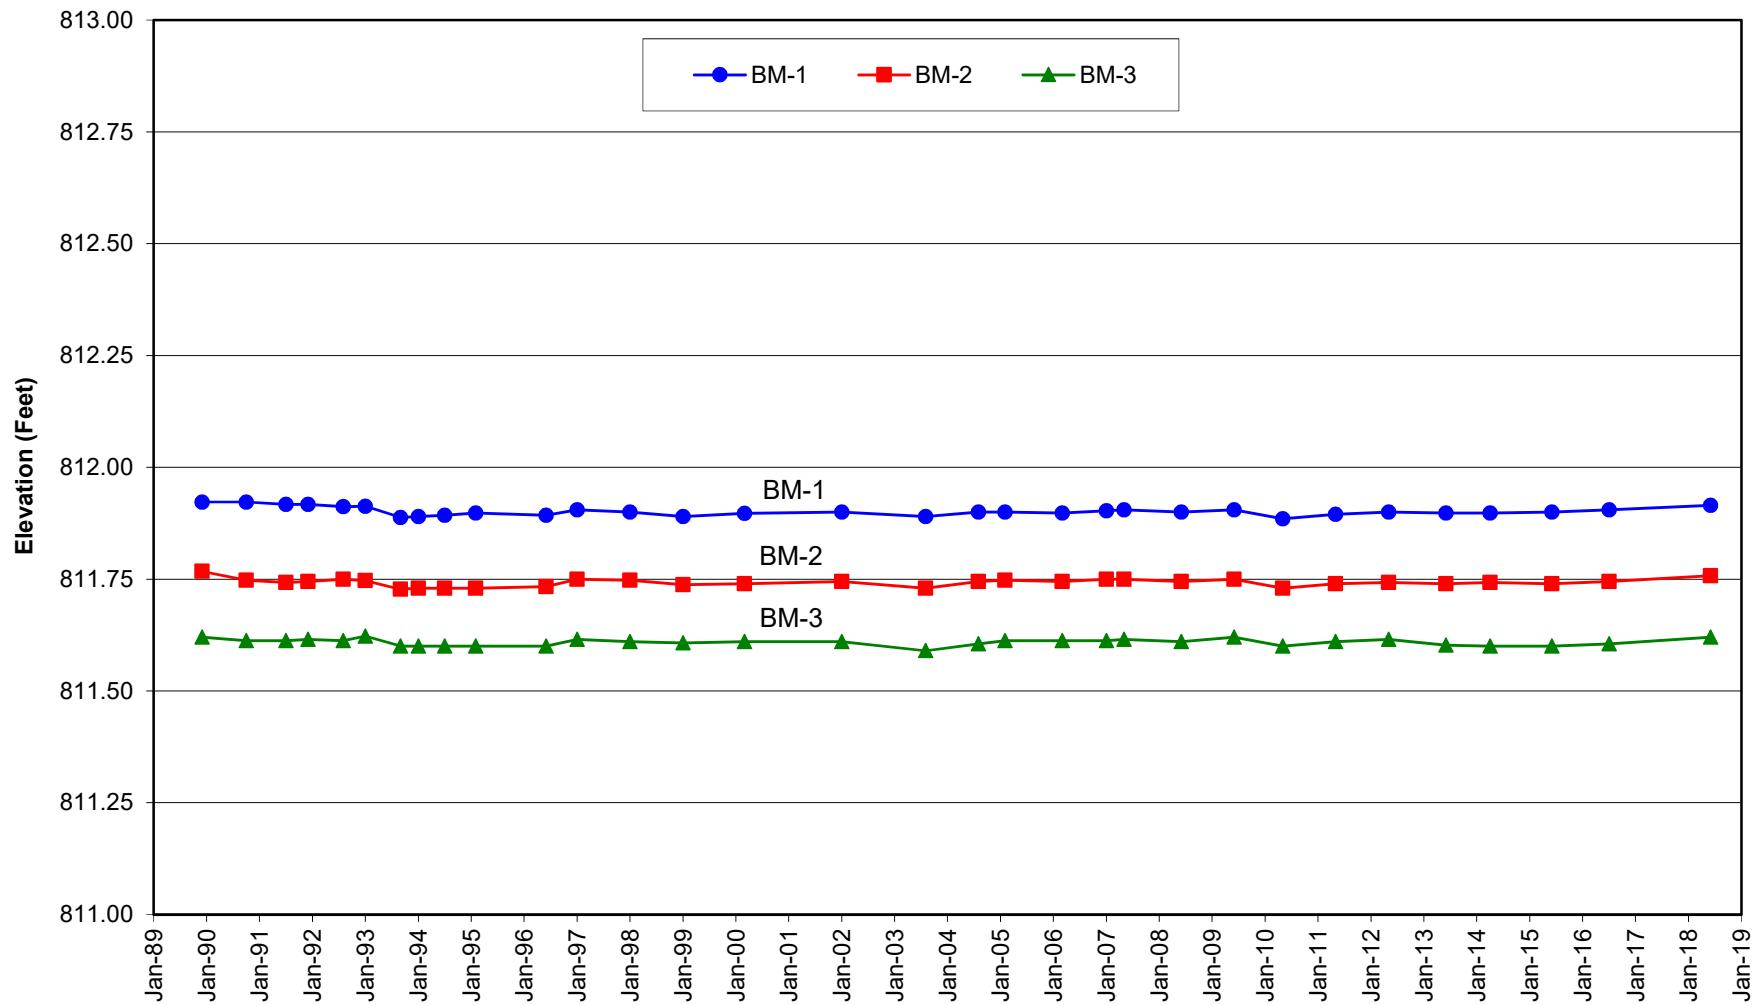
SANTIAGO CREEK DAM
ELEVATIONS OF SURVEY MONUMENTS BM-1, BM-2, AND BM-3
1989 THROUGH 2018

Based on GENTERRA's review of the survey data, none of the movements indicate any adverse conditions. The dam was not surveyed during calendar year 2017.
