INSPECTION OF DAM AND RESERVOIR IN CERTIFIED STATUS

Name of Dam Rattlesnake Canyon Dam No. 1029-3 County Orange
Type of Dam Earth Type of Spillway _____
Water is 28.4 feet below spillway crest and 34.4 feet below dam crest.

Reason for Inspection Annual Maintenance Inspection

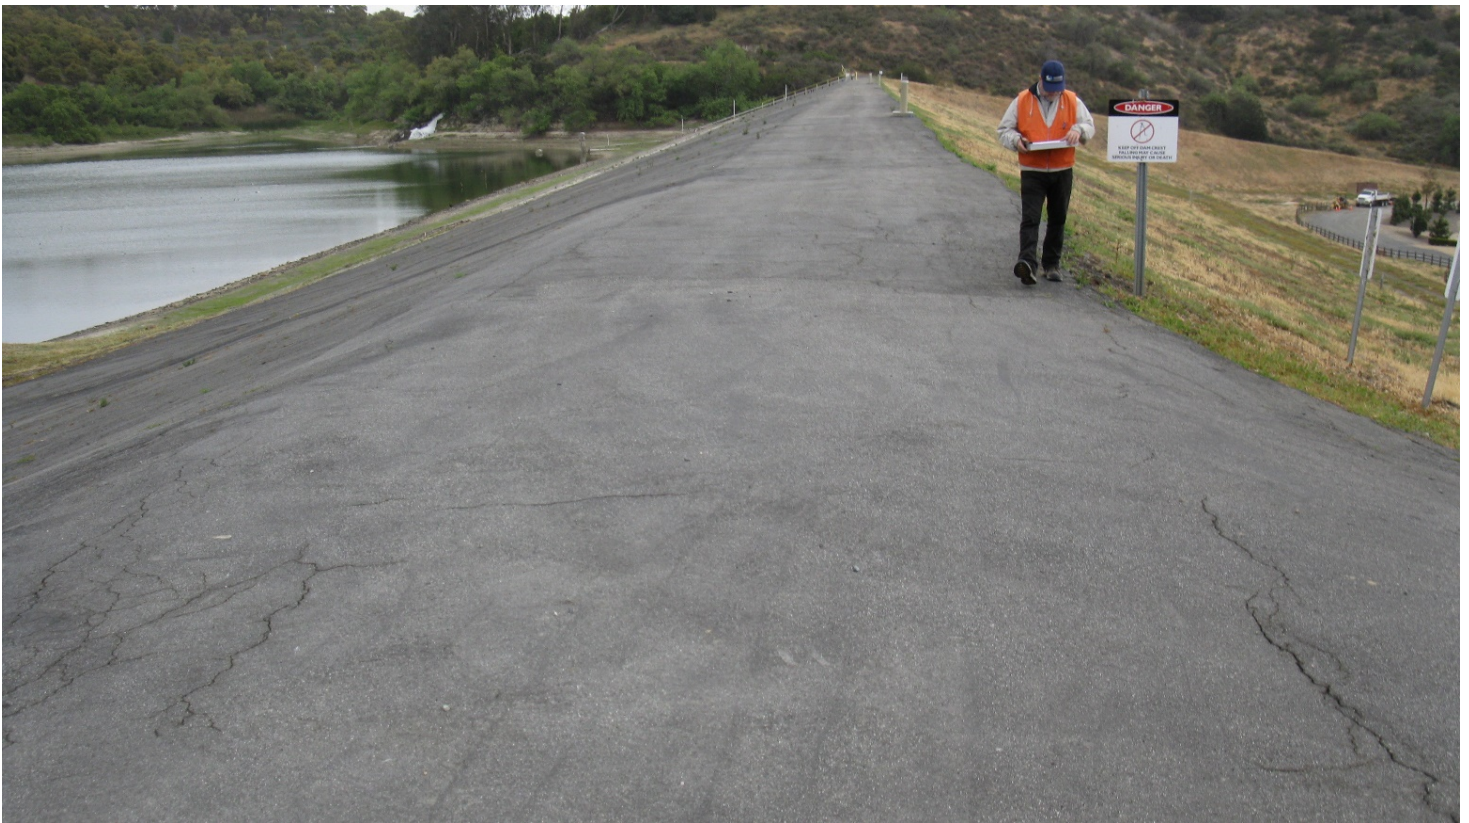
Crest

<u>Dam</u>	The AC paved crest was reasonably level and in satisfactory condition. The crest and upper portion of the upstream slope appeared to have been recently treated with an asphalt seal coat. There was some woody vegetation and a tree on the left upstream groin that needs to be removed. The remainder of the upstream slope is satisfactory. The downstream slope was well mowed, free of rodent activity, unfavorable vegetation, signs of seepage or instability, and appeared satisfactory overall.
<u>Spillway</u>	The side channel approach, weir, drop inlet, and trapezoidal shaped open channel were clear and in satisfactory condition. The grasses growing out of the cracks and joints in the concrete lining should be treated with plant retardant. The sediment and vegetation in the stilling basin should also be cleared and treated with plant retardant before Fish and Wildlife takes possession and converts it into a riparian/wildlife habitat.

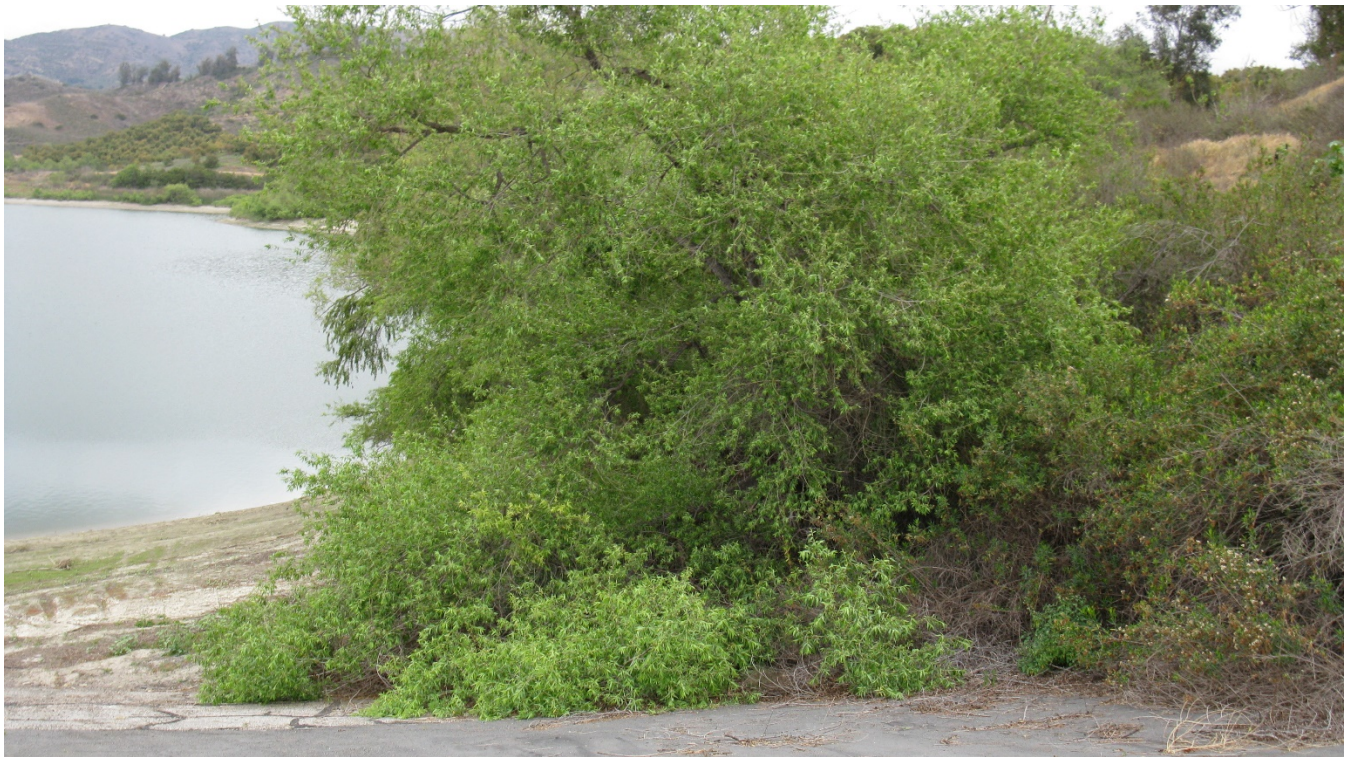
Trees and Woody Vegetation on Left Upstream Groin must be removed.

Remove the tree and clear woody vegetation on the left upstream groin by November 1, 2018.
Consider replacing the outlet works with a more efficient and reliable operating system in the future.

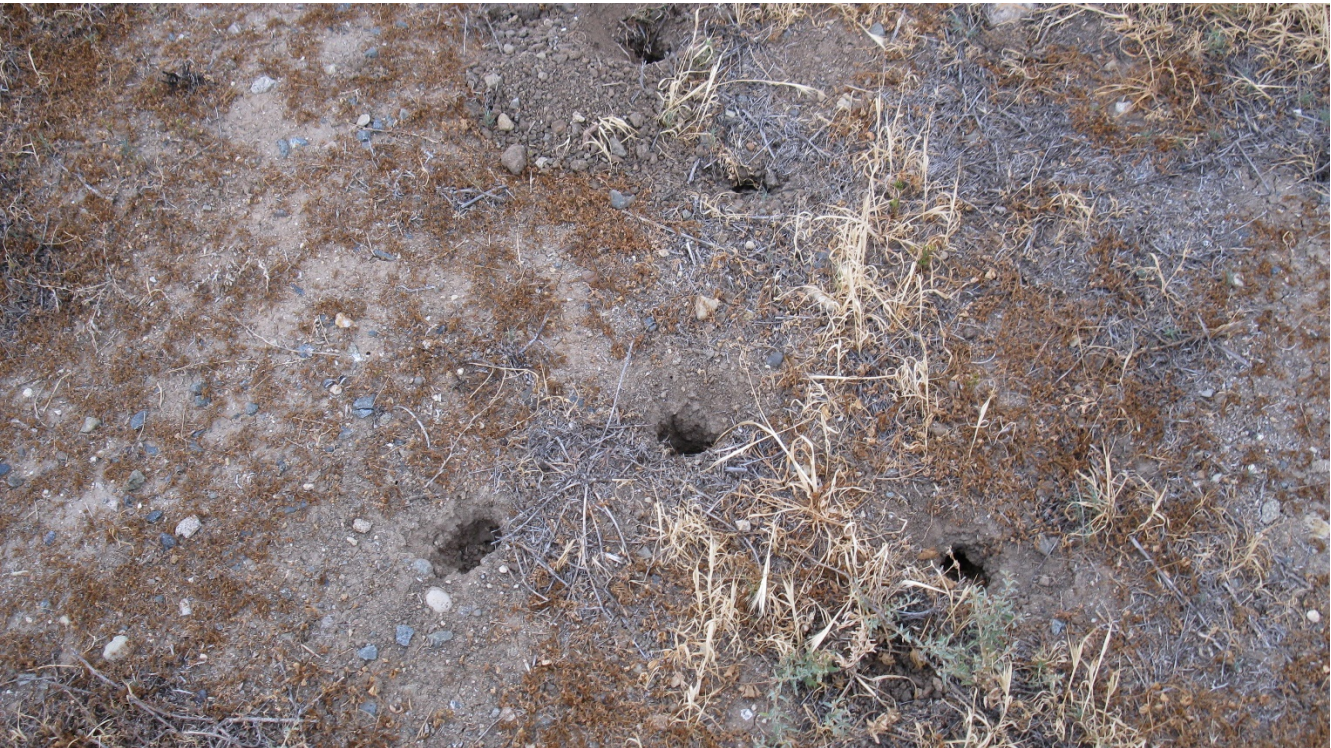
Rodent Activity on left side of Spillway Channel

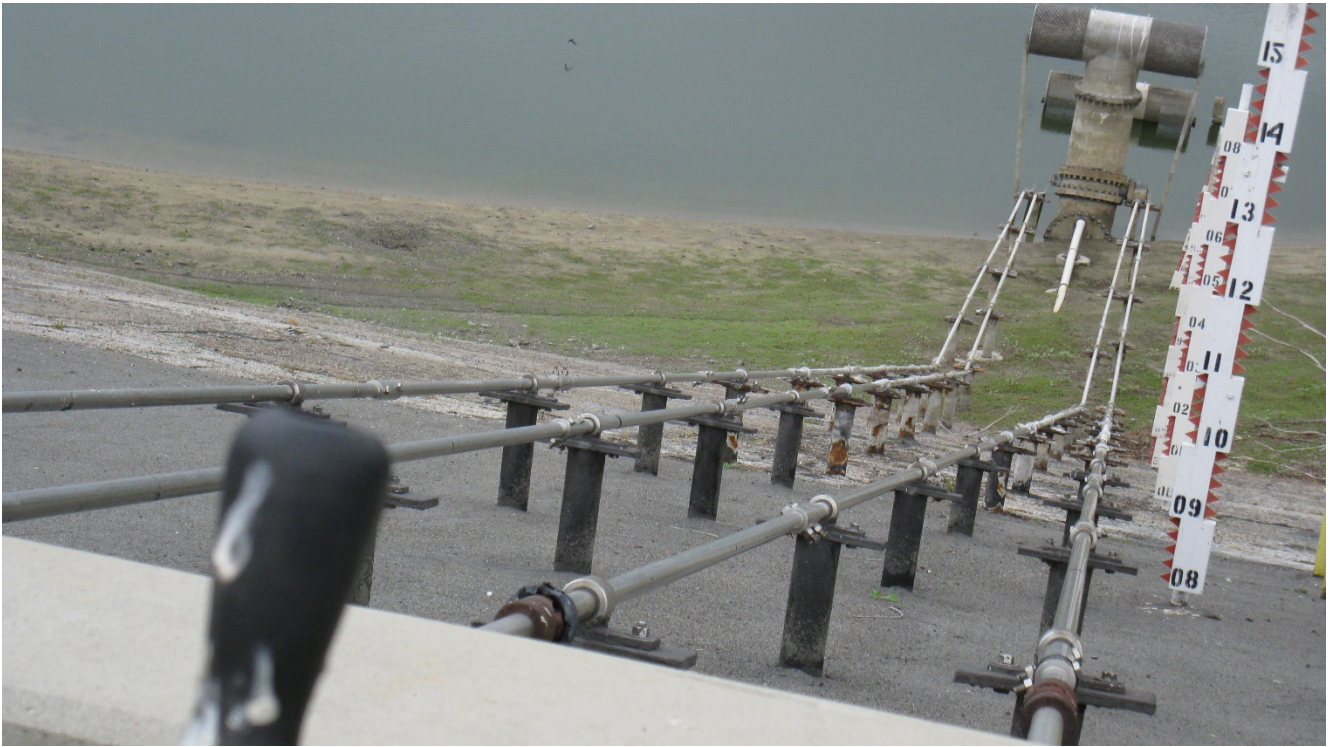
<u>Outlet</u>	The outlet consists of four upstream gate valves and two downstream valves. The upstream valves were all fully cycled, with great difficulty. The high friction inherent in the design of the control assemblage would make operating the valves a realistic challenge in an emergency situation. If this dam is slated for long term future operations, a new system of valve controls is recommended for consideration in the District's long range plans. The downstream valves were not operated this time because work was in progress involving new outlet modifications taking place in the vault where the blowoff was located. This work was approved by the Division in March 2018 under the category of minor maintenance. As-built plans will be submitted upon completion.
<u>Seepage</u>	There was no seepage noted on the downstream slope, groins, or toe of the dam. The weeps in the spillway channel were all dry. The 6 seepage drain pipe outfalls in the drain vault were estimated as: #2 = trickle; #3 = 3 gpm; #4 = 1 gpm; #5 = dry; #8 = dry; #11 = dry. These measurements are all within normal limits. The flow points were not read at this time.

Upstream Valve Controls – High inherent friction made operating the valves very difficult

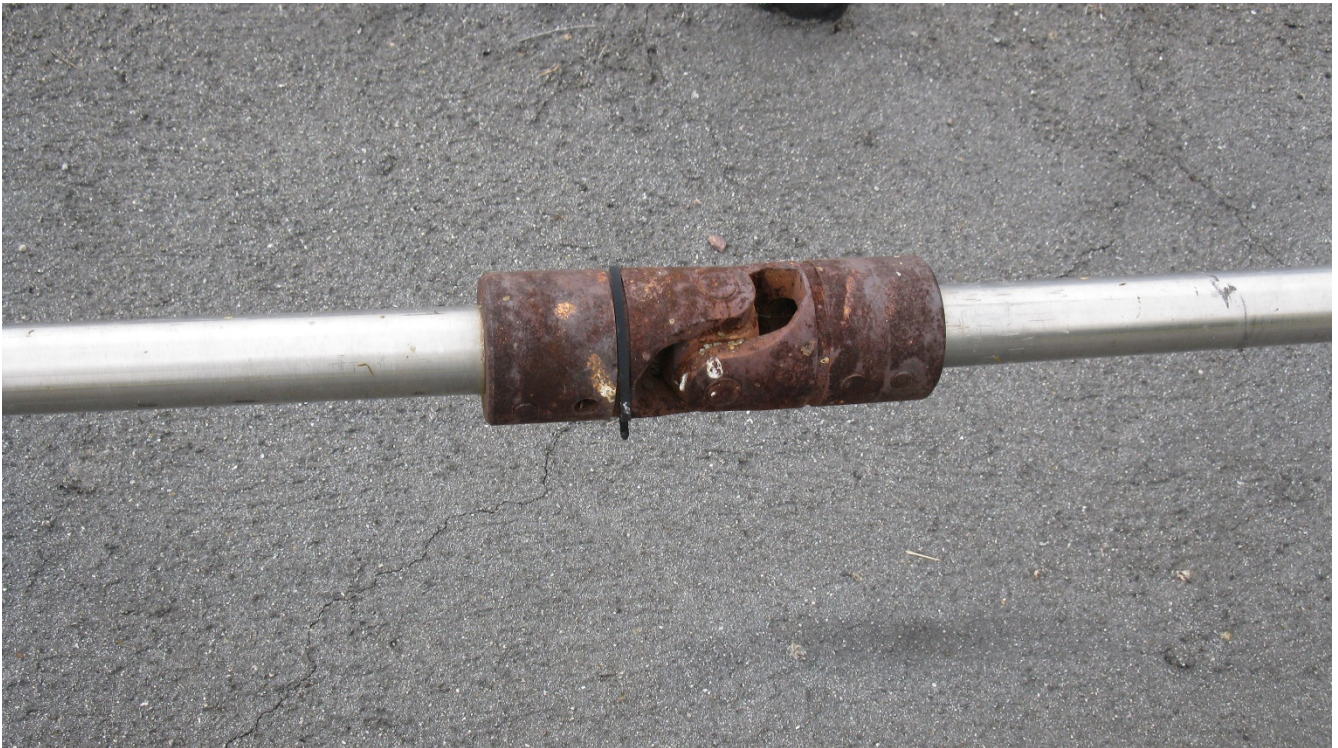
Typical Corroded U-Joints

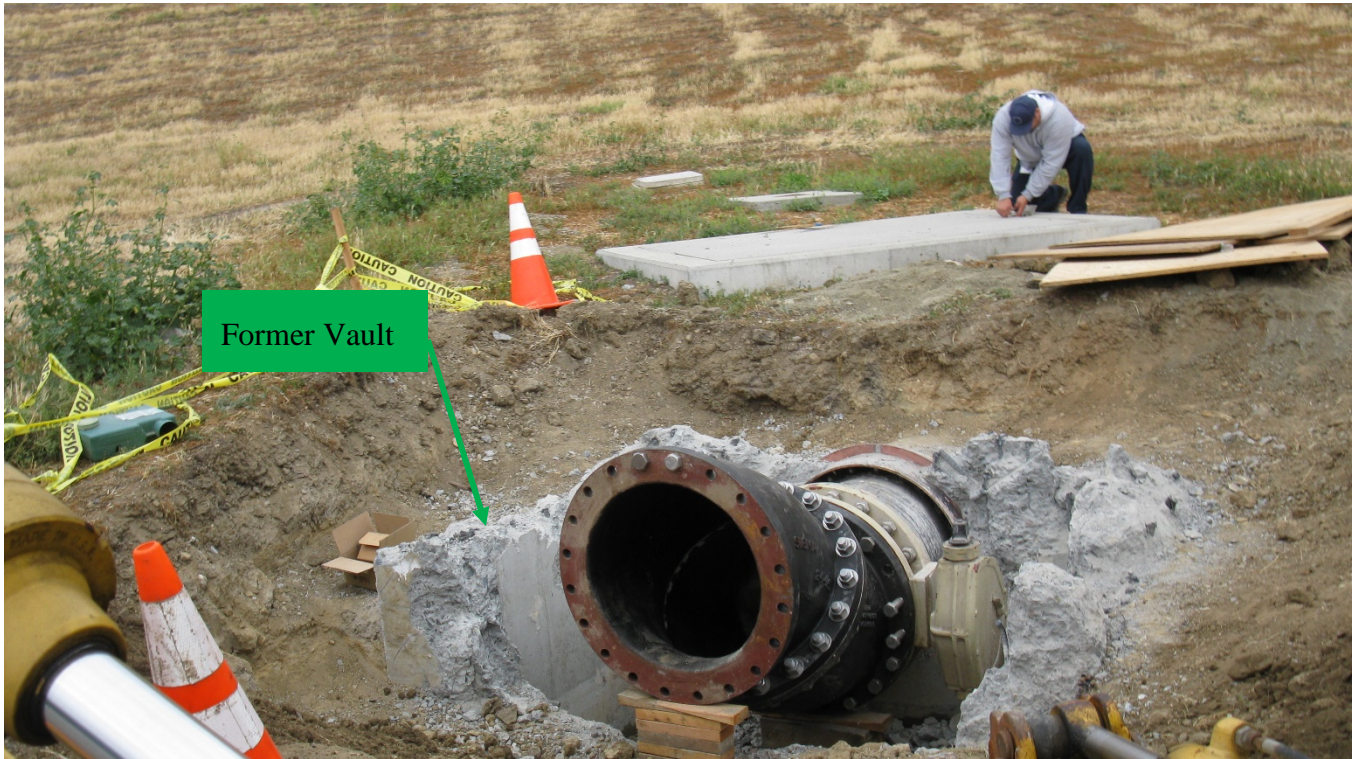
New Outlet Works in progress at downstream vault

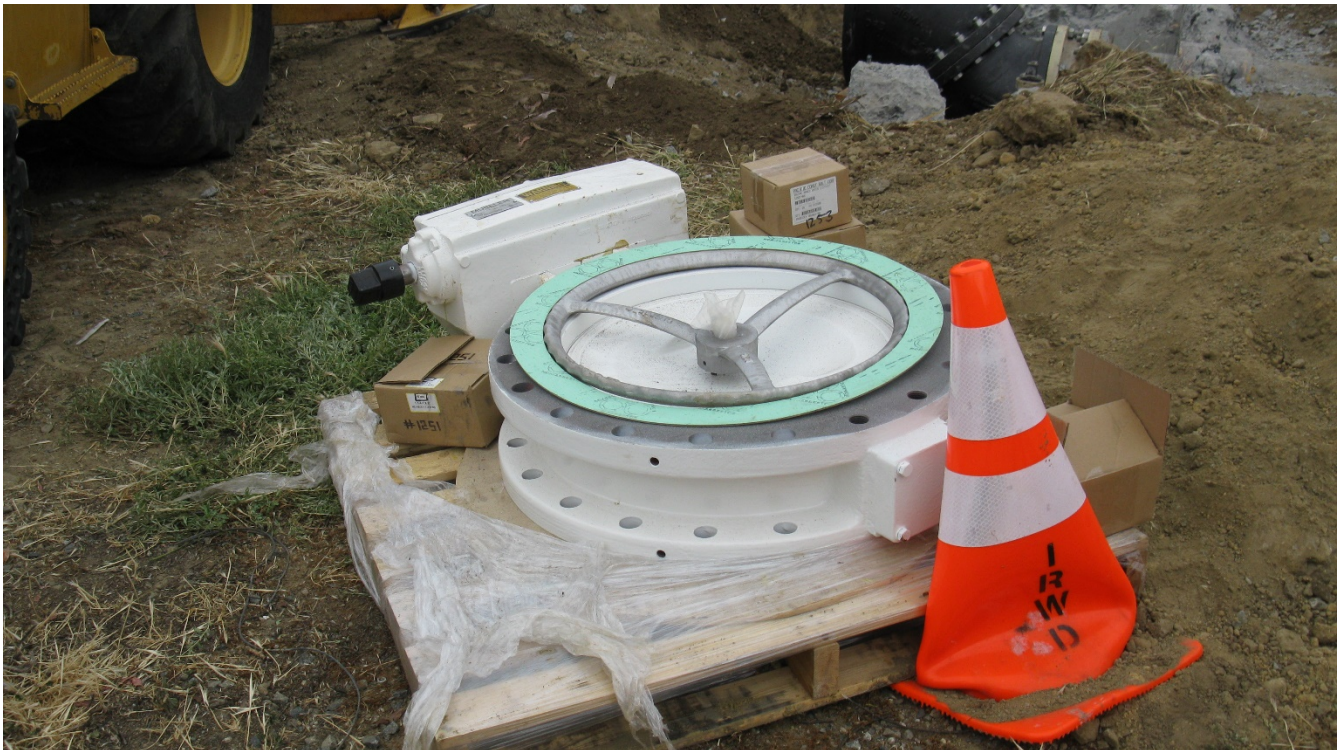
New Valve and Actuator
