STATE OF CALIFORNIA
CALIFORNIA NATURAL RESOURCES AGENCY
DEPARTMENT OF WATER RESOURCES
DIVISION OF SAFETY OF DAMS

INSPECTION OF DAM AND RESERVOIR IN CERTIFIED STATUS

Name of Dam San Joaquin Dam No. 1029 County Orange
Type of Dam Earth Type of Spillway 2 - Drop Box Inlets
Water is 21.4 feet below spillway crest and 26.9 feet below dam crest.

Reason for Inspection Annual Maintenance Inspection

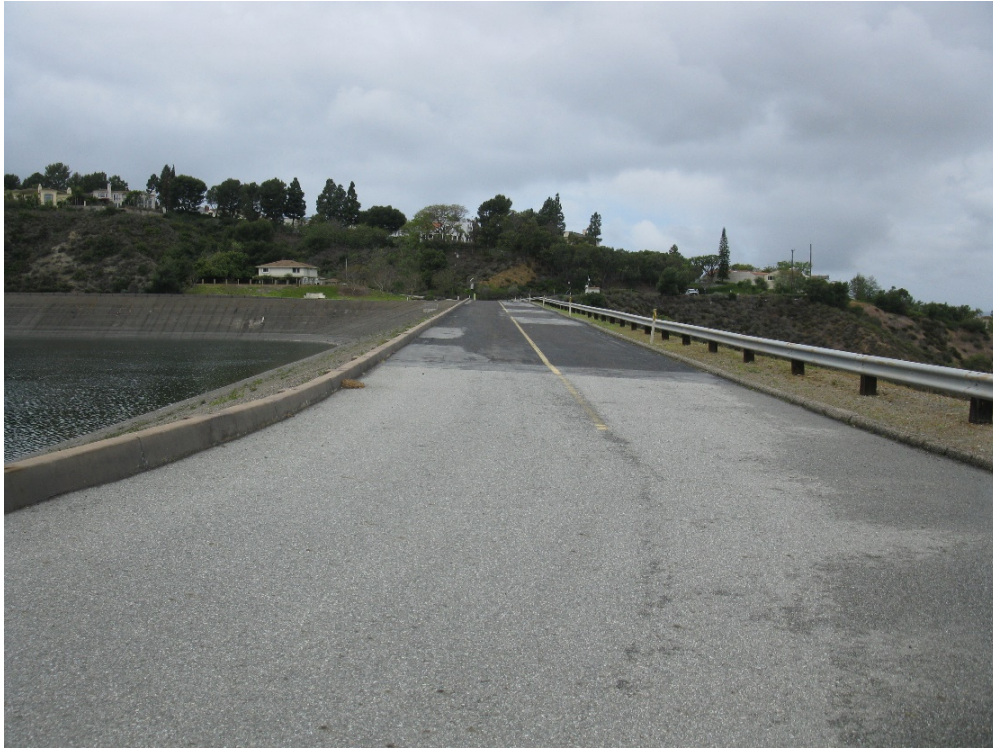
Crest

This is a sizeable zoned earthen embankment consisting of a thin impervious zone on the upstream slope, backed by a filter-drain blanket that reverses direction at the bottom. The reservoir stores reclaimed water. The AC paved crest and curbs were well aligned and reasonably level, with no indication of embankment distress. The highly weathered asphalt paved upstream slope was relatively uniform and revealed no indication of slope instability. The upstream AC liner serves only for erosion control and not as an impervious liner. The downstream slope contains three mid-level benches which were traversed. No detrimental conditions were observed. The "low spot" on the downstream slope, located just below the "El. 420 bench" near the right abutment, was explained by Genterra as having likely been caused by reconstruction of the bench (widening and re-shaping of the curve), whereby the spoil materials were pushed over the bench, causing an overly-steepened slope below the bench. The riprap originally on the slope was buried by the dumped spoil material, giving the appearance that the riprap was missing. This explanation reasonably matched my observations. This "low spot" was first noted in a 12/29/94 Inspection Report, which indicated this was a "longstanding condition". Subsequent annual monitoring has indicated no changes since. This spot is located above the coarse (12" minus) pervious embankment zone, expected to have negligible pore pressures. Combined with the absence of indications from the dam surveillance program, it is my opinion that this "low spot" is not a developing sinkhole, soil creep, or local slide in progress. As such, it is my recommendation that further monitoring of this "low spot" be discontinued. Rodent and vegetation control was satisfactory overall, except for a grove of woody vegetation on the dam near the right abutment at the bottom of the downstream slope. It is left of the right-groin. Mr. Habiger agreed to have that area cleared (see photograph below).

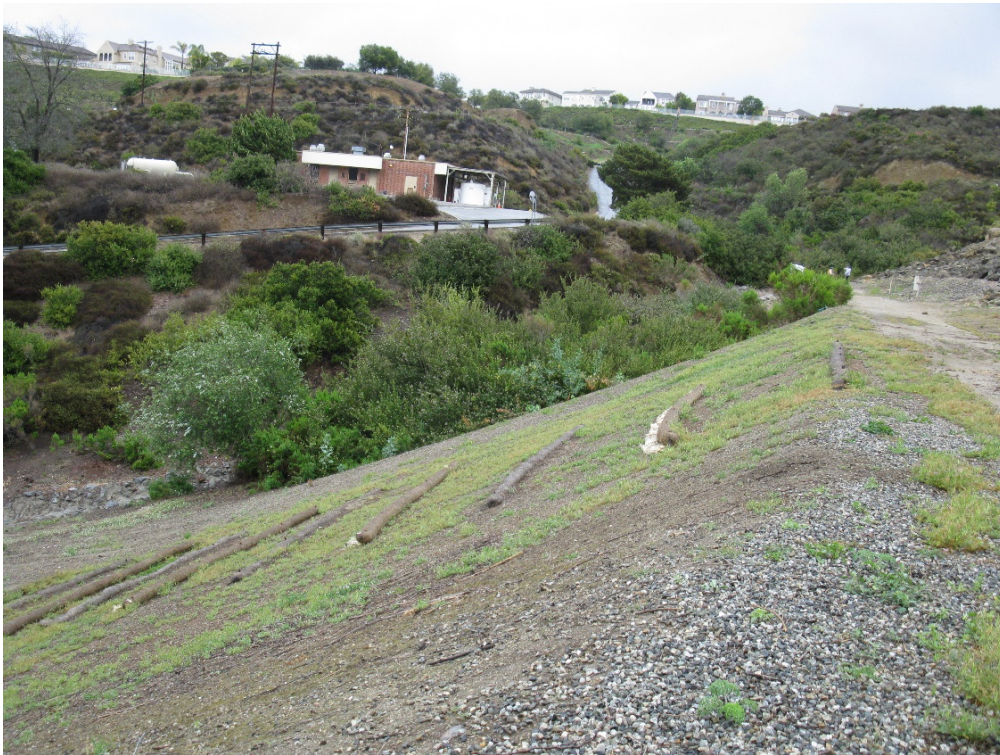
Grove of woody vegetation near the downstream toe near the Right Abutment (should be cleared)

1. Clear the grove of woody vegetation near the right downstream toe by November 1, 2018.
2. Monitoring of the "low spot" below the Downstream El. 420 Bench can be discontinued.

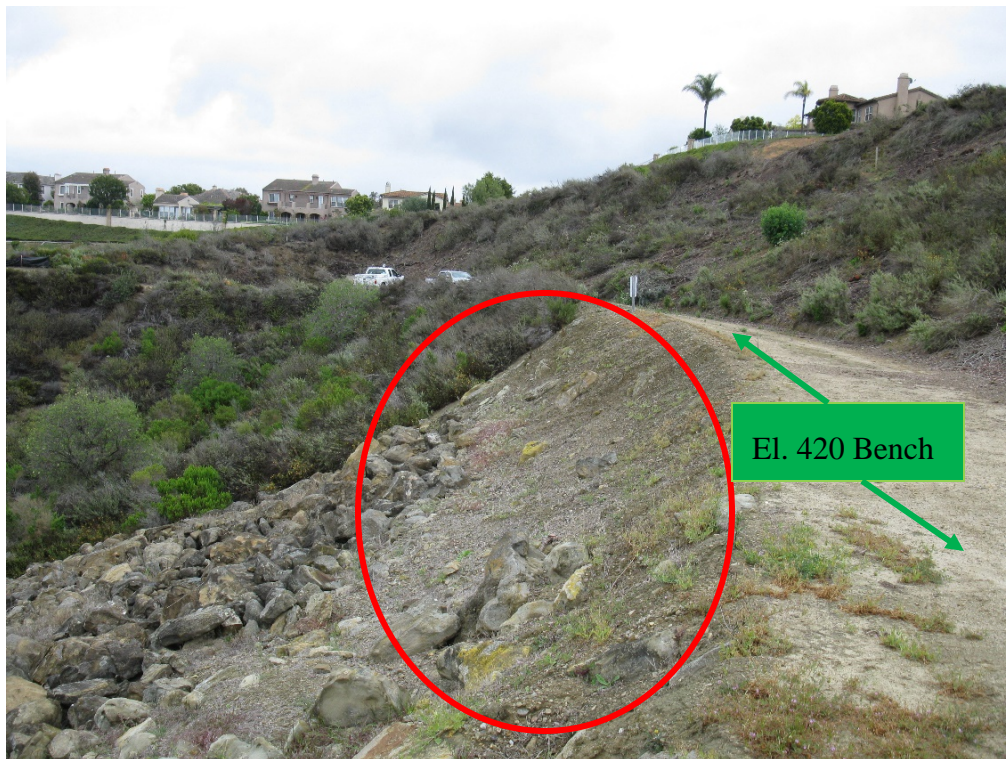
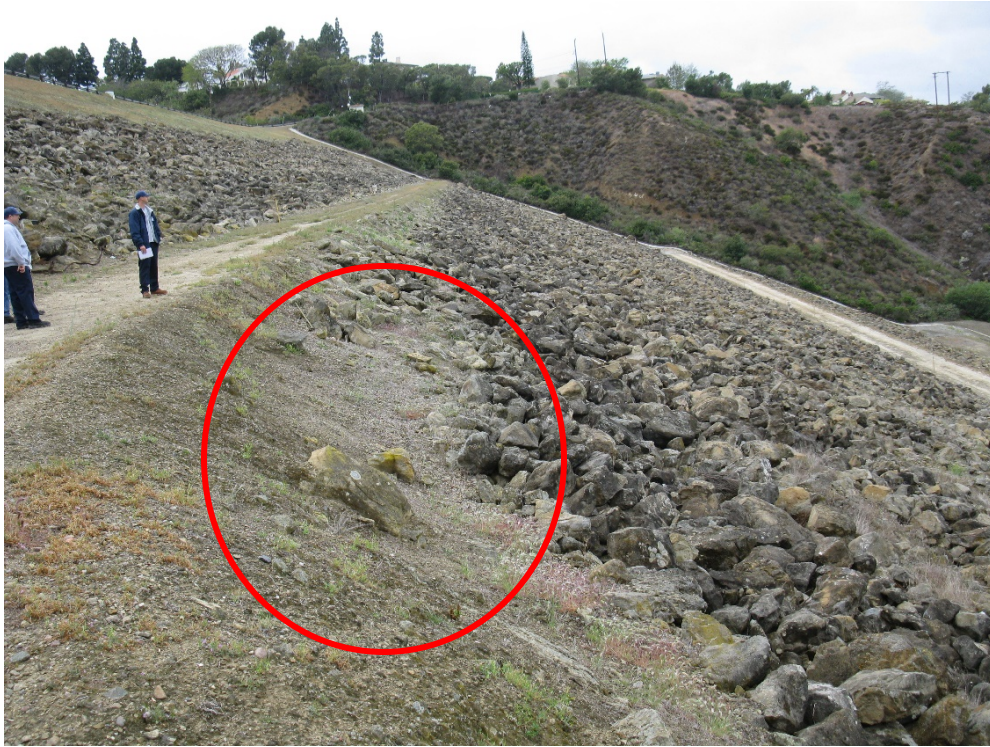
Previously noted "Low Spot" below the "El. 420 bench"

Another view of the “Low Spot”

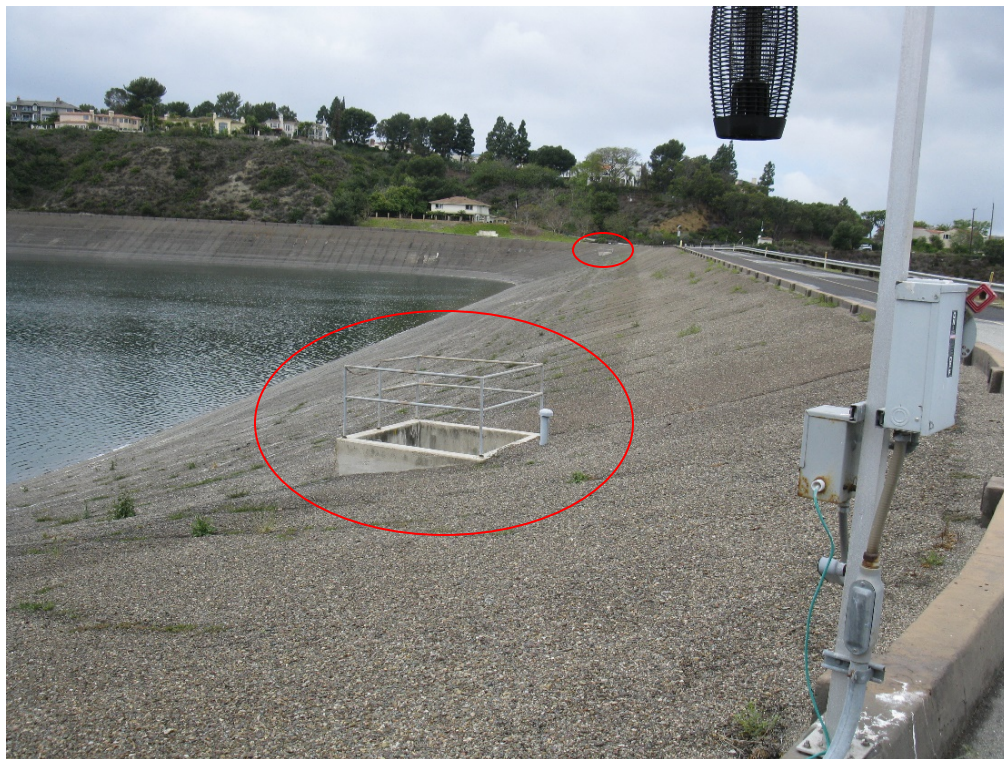
The two drop box inlet spillways were open and clear. The concrete was in good condition. The entrances to the two 48-inch RCP conduits were clear. The exit at the dissipater structure was reasonably clear.

(2) – Drop Box Inlet Spillways

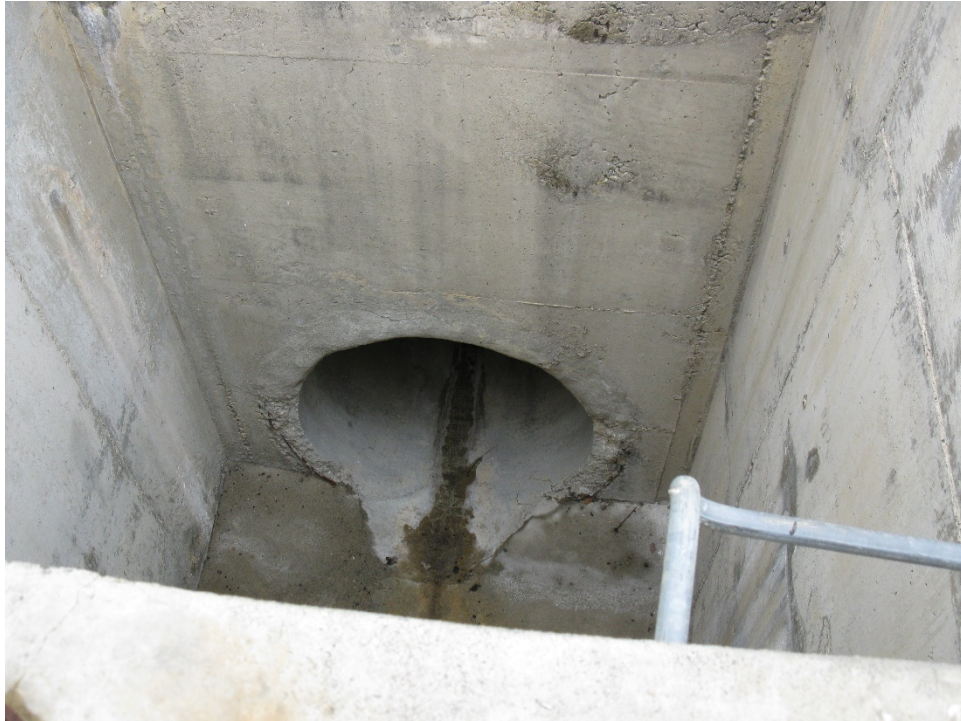
Entrance to 48" RCP at Bottom of Right Drop Box Inlet Spillway

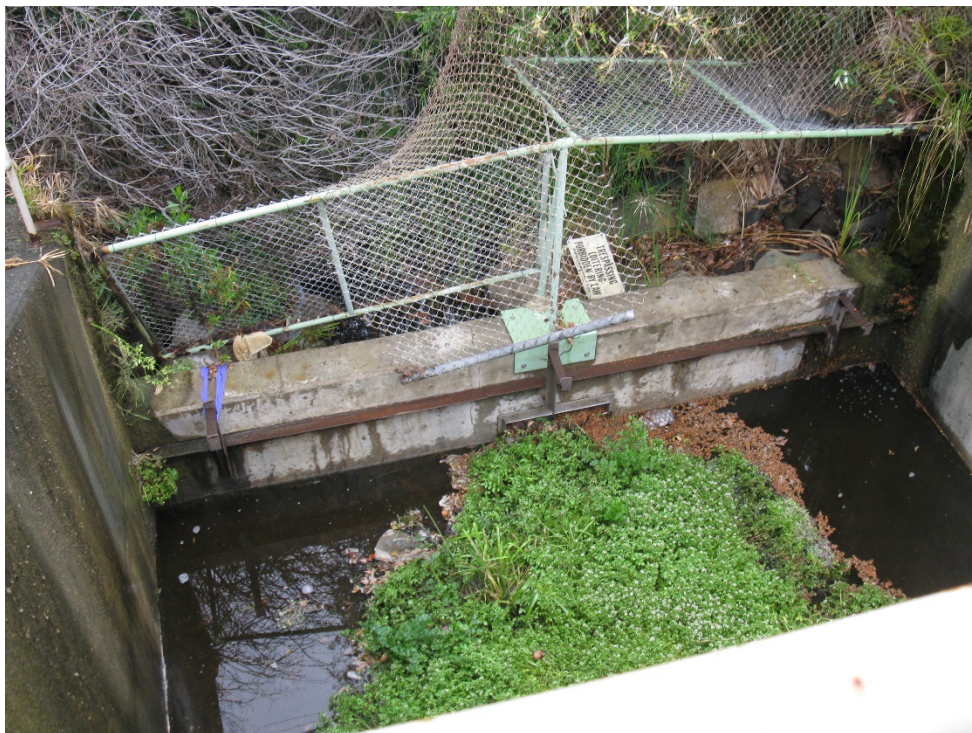
Spillway Impact Dissipater (Exit) Structure
