STATE OF CALIFORNIA
CALIFORNIA NATURAL RESOURCES AGENCY
DEPARTMENT OF WATER RESOURCES
DIVISION OF SAFETY OF DAMS

INSPECTION OF DAM AND RESERVOIR IN CERTIFIED STATUS

Name of Dam Syphon Canyon Dam No. 1029-4 County Orange
Type of Dam Earth Type of Spillway Concrete weir and open channel
Water is 11.1 feet below spillway crest and 18.1 feet below dam crest.

Reason for Inspection Annual Maintenance Inspection

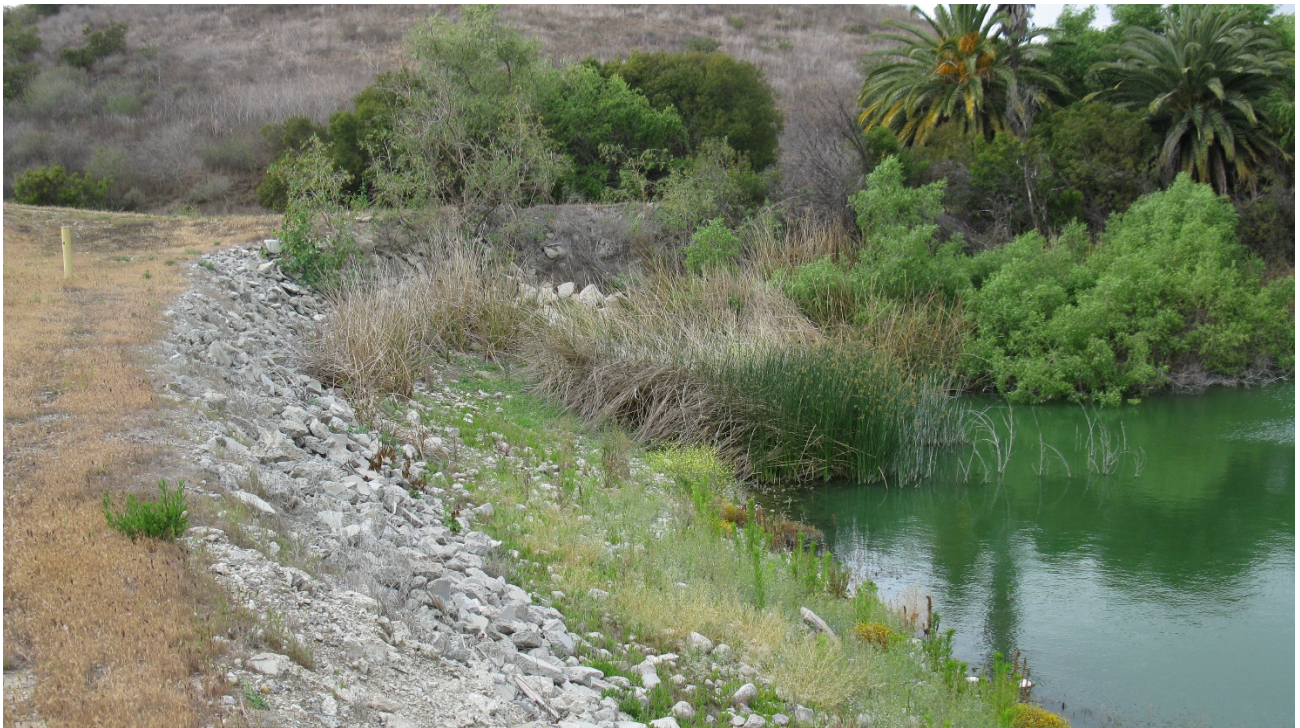
Vegetation on Right Upstream Groin must be cleared to permit inspection

Remove the vegetation on the right upstream groin by November 1, 2018.

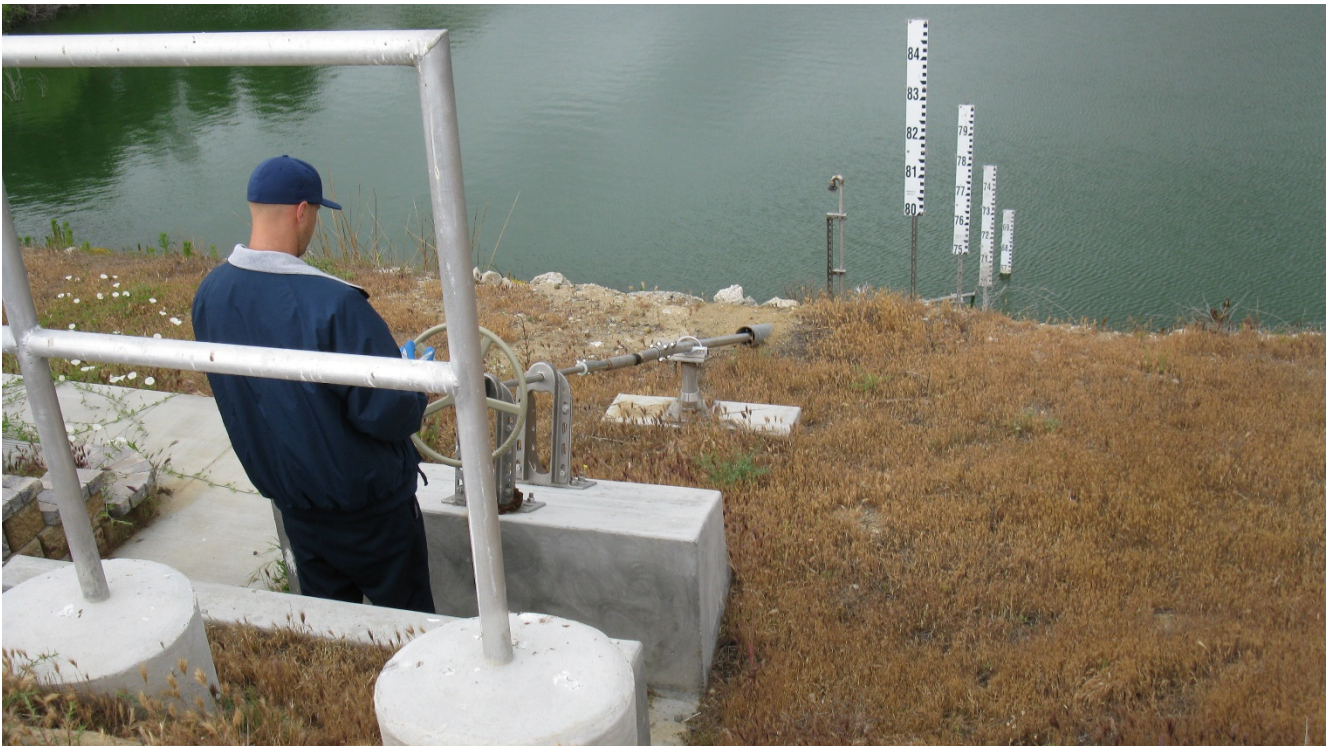
Outlet Valve Operation

<u>Outlet</u>	The outlet consists of a 12-inch upstream butterfly and two 16-inch downstream butterfly valves, installed sometime after 2014. All valves were fully cycled satisfactorily. The exit portal inside the storm drain manhole was clear.
<u>Seepage</u>	No seepage or indications thereof, were observed on the downstream slope, groins, and toe of the dam. The seepage from the toe drain was estimated at about 2 gpm. This is within normal limits.
<u>Instr.</u>	Instrumentation at this dam consists of 12 piezometers and one seepage point. The most recent surveillance report submittal was dated August 25, 2017, and included data through December 2016. I reviewed the data and found all readings for this reporting period were within the boundaries of historical norms. No abnormal trends were observed. The piezometers at the crest tend to be influenced by the reservoir level, due to proximity, but all readings plotted within the expected phreatic zone and pore pressure gradients. The instrumentation data indicates the dam is performing satisfactorily and no additional instrumentation is judged necessary at this time.
