**INSPECTION OF DAM AND RESERVOIR IN CERTIFIED STATUS**

Name of Dam Santiago Creek Dam No. 75-0 County Orange  
Type of Dam Earth Type of Spillway Concrete weir and channel  
Water is 39.6 feet below spillway crest and 59.6 feet below dam crest.

Reason for Inspection Annual Maintenance Inspection

Inspected by PW Lee  
Date of Inspection 5/3/2018  
Date of Report 6/8/2018

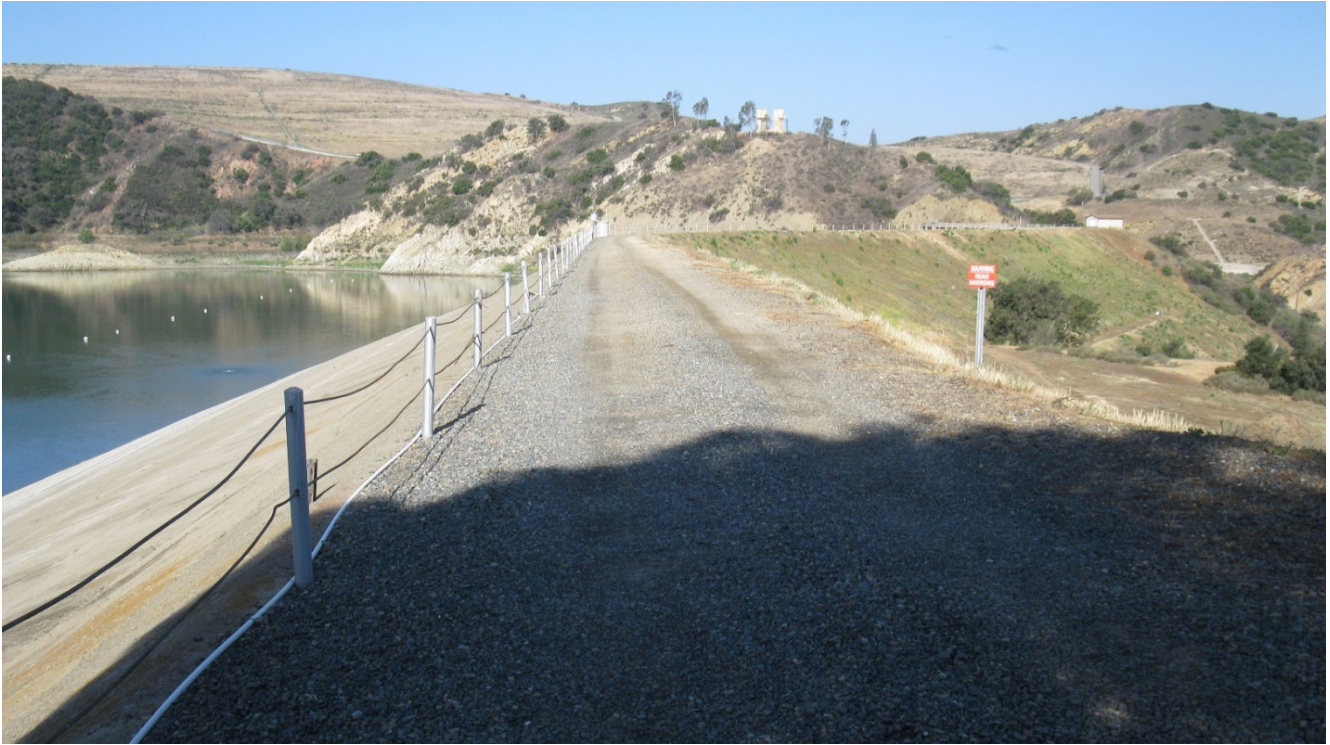
Crest

This is a dual zoned embankment with the impervious zone positioned in the upstream fourth of the dam, with no drains. The graveled crest was level, well aligned, and in satisfactory condition. The upstream slope was lined with panels of concrete, moderately weathered, but revealed no signs of instability. My review of the Files found no historical upstream slope stability issues. Minor spalls and deterioration expected of concrete this age were observed in the lower panels close to the waterline. The downstream slope was covered with low grasses and scattered clumps of anise and sumac brush. The owner's vegetation control contractor comes out once a year to clear the brush. What was visible of the downstream slope, appeared uniform and stable. A large sycamore tree at the downstream toe needs to be removed, as well as the woody vegetation along both abutments for a distance of 10-feet beyond the groins. Light rodent activity observed along the lower sections of the downstream slope calls for continued rodent control measures.

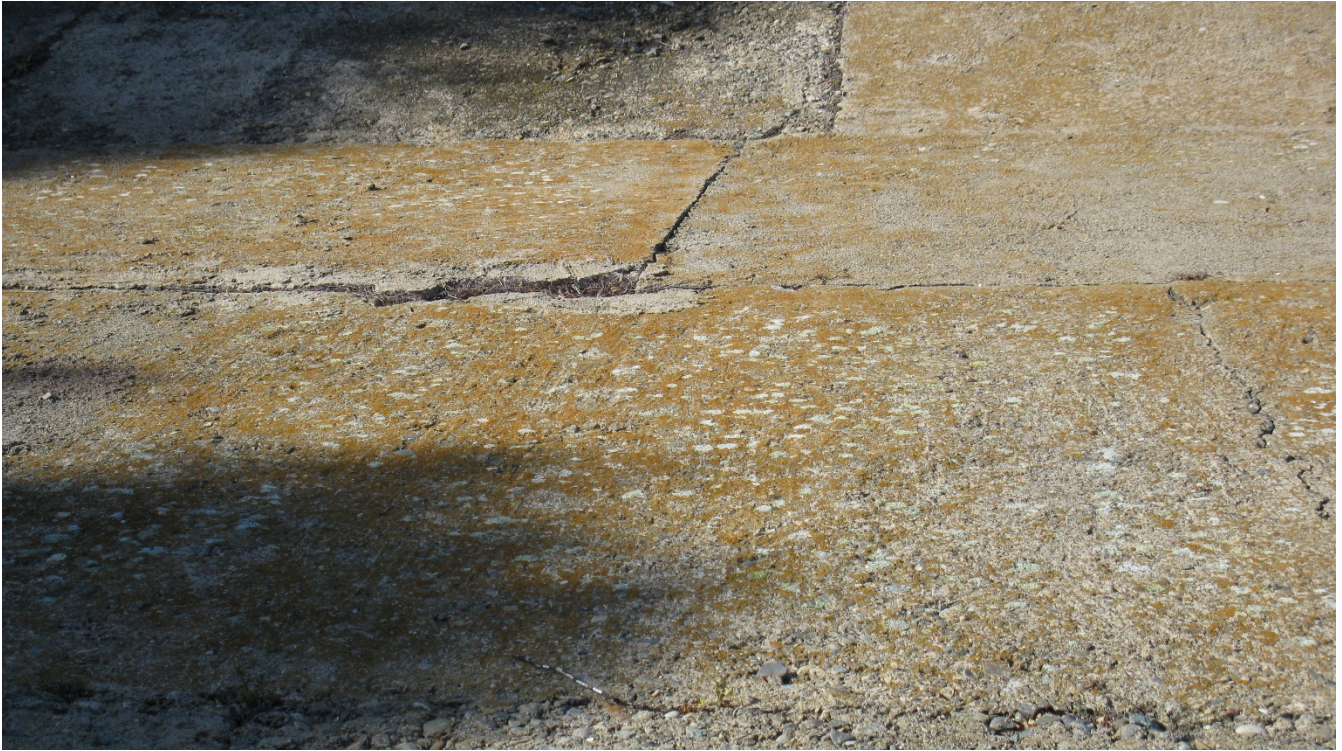
Concrete Panels lining the Upstream Slope

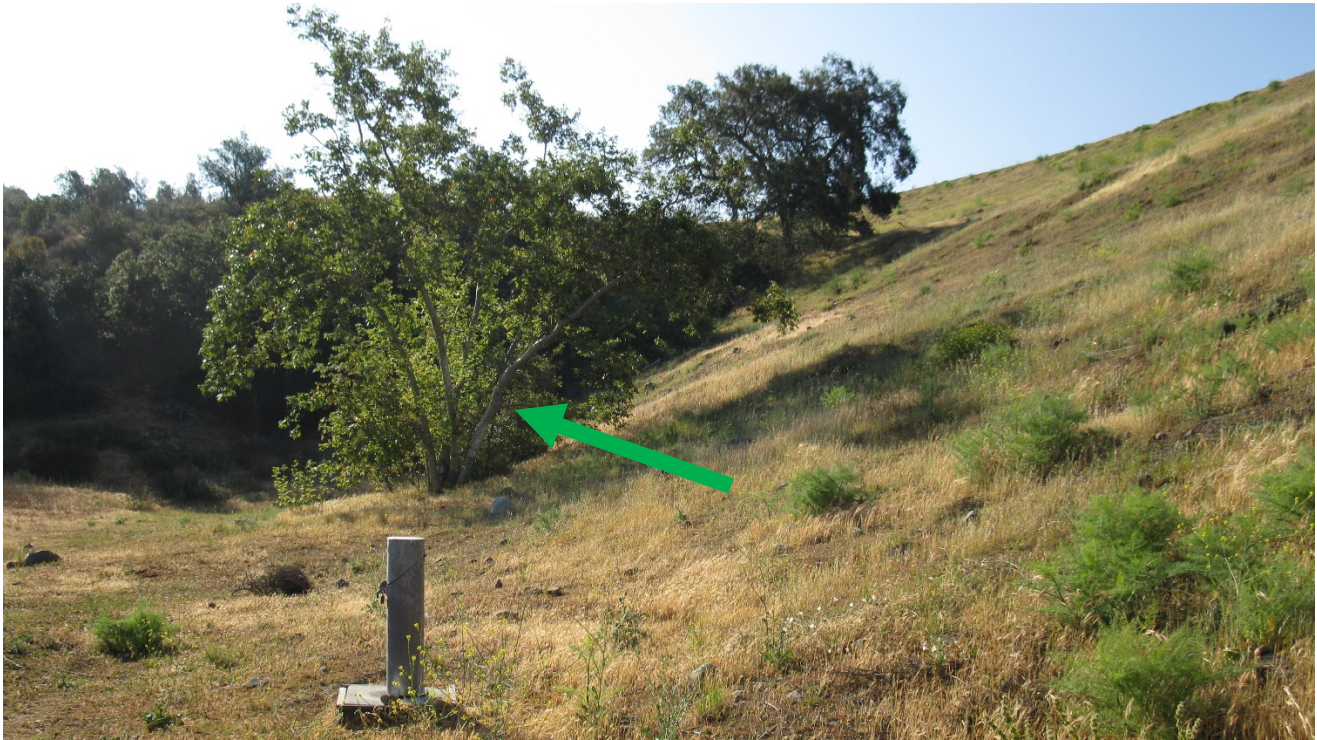
Remove this Tree at Downstream Toe

1. Clear the woody vegetation beyond both groins a distance of 10-feet by November 1, 2018.
2. Remove the large sycamore tree near the downstream toe of the dam by November 1, 2018.
3. Repair the damaged left spillway training wall at the ski jump by November 1, 2019.
4. Stabilize the eroding foundation under the spillway ski jump by November 1, 2019.
5. Stabilize the left spillway abutment near the approach by November 1, 2023 (pending conclusions from the Spillway Assessment Review and Evaluation).
6. Replace the ladder on the tower when the reservoir level permits access.

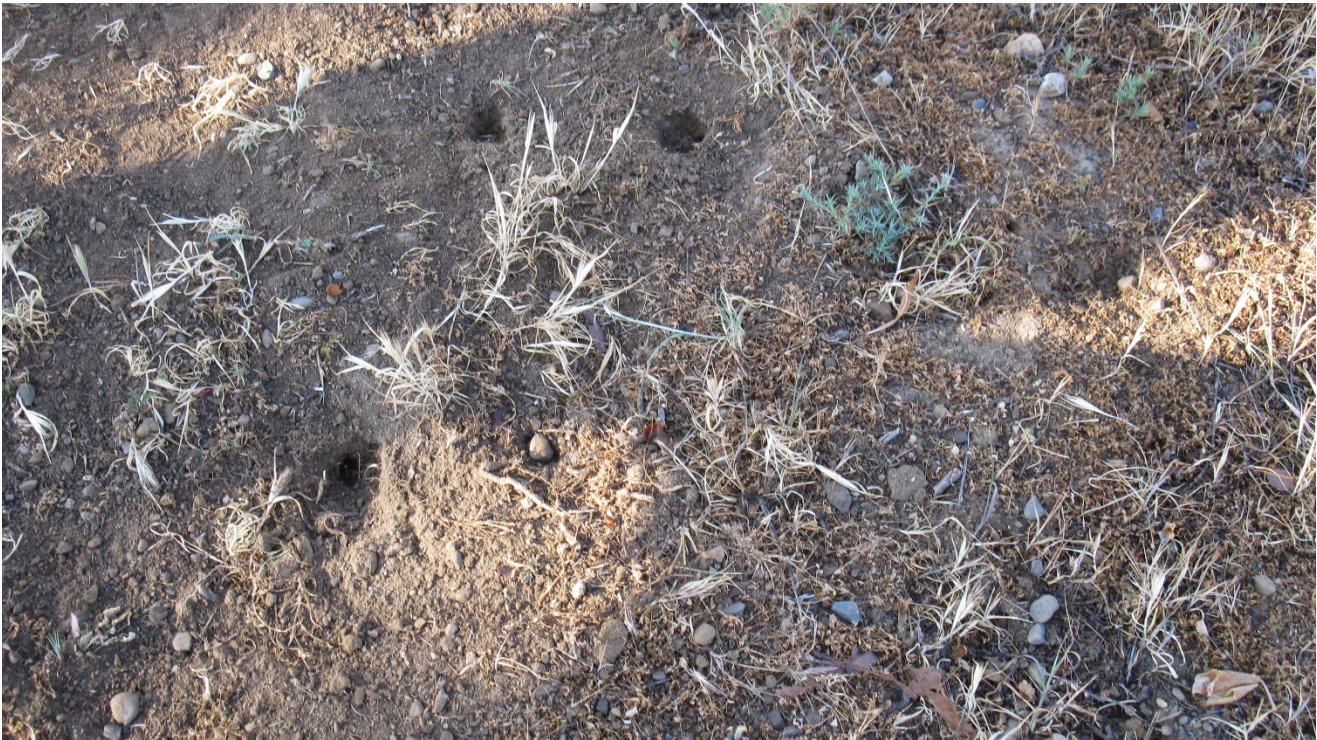
Rodent Activity on lower portion of Downstream Slope

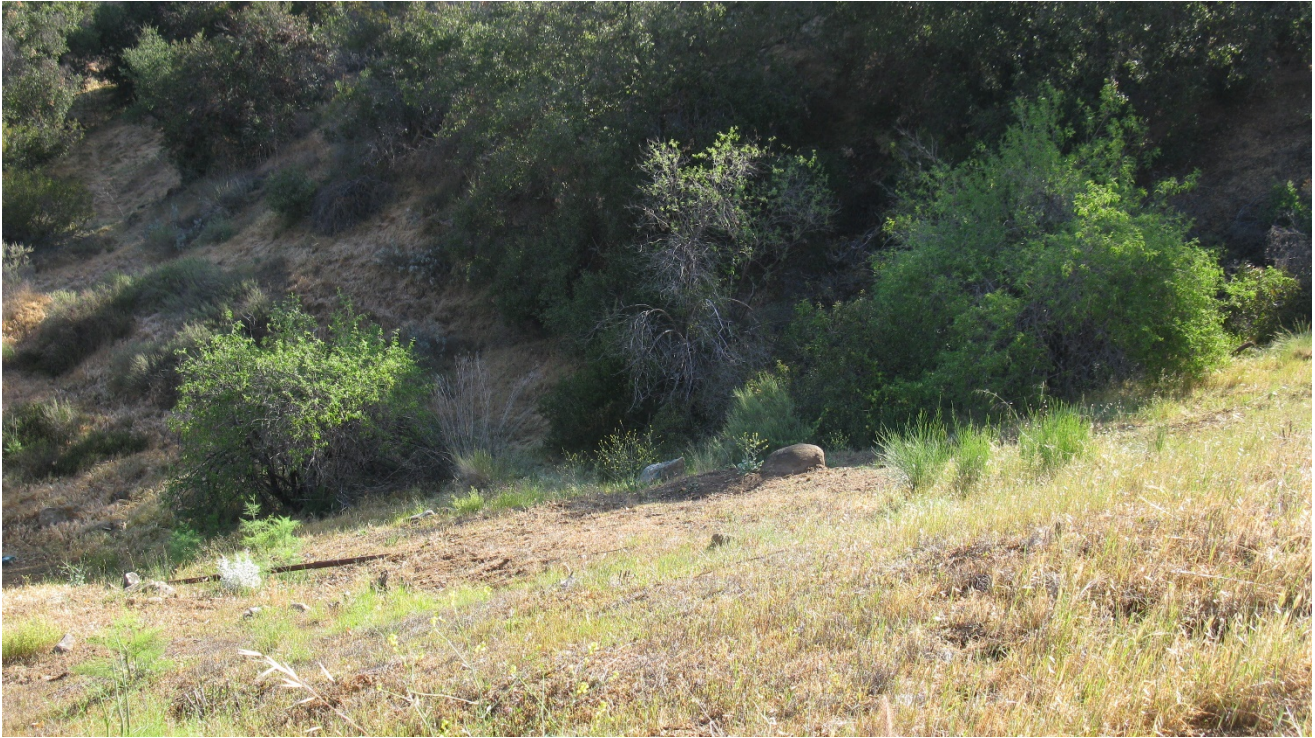
Remove Woody Vegetation 10-feet beyond the groins

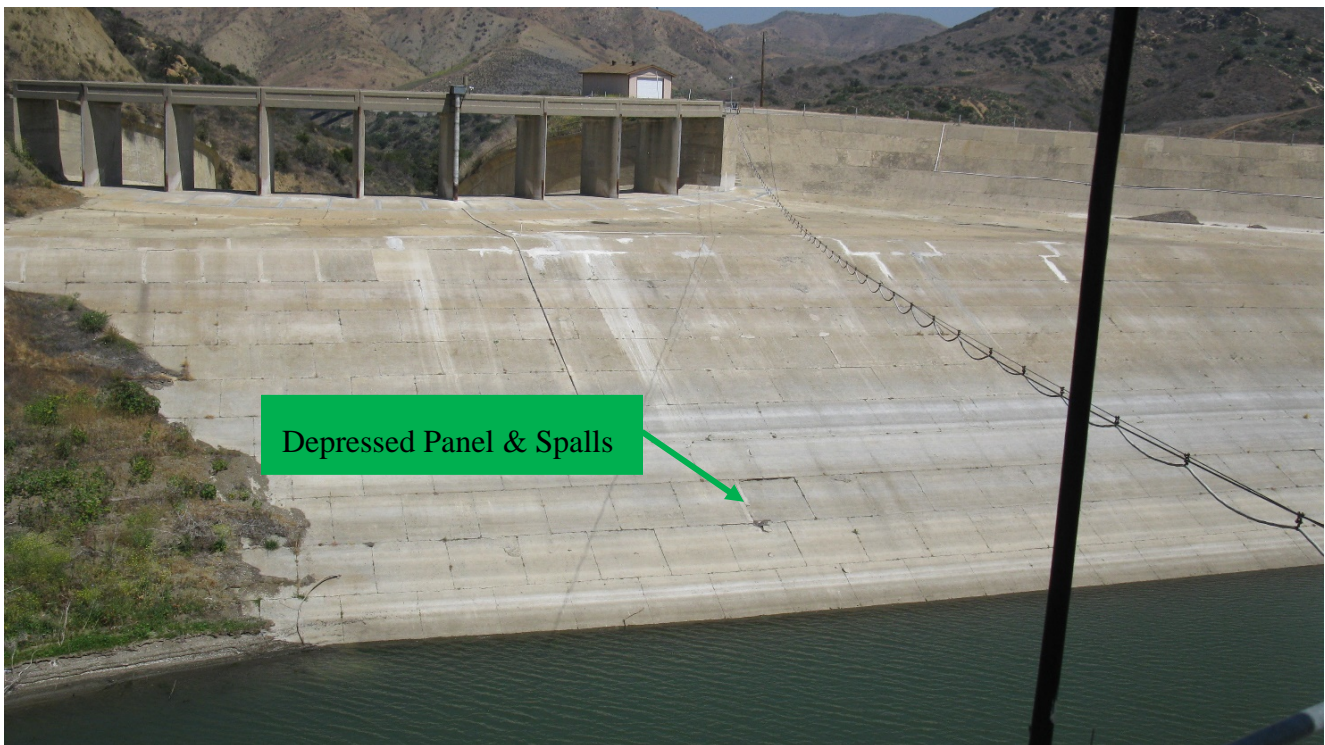
Spillway Approach

The spillway approach was clear and unobstructed, except for the approach at the left-most bay, which was partially blocked with colluvial deposits from chronic erosion of the steep left abutment. The abutment is eroding away from the left training wall and bridge structure. The concrete lining the spillway floor is aged, with alligator cracking, exposed rebars, spalls, cracks, and numerous patching efforts evident. Except for the joint separating the original and rebuilt sections, there are no joints in the slab or training walls. Both training walls contain numerous long diagonal shear cracks, superficially patched. The right training wall abuts a narrow ridge of native sandstone separating the spillway and dam. At the location of the ski jump, the left training wall was damaged by what might have been falling boulders. This section of wall should be repaired to halt continued undermining of the ski jump structure during spillway flows. The underside of the ski jump and waste channel were not inspected due to safety concerns. If the piers supporting the ski jump section become exposed due to continuing erosion, measures should be taken to halt the erosion. The bull noses of the bridge piers contain alligator cracks up to about 4-feet above the base. This

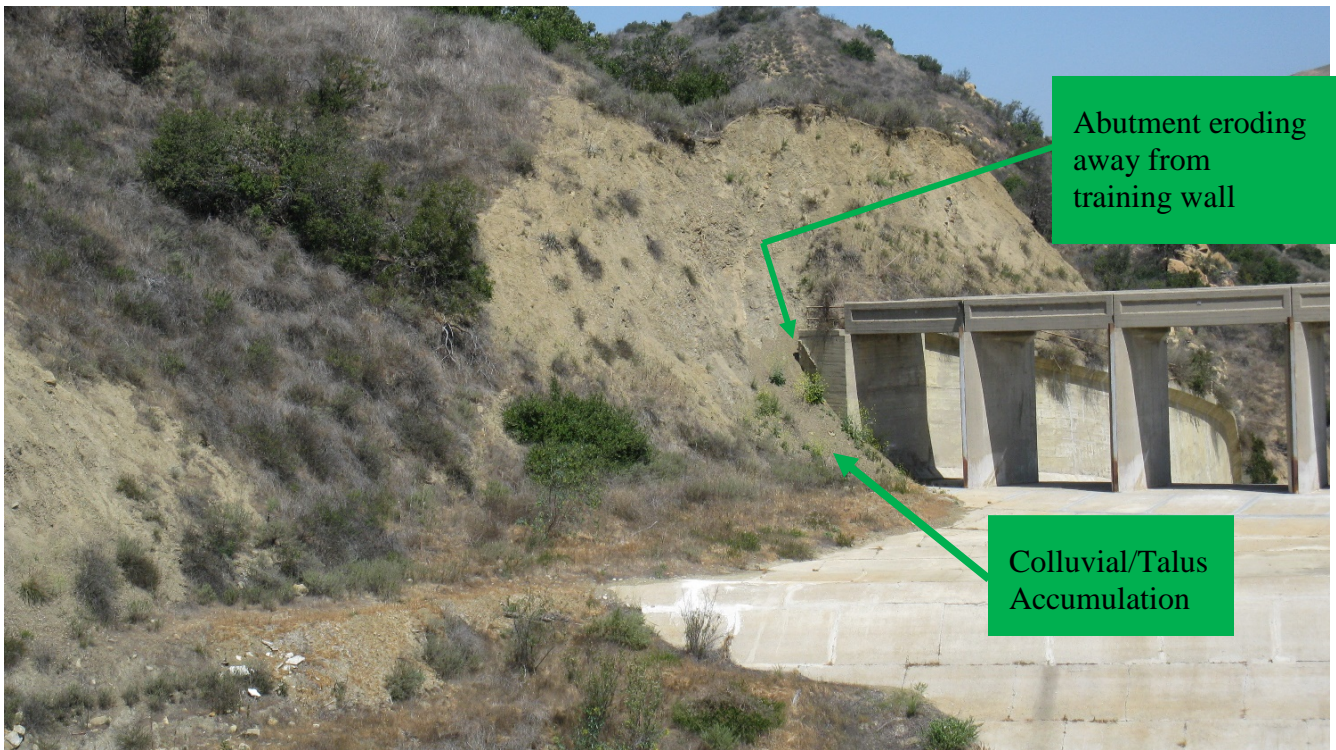
Chronic Erosion of Left Abutment at Spillway Approach

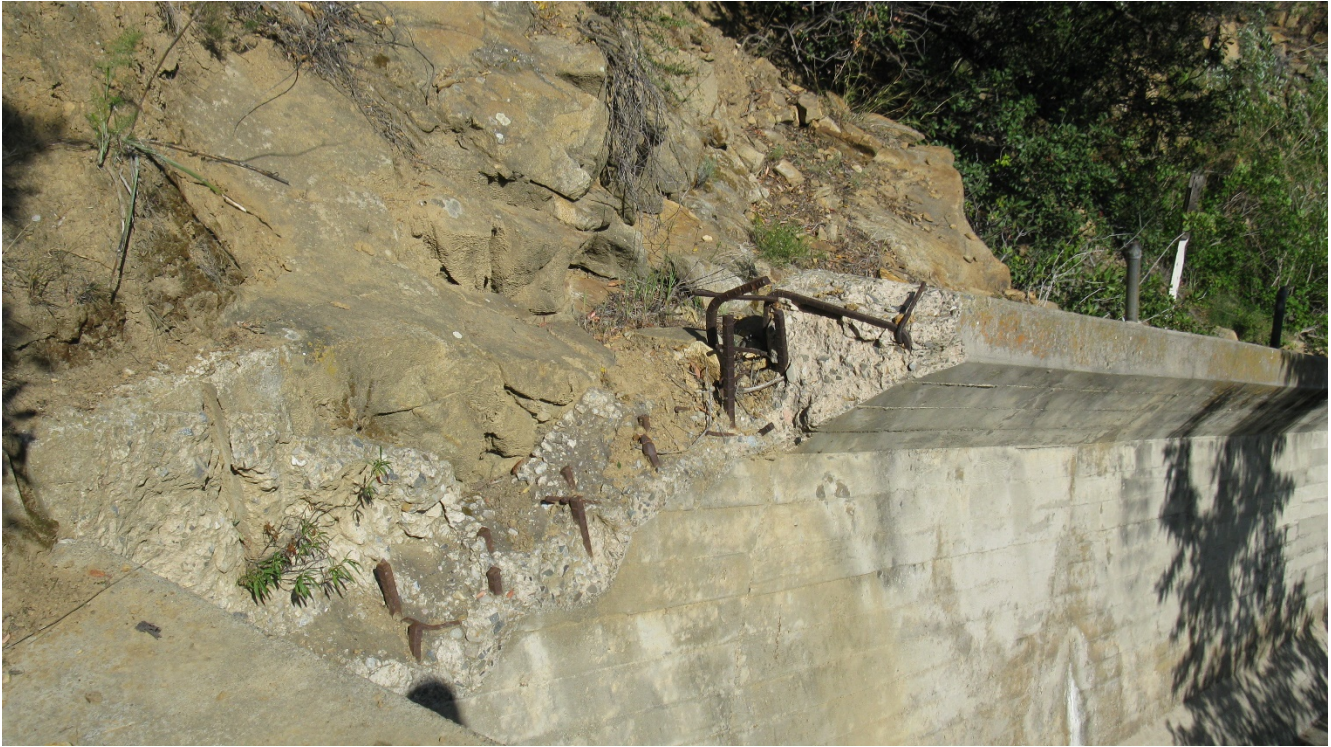
Damaged Left Training Wall at Ski Jump

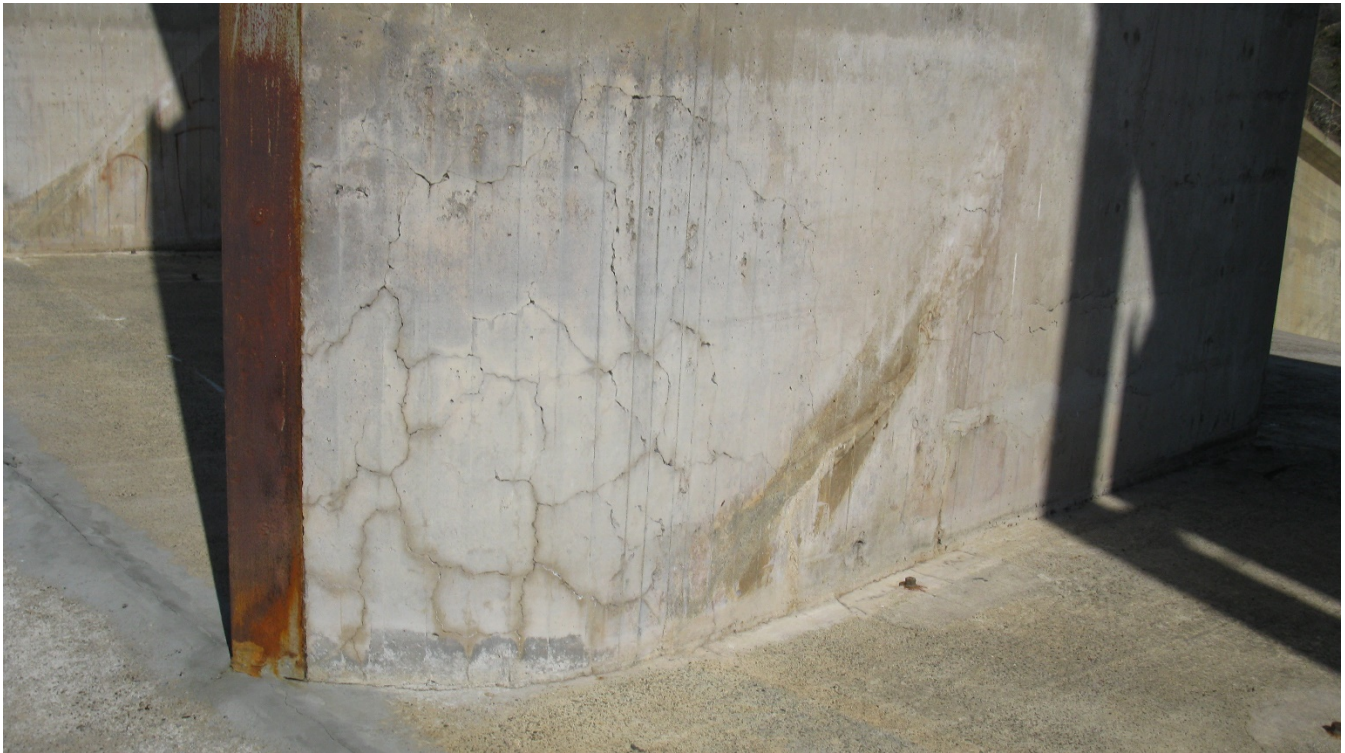
Alligator Cracking on Bull Noses of Spillway Bridge Piers

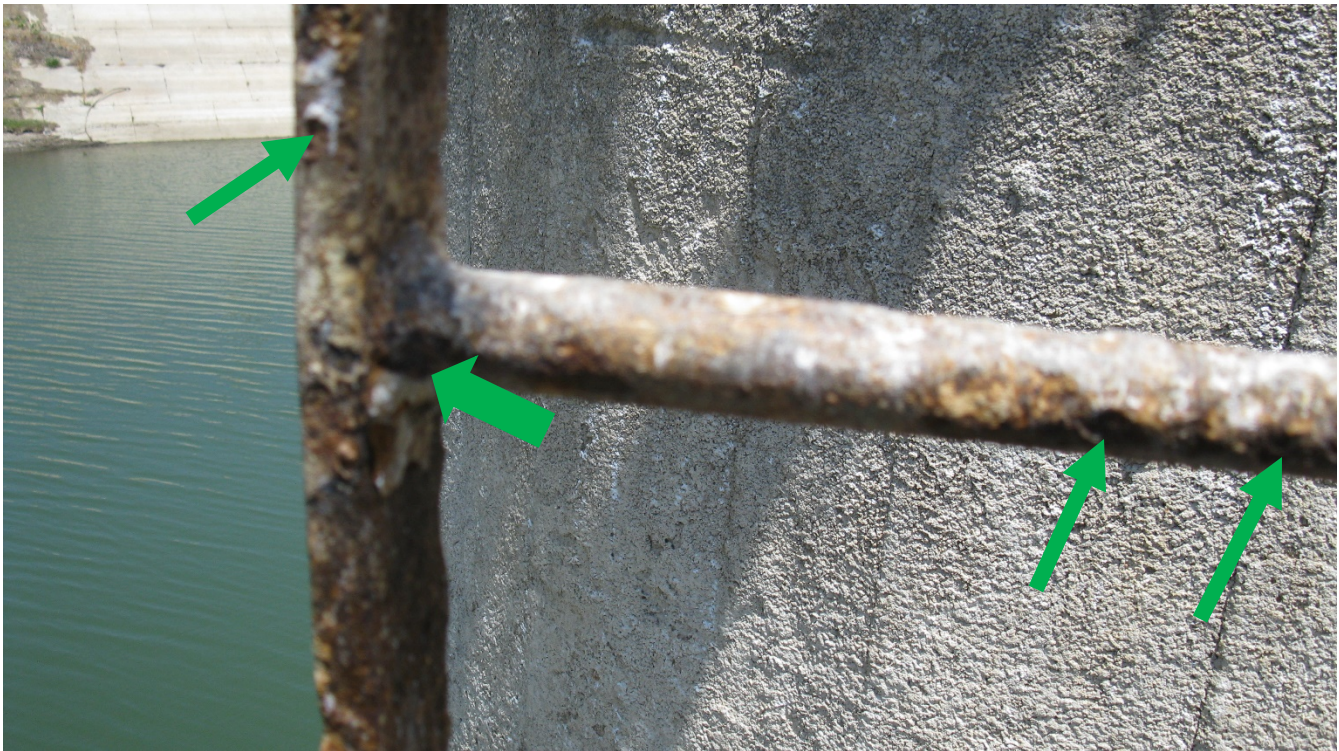
<u>Seepage</u>	<p>There were no signs of seepage observed on the downstream slope, groins, or toe of the dam.</p>
<u>Instr.</u>	<p>Instrumentation at this dam consists of 7 open well multistage piezometers, 5 single stage piezometers, and 5 survey monuments. The latest instrumentation surveillance report submittal was dated 8/25/2017 and included data for all of 2016. My review of the data for this period found no alarming trends beyond the anomalies associated with contamination of the open tube piezometers, which have been addressed. The survey data showed negligible movements. The instrumentation data indicates the dam is performing satisfactorily and no new instrumentation is judged necessary at this time.</p>
<u>Other</u>	<p>The only way to access the upstream outlet valves is from the top of the tower. The highly corroded ladder to access this platform poses a potential impediment to the controls (say in an emergency) if someone gets injured from the rungs or mounting devices breaking off while climbing the ladder. Recommend replacing this ladder as soon as practical, while the reservoir level is still low. No application is required.</p>

Typical Ladder Rung Accessing Tower – Note Holidays and Cracked weld
