STATE OF CALIFORNIA
CALIFORNIA NATURAL RESOURCES AGENCY
DEPARTMENT OF WATER RESOURCES
DIVISION OF SAFETY OF DAMS

INSPECTION OF DAM AND RESERVOIR IN CERTIFIED STATUS

Name of Dam San Joaquin Reservoir Dam No. 1029 County Orange
Type of Dam Earth Type of Spillway Concrete drop inlets
Water is 7.5 feet below spillway crest and 13 feet below dam crest.

Reason for Inspection Periodic Maintenance Inspection

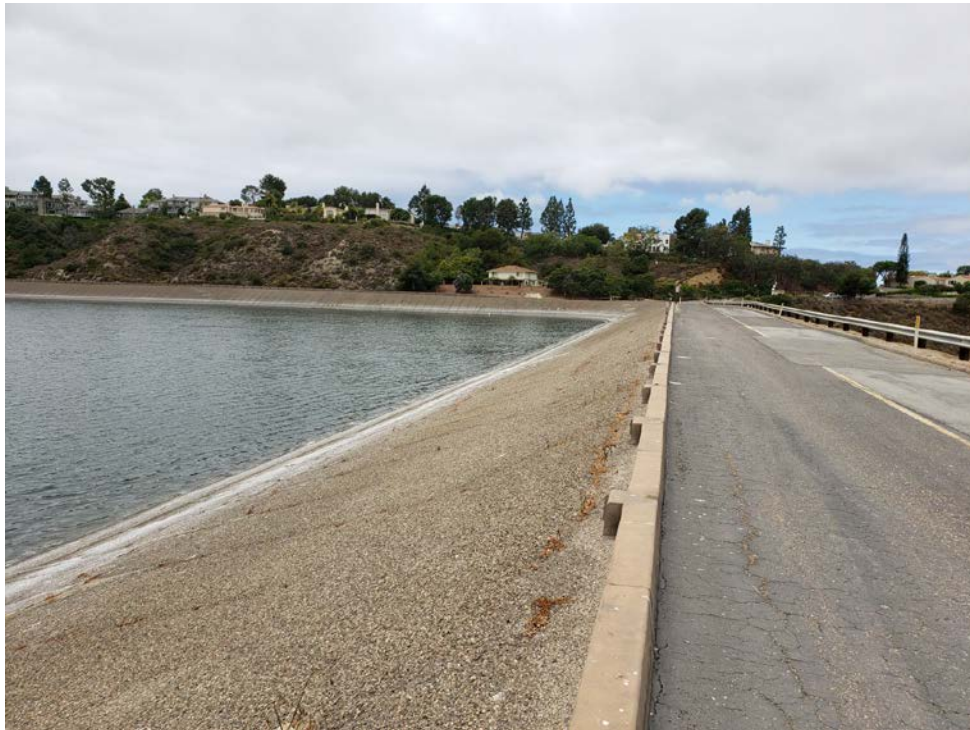
<u>Dam</u>	The crest appeared to be well-aligned and in satisfactory condition. There is a crown in the middle of the crest that rises about two feet. The visible portion of the lined upstream slope and rip-rap covered downstream slope appeared to be uniform, stable, and in satisfactory condition. The downstream benches appeared to be stable and in satisfactory condition. Vegetation and rodent control appeared adequate. Bait traps are strategically placed on the embankment. The downstream toe area appeared to be normal.
<u>Spillway</u>	There are two overpour drop inlets for the spillway; one located at each abutment. The approach areas and both drop inlet structures were open and clear. The exit portal in the downstream tailworks dissipating structure was unobstructed. The concrete sections of the spillway appeared to be in satisfactory condition with no signs of distress.
<u>Outlet</u>	The outlet consists of five upstream valves and two in-line downstream butterfly blowoff valves. The blowoff valves are located inside the outlet vault that also houses the east, west, and filter drains. The vault is a permit required confined space. According to the logs, all the valves were last operated on May 25, 2022. We witnessed all the valves fully cycled during the January 14, 2020, and October 19, 2020, inspections. All the outlet valves need to be fully cycled in our presence during the next inspection.

View of the crest and upstream slope.

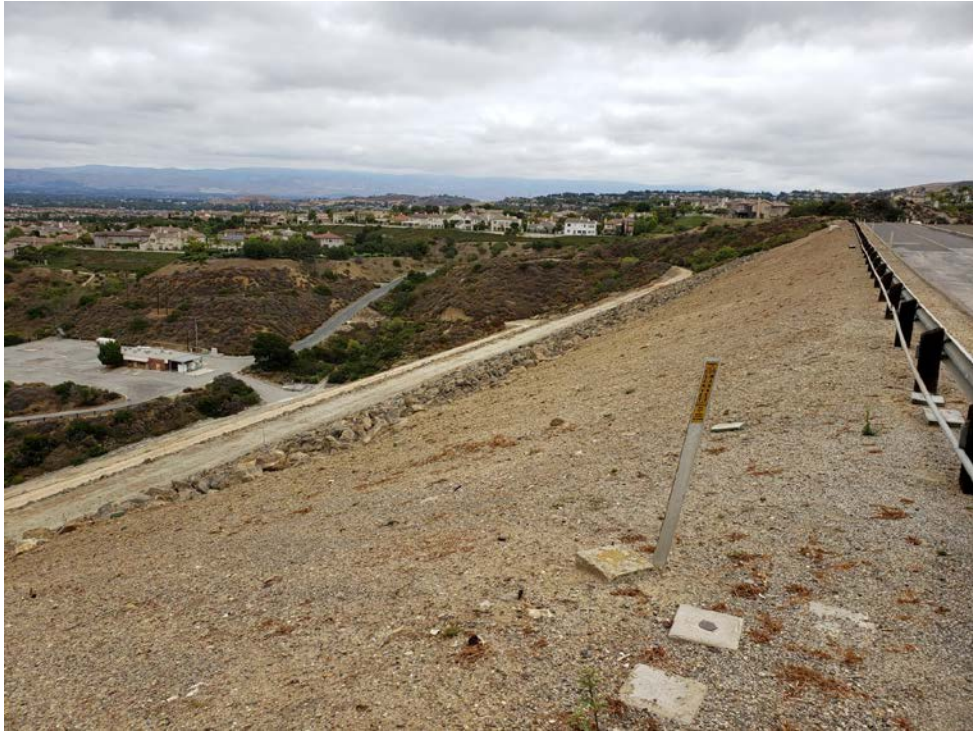
The upper downstream slope.

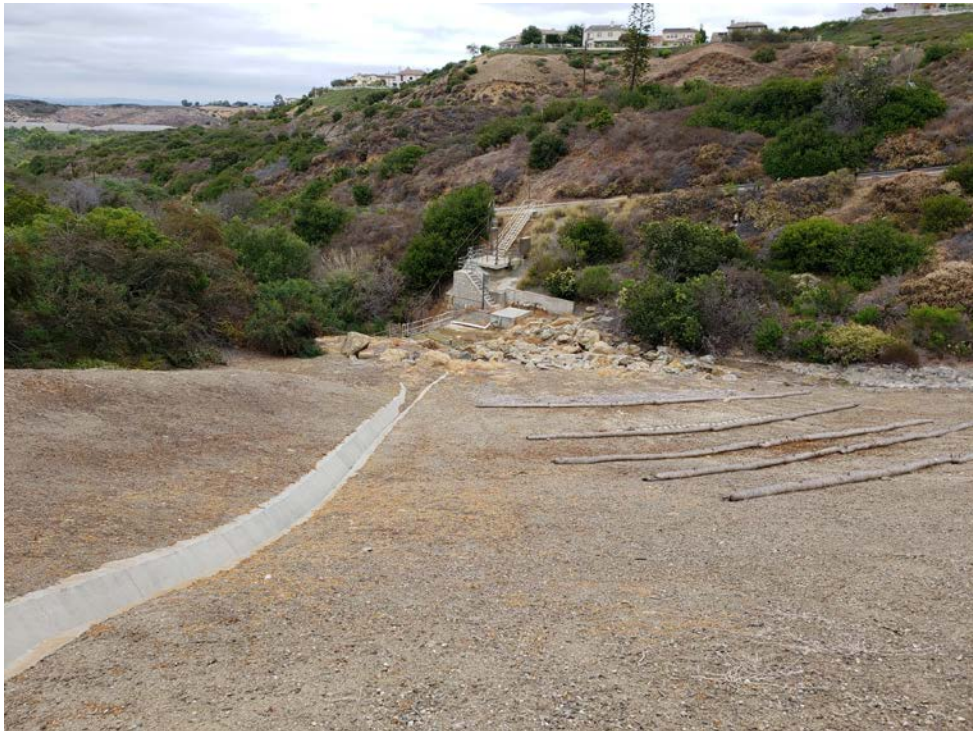
The lower downstream slope area.

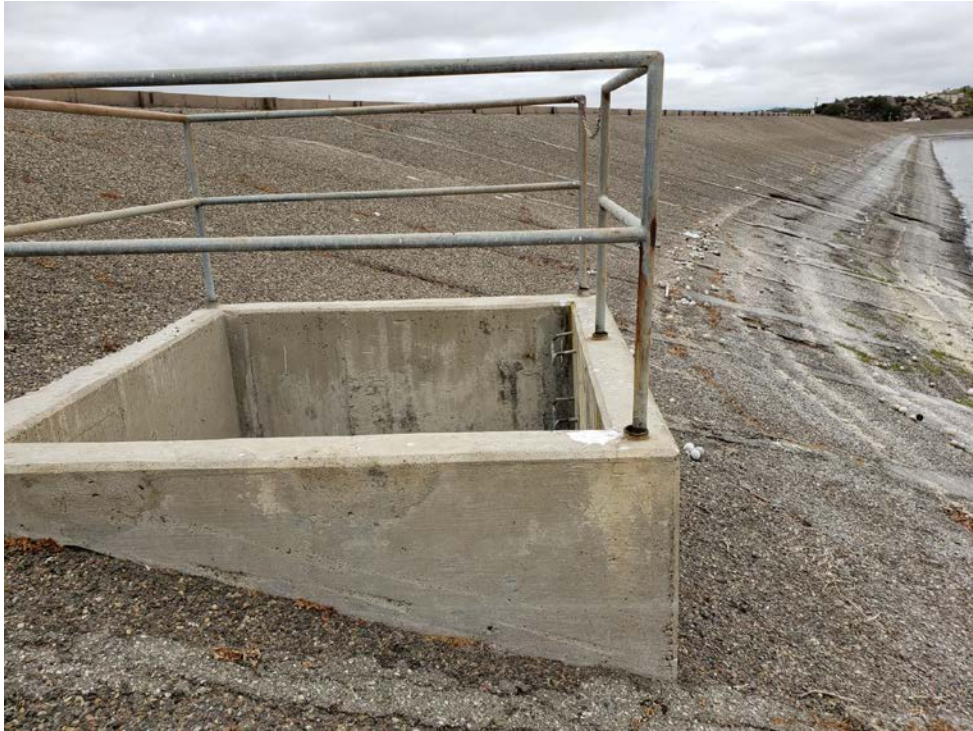
The approach to the two spillways were open and clear.

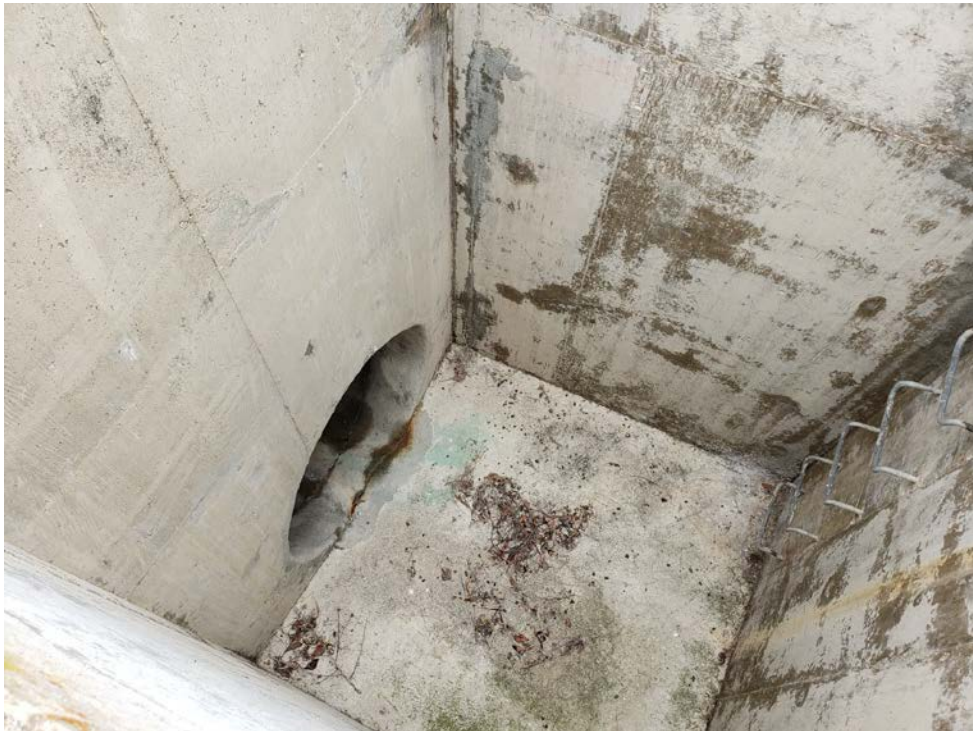
View looking in one of the drop inlet spillways.
