STATE OF CALIFORNIA  
CALIFORNIA NATURAL RESOURCES AGENCY  
DEPARTMENT OF WATER RESOURCES  
DIVISION OF SAFETY OF DAMS

**INSPECTION OF DAM AND RESERVOIR IN CERTIFIED STATUS**

Name of Dam Santiago Creek Dam No. 75 County Orange  
 Type of Dam Earth Type of Spillway Concrete weir and channel  
 Water is 55 feet below spillway crest and 75 feet below dam crest.

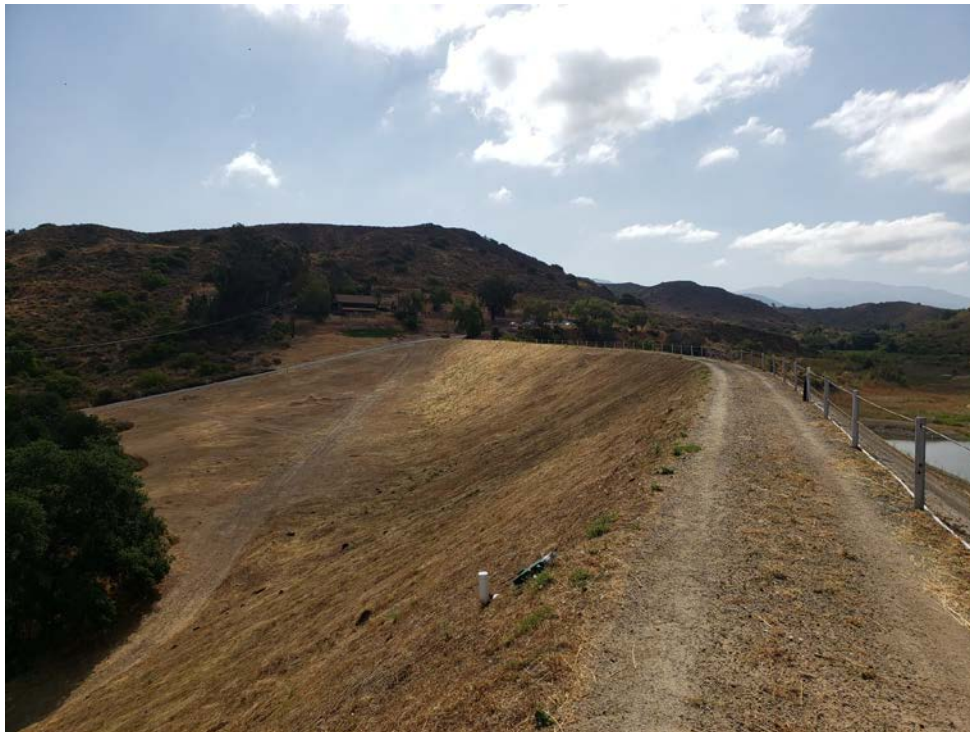
| <u>Dam</u> | The gravel crest of the dam appeared to be level and in satisfactory condition. The visible portion of the concrete lined upstream slope appeared to be uniform, stable, and in satisfactory condition. The downstream slope also appeared to be stable and in satisfactory condition. Woody vegetation on the downstream slope was requested to be removed. The woody vegetation was promptly cleared following the inspection and photos were submitted showing the removal. Rodent control appeared adequate with bait traps strategically placed on the downstream embankment. No concerning erosion was detected on the dam embankment. The downstream toe area was dry and appeared to be normal. |

View of the crest and downstream slope looking towards the right abutment.

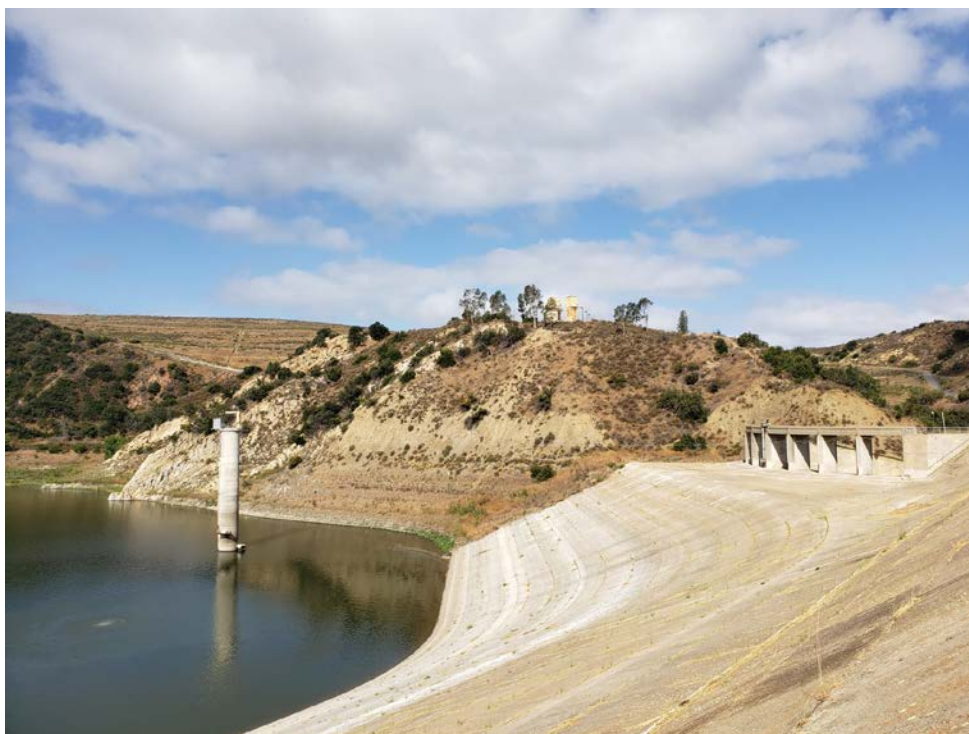
View of the outlet tower and spillway approach.

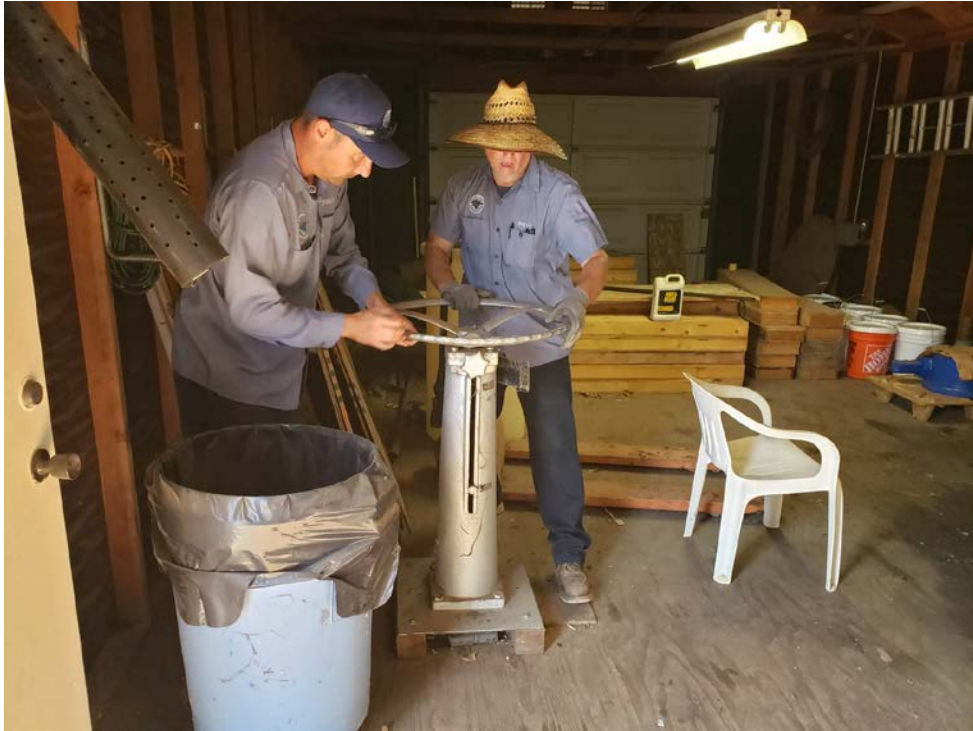
The downstream diverter valve in the outlet house was fully cycled.

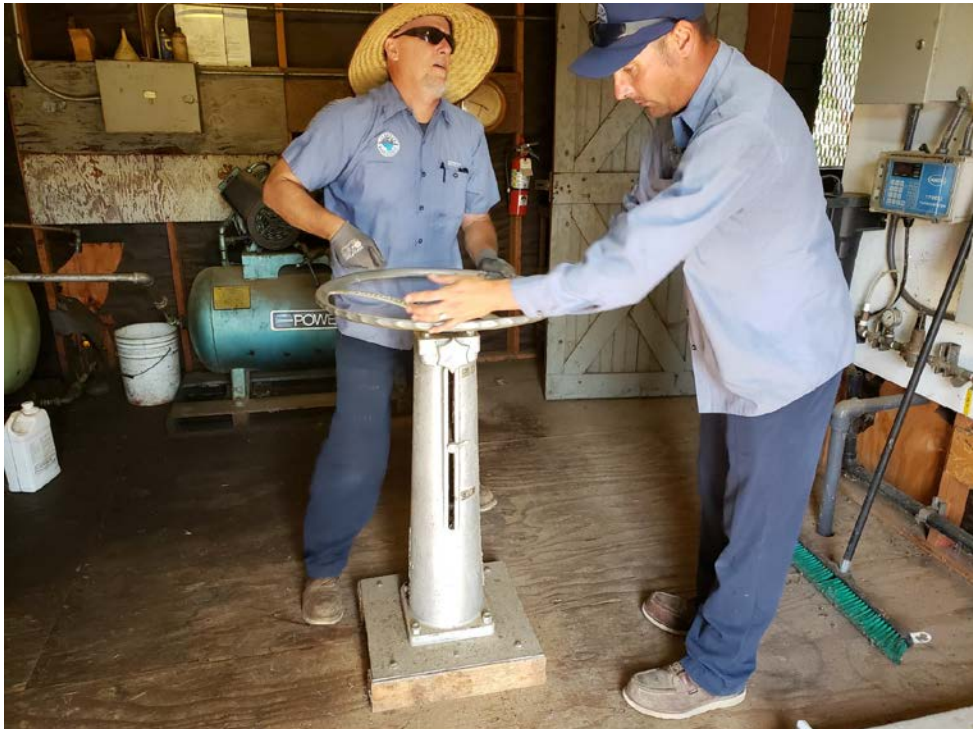
| <u>Outlet</u> | The upper four gates in the outlet tower were fully cycled with an electric motor operator during this inspection. The lower four gates on the outlet tower are silted in and inoperable. The main service valve was cycled 50% during this inspection due to water demands. It was reported that the main service valve was fully cycled on May 18, 2022, when there were no water demands. The diversion valve and 30" blowoff were fully cycled 100% with no problems encountered. The exit and dissipating structure were unobstructed and appeared to be in satisfactory condition. |

The main service valve was cycled 50% due to water demands.

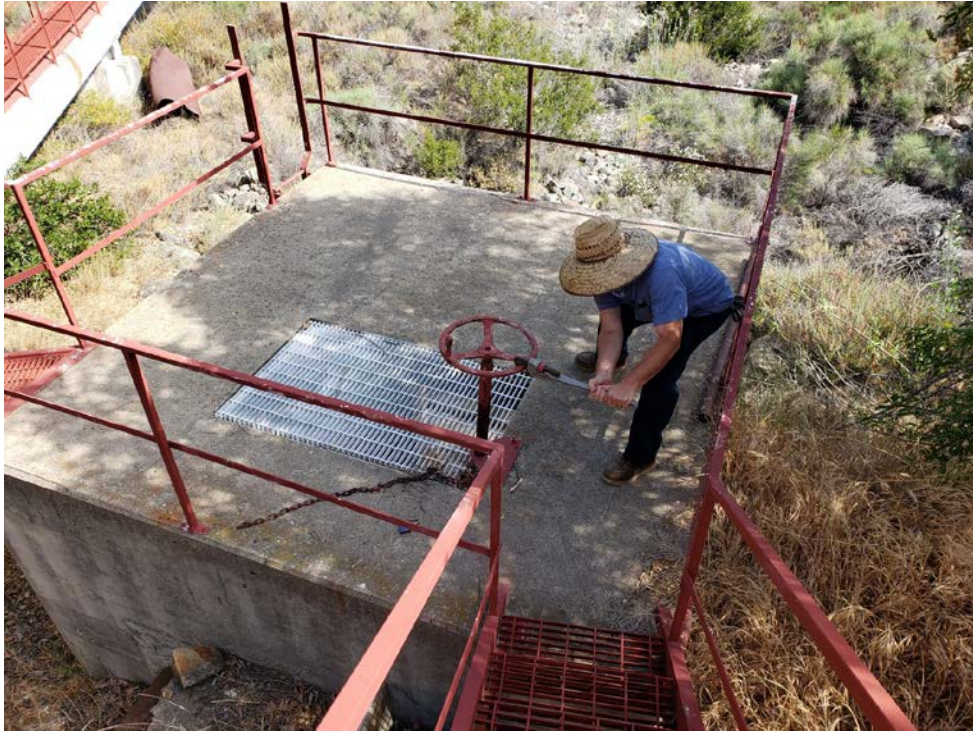
The downstream blowoff valve was fully cycled.

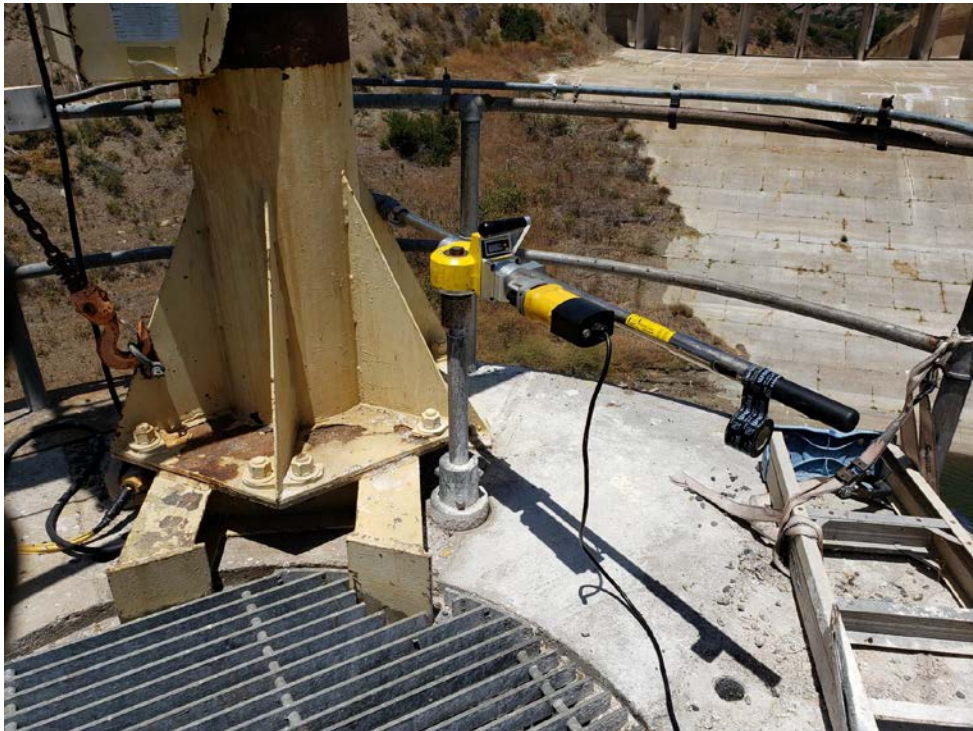
The four upstream valves in the outlet tower were fully cycled.
