Annual Surveillance Report January 2024 to December 2024 for Sand Canyon Dam DSOD Dam No. 1029-002

Irvine, California

**Re: Sand Canyon Dam, DSOD Dam No. 1029-002,
Annual Surveillance Report from January 2024 to December 2024**

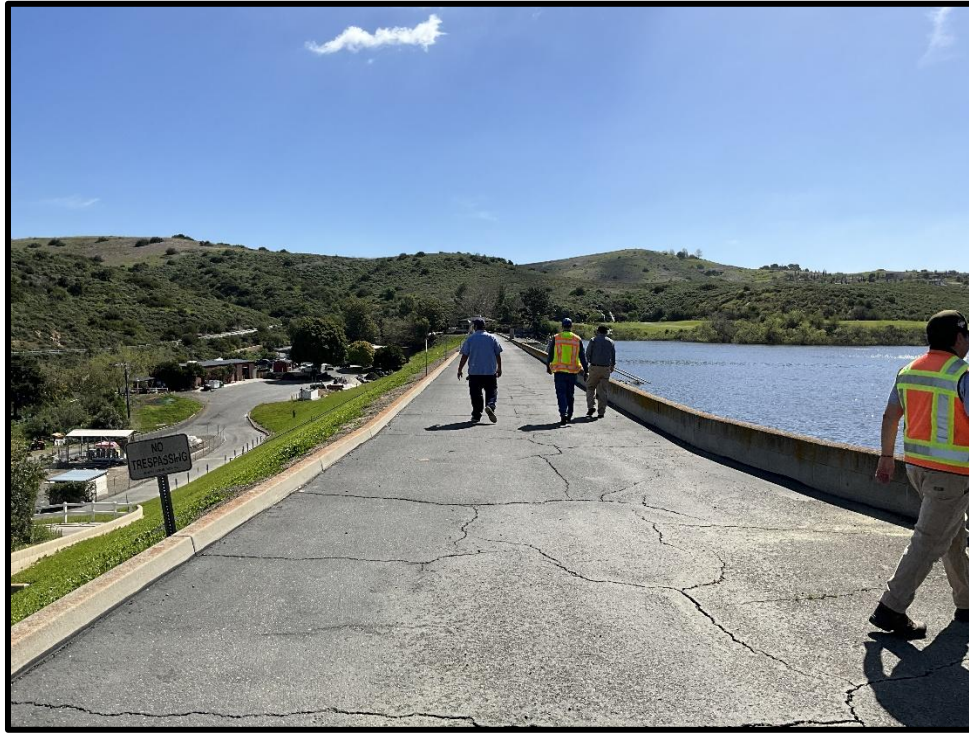
The crest of the dam was walked, and the asphalt concrete surface was observed to be in good condition with no signs of movement and significant cracking, see Photo 1. Minor temperature related AC cracking was observed near the left abutment, see Photo 1. The exposed upstream AC-lined slope face above the reservoir water level had some long-standing transverse and longitudinal shrinkage-expansion cracking with vegetation growing within the cracks, see Photo 2. The dam crest and upstream face looked similar to what was observed during the July 2023 inspection.

Photo 1) AC paved crest looking towards the right abutment, including 1-foot-high curb wall.

- 9) Repair AC at localized crack areas on the upstream slope and crest of the dam. These cracks should be repaired with a Sika AC repair product. Vegetation and brush at the upstream slope need to be removed.

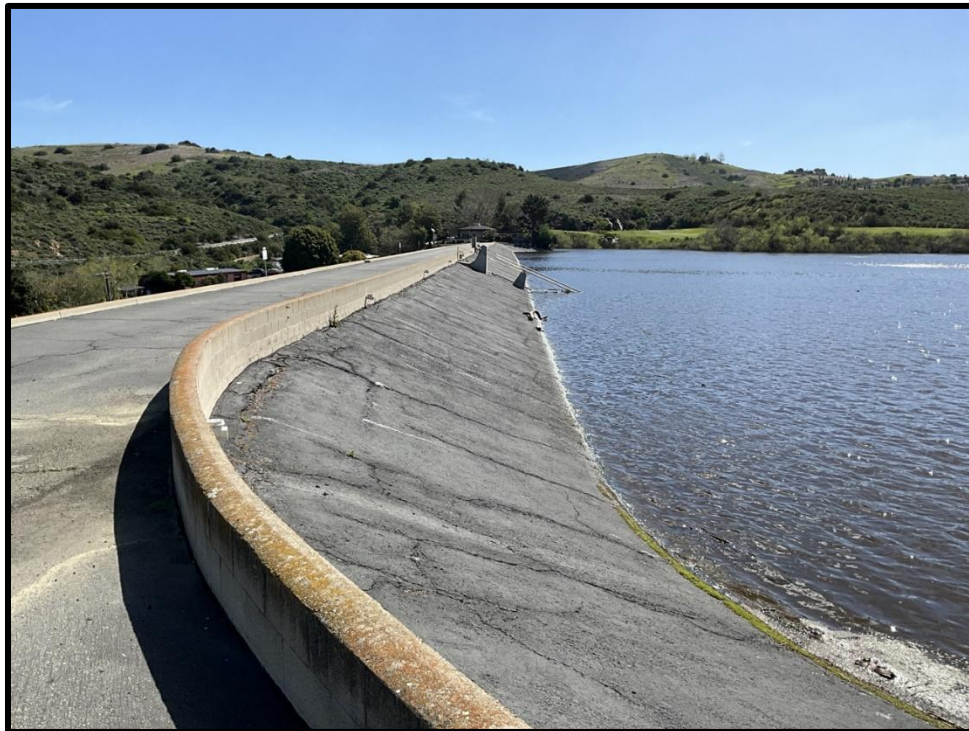
- 11) The long-standing transverse and longitudinal shrinkage-expansion cracking along the upstream face of the AC liner appeared similar to what was observed during the July 2023 inspection.

Photo 2) AC-lined upstream face looking towards right abutment. Note cracks along face.

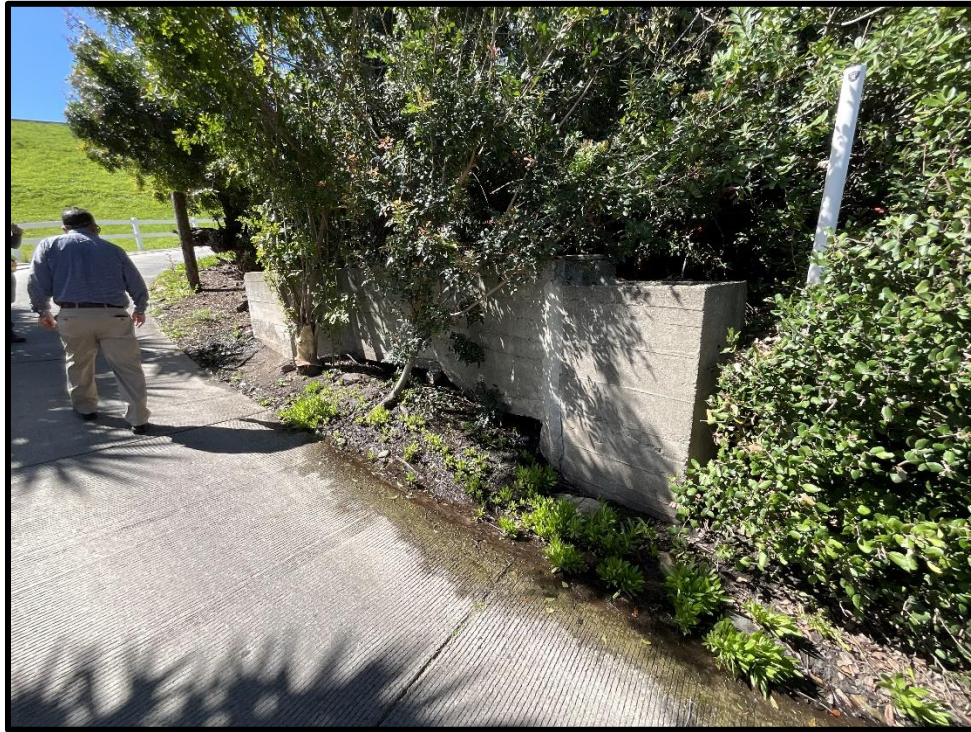
GEI inspected the abandoned irrigation weir box which has previously shown signs of seepage, see Photos 3-5. GEI observed water seeping around the weir box and accumulated water within the box. Minor seepage was also observed trickling from the crack in the weir box, see Photo 4. The water in the weir box appears to be a combination of seepage and surface runoff from the surrounding area that has migrated through the cracks of the abandoned irrigation weir box. It is possible that the source of the seepage around the weir box and inadvertently collected in the weir box is from the reservoir. This possibility is further supported with observation that the seepage in the area is most noticeable during periods of elevated water levels in the reservoir.

Photo 3) Abandoned irrigation weir box. Note seepage surrounding the box.

- 8) IRWD should continue monitoring abandoned irrigation weir box throughout the year to observe any changes during drier seasons and lower reservoir water levels. GEI recommends that IRWD establish a method to capture and measure flows at this location if determined to be coming from the reservoir. IRWD should provide monitoring data to include in annual surveillance reports. GEI recommends that IRWD establish a method to capture and measure flows at this location if determined to be coming from the reservoir.

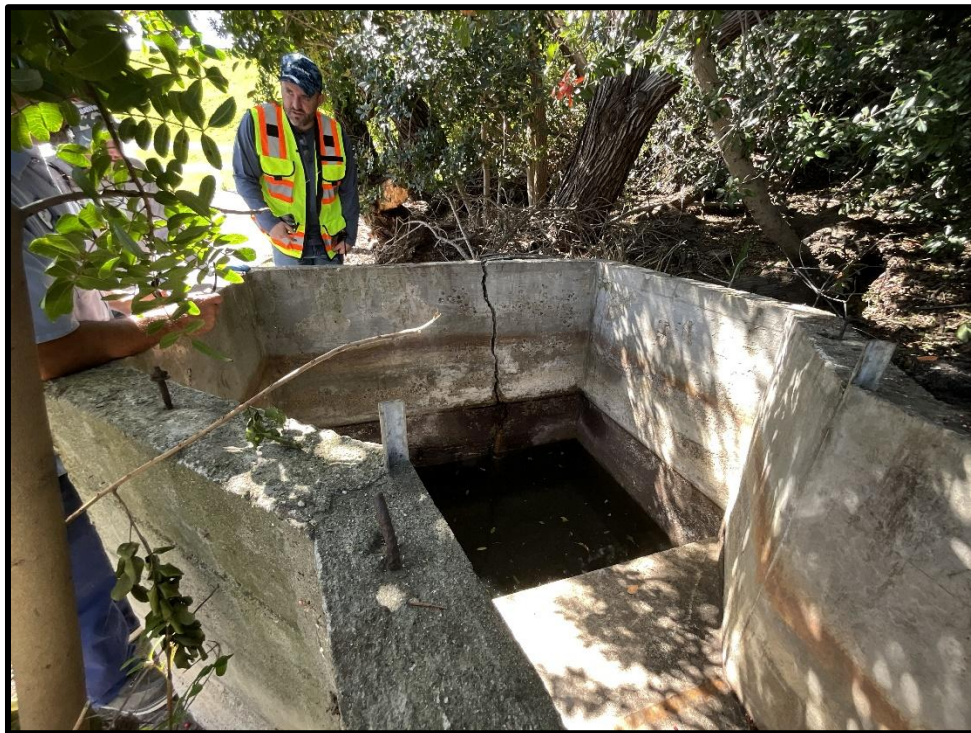
Photo 4) Abandoned irrigation weir box. Note pooled water.

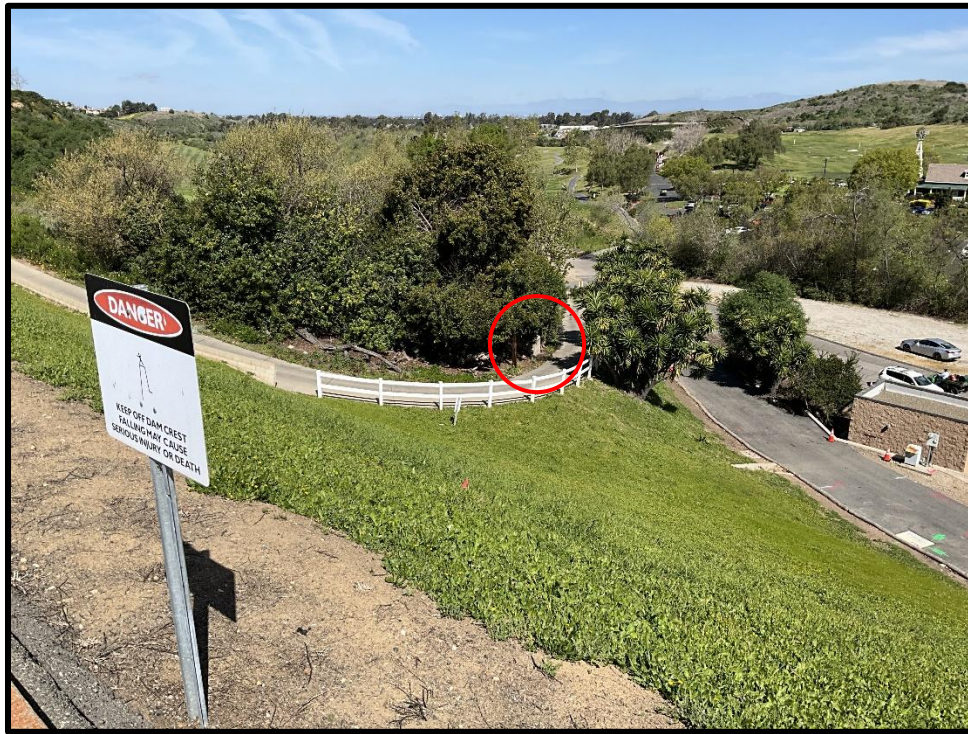
Photo 5) Downstream face of dam near left abutment. Note abandoned irrigation weir box.

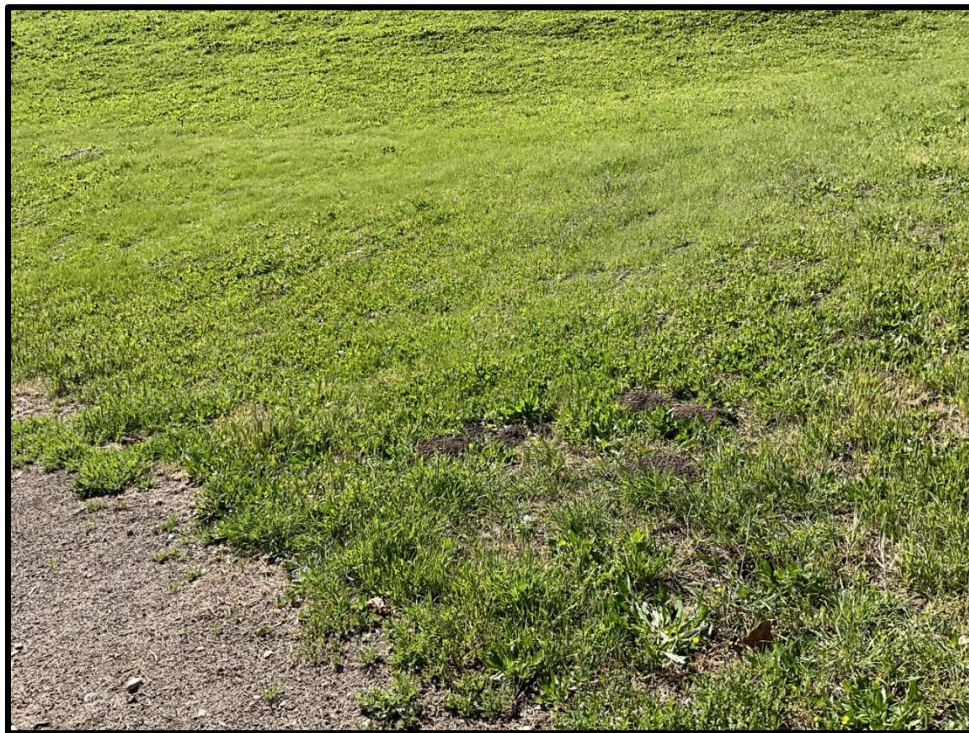
Photo 8) Minor rodent activity on the downstream toe near the left abutment.

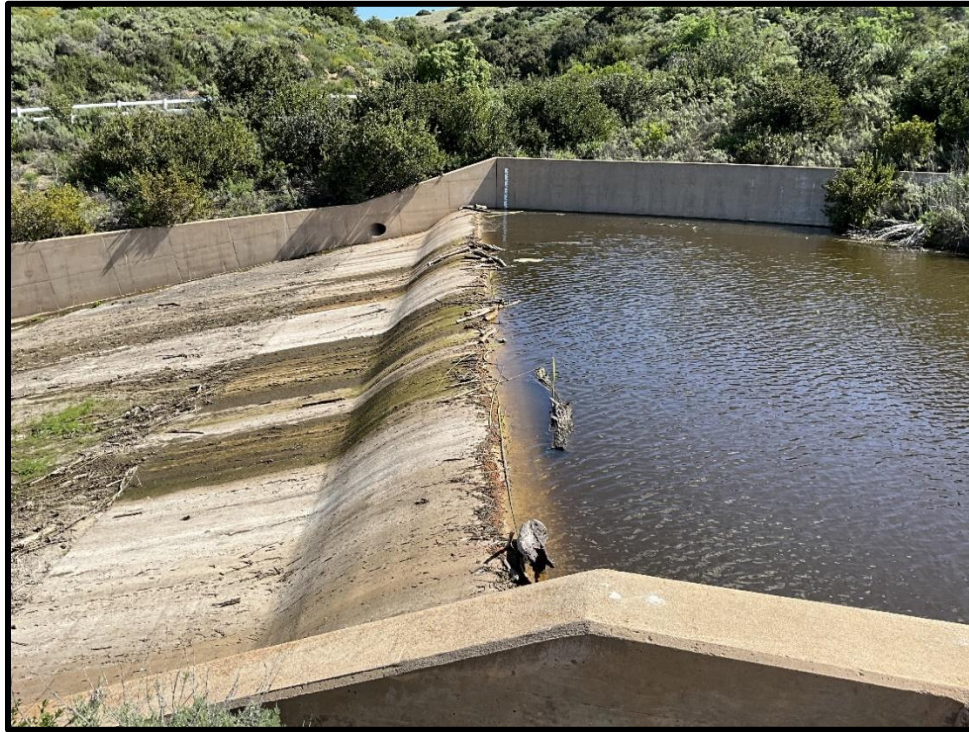
The reservoir was not spilling during the inspection, but reservoir water levels were near the ogee weir crest, see Photo 9. GEI was not able to access the spillway due to the high-water level. Vegetation and debris have accumulated along the spillway channel due to the recent spilling, see Photos 9 and 10. Minor brush/tule growth was observed at the end of the stilling basin, see Photo 11. The District is aware this vegetation growth has to be monitored continuously and cut

Photo 9) Spillway control ogee section and approach. Note debris and water level.

- 16) The District needs to remove vegetation and debris that accumulates in the spillway channel after a spilling event.
- 17) GEI recommends clearing the shrub and tree vegetation directly above the spillway channel walls.
- 18) GEI recommends performing a detailed Spillway Condition Assessment.
- 19) Continued careful monitoring by the District staff of the condition of the dam, appurtenances and instrumentation. Staff needs to be inspecting for signs of distress or movement, increased seepage, or any other unusual conditions including instrumentation readings. Any unusual observations need to be reported immediately to the Dam Safety Engineer.
- 20) GEI recommends continuing following IRWD's Dam Safety Program Guidelines after a 4.0 earthquake.

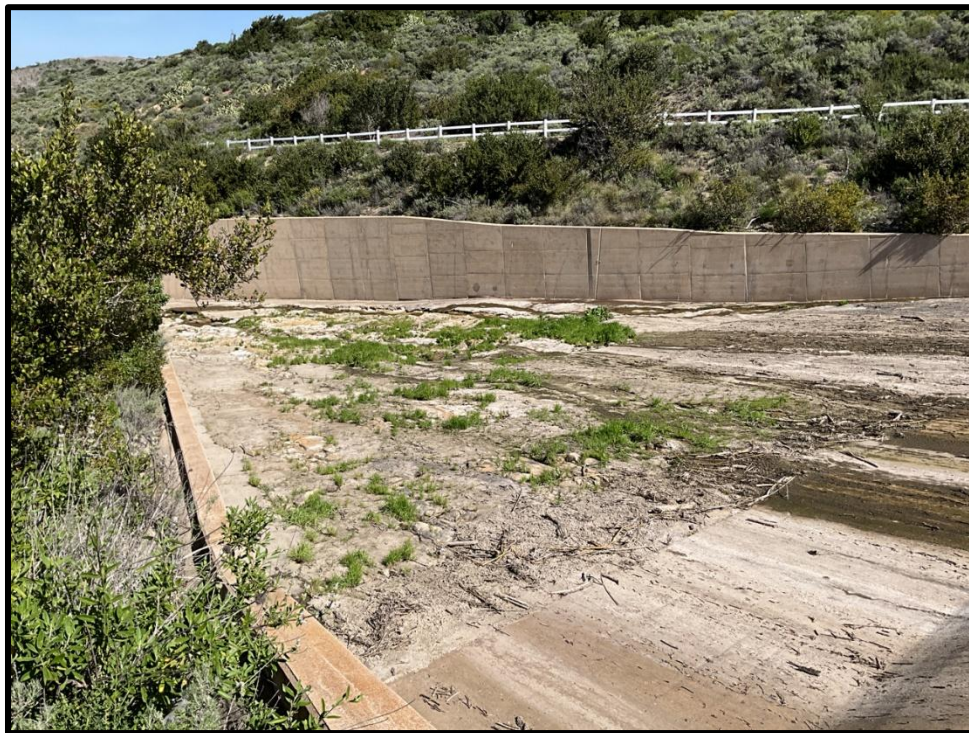
Photo 10) Spillway channel looking downstream. Note vegetation and debris.

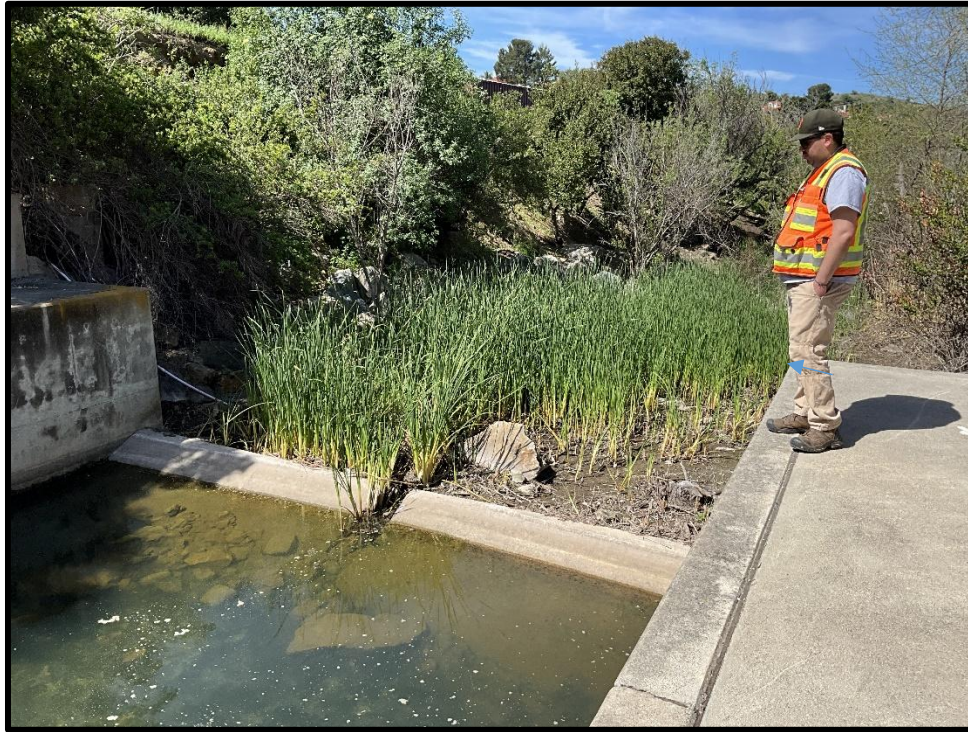
Photo 11) Close up view of spillway stilling basin. Note brush/tule growth downstream.

- 12) GEI recommends clearing the rocks and vegetation restricting access to the emergency valves.
- 13) The District needs to continue monitoring brush/tule growth at the spillway stilling basin and cut when appropriate to avoid any damage to spillway concrete or impacts to spillway operability.

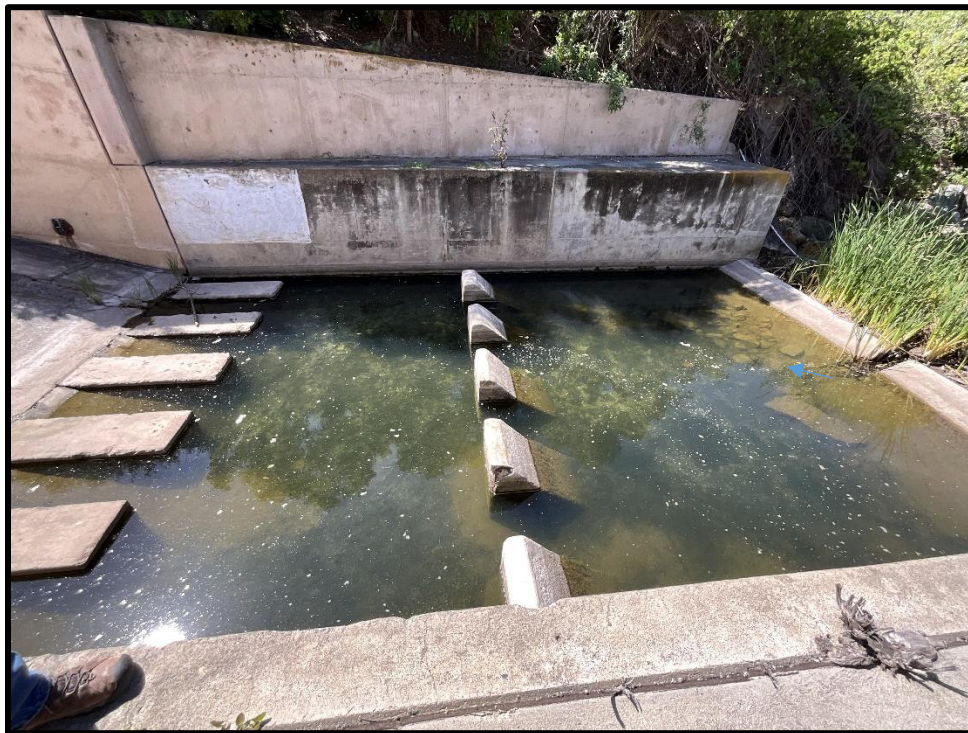
as required. GEI observed concrete spalling at one of the baffle blocks in the stilling basin which has exposed some rebar, see Photo 12. GEI was not able to take measurements at the crack gauges and inspect the undermining at the concrete repair work on the spillway channel floor due to restricted access. A more detailed inspection was conducted during the annual spillway inspections as follows.

Photo 12) Close up view of spillway stilling basin. Note brush/tule growth downstream.

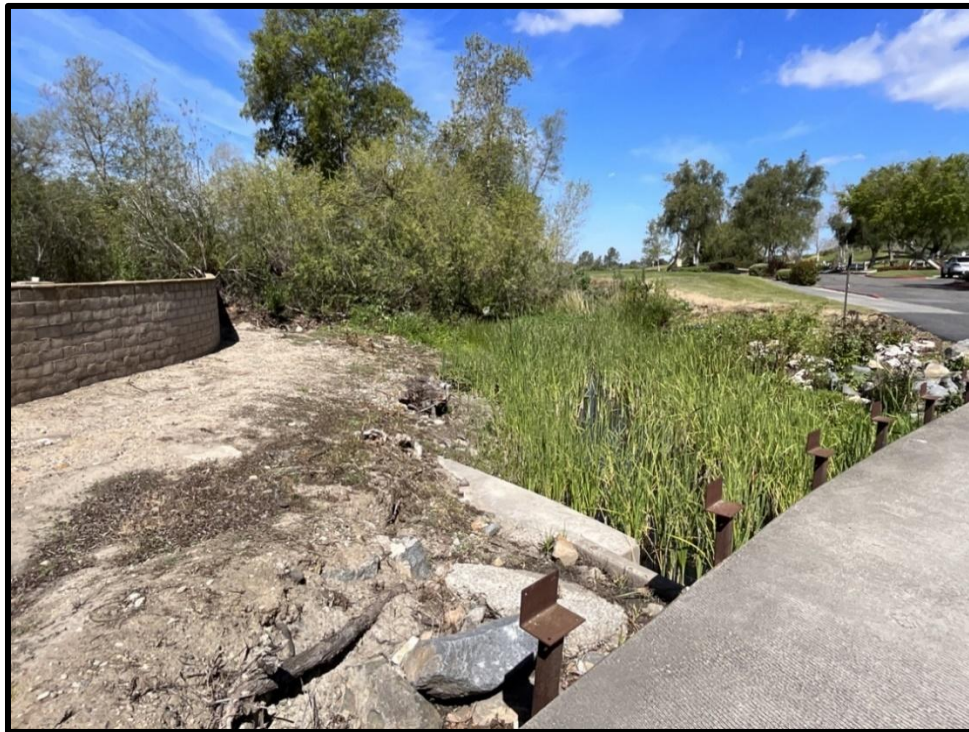
Photo 14) Sand Canyon creek. Note minor vegetation growth.

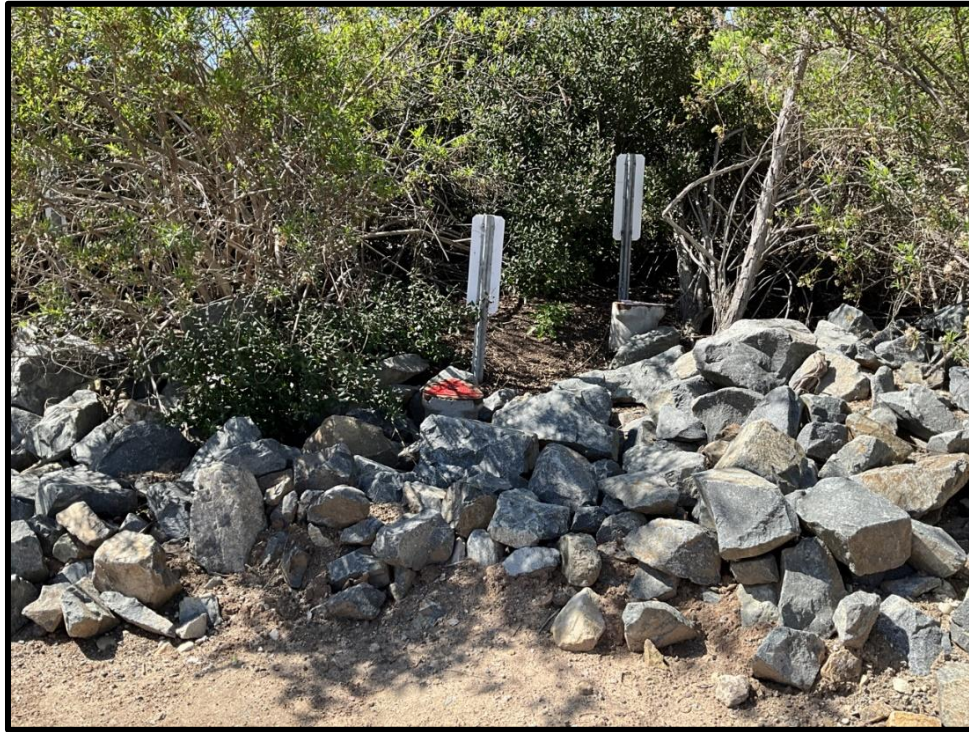
Photo 15) Close up of large diameter angular rocks and vegetation limiting access to emergency valves #23 and #24.

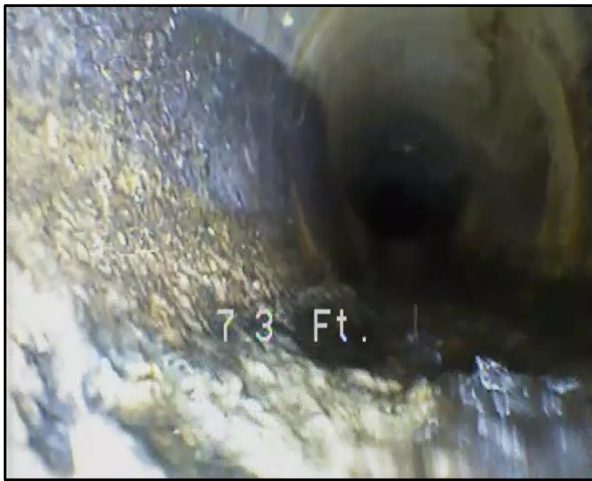
Photo 1 – STA 00+07: Pipe is in good condition with 75% staining on its walls (typical).

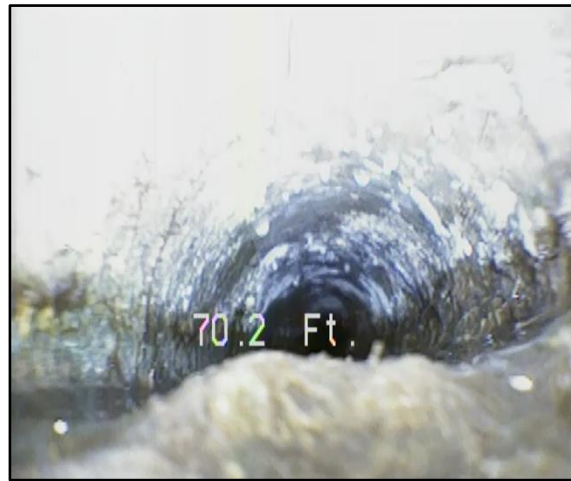
Photo 2 – STA 00+70: Pipe is in good condition.

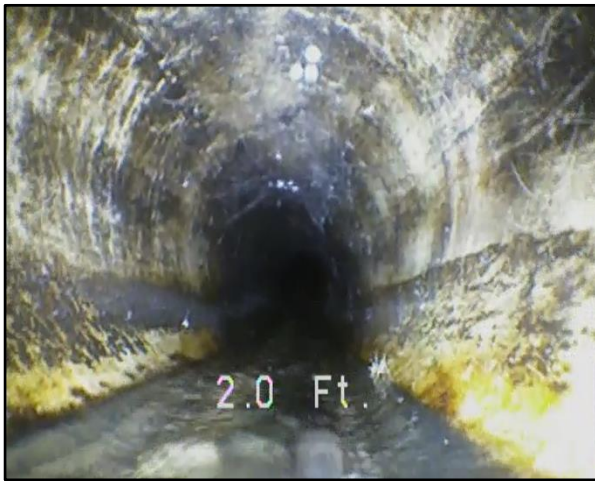
Photo 11 – STA 00+02: Pipe is in good condition with 100% staining on pipe walls.

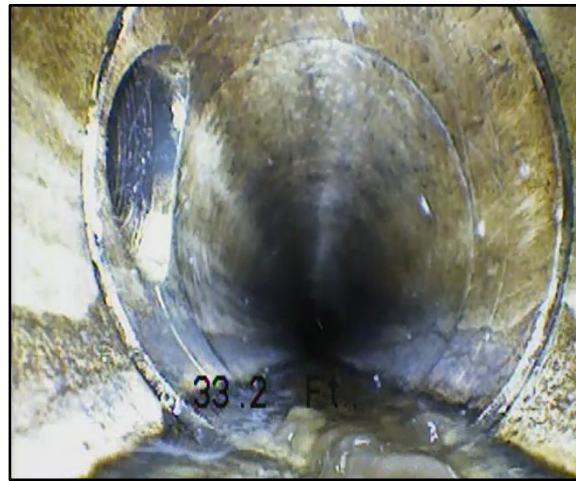
Photo 12 – STA 00+39: Lateral tap connection at 9 o'clock.

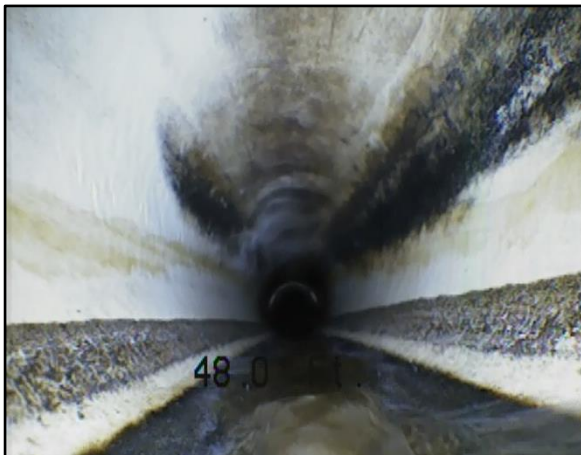
Photo 13 – STA 00+48: Pipe is in good condition with 65% staining on pipe walls.

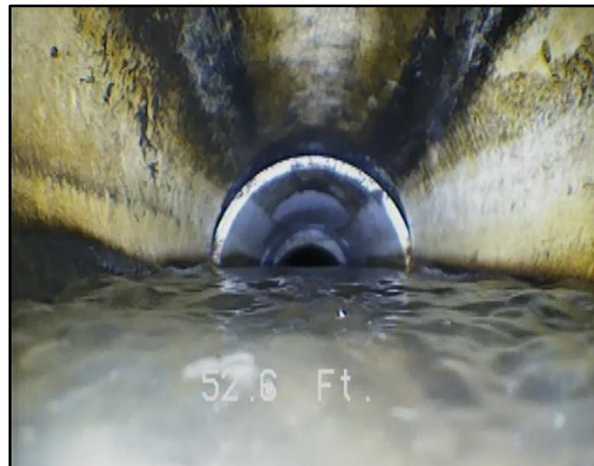
Photo 14 – STA 00+52: 50% water level and change in pipe diameter.

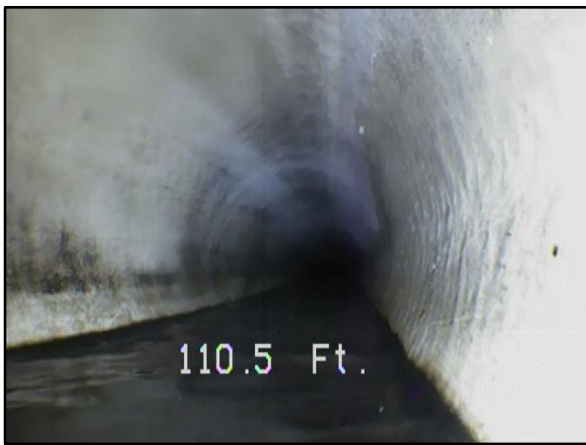
Photo 17 – STA 01+10: Pipe is in good condition.

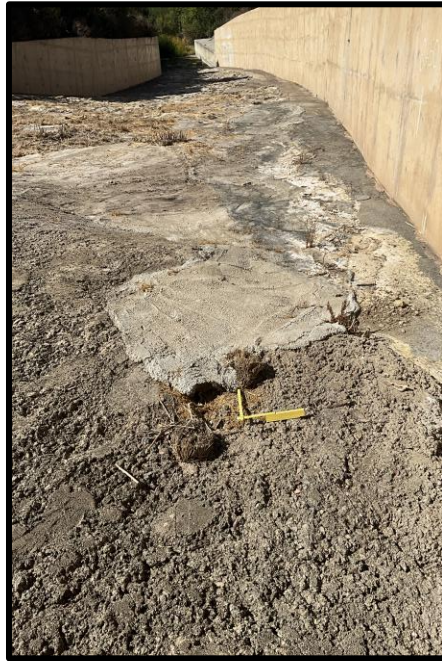
Photo 5) 5" depth void at previous spillway repair.

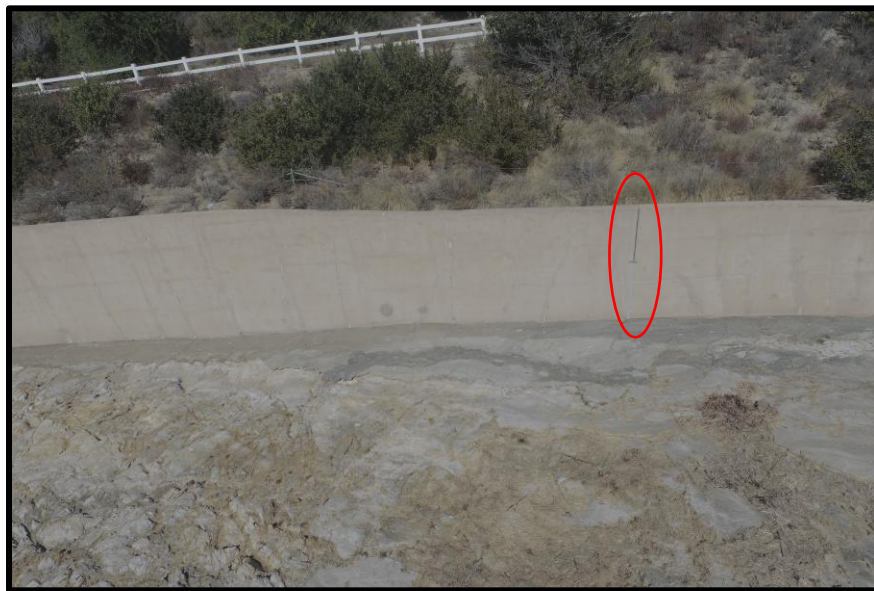
Photo 10) View of spillway wall panel R1 and R2. Note recent vertical joint repair.

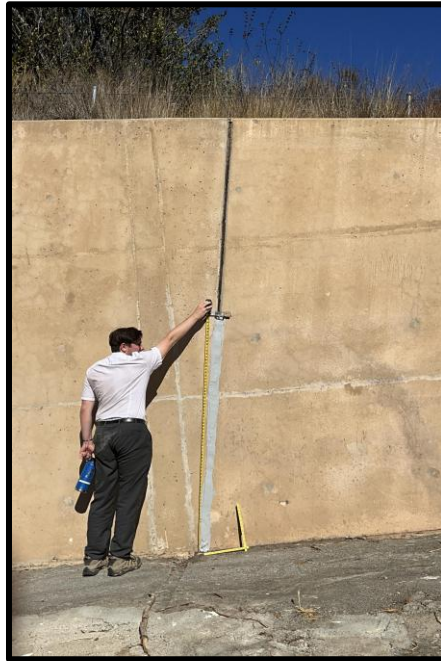
Photo 11) Vertical wall joint open $\frac{1}{2}$ " max between wall panels R1 and R2. Note recent repair of bottom half of joint.

- 15) GEI recommends measuring the crack gauge at the R1/R2 wall panel joint annually and during other spillway inspections if conducted.

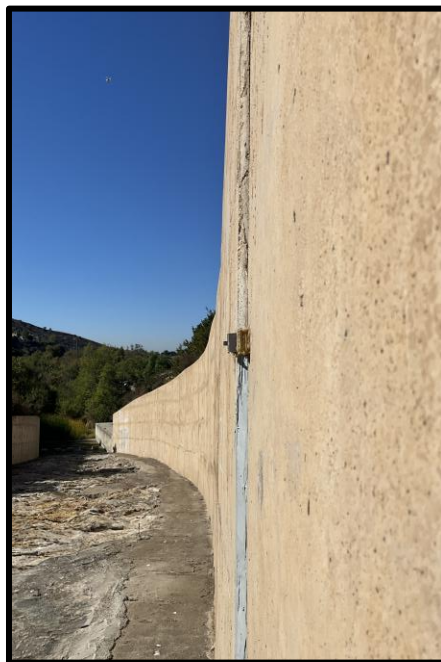
Photo 12) Crack gauge at wall panels R1 and R2 joint. Note recent repair.

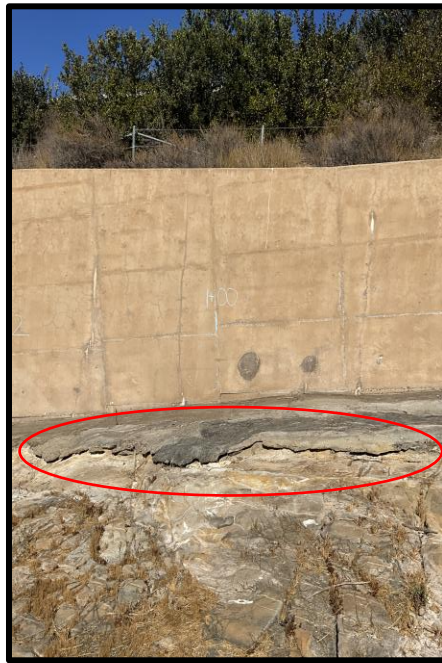
Photo 13) 5" height undermining of spillway floor.

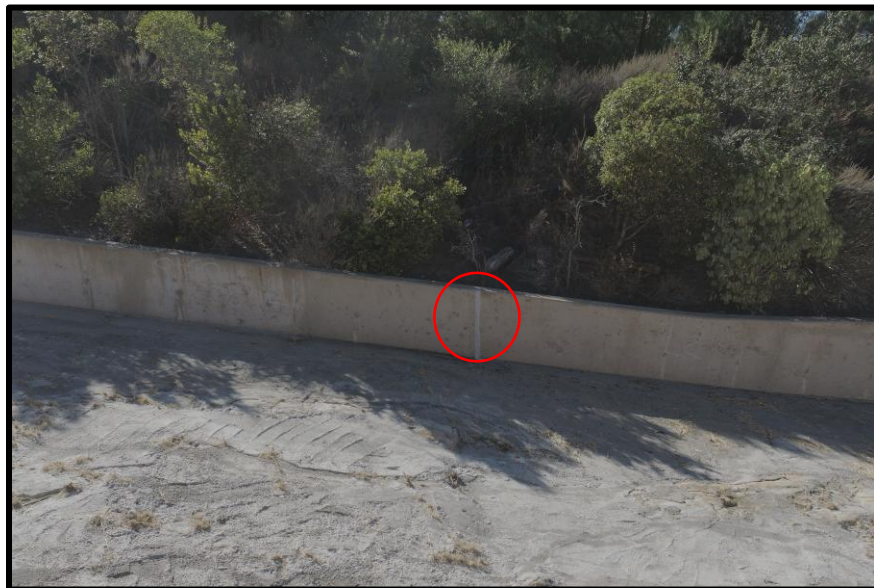
Photo 14) View of spillway wall panels L1 and L2. Note recently repaired wall joint.

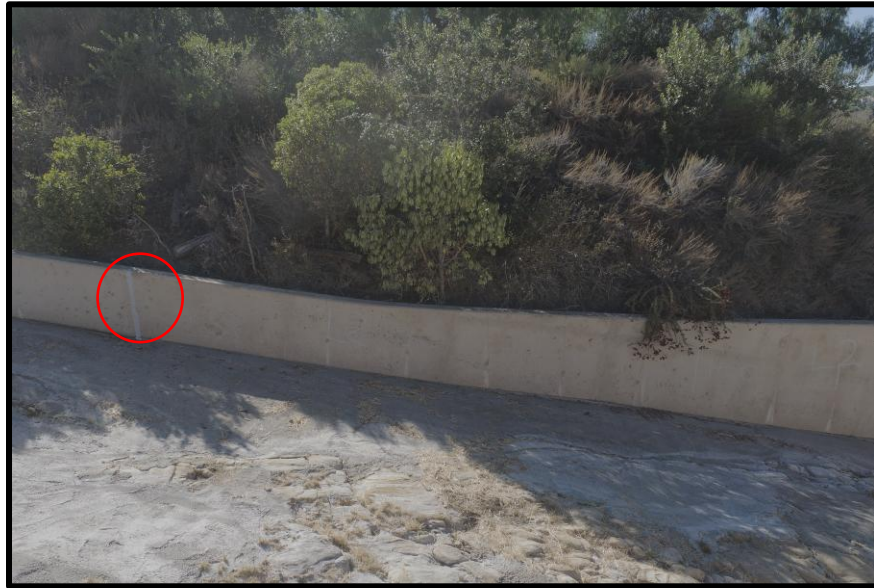
Photo 15) View of spillway wall panels L1 and L2. Note recently repaired wall joint.

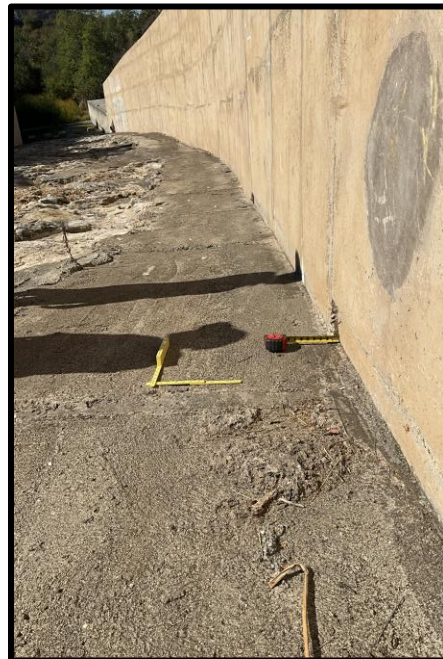
Photo 16) 1" offset at bottom of spillway wall panel R2.

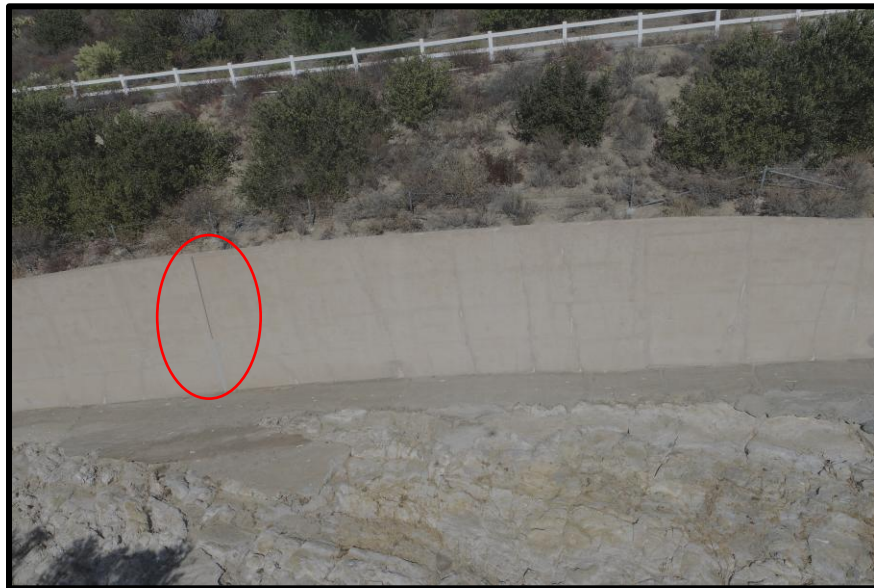
Photo 17) View of spillway wall panels R2 and R3. Note recently repaired wall joint.

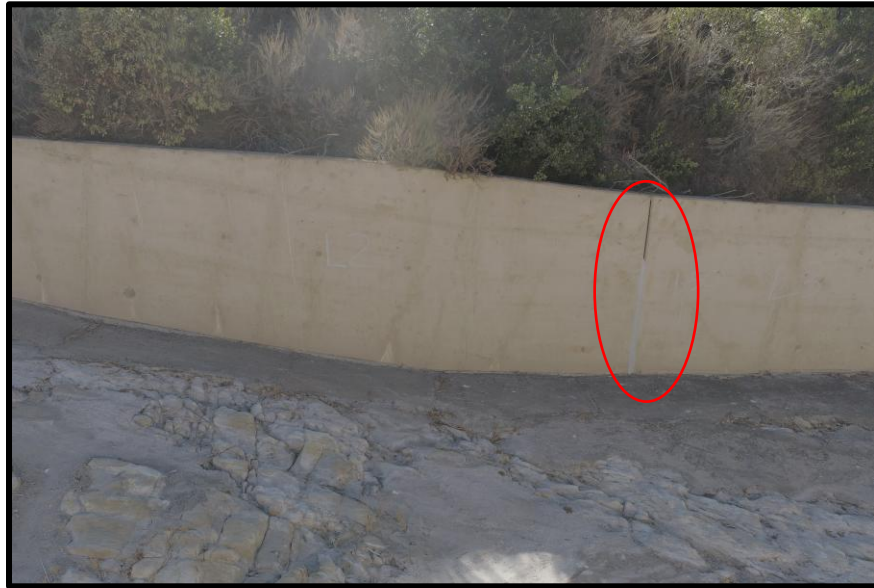
Photo 19) View of spillway wall panels L2 and L3. Note recently repaired wall joint.

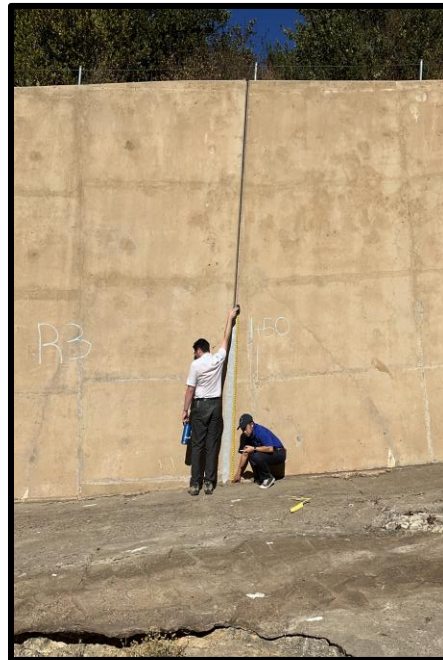
Photo 20) Vertical wall joint open $\frac{1}{2}$ " max between wall panels R2 and R3. Note recent repair of bottom half of joint.

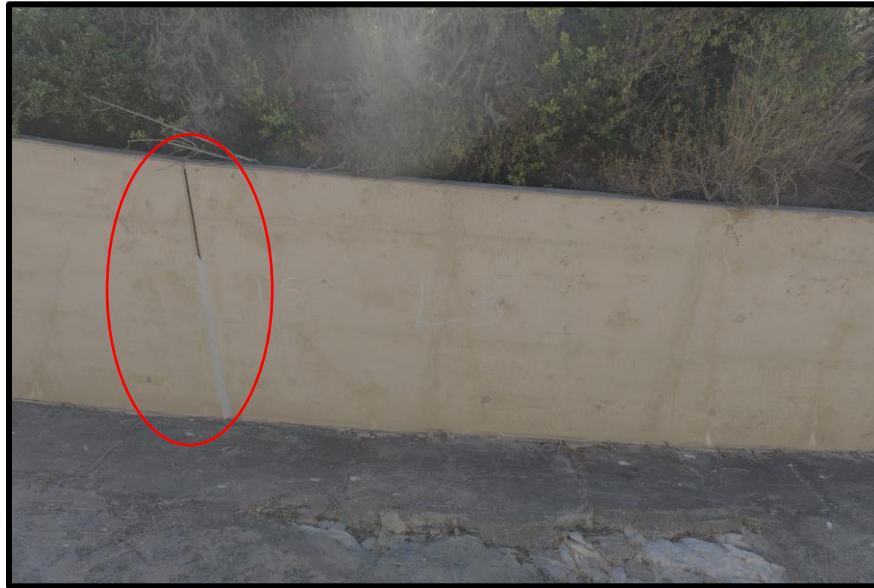
Photo 21) View of spillway wall panels L2 and L3. Note recently repaired wall joint.

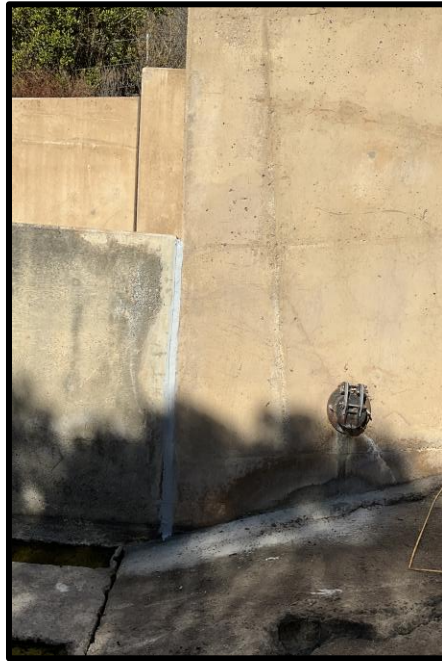
Photo 31) Recently repaired spillway vertical wall joint. Note spillway drain.

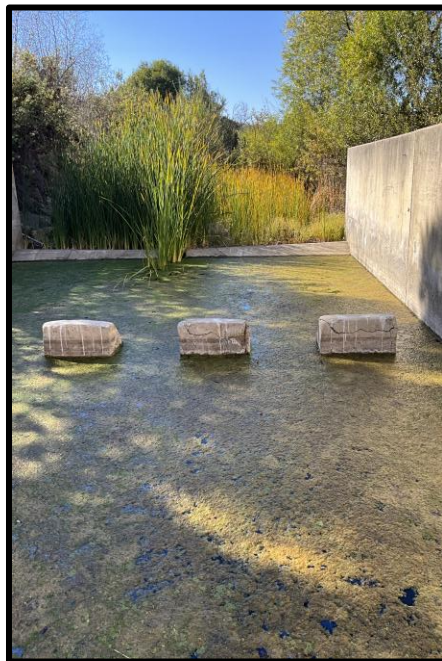
Photo 32) Spillway stilling basin. Note cracks on concrete baffles.

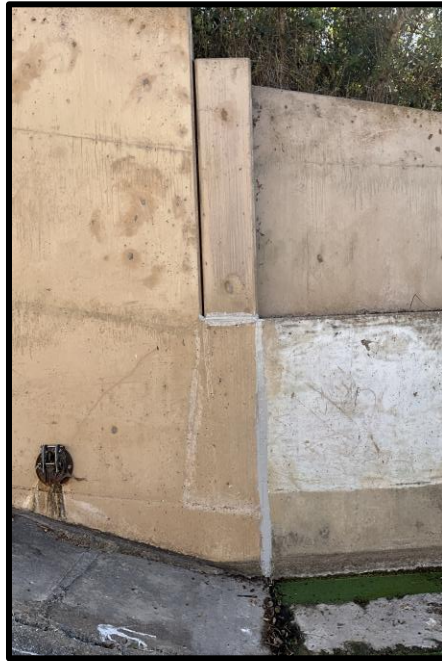
Photo 33) Recently repaired spillway vertical wall joint. Note spillway drain.

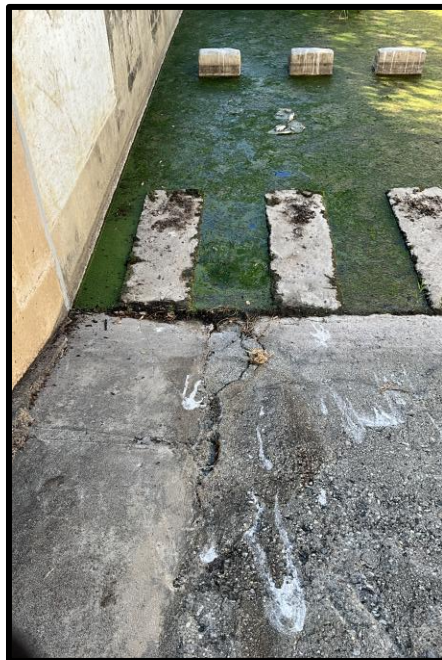
Photo 34) 1/2" cracks along spillway floor.

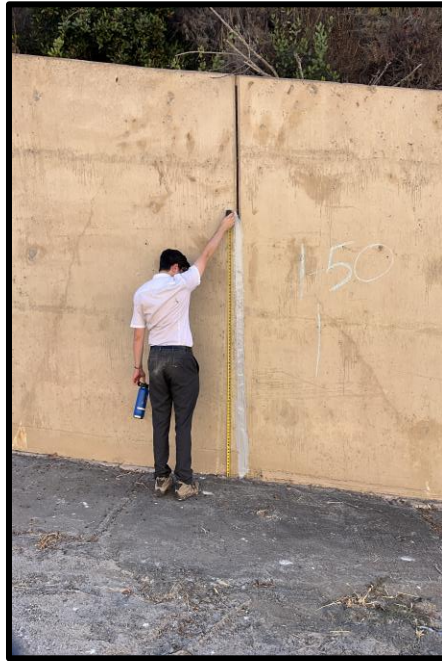
Photo 35) Vertical wall joint open $\frac{1}{2}$ " max between wall panels L2 and L3. Note recent repair of bottom half of joint.

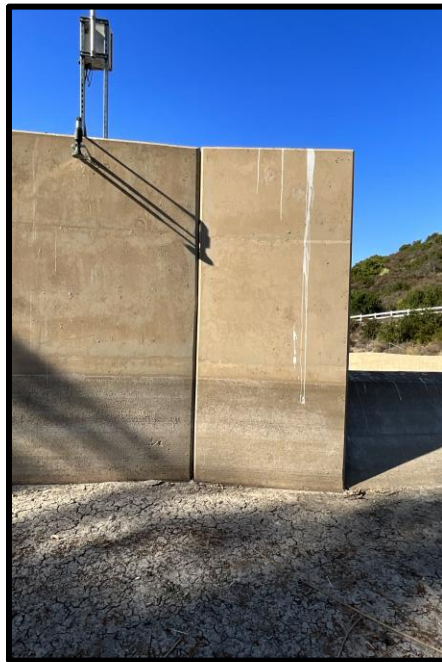
Photo 36) Vertical wall joint $\frac{1}{2}$ " open max with $1 \frac{1}{2}$ " max wall joint offset.
