STATE OF CALIFORNIA  
CALIFORNIA NATURAL RESOURCES AGENCY  
DEPARTMENT OF WATER RESOURCES  
DIVISION OF SAFETY OF DAMS

## INSPECTION OF DAM AND RESERVOIR IN CERTIFIED STATUS

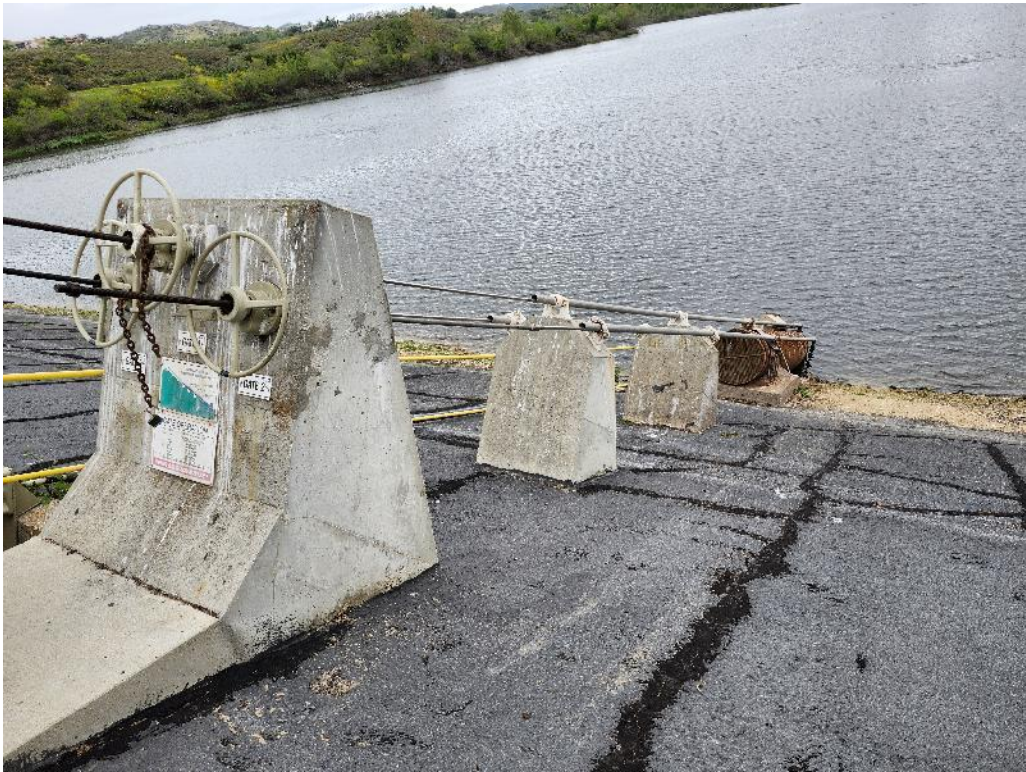
Photo 6. Slide Gate #2 bent stem has been repaired.
