STATE OF CALIFORNIA  
CALIFORNIA NATURAL RESOURCES AGENCY  
DEPARTMENT OF WATER RESOURCES  
DIVISION OF SAFETY OF DAMS

## INSPECTION OF DAM AND RESERVOIR IN CERTIFIED STATUS

Name of Dam Santiago Creek Dam No. 1029-6 County Orange  
 Type of Dam Earth Type of Spillway Concrete-lined open channel and chute  
 Water is 31 feet below spillway crest and 51 feet below dam crest.  
 Weather Conditions Overcast  
 Contacts Made Jacob Moeder, Nang Mwe, Steve Habiger, and Christian Wimenta with IRWD  
 Reason for Inspection Periodic Maintenance Inspection

Inspected by C.M. Lancaster *CM* 6/16/2025  
 Date of Inspection 5/6/25  
 Date of Report 6/16/25

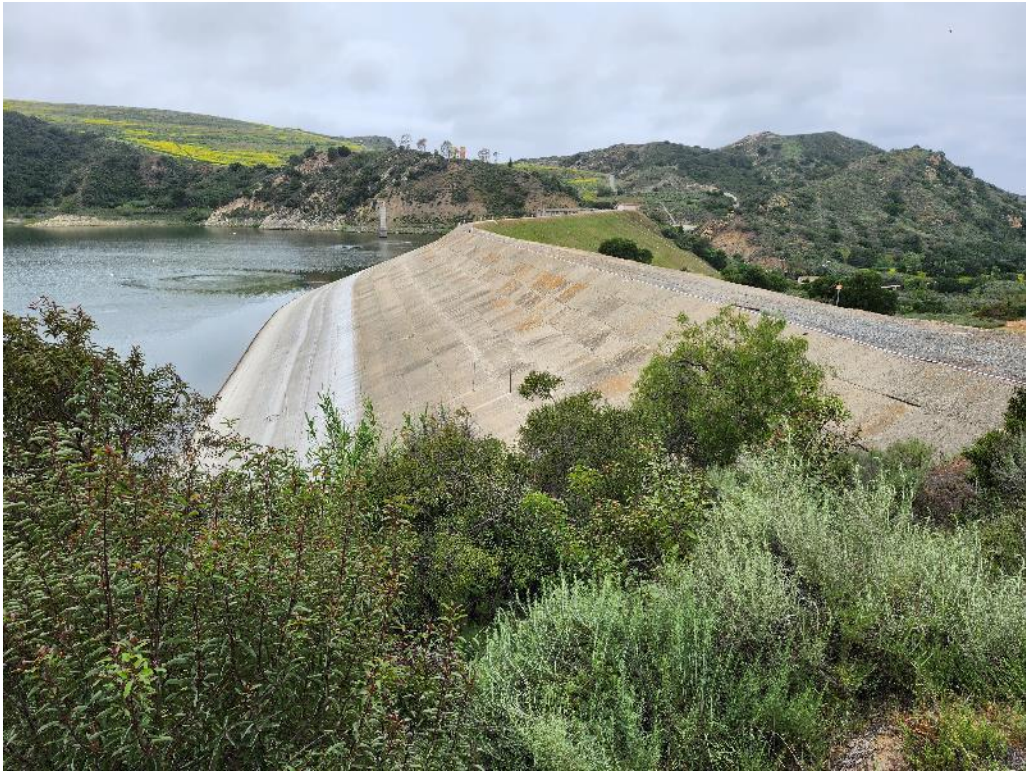
Photo 1. Upstream slope of the dam.

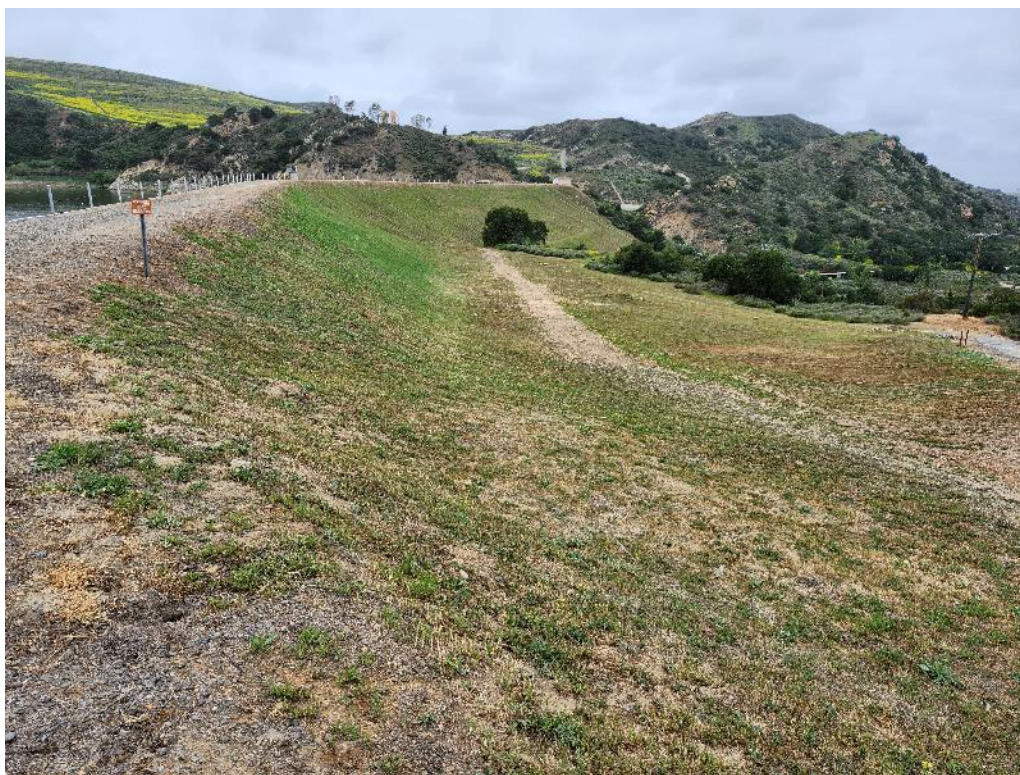
| Observations and Comments | |
|---|---|
| | <i>Maintenance needed:</i> A crack in the concrete liner at the upstream hinge point, between Piezometers R1 and R6, appeared unchanged from the last inspection. The enlargement application includes work that would involve demolishing this area of the concrete lining.<br><br>There are several erosion rills on the downstream slope which appeared to be unchanged since the last inspection. The enlargement application will include a downstream buttress that will address the erosion rills during construction. |

Photo 2. Downstream slope of the dam.

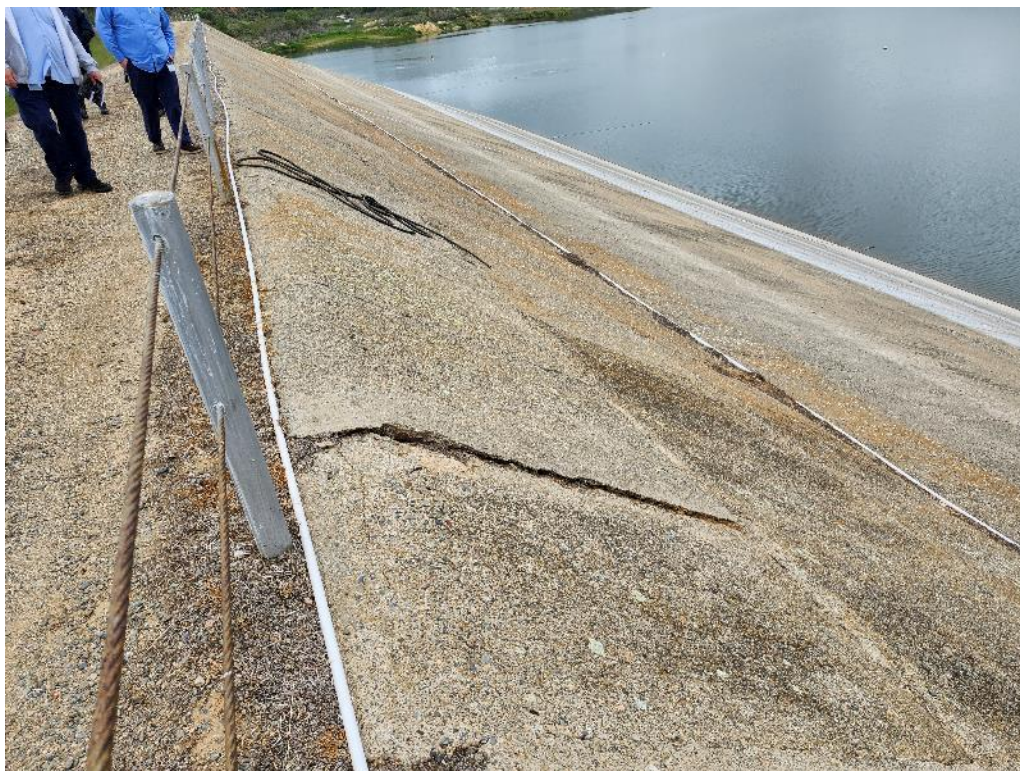
Photo 3. Crack in the upstream concrete liner.

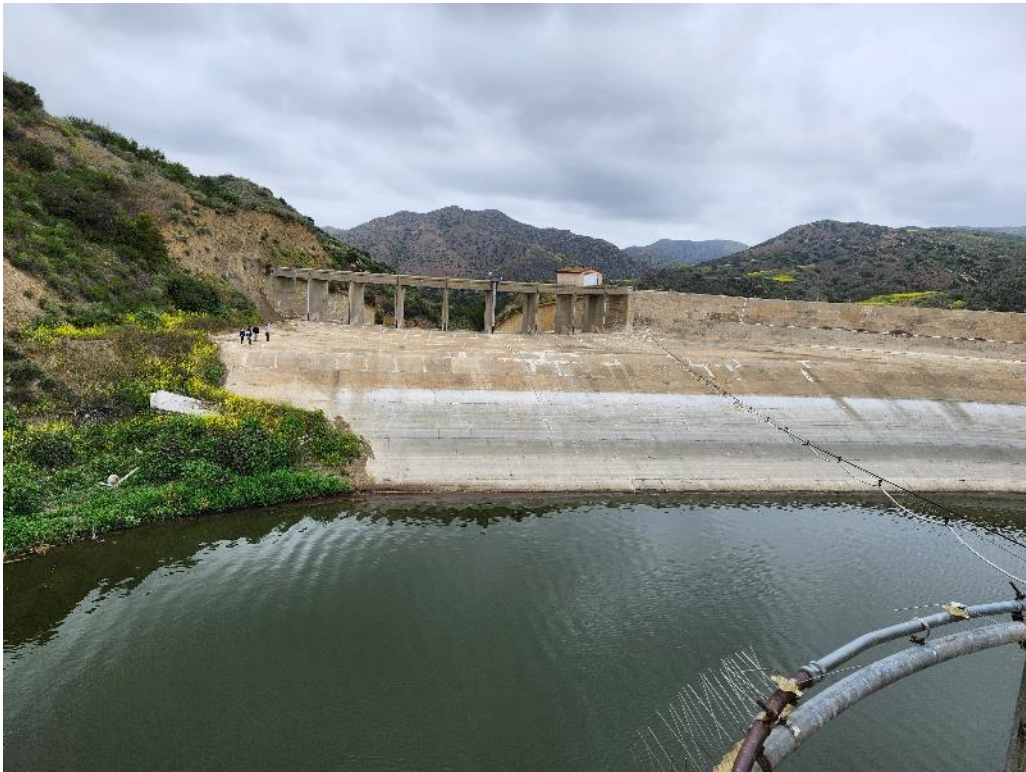
| Observations and Comments | |
|---|---|
| | <p><i>Maintenance needed:</i> A minor amount of sediment had eroded down into the left side of the approach. This will be addressed during the enlargement application work.</p> <p><i>Spillway condition satisfactory:</i> <span style="float: right;"><input type="checkbox"/> Yes <input checked="" type="checkbox"/> No</span></p> <p><i>Maintenance needed:</i> There are large spalls with exposed rebar and diagonal cracking along the walls of the spillway.</p> <p><i>Spillway comments:</i> The enlargement application consists of the demolition of the existing spillway and construction of a new spillway. This work will address the maintenance items listed above.</p> |

Photo 4. Spillway approach.

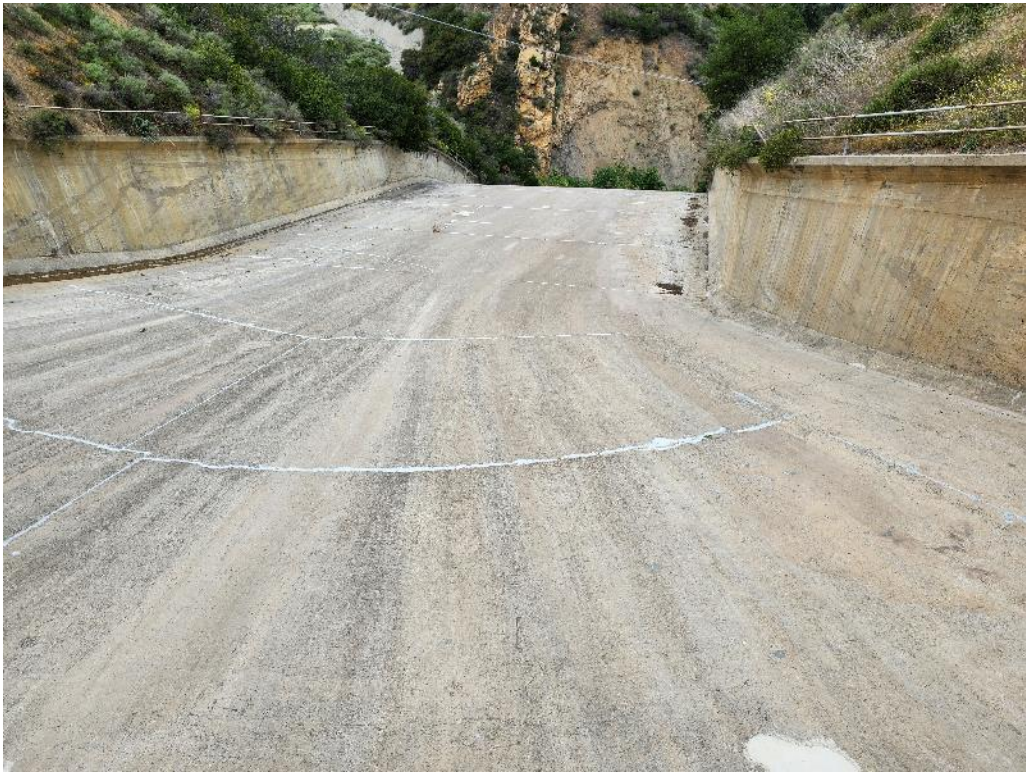
Photo 5. Spillway downstream chute.

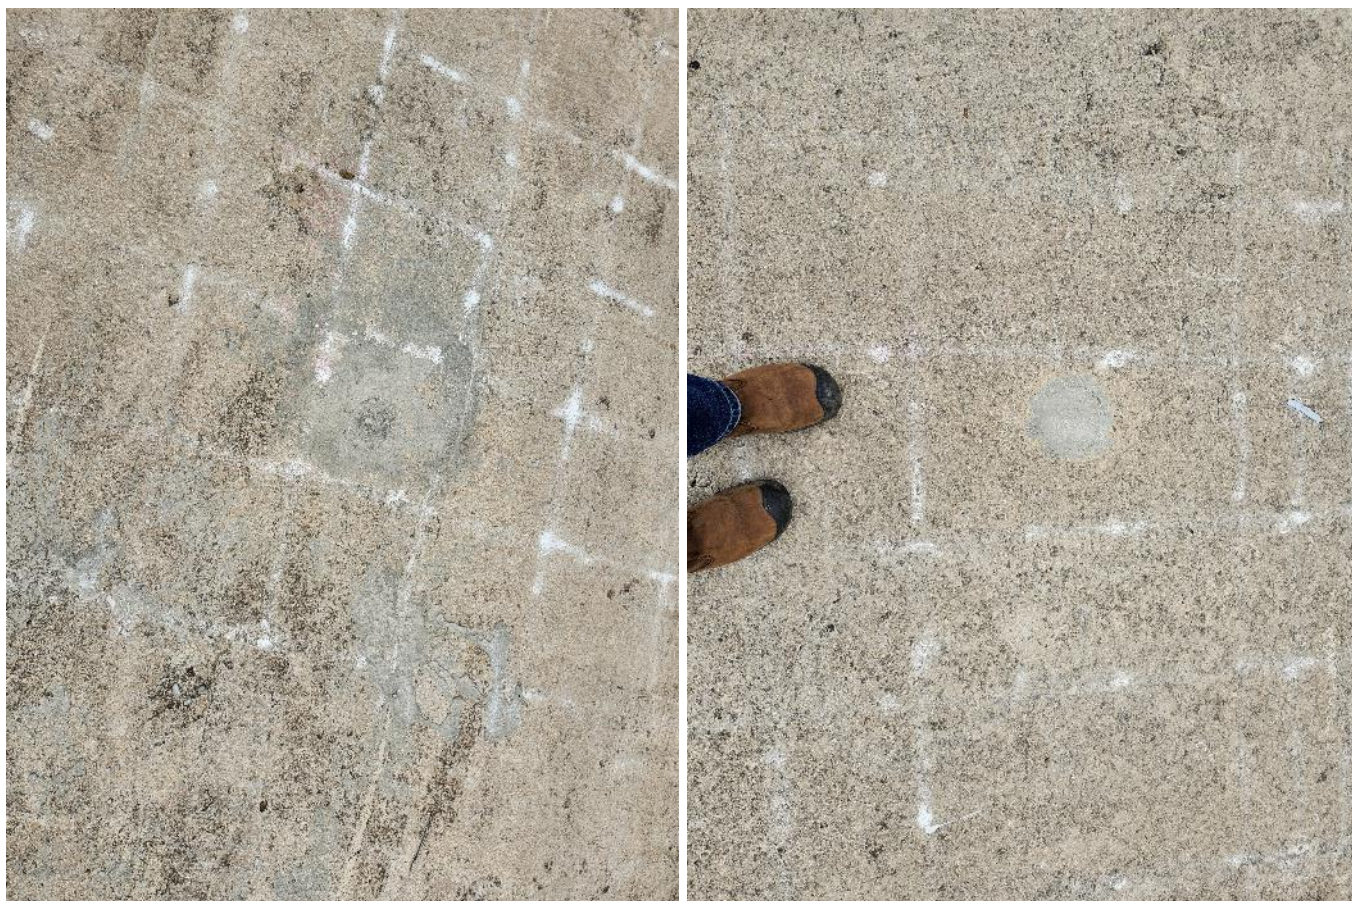
| Select if needed: | | Descriptions, actions, and recommendations: |
|---|---|---|
| <input checked="" type="checkbox"/> | Maintenance items required. | <ul style="list-style-type: none"> <li>The enlargement application filed on December 17, 2021, is progressing through the design phase, and construction is expected to begin in 2026. The application work consists of constructing a new inclined outlet intake structure, a new spillway, and constructing a downstream buttress.</li> <li>Because several portions of this dam are expected to be replaced or improved in the next year, the following maintenance items, observed during this inspection, will not need to be addressed: <ul style="list-style-type: none"> <li>Repair the crack in the concrete liner on the upstream slope, located between Piezometers R1 and R6 (Photo 3).</li> <li>Repair spalls with exposed concrete and damaged section of concrete in the spillway.</li> <li>Remove sediment and vegetation from the left side of the spillway approach.</li> <li>Repair erosion rills on the downstream slope.</li> </ul> </li> <li>However, if the enlargement project is significantly delayed, these maintenance items will need to be addressed during routine maintenance work.</li> <li>Restore the upstream 24-inch slide gate at Elevation 730 feet to a fully operable condition during routine maintenance work. Arrangements need to be made to fully cycle this slide gate in our presence if the enlargement application work has not begun before the next inspection.</li> <li>The alteration application filed on June 24, 2020, and approved on September 21, 2020, consists of geotechnical investigations to support the replacement of the outlet intake and spillway, and to support a crack study at the dam. The work was verified during this inspection and appeared to be completed satisfactorily. This inspection report will serve as the final construction inspection for the work (Photo 6).</li> </ul> |

Photo 6. Examples of corings in the spillway satisfactorily backfilled.

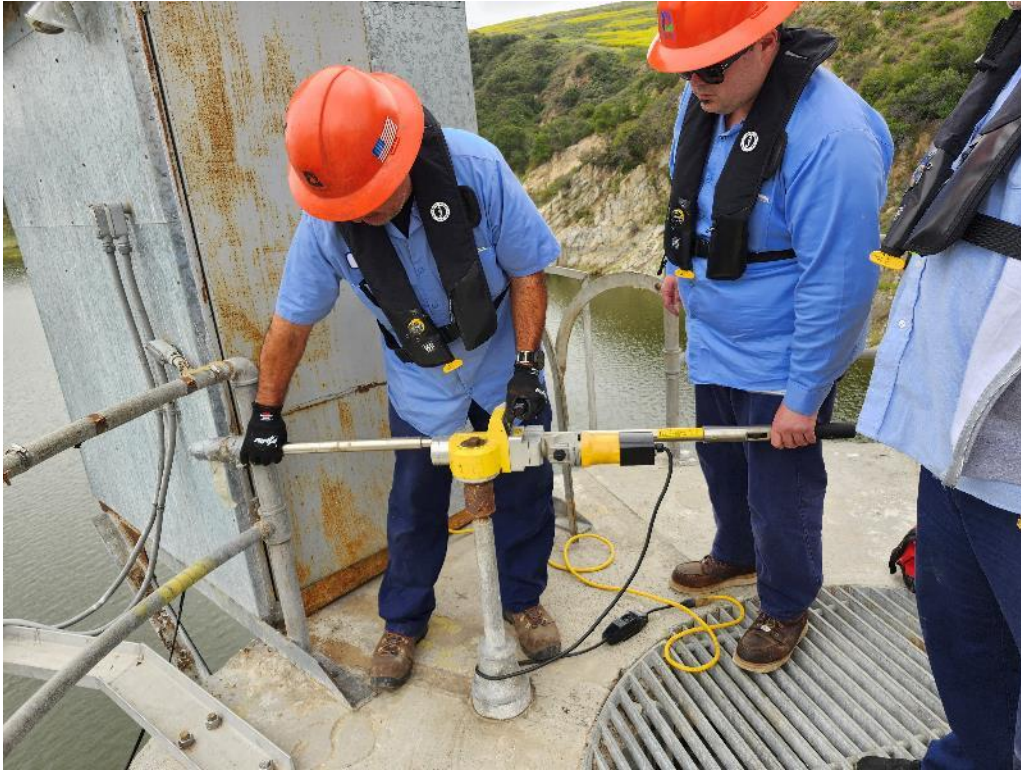
Photo 7. Cycling the upstream slide gates.

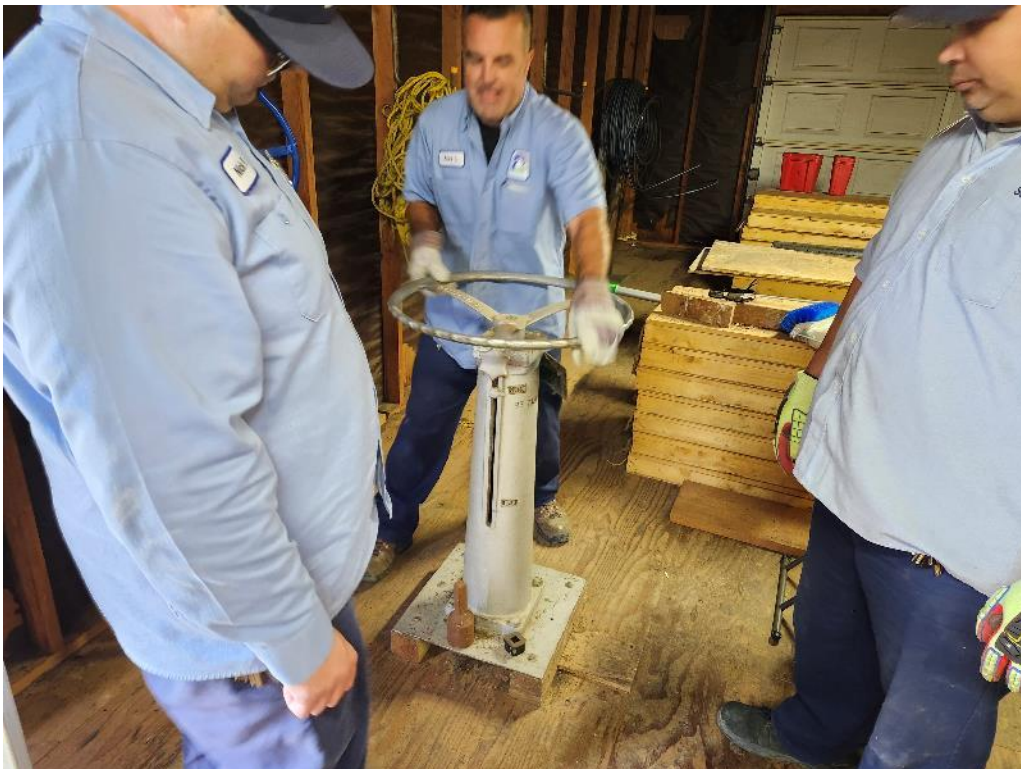
Photo 8. Cycling one of the downstream 30-inch blowoff butterfly valves.
