# **Annual Surveillance Report January 2023 to December 2023 for Sand Canyon Dam DSOD Dam No. 1029-002**

Irvine, California

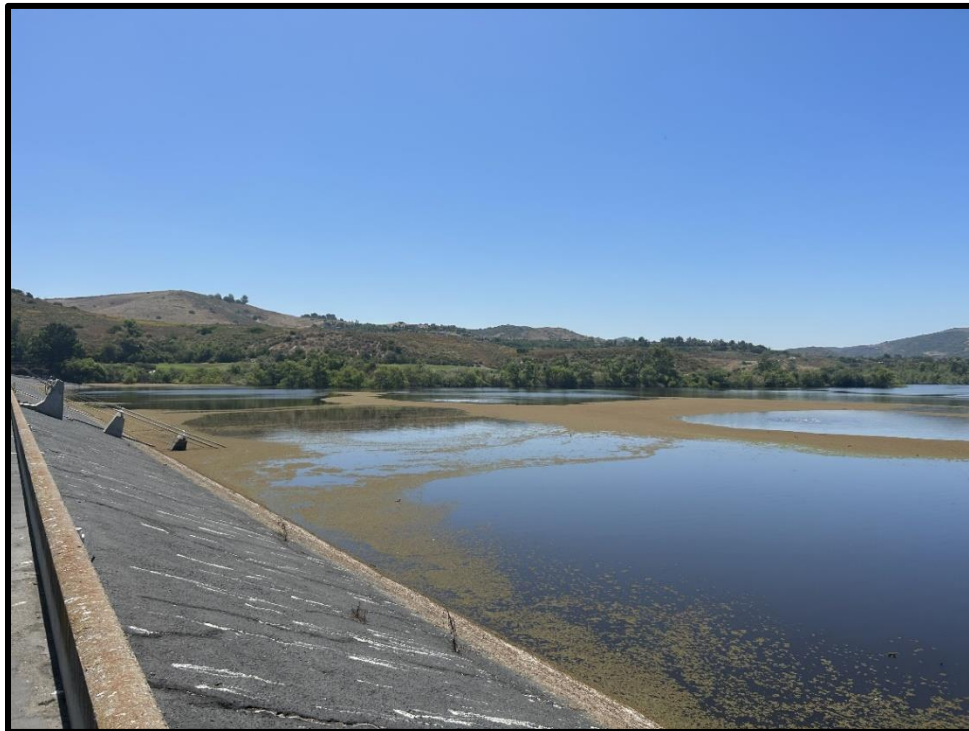
**Photo 2)** AC-lined upstream face looking towards right abutment. Note cracks and brush along the face.

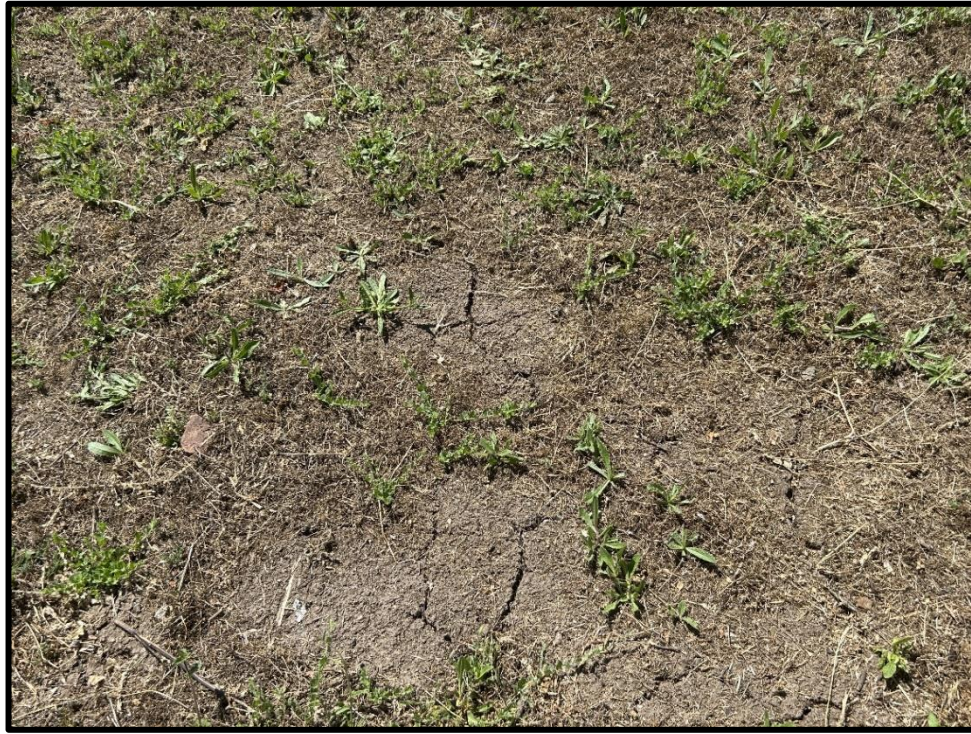
**Photo 3)** Previously reported desiccation cracking near piezometer P-7.

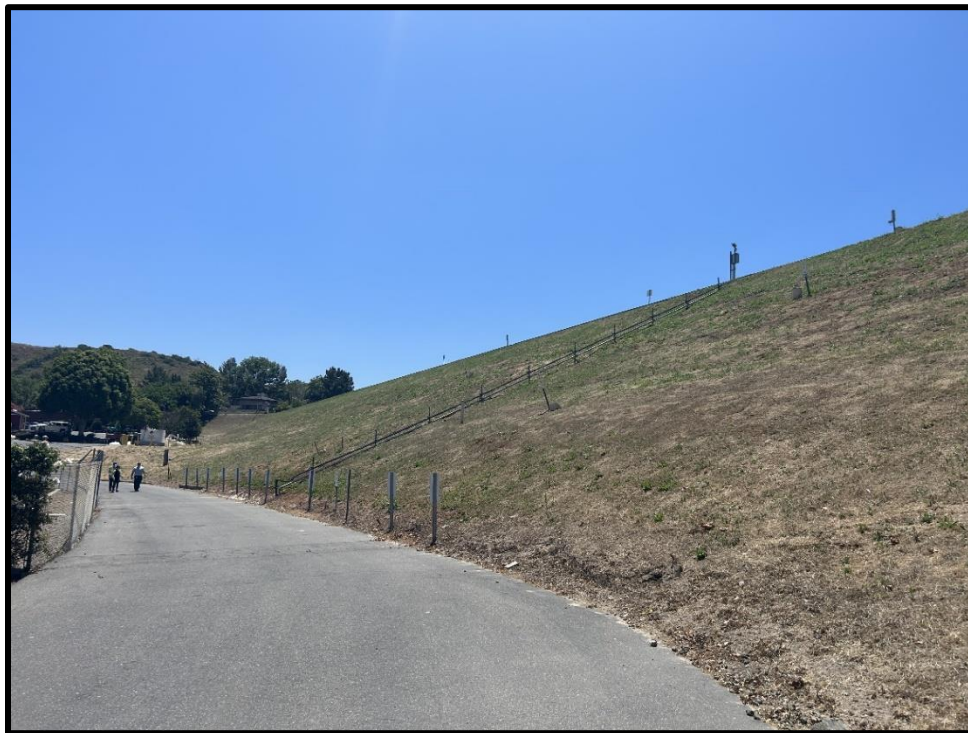
**Photo 4)** Downstream face looking towards the right abutment from dam toe.

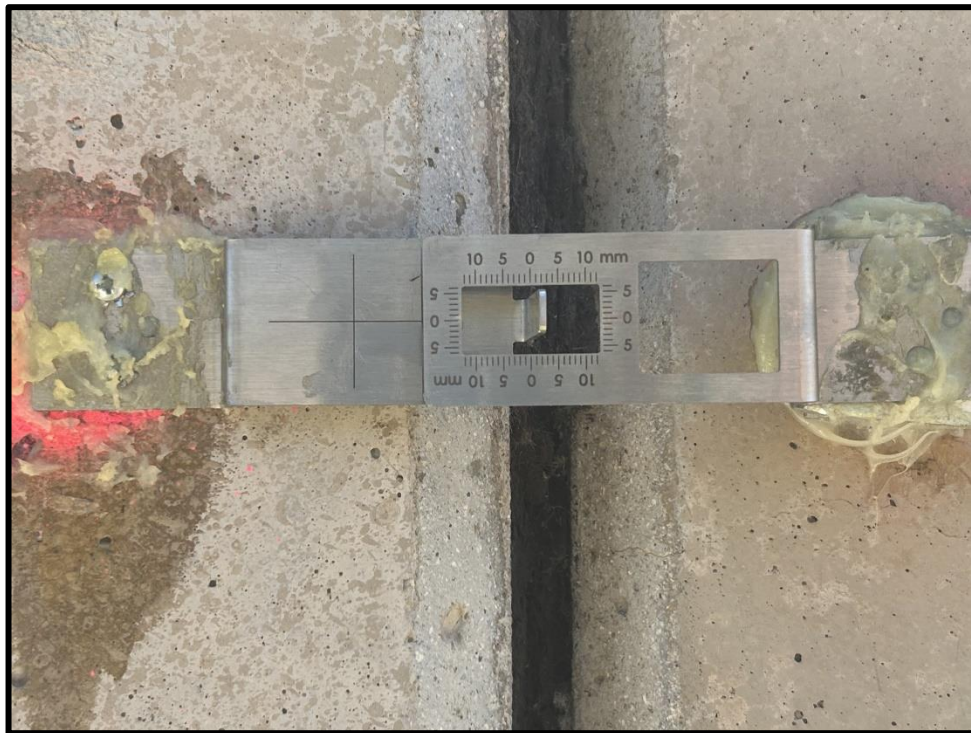
**Photo 12)** Recently installed crack meter at the right spillway concrete wall vertical joint offset (+2 mm x-direction).

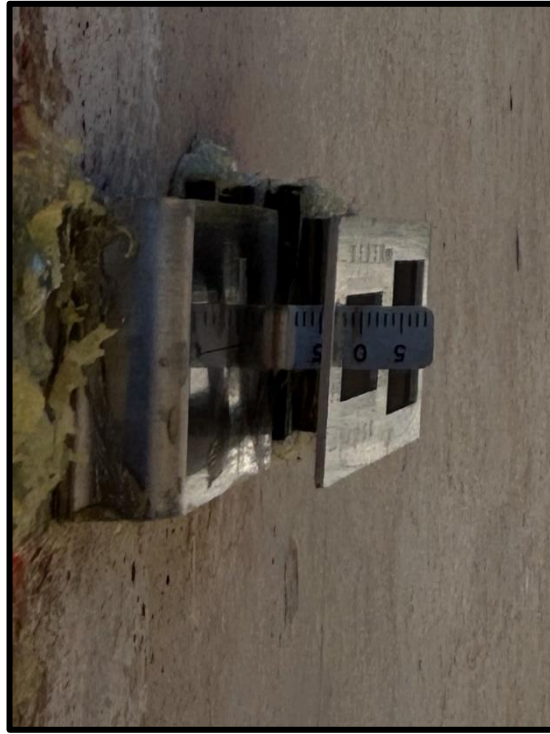
**Photo 13)** Recently installed crack meter at the right spillway concrete wall vertical joint offset. (-2 mm z-direction).

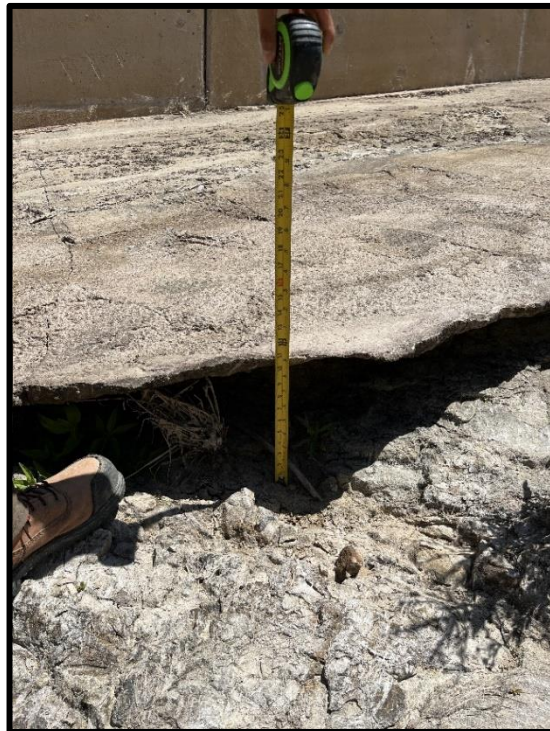
**Photo 14)** Close up view of undermining of recent concrete repair in the spillway channel floor.

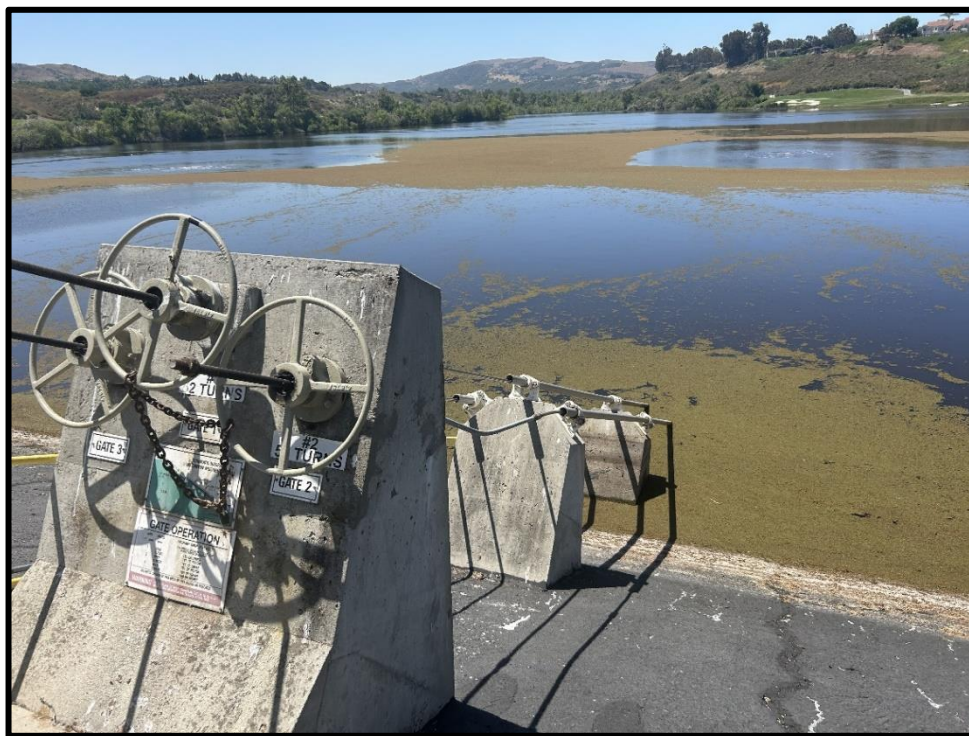
**Photo 15)** Outlet valve controls and stems. Note damaged gate valve #2 stem.

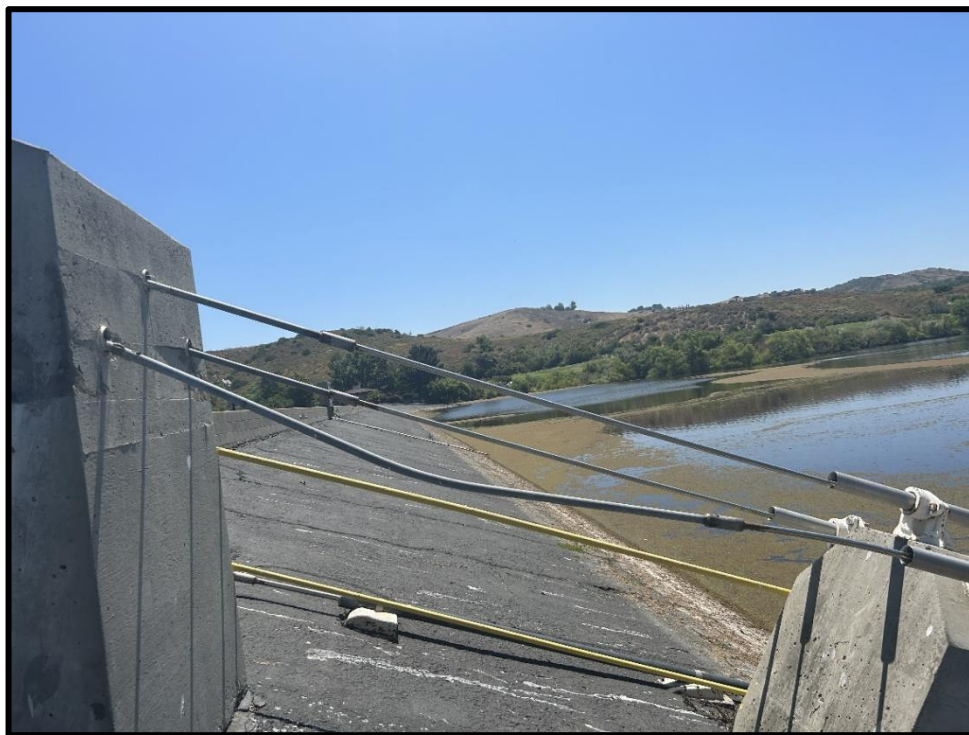
**Photo 16)** Close up view of the buckled gate valve #2 stem.
