Annual Surveillance Report January 2025 to December 2025 for Sand Canyon Dam

DSOD Dam No. 1029-002

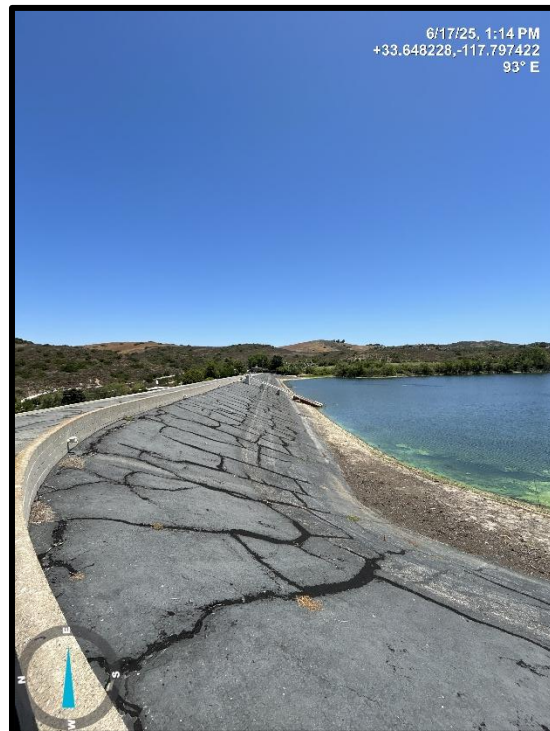
Photo 2) AC-lined upstream face looking towards right abutment. Note cracks along face.

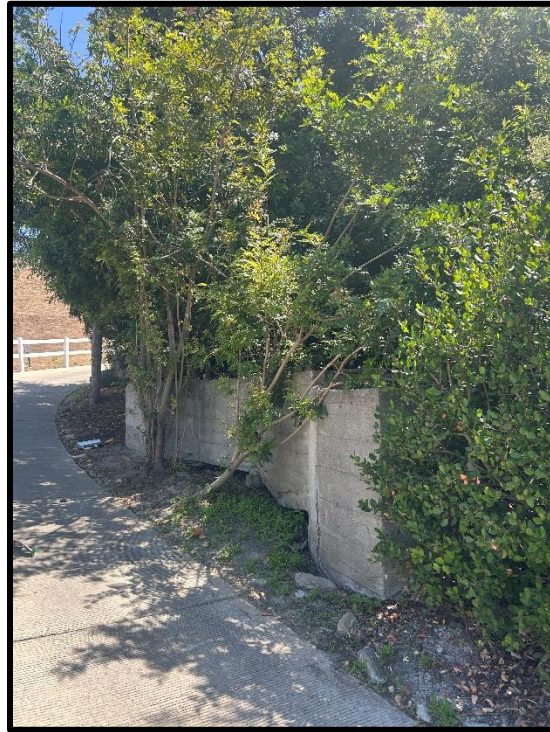
Photo 3) Abandoned irrigation weir box. Note seepage surrounding the box.

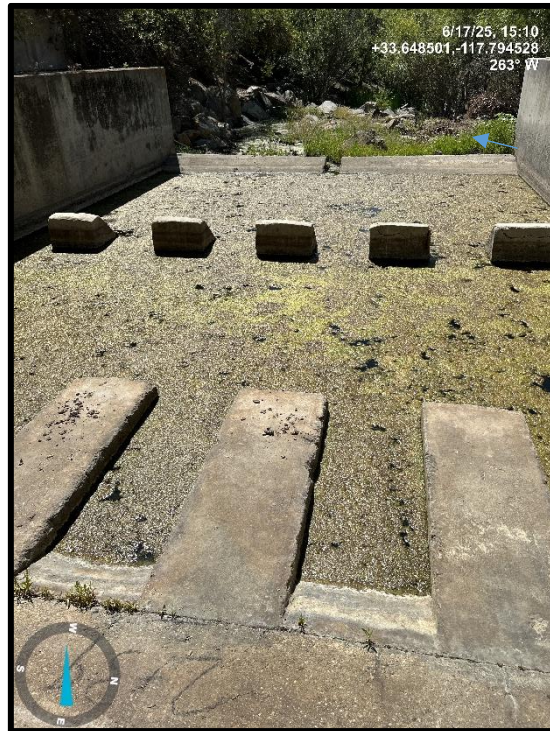
Photo 11) Close up view of spillway stilling basin. Note brush/tule growth downstream and two spalling baffle blocks on the right.

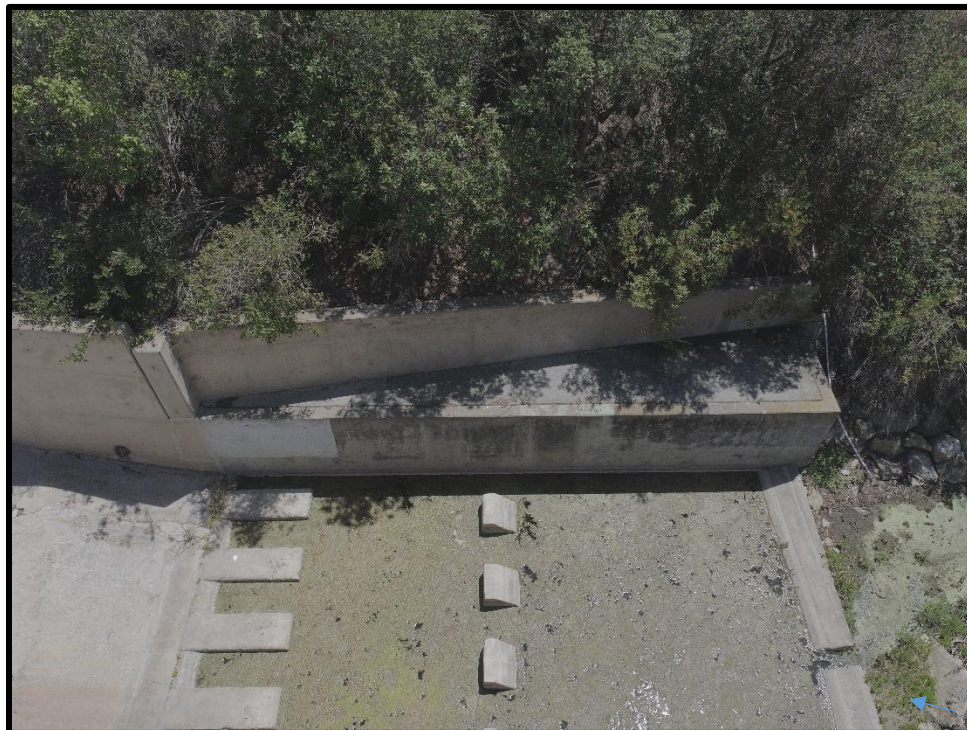
Photo 12) Close up view of spillway stilling basin. Note brush/tule growth downstream.

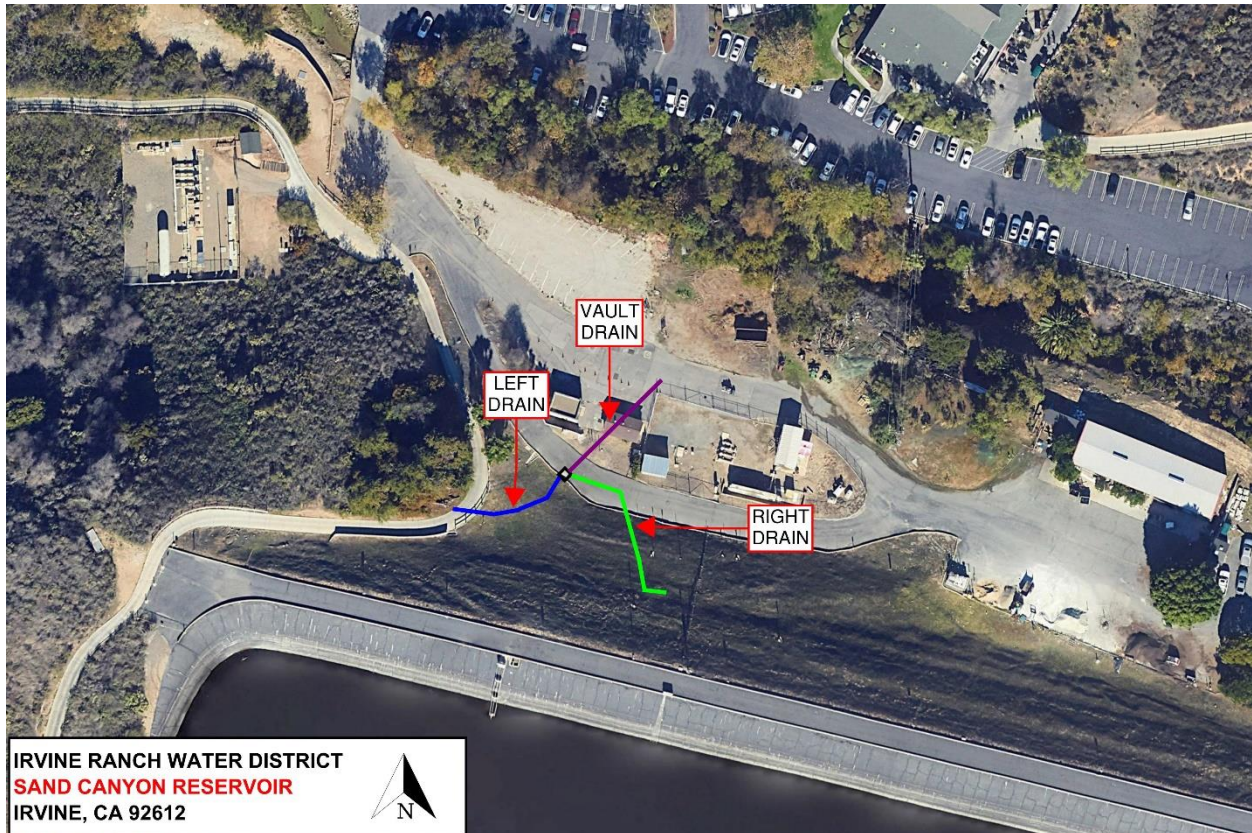
Figure 1 – Irvine Ranch Water District Sand Canyon Left, Right, and Vault Drains.

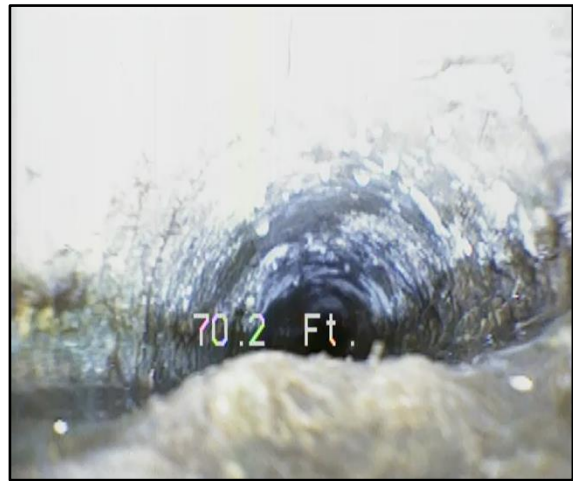
Photo 2 – STA 00+70: Pipe is in good condition.

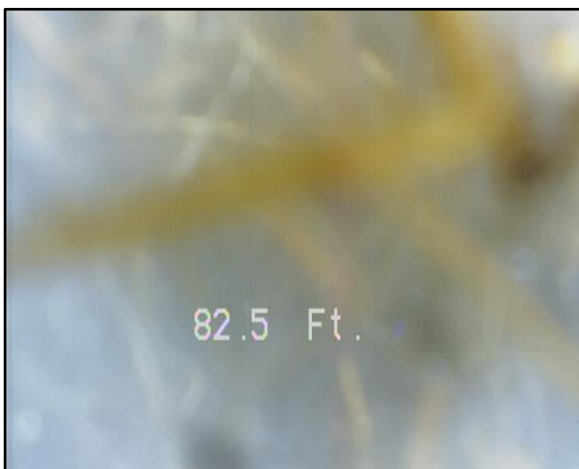
Photo 3 – STA 00+82: Root ball inside pipe.

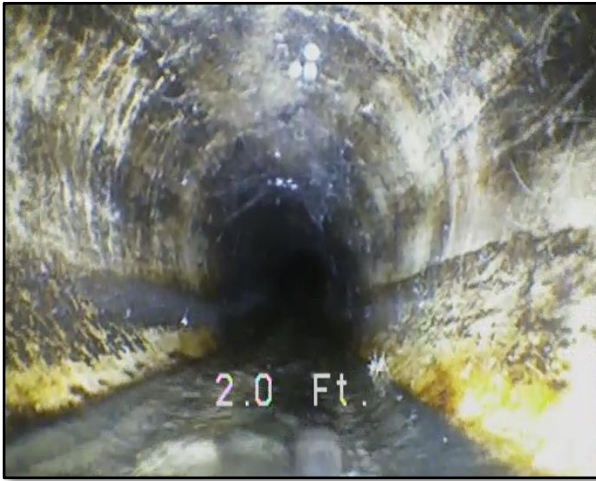
Photo 11 – STA 00+02: Pipe is in good condition with 100% staining on pipe walls.

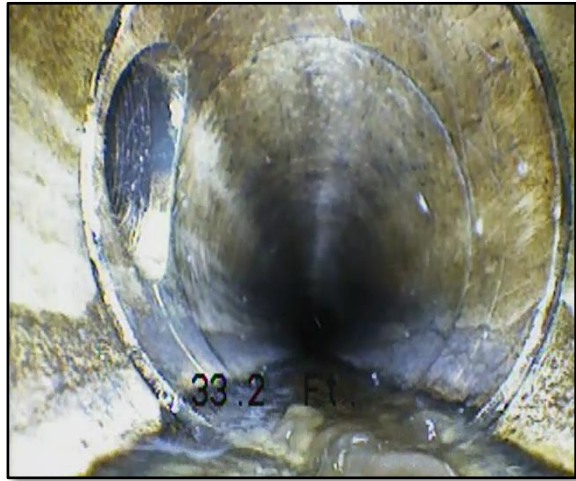
Photo 12 – STA 00+39: Lateral tap connection at 9 o'clock.

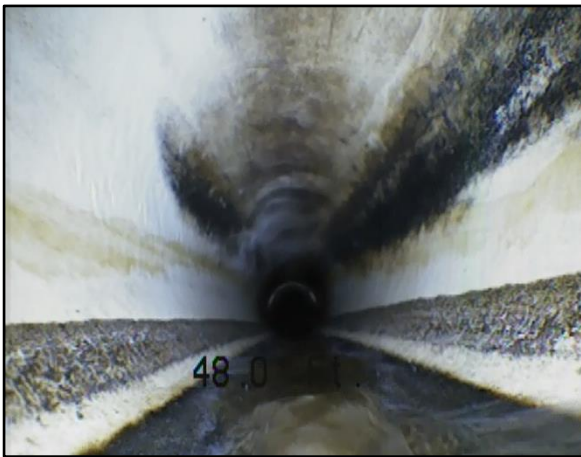
Photo 13 – STA 00+48: Pipe is in good condition with 65% staining on pipe walls.

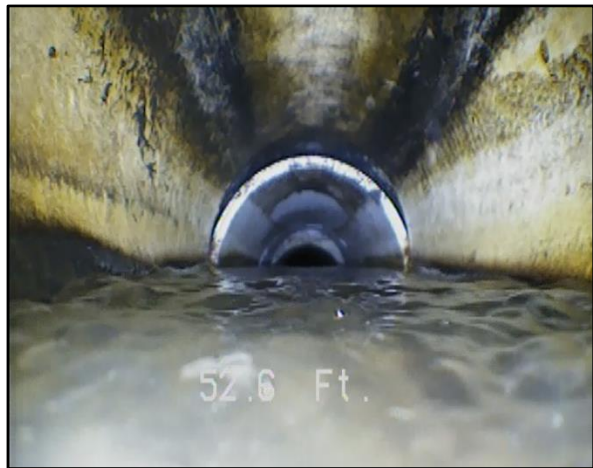
Photo 14 – STA 00+52: 50% water level and change in pipe diameter.

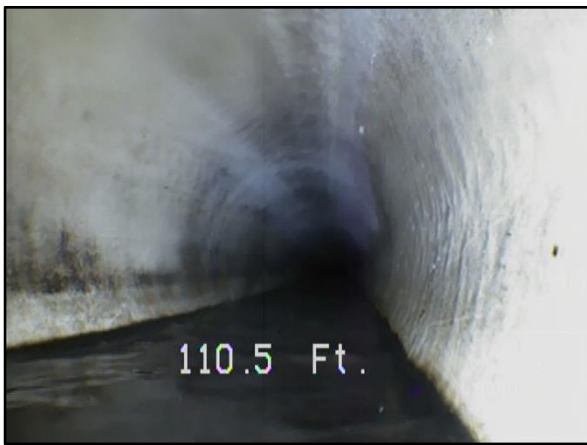
Photo 17 – STA 01+10: Pipe is in good condition.

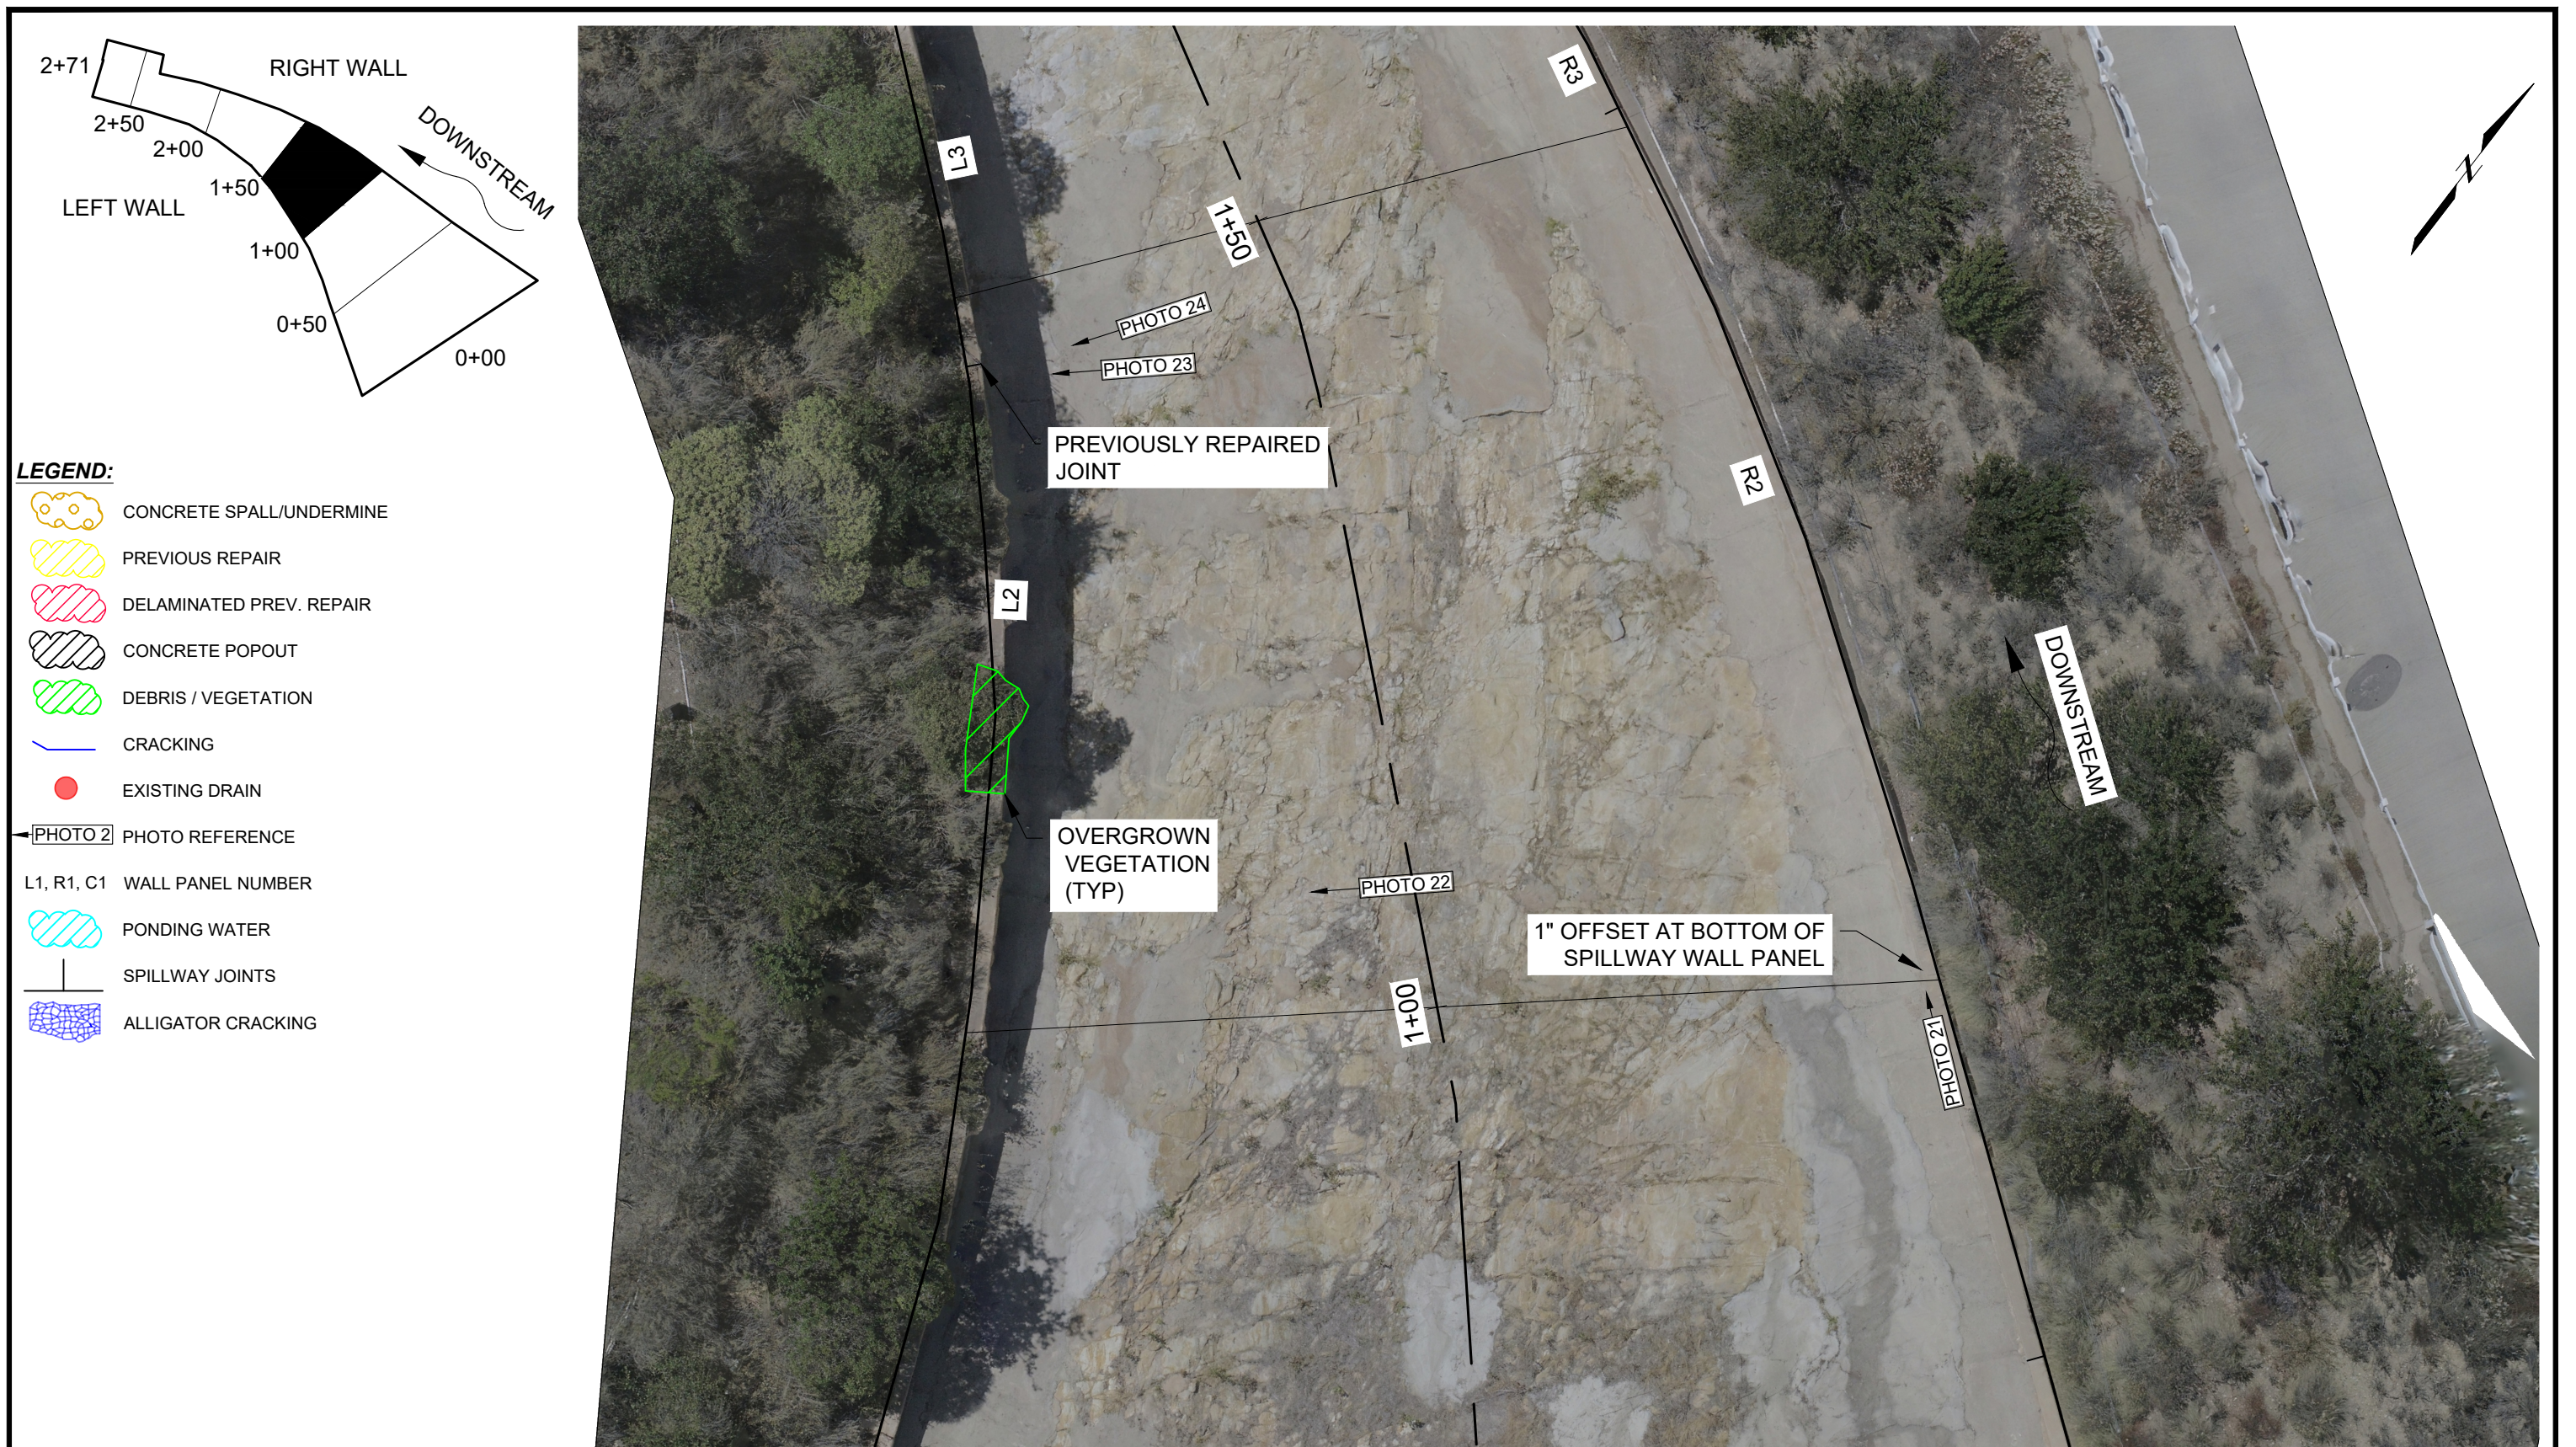
- LEGEND:**
- CONCRETE SPALL/UNDERMINE
 - PREVIOUS REPAIR
 - DELAMINATED PREV. REPAIR
 - CONCRETE POPOUT
 - DEBRIS / VEGETATION
 - CRACKING
 - EXISTING DRAIN
 - PHOTO REFERENCE
 - L1, R1, C1 WALL PANEL NUMBER
 - PONDING WATER
 - SPILLWAY JOINTS
 - ALLIGATOR CRACKING

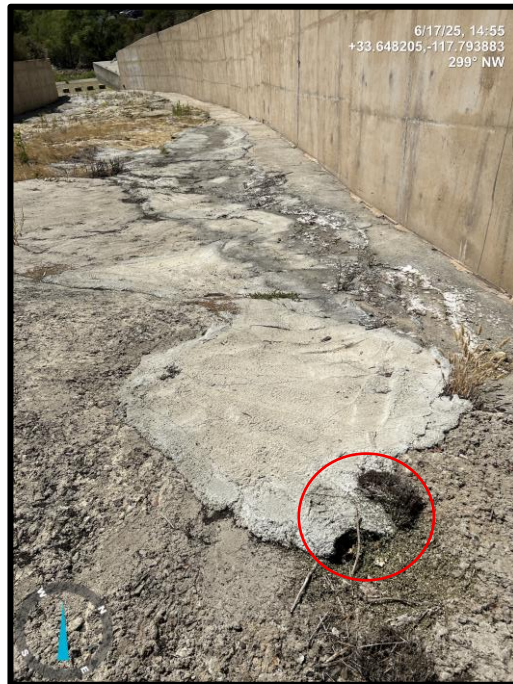
Photo 5) 5” depth void at previous spillway repair.

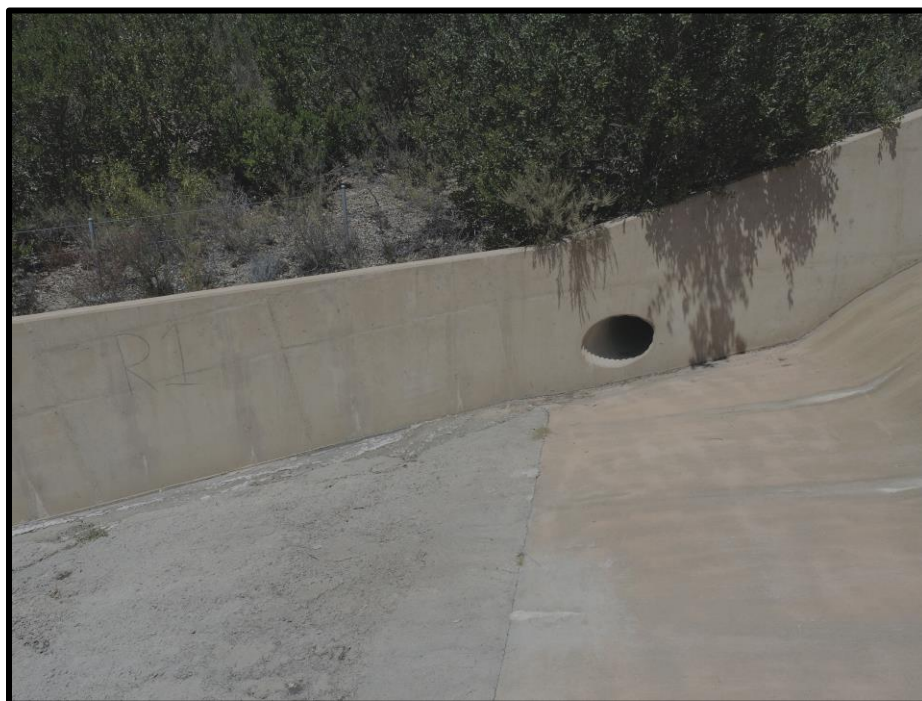
Photo 6) View of spillway wall panel R1.

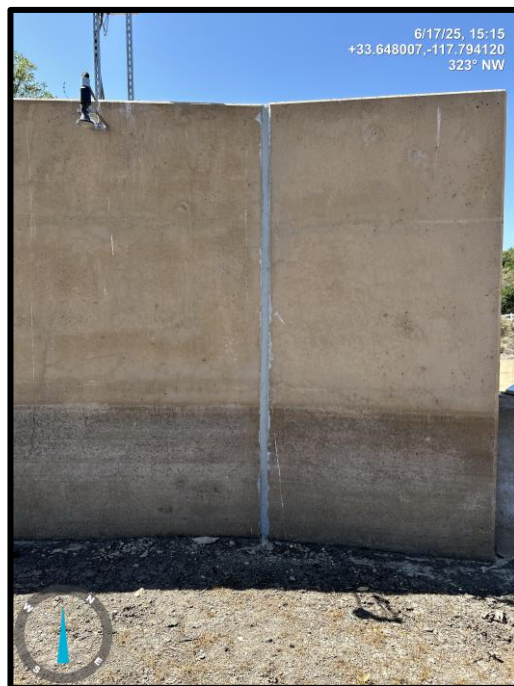
Photo 10) Recently repaired joint.

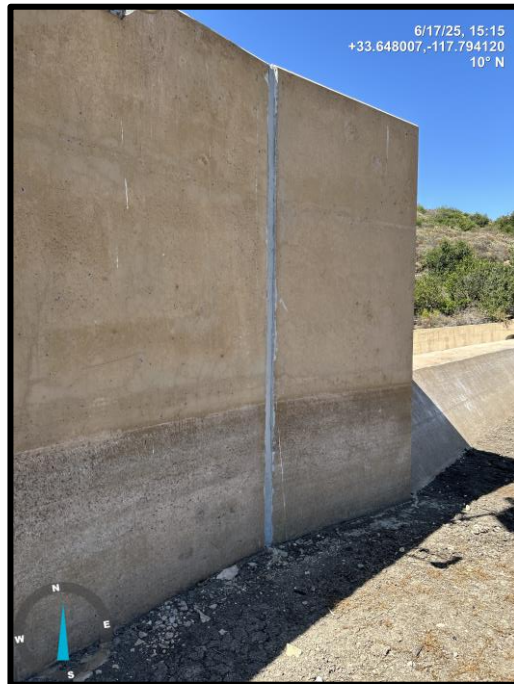
Photo 11) Recently repaired joint.

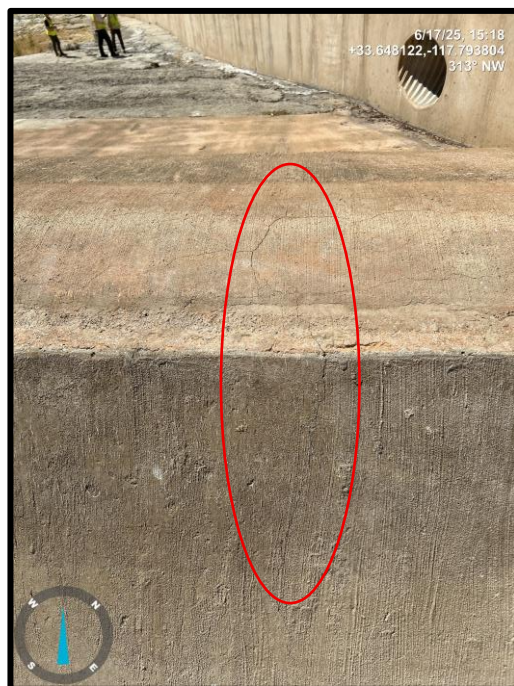
Photo 12) Minor cracking along upstream face of weir.

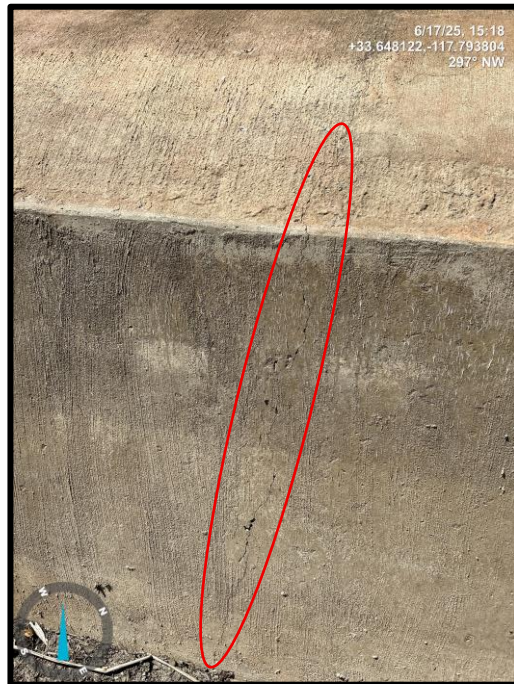
Photo 13) Minor cracking along upstream face of weir.

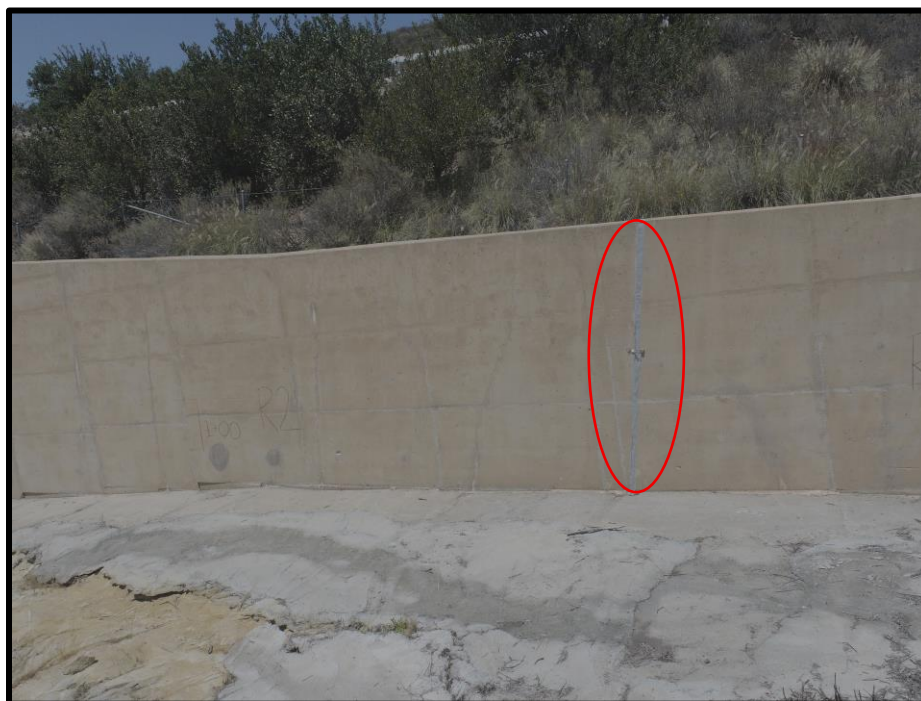
Photo 14) View of spillway wall panel R1 and R2. Note previous repair of joint.

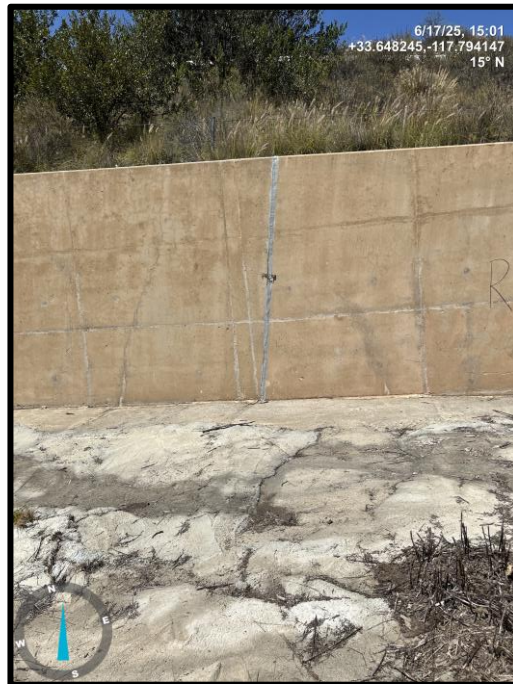
Photo 15) Previously repaired joint.

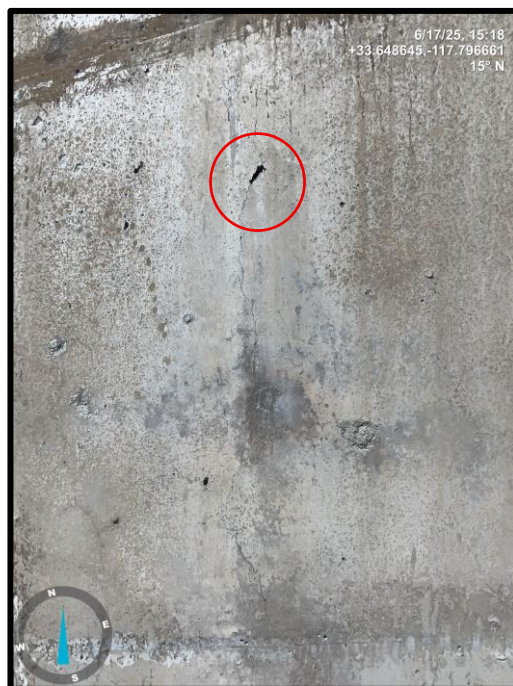
Photo 16) 1/8" crack and 2" x 3/4" concrete popout wall panel R1.

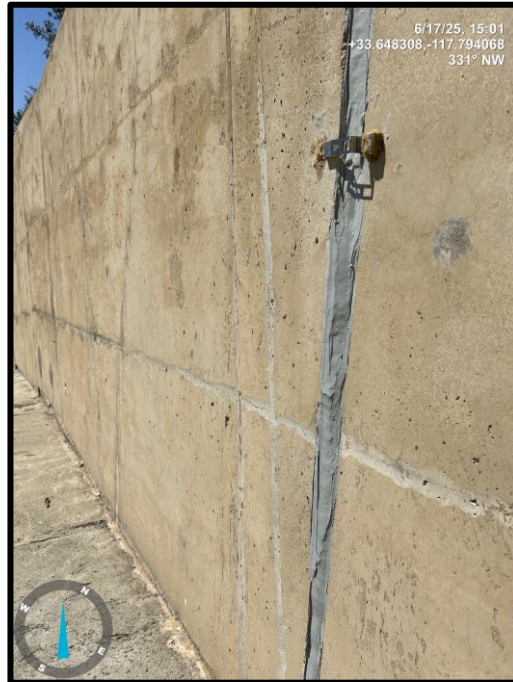
Photo 17) Crack gauge at wall panels R1 and R2 joint. Crack gauge measured joint opening 1.5mm and joint offset 1.5mm. Note previously repaired joint.

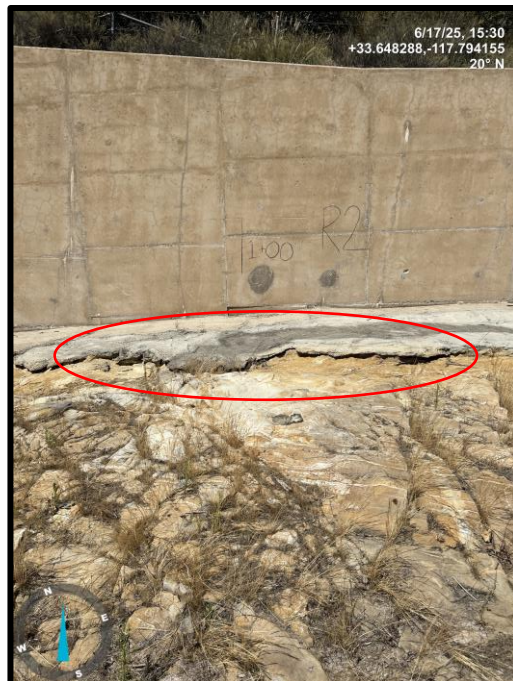
Photo 18) 6" Height x 8" Depth spillway floor undermining.

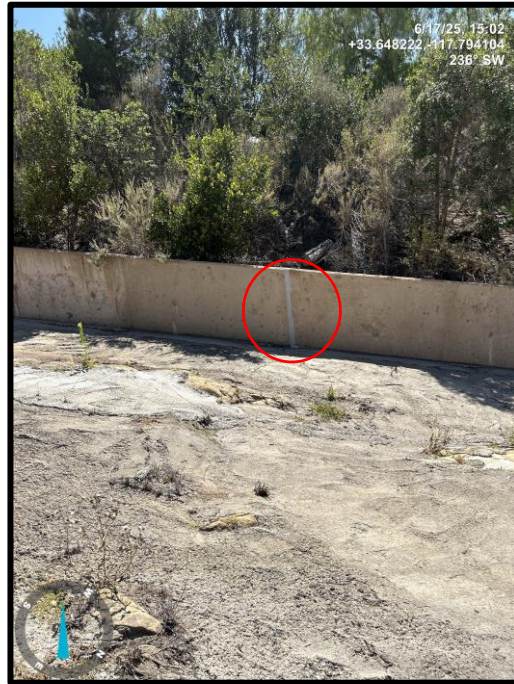
Photo 19) View of spillway wall panels L1 and L2. Note previously repair of joint.

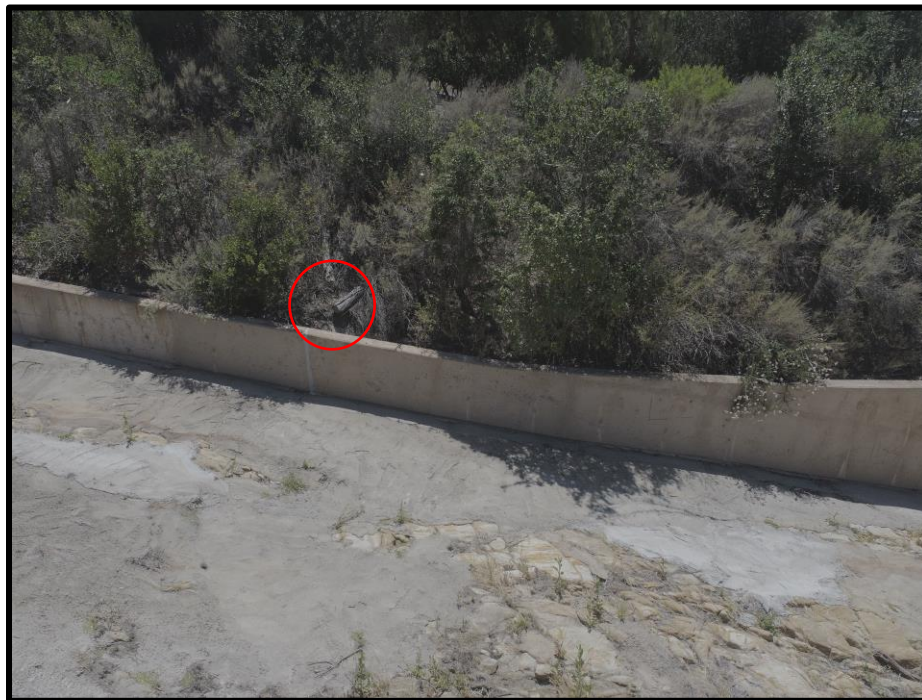
Photo 20) View of spillway wall panels L1 and L2. Note previous repair of joint.

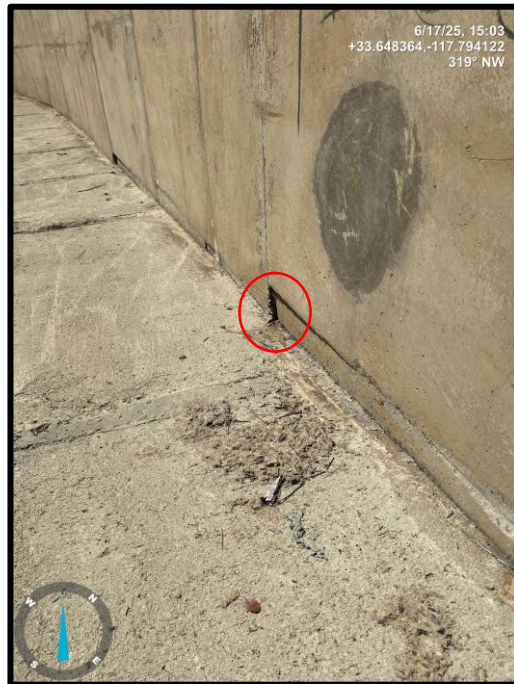
Photo 21) 1” offset at bottom of spillway wall panel R2.

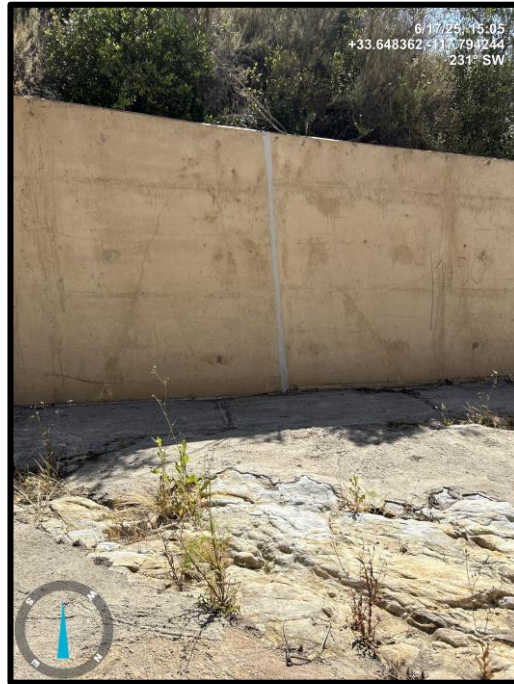
Photo 23) View of spillway wall panels L2 and L3. Note recent repair of joint.

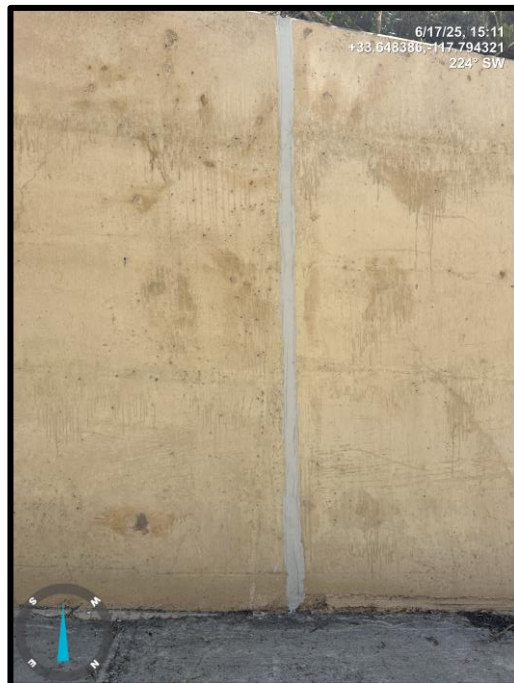
Photo 24) Vertical wall joint open 1/2" max between wall panels L2 and L3. Note recent repair of joint.

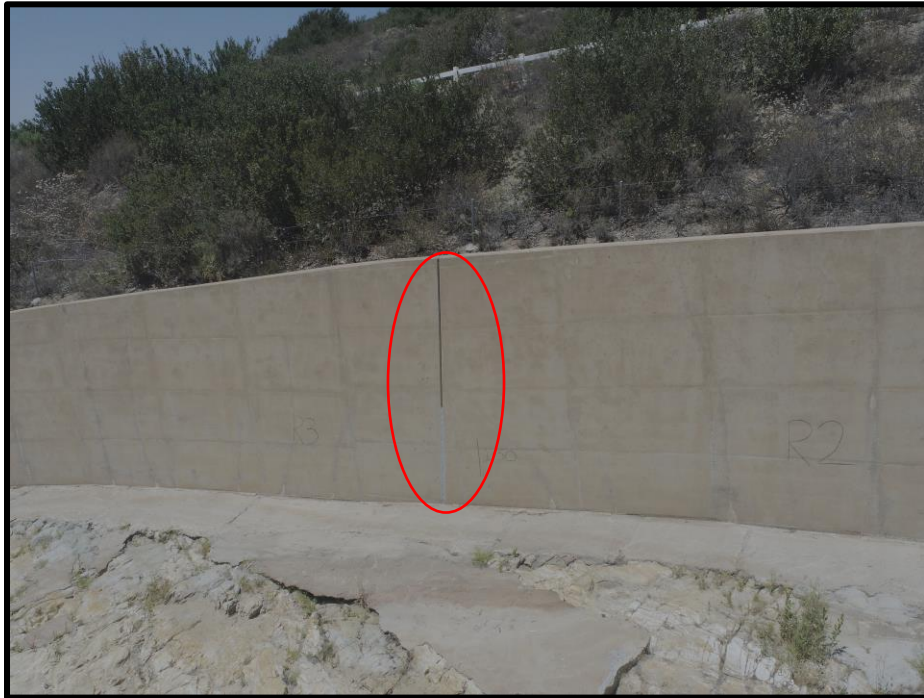
Photo 25) View of spillway wall panels R2 and R3. Note previous repair of bottom half of joint.

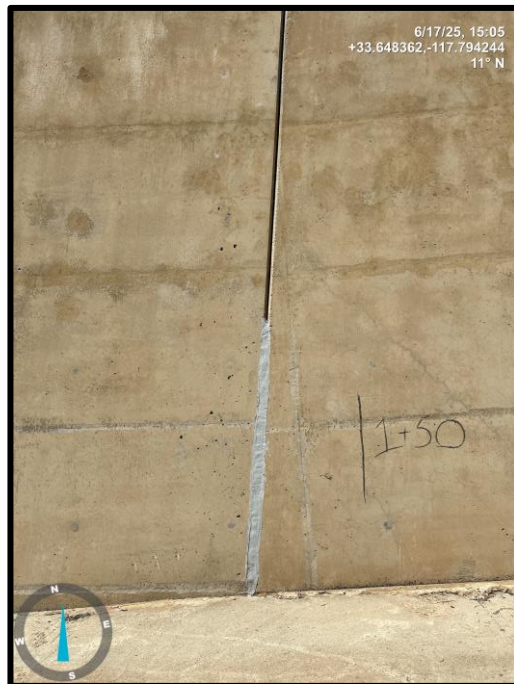
Photo 26) Vertical wall joint open ½" max between wall panels R2 and R3. Note previous repair of bottom half of joint.

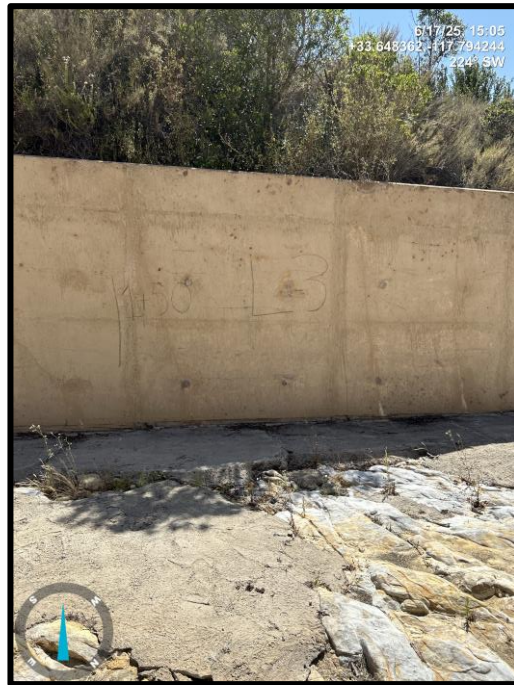
Photo 27) View of spillway wall panel L3.

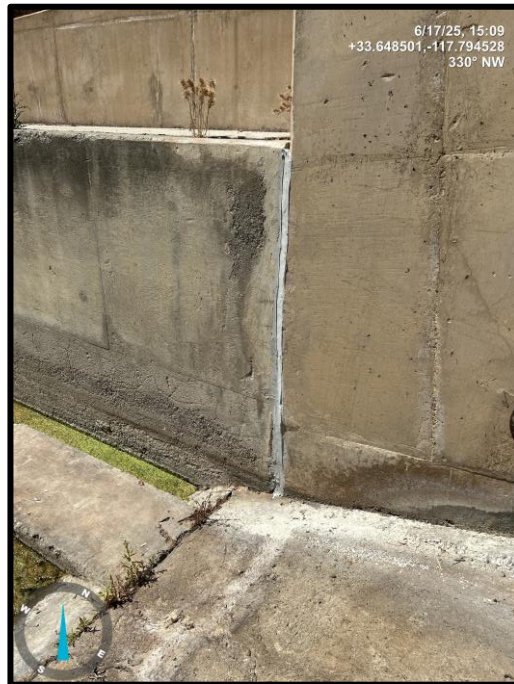
Photo 35) Previously repaired spillway vertical wall joint.

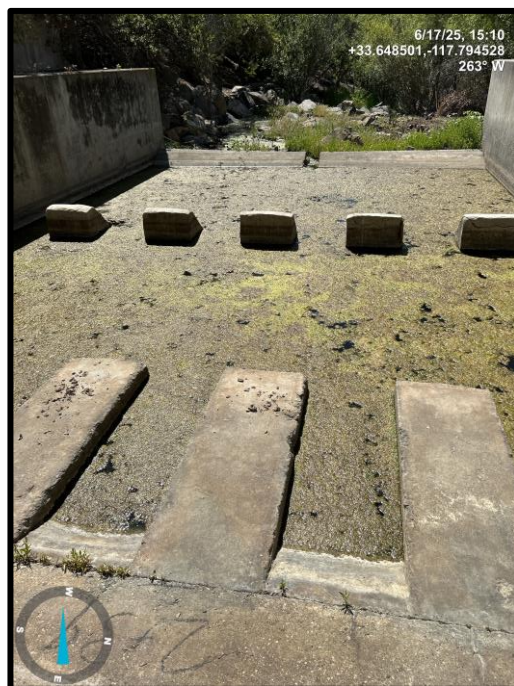
Photo 36) Spillway stilling basin. Note 1/2" cracks on right two concrete baffles.

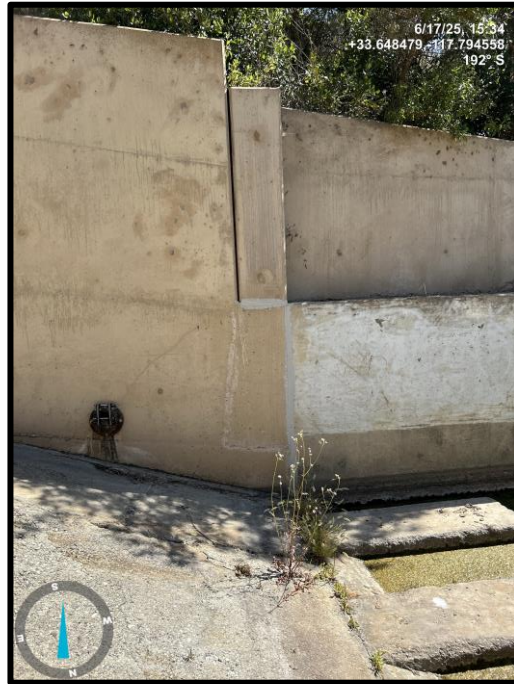
Photo 37) Previously repaired spillway vertical wall joint. Note spillway drain and vegetation..

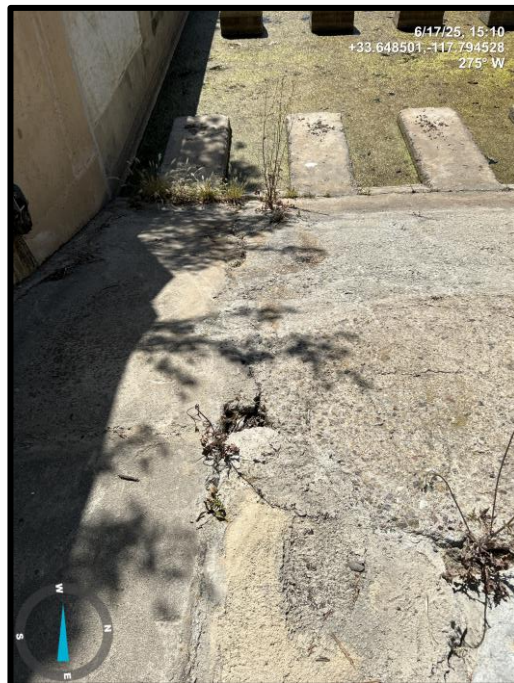
Photo 38) 1/2" cracks along spillway floor. Note vegetation.
