Integrated Pest Management Plan for the Irvine Ranch Water District

2024 Annual Report

Provided By:
Endemic Environmental Services Inc.

Prepared For:
Irvine Ranch Water District

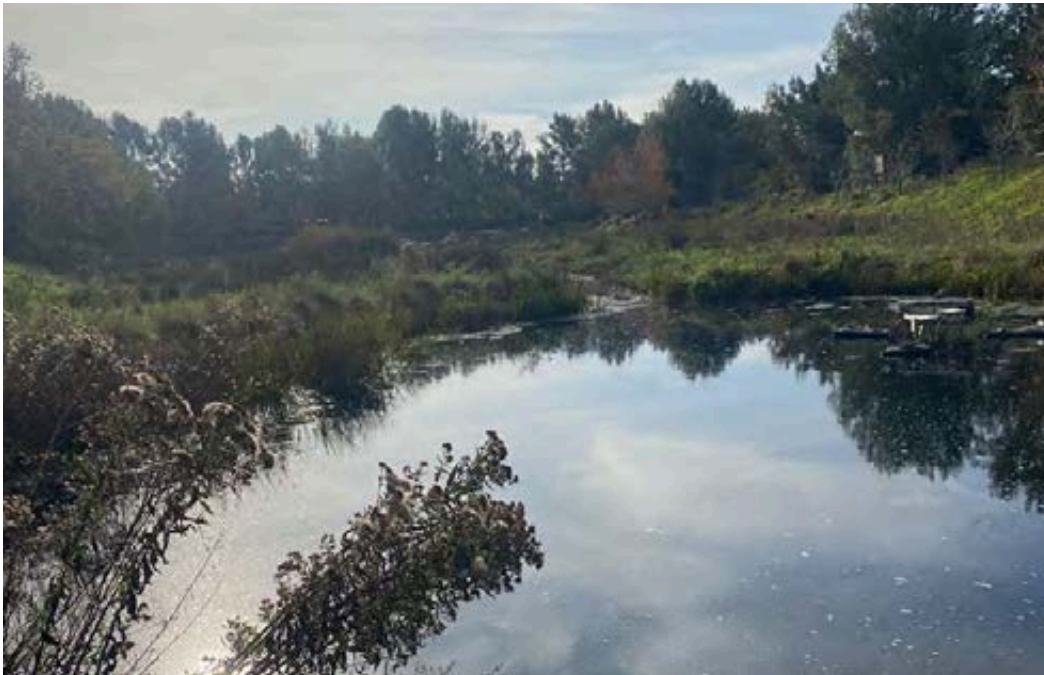
Figure 2. Forge Meadow Site Overview as of December 2024.

Forge Meadow is a 2.11-acre NTS basin adjacent to Portola Parkway in north Irvine. This basin consists of two ponds connected by a long channel. Forge Meadow is characterized primarily by annual and biennial species, including western ragweed, marsh fleabane, annual saltmarsh aster, and mugwort. Relative to other NTS sites, Forge Meadow is particularly low in native diversity. Endemic advised various manual removal methods to reduce and maintain the cover of non-native & invasive species. The most prevalent species were bristly oxtongue, curly dock, smilo grass, and umbrella sedge. Other non-native species advised for maintenance included Bermuda grass, barnyard grass, burr clover, clustered dock, common purslane, common sowthistle, common stork's bill, dallisgrass, English plantain, flax-leaved horseweed, hairy crabgrass, Italian rye, jungle rice, Mexican fan palm, Mexican primrose, prickly lettuce, prostrate pigweed, spotted spurge, Spanish false fleabane, tropical horseweed, umbrella sedge, wall barely, white sweetclover, and yellow sweetclover.

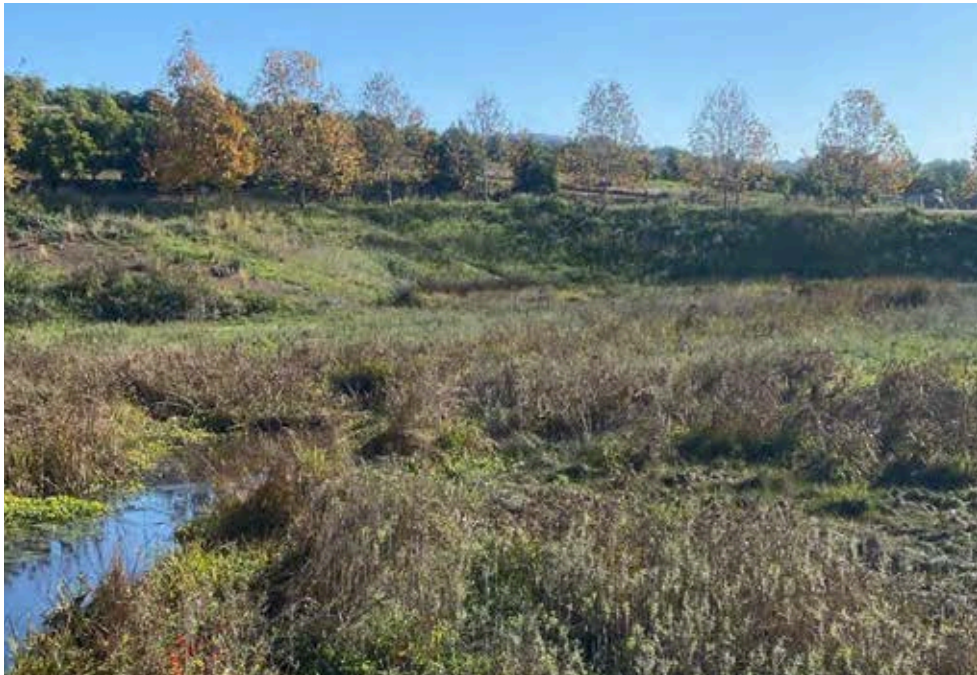
Figure 3. Overview of Port Culver as of November 2024.

Port Culver is a 3.40-acre basin north of Portola Parkway, adjacent to a large agricultural area in north Irvine. This basin consists primarily of a pilot channel, where water often overflows from the channel and spreads throughout the bottom. Due to its proximity to an avocado plantation, the site experiences high invasion rates for plants that are not particularly characteristic of the NTS sites. As a result, there is particularly low native coverage for existing perennials. Over 400 native plantings (i.e. *Anemopsis californica*, *artemisia douglasiana*, *asclepias fascicularis*, *cyperus eragrostis*, *elymus triticoides*, *elmyus codensatus*, *epilobium canum*, *heliotropium curassavicum*, *mimulus guttatus*, *muhlenbergia rigens*, *salvia mellifera*, *sisyrinchium bellum*, *stipa lepida*, *stipa pulchra*) were planted throughout the basin and slopes at the beginning of the year. Manual hand removal was the primary advised method to reduce and control non-native cover. The most prevalent non-native species on the site included bristly oxtongue, smilo grass, Italian ryegrass, and burr clover, Other non-native species observed included: annual wall-rocket, Brazilian peppertree, bristly oxtongue, common dandelion, common soft brome, common sowthistle, compact brome, english plantain, flax-leaved horseweed, Peruvian peppertree, pickerelweed, prickly lettuce, prickly sowthistle, purple nutsedge, rabbitsfoot grass, red brome, shortpod mustard, spanish false fleabane, tropical horseweed, umbrella sedge, wall barley, wax leaf privet, whorled pennywort, yellow sweetclover.

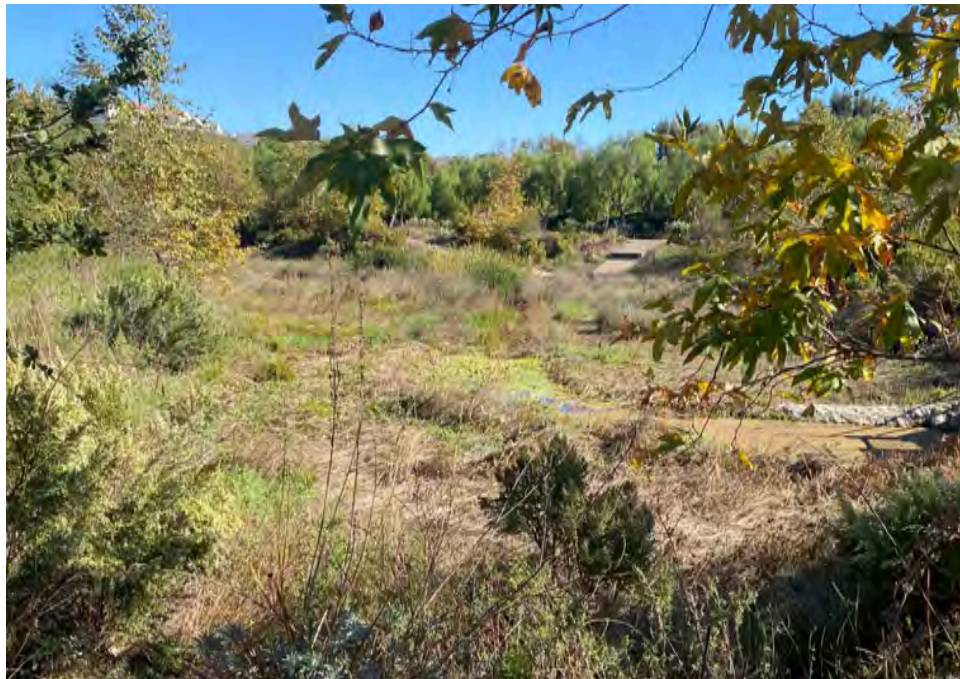
Figure 4. Overview of Orchard Meadow as of November 2024.

Orchard Meadow is a 1.18-acre basin located north of Portola Parkway and adjacent to a large agricultural area in north Irvine. This basin consists primarily of a pilot channel. Water often overflows from the channel and spreads throughout the bottom of the basin, creating a pond. Compared to other NTS basins in the relative area, Orchard Meadow exhibits minimal invasive slope cover due to the established Coastal Sage Scrub (CSS) vegetation. Due to this, Orchard Meadows is a particularly successful restoration project and likely to see long-term native persistence. Manual hand removal was the primary method prescribed for management. The most prevalent species included bristly oxtongue, curly dock, shortpod mustard, and Spanish false fleabane. Other non-native species observed included African asparagus, burr clover, common cattail, common sowthistle, flax-leaved horseweed, great brome, Peruvian peppertree, prickly lettuce, rabbitsfoot grass, rescuegrass, scarlet pimpernel, slender wild oats, Taiwanese firethorn, tropical horseweed, water beard grass, water smartweed, white sweetclover, yellow sweetclover.

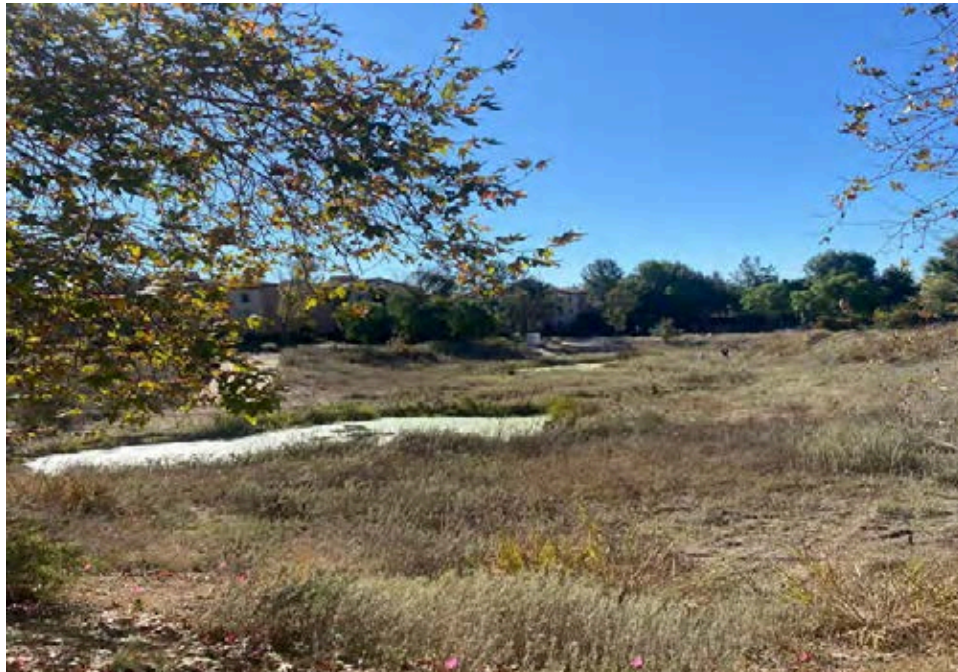
Figure 5. Overview of Lower Eastfoot as of November 2024.

Lower Eastfoot is a 1.62-acre basin north of Portola Parkway adjacent to residential housing and the 261 freeway in north Irvine. The site basin consists primarily of a pilot channel connected with two ponds on each side. Due to the high desiccation rate in warm months and low existing native cover, this site exhibits consistent cover of annual non-native and invasive species. This site harbors a relatively new species to the county [marking the third county detection (white-stem filaree (*Erodium malacoides*)]. This species is featured on the review board for the California Native Plant Society as potentially invasive. Over 400 plantings (i.e. *Anemopsis californica*, *artemisia douglasiana*, *asclepias fascicularis*, *cyperus eragrostis*, *elymus triticoides*, *elmyus codensatus*, *epilobium canum*, *heliotropium curassavicum*, *mimulus guttatus*, *muhlenbergia rigens*, *salvia mellifera*, *sisyrinchium bellum*, *stipa lepida*, *stipa pulchra*) were planted throughout the basin and slopes at the beginning of the year. The overall most prevalent non-native species observed included bristly oxtongue, burr clover, and smilo grass. Various non-native brome species densely covered the slopes during the spring. All other non-native species observed included Bermuda grass, blue water speedwell, cheeseweed, common sowthistle, compact brome, curly dock, dallisgrass, field bindweed, flax-leaved horseweed, fountain grass, hairawn muhly, Italian rye, jungle rice, musky stork's bill, oat sp., rabbitsfoot grass, rescuegrass, Russian thistle, Spanish false fleabane, and yellow sweetclover. Regarding tree health, minor symptoms characteristic of potential Invasive Shot Hole Borer infestation (ISHB) were demonstrated by a sycamore tree on site.

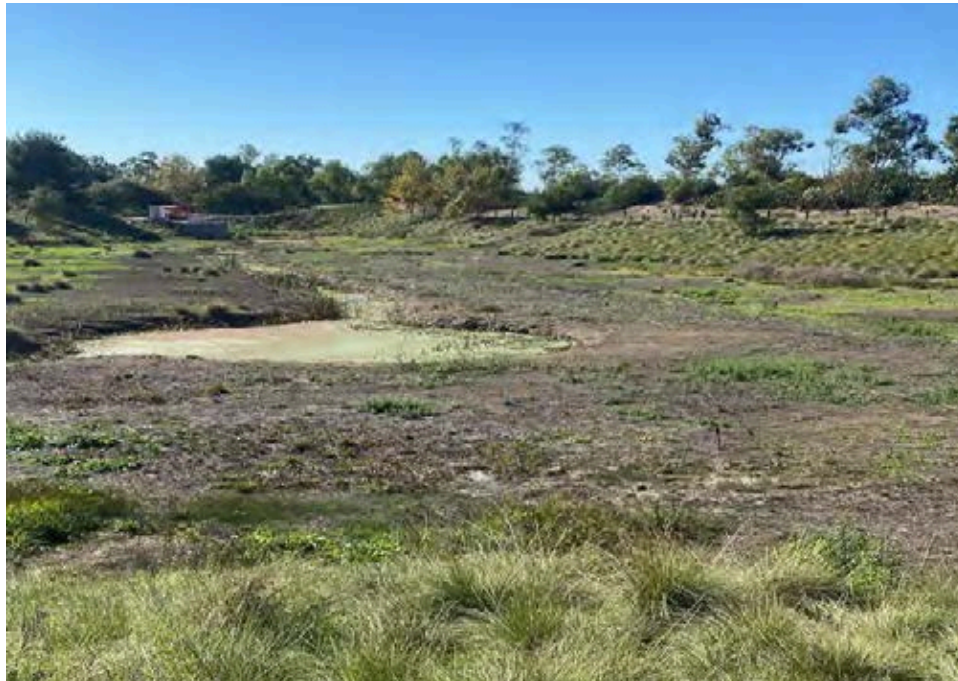
Figure 6. Overview of the Middle Eastfoot as of December 2024.

Middle Eastfoot is a 3.82-acre basin located north of Settlers Road in north Irvine. This basin is adjacent to residential housing, the 261 freeway, and agricultural land. The basin consists primarily of a pilot channel, which often overflows. Water spreads throughout the bottom of the basin and creates a pond. Similarly to Lower Eastfoot, there are high rates of non-native and invasive recruitment throughout the year. The basin in particular didn't have any emerging natives this year. The most diverse portions of this basin are along the peripheries of the basin, where water from irrigation is caught and held; here native bioswale vegetation can be found, such as spikerush (*Eleocharis sp.*), false daisy (*Eclipta prostrata*), alkali bulrush (*Bolboshoenus maritimus ssp. paludosus*), fragrant flatsedge (*Cyperus odoratus*), tall flatsedge (*Cyperus eragrostis*), and California loosestrife (*Lythrum californicum*), Mexican Sprangletop (*Leptochloa fusca ssp. uninervia*). The total coverage of this habitat has undergone impacts due to the encroachment of invasive vegetation and disturbance from trampling. In terms of prevalence, the most dominant non-native species included bristly oxtongue, Bermuda grass, burr clover, curly dock, and Mexican primrose. Other non-native species observed included, bristly oxtongue, common sowthistle, dallisgrass, English plantain, fountain grass, hyssop loosestrife, Maltese star thistle, ngaio, prickly sowthistle, rabbitsfoot grass, smilo grass, Spanish false fleabane, watercress, white sweetclover, and yellow sweetclover.

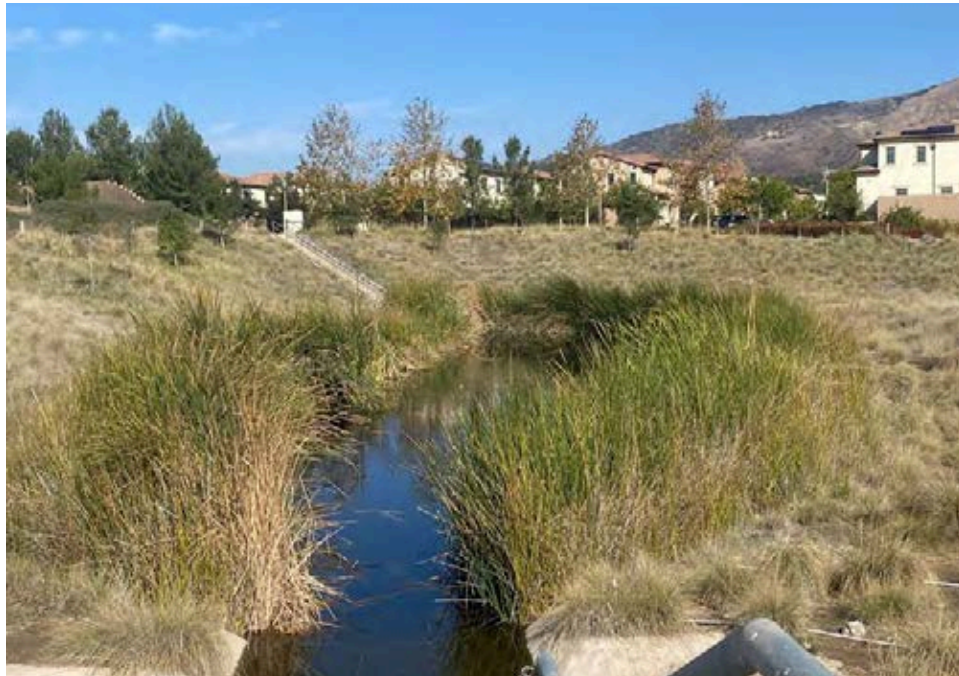
Upper Eastfoot is a 1.41 acre basin located east of the 261 freeway in north Irvine. The basin is adjacent to residential housing and consists primarily of a pond at the base of the slope. Upper Eastfoot remains only vernal wet and thus is almost barren of all non-planted vegetation for a large portion of the year. Due to this, problem areas were within the small corners of the site with consistent irrigation, and no particular non-native species dominated. Throughout the year, hand removal and hula hoe were primarily advised to manage non-native cover. Non-native species observed included yellow sweetclover, rabbitsfoot grass, Bermuda grass, bristly oxtongue, common lantana, matted sandmat, flax-leaved horseweed, hairawn muhly, hyssop loosestrife, prickly sowthistle, and scarlet pimpernel.

Figure 7. Overview of Upper Eastfoot as of December 2024

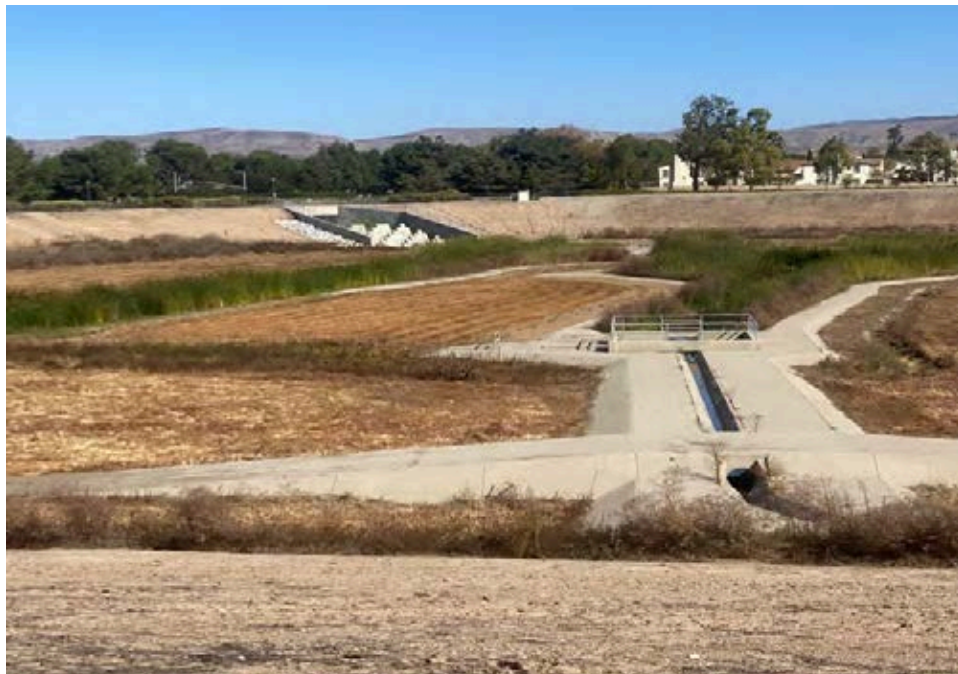
Figure 9. Overview of Trabuco as of November 2024.

Trabuco is an 18.06-acre basin located north of Trabuco Rd in north Irvine. The basin is adjacent to residential housing. Trabuco consists of three ponds connected by two pilot channels. Characteristic of the flood basin sites, invasive cover remained relatively constant throughout the year, including on slopes, in basin waterways, and the basin bottom. Hand Removal and hula hoeing were the primary methods advised to manage the non-native cover. Following a directive from IRWD, Endemic biologists sought only to order the removal of invasives within 15 feet of the waterways in the latter half of the year. Spanish false fleabane, curly dock, and Italian rye were the most prevalent non-native species. Other non-natives advised for maintenance included: blue water speedwell, brass buttons, bristly oxtongue, burr clover, cheeseweed, Chinese elm, flax-leaved horseweed, lesser swinecress, prickly lettuce, rescuegrass, Shepherd's purse, shortpod mustard, stinknet,, water speedwell, white sweetclover, and yellow sweetclover.

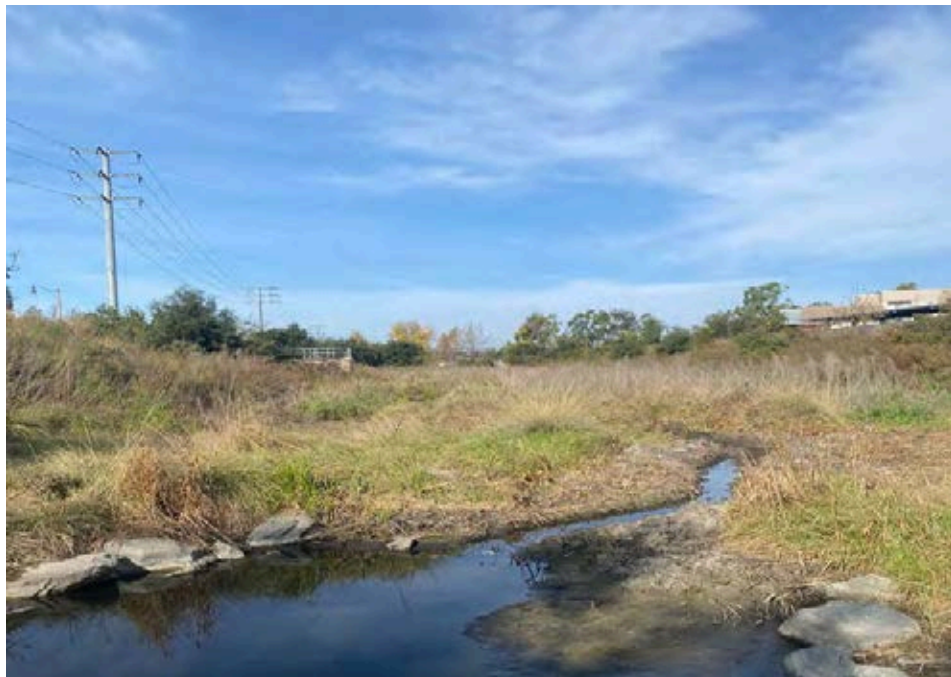
Figure 10. Overview of Parasol Park as of December 2024.

Parasol Park is a 2.07-acre site located north of Great Park Boulevard. It consists mainly of a pilot channel, with water often overflowing into the basin bottom. The site's primary spring and summer cover remains the non-native tropical horseweed (*Erigeron sumatrensis*). Despite its dense appearance, the native cover is relatively low compared to similarly seeded sites, and the waterways remain consistently weedy. Bare patches on the ground populate the site with heavy and compacted fill soil. These empty patches consistently foster Spanish false fleabane and brass buttons, with no opportunities for natives to recruit. Throughout the year, hand removal and digging were the primary methods advised to reduce total invasive cover. Tropical horseweed, curly dock, and Spanish false fleabane were the most prevalent species on site. Other non-natives advised for maintenance included black mustard, Brazilian peppertree, buffelgrass, bull thistle, carrotwood, crape myrtle, fountain grass, hairawn muhly, lindheimer's muhly, prickly lettuce, prickly sowthistle, shamel ash, stalked bulbine, and tropical milkweed.

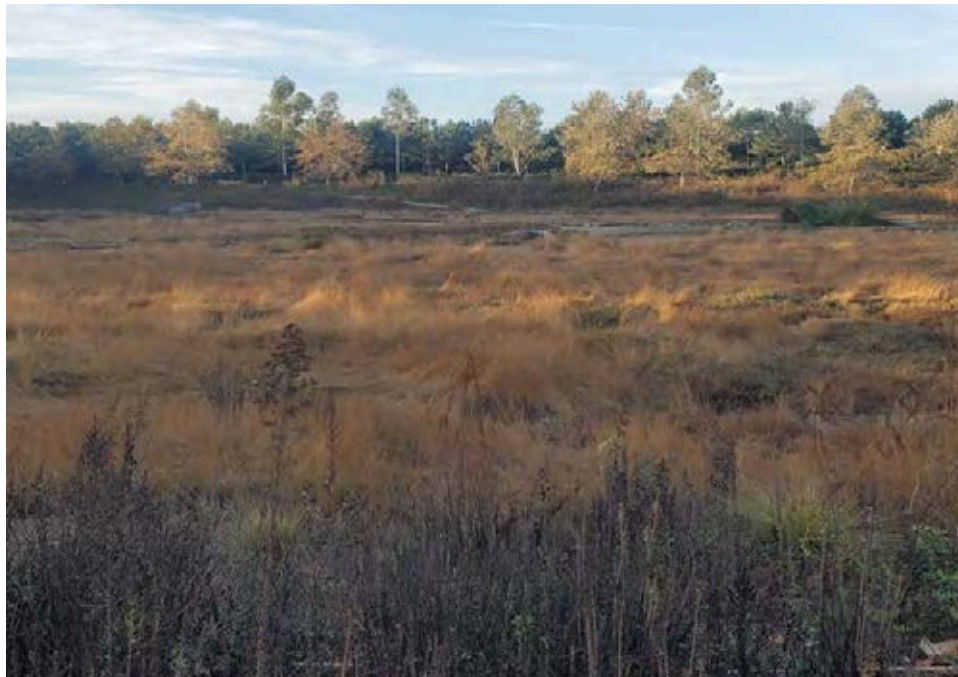
Cypress Meadow A is a 6.77-acre basin north of the 5-freeway and adjacent to residential housing in north Irvine. This basin consists primarily of three pilot channels connected by a pond at the bottom. During wet months, the slopes and basins exhibited high cover by non-native species. However, during the dry season, almost all plant cover (including non-native) senesced in the basin, leaving major bare patches throughout the site the majority of the year. Slopes consistently harbored non-native and invasive growth along the drip lines of trees and on the edge of sites, where moisture was present year-round. Due to high foot traffic, low moisture, and disturbance, there has been a notable reduction of native diversity in the already disturbed basin. Large patches of creeping wild rye (*Leymus triticoides*) and alkali heath (*Frankenia salina*) have disappeared, along with a moderate loss of wetland vegetation cover on the western portion. Native species of interest in this site include Scarlet toothcup (*Ammannia coccinea*) and Narrowleaf milkweed (*Asclepias fascicularis*). Hand Removal, hula hoeing, and digging were the primary methods advised for reducing the non-native cover. The most prevalent species included Spanish false fleabane and Mexican primrose. Other non-native species advised for maintenance included Brazilian peppertree, bristly oxtongue, camphor tree, carrotwood, Chinese elm, common stork's bill, creeping myoporum, curly dock, fountain grass, Japanese cheesewood, Mexican feathergrass, pampas grass, panic veldtgrass, perennial pepperweed, Peruvian peppertree, prickly sowthistle, St. Augustine grass, sticky snakeroot, Taiwanese firethorn, and yellow sweetclover.

Figure 11. Overview of Cypress Meadows A as of November 2024.

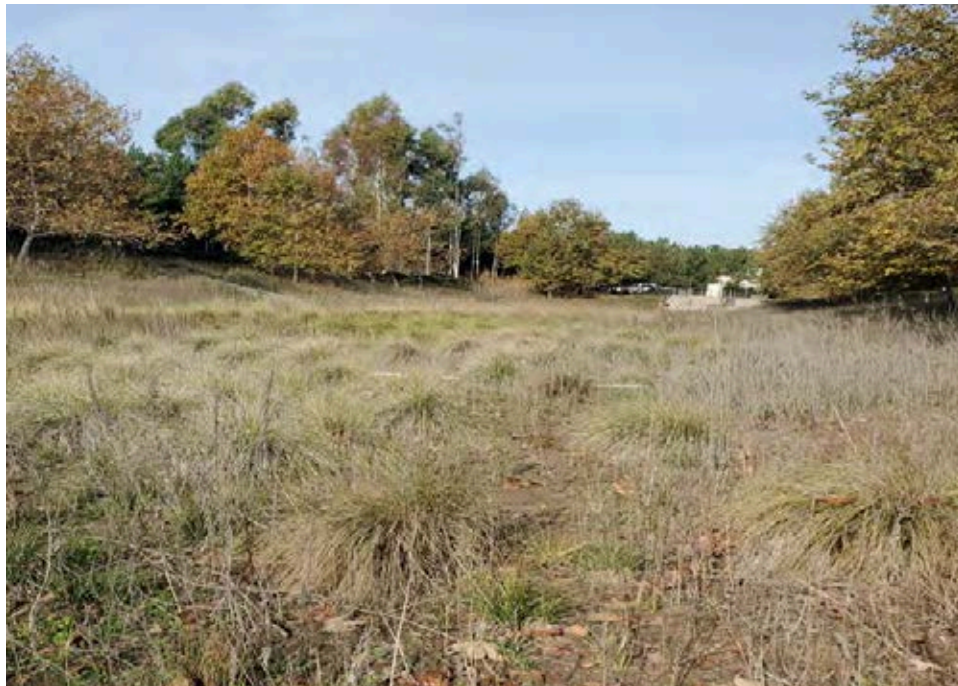
Figure 12. Overview of Cypress Meadows B as of November 2024.

Cypress Meadow B is a 2.29-acre basin located north of the 5 freeway and adjacent to residential housing in north Irvine. This basin consists primarily of a pilot channel that runs throughout the bottom. Hand removal and hula hoeing were the primary methods advised to decrease invasive cover. The most prevalent non-native species documented included bristly oxtongue, common sowthistle, prickly sowthistle and prickly lettuce. Other non-native species advised for removal included Bermuda grass, black medic, burr clover, Chinese elm, common mugwort, great brome, Japanese honeysuckle, Jersey cudweed, Mexican fan palm, Mexican primrose, Peruvian peppertree, pyracantha, rabbitsfoot grass, rat-tail fescue, scarlet pimpernel, smilo grass, Spanish false fleabane, Taiwanese firethorn, wax-leaf privet, and yellow sweetclover.

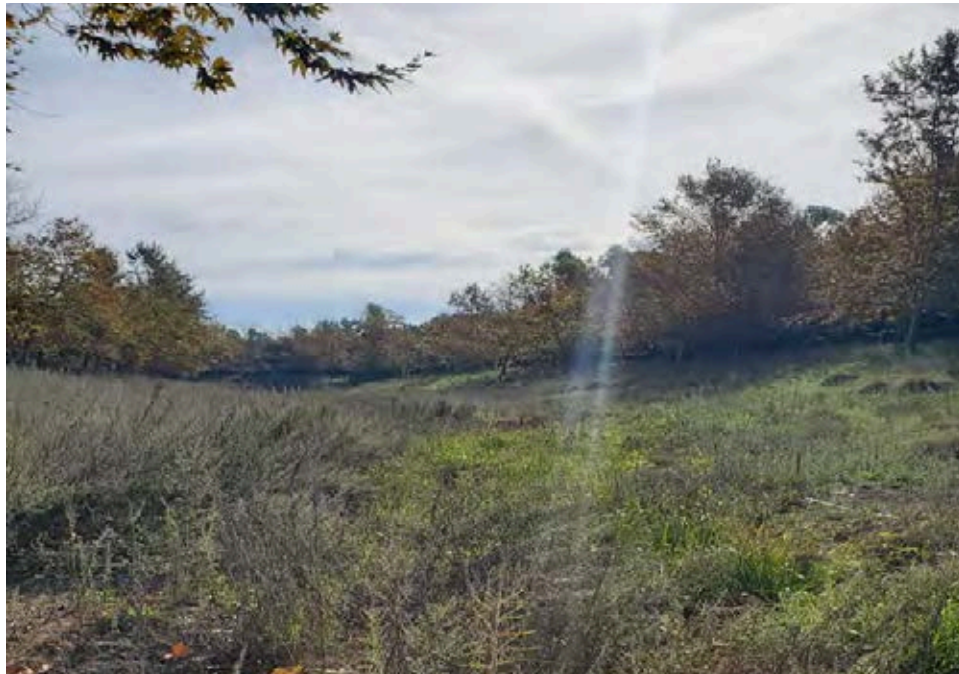
Figure 13. Overview of Cypress Meadows C as of November 2024.

Cypress Meadow C is a 2.92-acre basin located north of the 5 freeway and adjacent to residential housing in north Irvine. This basin consists primarily of a pilot channel that runs along the bottom. Digging and hand removal were the primary methods advised to minimize native cover. Common sowthistle, yellow sweet clover, burr clover, and bristly oxtongue were the most prevalent non-native species on site. Other non-natives species include Asian mustard, Brazilian peppertree, camphor tree, Chinese elm, common stork's bill, compact brome, flax-leaved horseweed, fountain grass, Japanese honeysuckle, Lindheimer's muhly, Mexican fan palm, Mexican primrose, musky stork's bill, pampas grass, prickly lettuce, prickly sowthistle, rabbitsfoot grass, rescuegrass, shepherd's purse, smilo grass, trumpet flower.

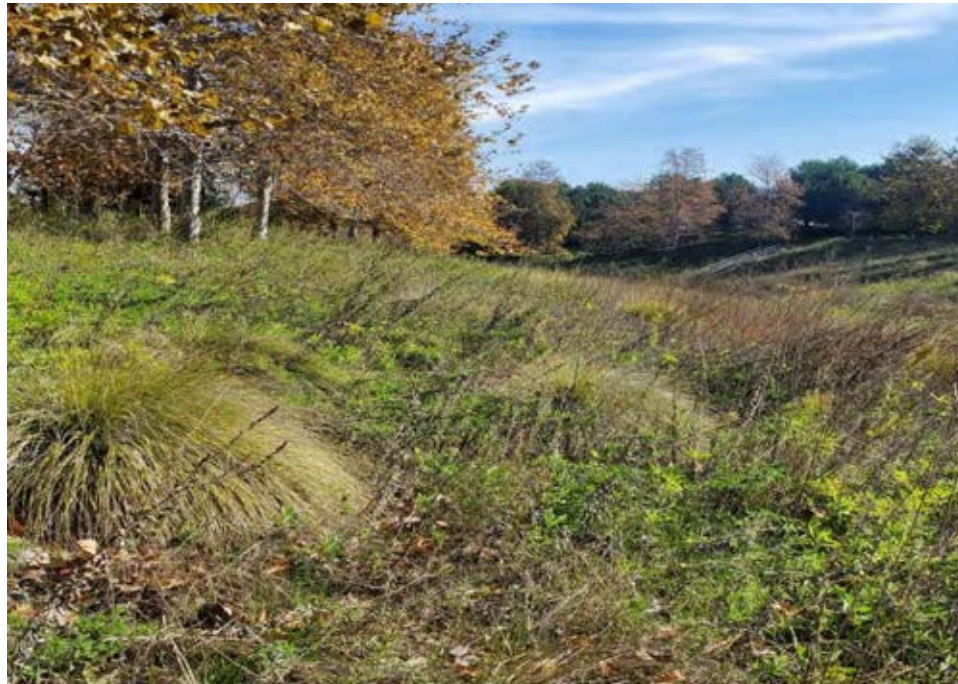
Figure 14. Overview of Cypress Meadows D

Cypress Meadow D is a 3.44-acre basin located north of the 5 freeway and adjacent to residential housing in north Irvine. This basin consists primarily of a pilot channel that runs throughout the bottom. Hand removal, hula hoeing, and digging were the primary methods advised to reduce non-native plant cover. Bristly oxtongue, Mexican primrose, and prickly sowthistle were the most prevalent species. Other native plants advised for removal included annual bluegrass, bermuda grass, Brazilian peppertree, brass buttons, bull thistle, burr clover, carrotwood, common sowthistle, floating primrose-willow, jersey cudweed, Mexican fan palm, Peruvian peppertree, prickly lettuce, scarlet pimpernel, Spanish false fleabane, Taiwanese firethorn, tropical horseweed, tropical milkweed, willow dock, and yellow sweetclover.

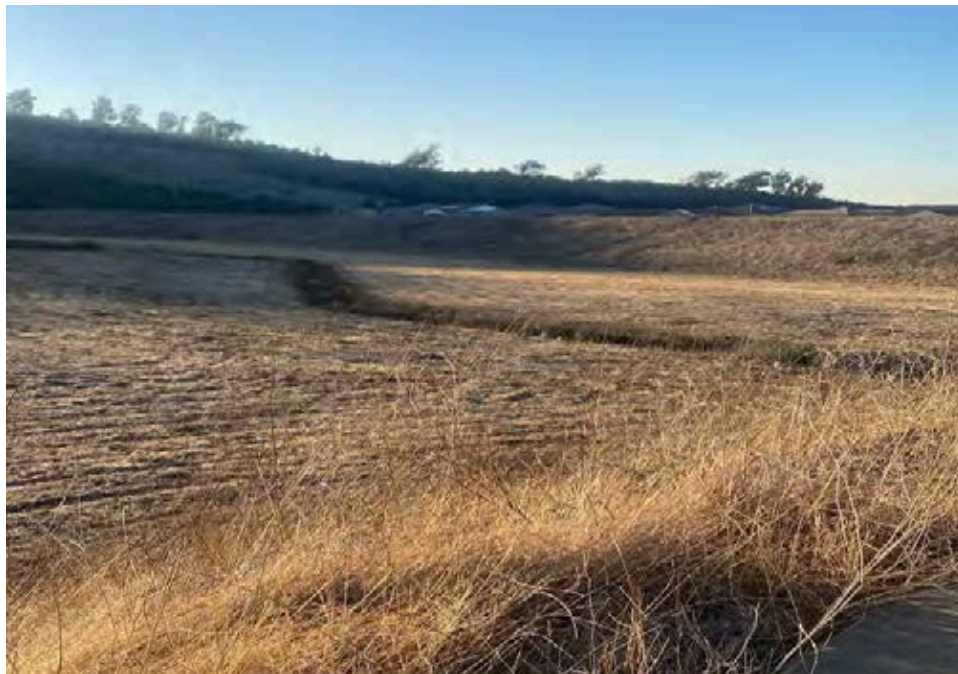
Figure 15. Overview of Eastfoot Retarding Basin as of November 2024.

Eastfoot Retarding Basin is a 14.82-acre basin located east of Leafy Pass in north Irvine. The basin is adjacent to agricultural land and residential housing. It consists primarily of a pilot channel connected to three ponds along the basin bottom. Since this site is not under the direct management of IRWD and must primarily function as a flood basin, mowing efforts were the default weed maintenance measure required. To prevent non-native seeds from spreading into the waterway, only non-native individuals within 15 feet of the channels were advised for removal. Hand removal and hula hoeing were the primary advised maintenance methods, with shortpod mustard, Maltese star thistle, common sowthistle, bristly oxtongue, and cheeseweed being the most prevalent. Other non-native species observed on the site included Australian saltbush, bermuda grass, cheeseweed, common stork's bill, compact brome, prickly lettuce, red brome, ripgut brome, Russian thistle, slender wild oats, smilo grass, smooth barley, Spanish false fleabane, stork's bill sp., wall barley, and white sweetclover.

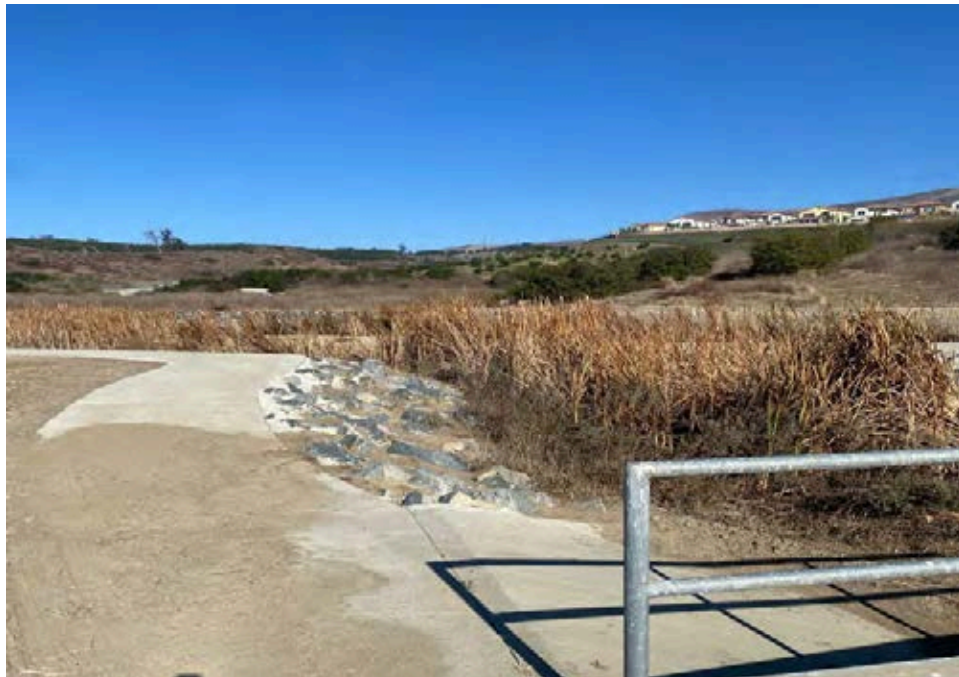
Figure 16. Overview of Quail Springs as of November 2024.

Quail Springs is a 8.38 acre basin located south of the I-405 freeway in north Irvine. The basin is adjacent to a large open field area and residential housing. Quail Springs consists primarily of a pilot channel connected to four ponds. For this site to primarily function as a flood basin, mowing efforts were the default weed maintenance measure required. However, to prevent non-native seeds from spreading into the waterway, non-native individuals within approximately 15 feet of the channels were advised for removal. Hand removal and hula hoeing were the most frequent removal methods advised for decreasing non-native cover, with curly dock, Spanish false fleabane, and burr clover being the most prevalent species to address. Other non-native species observed include the following: African sumac, black mustard, black willow, bristly oxtongue, castor bean, Chinese elm, common fennel, common purslane, common sowthistle, dallisgrass, fountain grass, Italian rye, Maltese star thistle, musky stork's bill, mustard sp., perennial ryegrass, prickly sowthistle, rat-tail fescue, Russian thistle, shepherd's purse, shortpod mustard, tamarisk, wall barley, watercress, white horehound, white sweetclover, wild radish, and yellow sweetclover.

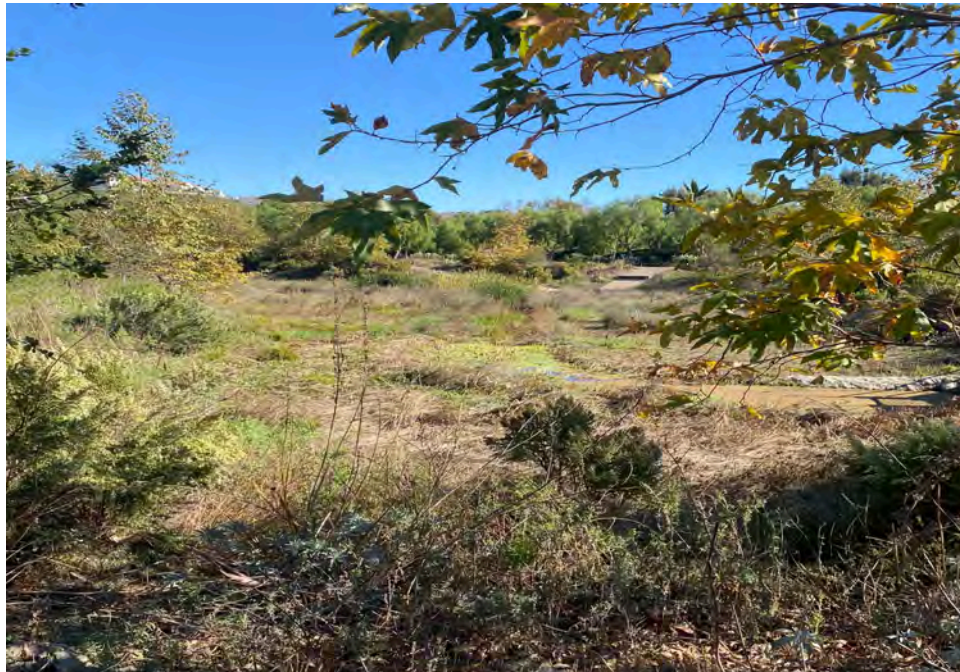
Figure 17. Overview of Orchard Retarding Basin as of December 2024.

Orchard Retarding Basin is a 0.97-acre basin located adjacent to a housing development and the Orchard Hills Staging Area. The area consists of a basin connected to a channel with a paved walkway around the basin's edge. For this site to primarily function as a flood basin, mowing efforts were the default weed maintenance measure required. However, to prevent non-native seeds from spreading into the waterway, non-native individuals within approximately 15 feet of the channels were advised to remove them. As a flood basin, Orchard Retarding Basin remains relatively barren for the large majority of the year. Due to the lack of supplemental irrigation, seed bank, and foot traffic, little to no colonization of any species is present. Hula hoeing, hand removal, and digging were the primary advised methods for addressing non-natives bordering the channels, of which bristly oxtongue, Spanish false fleabane, shortpod mustard, and flax-leaved horseweed were the most prevalently observed. Other non-native species observed included common fennel, flax-leaved horseweed, Maltese star thistle, Mediterranean grass, prostrate pigweed, rabbitsfoot grass, ripgut brome, slender wild oats, and wall barley.

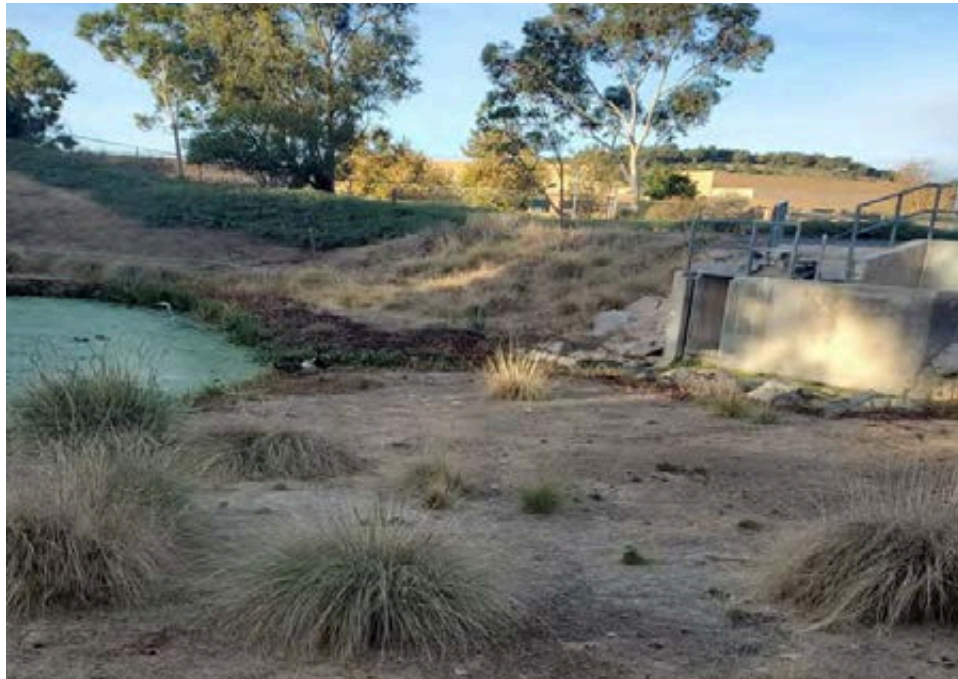
Twisted Oak is a 0.40-acre basin located northeast of Northwood High School. It consists of one circular pond. This site does not have access to a controller or irrigation system. Consequently, a large bareground area occupies the majority of the basin's bottom. Hand removal and hula hoeing were the primary methods recommended to manage the sparse non-natives occupying the disturbed areas. Due to the highly exposed soil, there was no particularly dominant species. In the waterway, the dominant non-native was floating primrose-willow; Bristly oxtongue and floating primrose-willow were the most prevalent non-native species; other non-natives observed in the site include Bermuda grass, burr clover, cheeseweed, common sowthistle, flax-leaved horseweed, prickly sowthistle, rabbitsfoot grass, scarlet pimpernel, sharpleaf cancerwort, and yellow sweetclover. In December, a grade-A mulch was distributed onto the barren areas. Follow-up restoration was advised to seed the bank conjunctly with planting. However, this plan should be reconsidered once a more readily available irrigation system has been secured on-site. Additionally, plant choices should be vetted to ensure proper nativity. Among the remaining planted vegetation at Twisted Oak, a plant native to Northern California (*Leymus mollis*) was detected. Only two plants were present, and the health of the individuals appeared to indicate no invasive risks. However, caution should be taken due to the capacity of seed distribution through the waterway.

Figure 18. Overview of Twisted Oak with bareground in the basin as of November 2024.

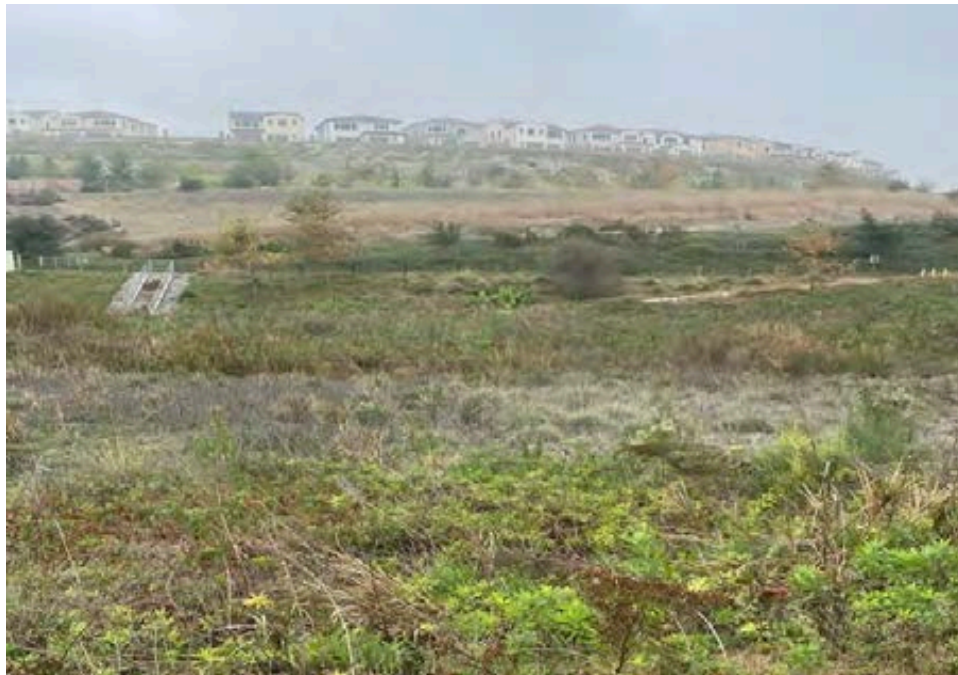
Agua Chinon A is a 2.10-acre basin located near a housing development off Portola Springs Road and adjacent to SR-241. Hand removal was the primary method advised to reduce the non-native cover. Fountain grass and Spanish false fleabane were the most prevalent species observed. Due to its proximity to other weedy areas, the basins often receive 'tumbleweeds' from nearby senesced Russian thistle. Other non-natives advised for removal included bristly oxtongue, bull thistle, common sowthistle, marsh celery, pampas grass, prickly sowthistle, rabbitsfoot grass, scarlet pimpernel, shortpod mustard, stork's bill sp, and tamarisk..

Figure 19. Overview of (Upper) Agua Chinon A as of November 2024.

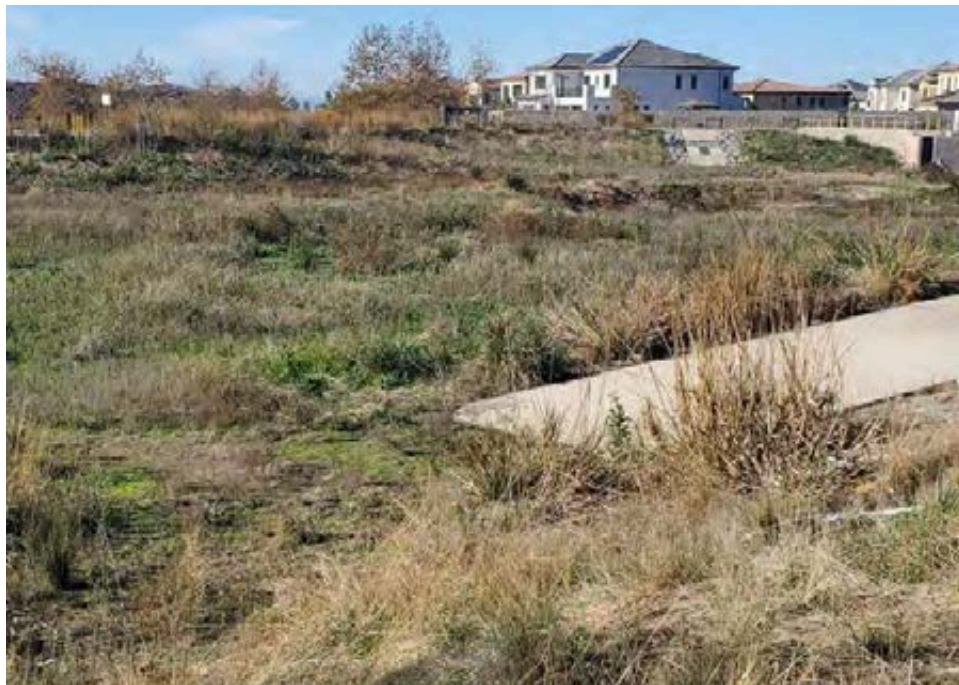
Aqua Chinon B is a 2.36-acre basin located near a housing development off Portola Spring Road and adjacent to SR-241. Hula hoeing and hand removal were the primary methods advised to decrease non-native cover. Spanish false fleabane was the most prevalent and problematic non-native species on site. Additionally, a polygon of newly germinating smilo grass was allowed to seed in the center of the site, which will be an issue to anticipate in the wet season. Other non-natives observed include bristly oxtongue, burr clover, common sowthistle, curly dock, fountain grass, golden wreath wattle, prickly sowthistle, rabbitsfoot grass, shortpod mustard, smilo grass, stinknet, tamarisk, and yellow sweetclover.

Figure 20. Overview of (Upper) Agua Chinon B as of December 2024.

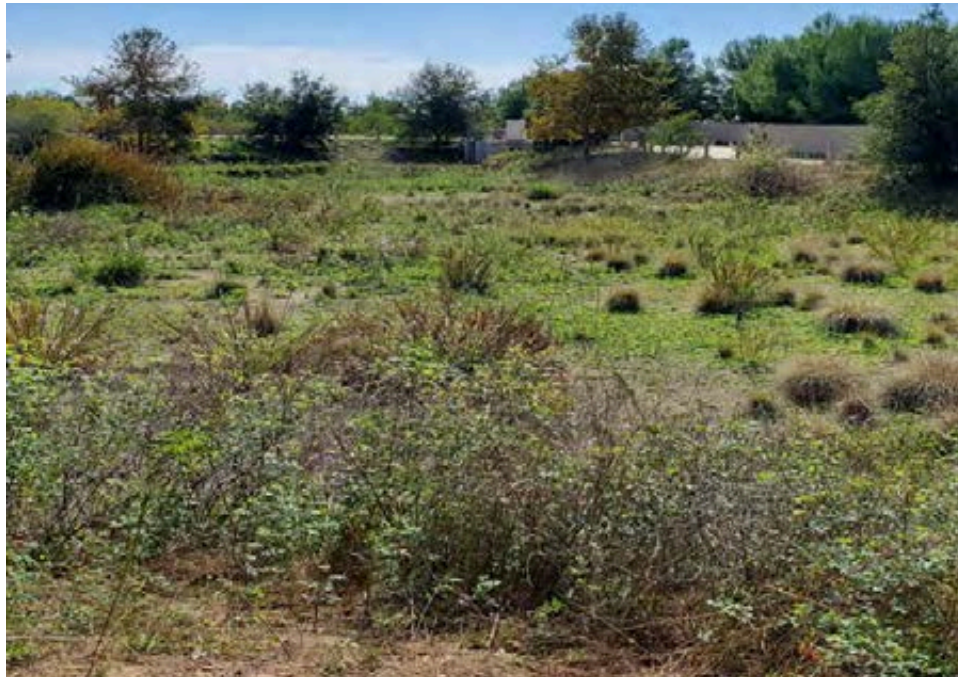
Aquila Springs is a 1.19-acre basin located in the Altair Community development east of Irvine Boulevard. The basin consists of one channel, which frequently floods. Once characterized by its high native cover, excessive foot traffic and invasive encroachment have significantly reduced native recruitment. While most slopes have retained a relatively high native cover, the basins and the west slope are in the process of degradation. Furthermore, large bare patches of rocky soil populate the site, which are only colonized by ephemeral natives and annual non-natives. Hand removal and digging were the primary methods advised for reducing non-native cover. Prevalent non-natives were Spanish false fleabane, horseweed spp. (flax-leaved and tropical), yellow sweet clover, and lesser swinecress. Other non-natives advised for removal included canary island date palm, common sowthistle, common stork's bill, fountain grass, garland daisy, hairawn muhly, lesser swinecress, lindheimer's muhly, Mexican fanpalm, milk thistle, prickly sowthistle, rabbitsfoot grass, Saharan mustard, scarlet pimpernel, shortpod mustard and yellow sweetclover.

Figure 21. Overview of Aquila Springs as of November 2024.

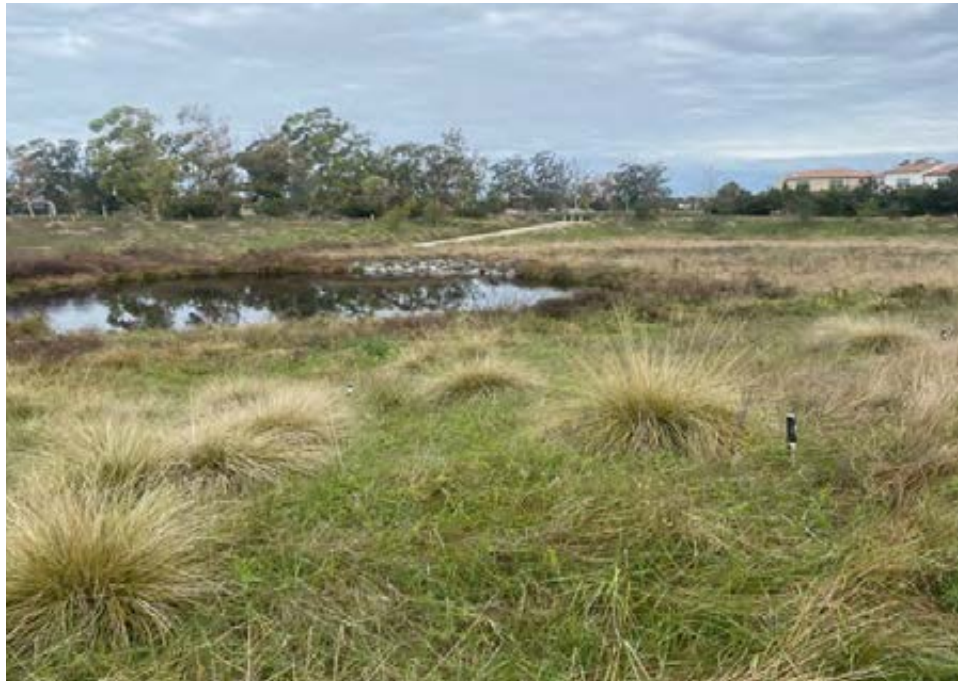
Floral View is a 2.49-acre basin located east of SR-133 and west of Floral View. It consists of one channel leading to a circular pond. The site had a moderate amount of annual non-native plants. Furthermore, large stands of Tall Fescue (*Festuca arundinacea*) were detected onsite, particularly on the Northeast slopes. Tall fescue is designated as a Moderate on the Cal-IPC rating system, indicating a substantial and apparent impact on the ecosystems it invades. Most of these plants have left large holes on the slopes upon removal. As a supplementary recommendation, Endemic suggests a replanting effort upon eradicating all of the Tall Fescue stands. Hand removal and hula hoeing were the primary methods advised to reduce general non-native cover. The most prevalent species observed were Spanish false fleabane, Mexican primrose, and rescuegrass. Other non-natives advised for removal include bay laurel, black mustard, bull thistle, burr clover, common fig, common sowthistle, compact brome, Italian thistle, Jersey cudweed, Mexican fan palm, Mexican primrose, poison hemlock, red brome, rescuegrass, riggut brome, slender thistle, tall fescue, tropical milkweed, and sweetclover spp. (white and yellow). Lastly, Floral View appears to have a notable decline in tree health, with all Coast live oaks undergoing significant stress, pest damage, and stunting.

Figure 22. Overview of Floral View as of November 2024.

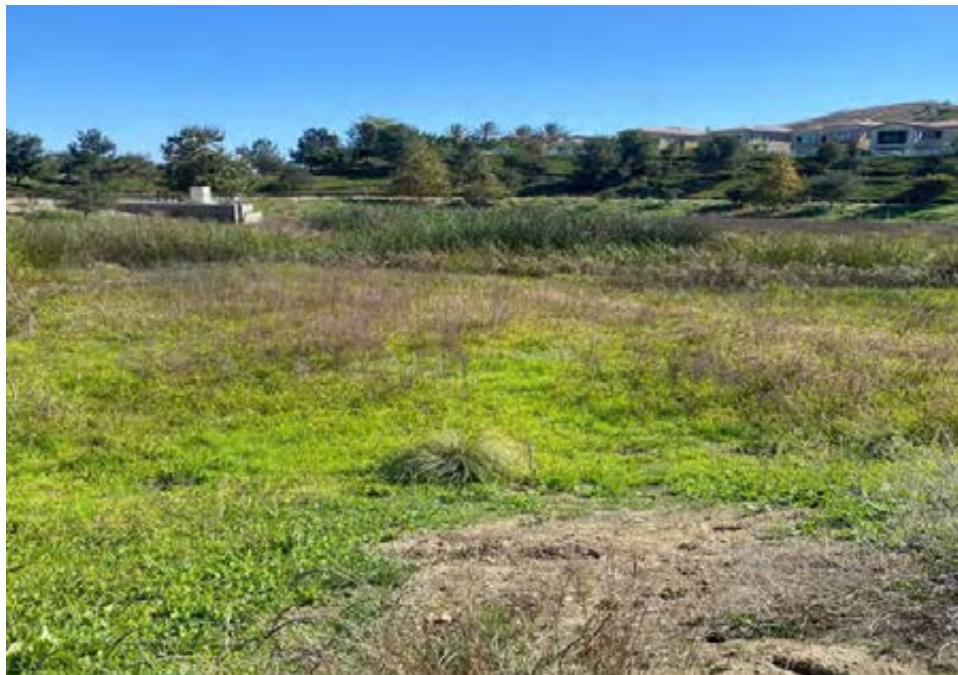
Hidden Canyon is a 2.89-acre basin located south of Lake Forest Drive and adjacent to the Hidden Canyon residential development. The basin consists of two inlets which flow into one pond. Due to high rates of flooding and perennial moisture, this basin exhibits high non-native species cover throughout the bottom and the south-facing slopes. Additionally, the site's presence in the formerly agrarian dominated San Joaquin Hills strongly influences the presence of weeds within. Thus, despite the moisture presence, invasives oriented towards high disturbance are plentiful onsite year-round. Hand removal, hula hoeing, and digging were the primary methods advised to reduce the non-native cover on site. Curly dock, bristly oxtongue, Bermuda grass, and smilo grass were among the most prevalent and problematic invasive and non-native species on site. Other non-natives observed included black mustard, bull thistle, burr clover, cheeseweed, common fennel, common sowthistle, creeping saltbush, creeping wood sorrel, flax-leaved horseweed, goosegrass, knotroot bristlegrass, musky stork's bill, prickly lettuce, prickly sowthistle, rabbitsfoot grass, rescuegrass, scarlet pimpernel, shepherd's purse, Spanish false fleabane, tamarisk, and yellow sweetclover. Oak tree(s) on site were observed experiencing root instability in October. Endemic provided irrigation adjustment recommendations to address this issue.

Figure 23. Overview of Hidden Canyon basin as of November, 2024.

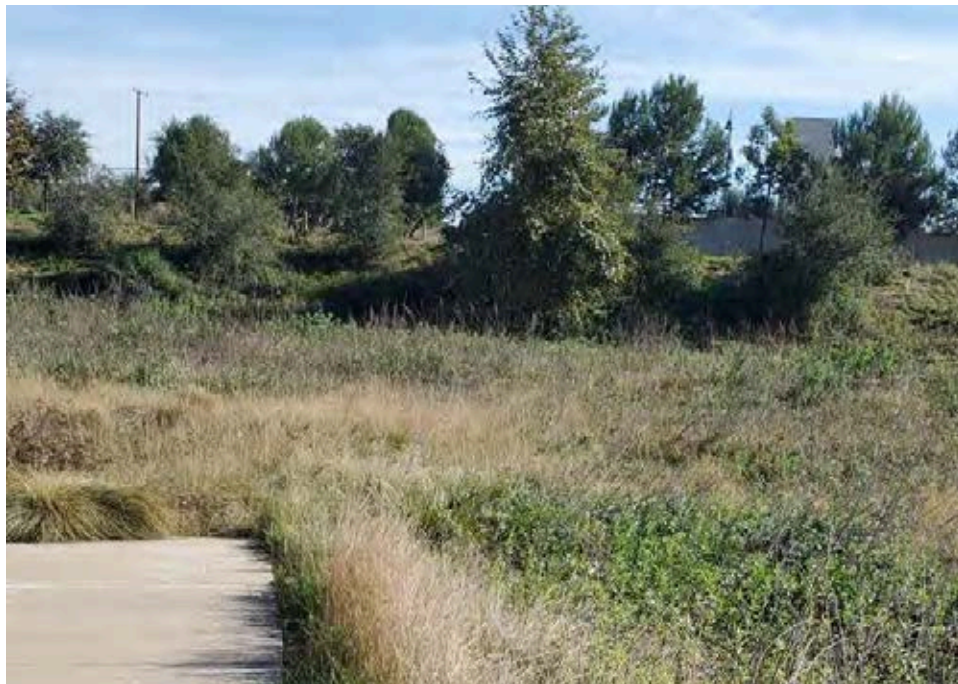
Figure 24. Overview of Iluna Spring as of November 2024

Iluna Springs is a 2.66-acre basin located in the Altair Community development. The development is north of Irvine Boulevard in northeast Irvine. This basin consists of two inlet channels. The basin and surrounding slopes experienced moderate coverage of annual non-native plants throughout the year. Otherwise, large patches of bareground are primarily in the Southeast basin. Uniquely, Iluna Springs remains one of two localities (the other being the San Joaquin Marsh sites) with consistent infestation of castor bean (*Ricinus communis*). Hand removal and digging were the primary methods advised for reducing non-native cover. Prevalent invasive species include curly dock, Spanish false fleabane, and castor bean. Other non-native species observed were annual bluegrass, black mustard, bristly oxtongue, Chinese elm, common sowthistle, field bindweed, fountain grass, lesser swinecress, Mexican primrose, shortpod mustard, and tree tobacco.
