Integrated Pest Management Plan for the Irvine Ranch Water District

2024 Annual Report

Provided By:
Endemic Environmental Services Inc.

Prepared For:
Irvine Ranch Water District

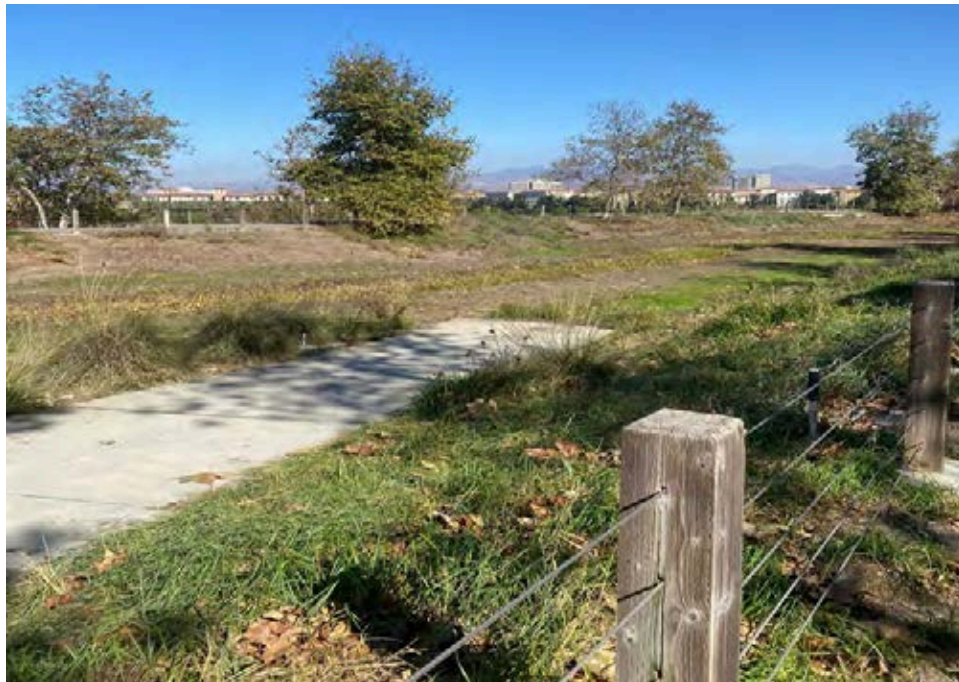
Laguna Altura North is a 1.53-acre basin north of the Laguna Altura housing development and south of I-405. Once characterized by a high level of native recruitment onsite, high rates of desiccation during the warm season have led to senescence and perennial mortality, creating patches of bareground. Hand removal and digging were the primary advised methods to reduce the non-native cover on site. Non-native species, such as common sowthistle, smilo grass, burr clover, and bristly oxtongue were most prevalent throughout the year. Other non-native species observed were castor bean, cheeseweed, compact brome, curly dock, field bindweed, fountain grass, hyssop loosestrife, Italian rye, lesser swinecress, Mexican primrose, Oak-leaved goosefoot, panic veldtgrass, prickly lettuce, prickly sowthistle, rabbitsfoot grass, rat-tail fescue, red brome, rescuegrass, scarlet pimpernel, tropical horseweed, wall barley, and water beard grass.

Figure 25. Laguna Altura North as of November, 2024.

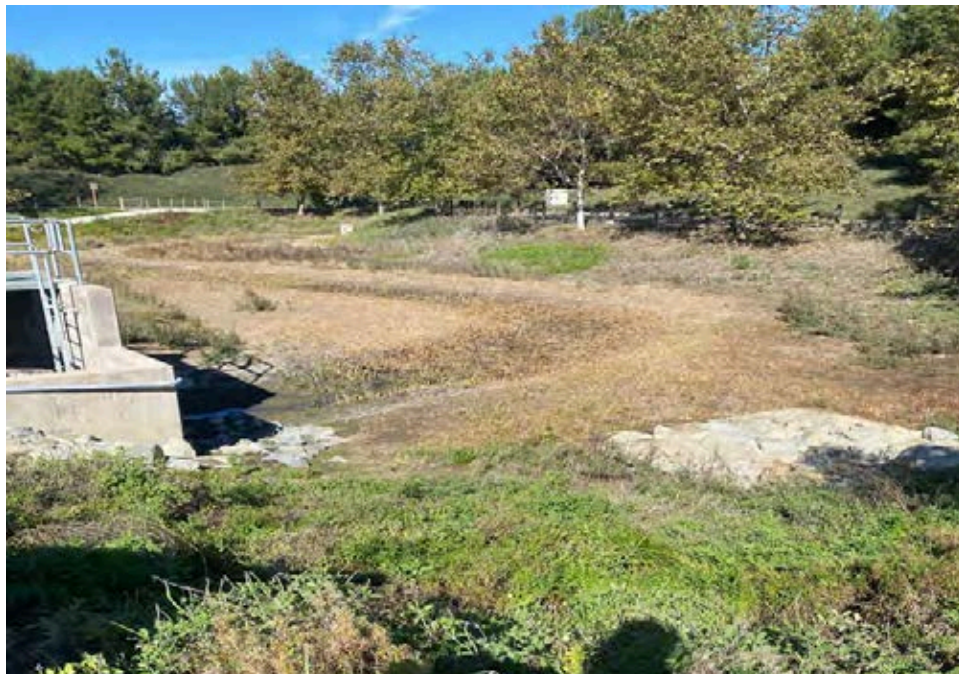
Laguna Altura South is a 0.92-acre basin located west of the Laguna Altura housing development and east of SR-133. While hand removal and hula hoeing were the primary methods advised to reduce non-native cover, solarization and herbicide were also prescribed. Laguna Altura South is another site that only remains wet during winter months. As a result, similar to other sites experiencing these conditions, bareground in the basin is present for the entirety of the warm season. Prevalent invasive species include rabbitsfoot grass and Bermuda grass. Other non-native species were as follows: bristly oxtongue, bull thistle, burr clover, common stork's bill, curly dock, field bindweed, Mexican primrose, petty spurge, prickly lettuce, prickly sowthistle, rabbitsfoot grass, rescuegrass, scarlet pimpernel, Spanish false fleabane, Taiwanese firethorn, tamarisk, and yellow sweetclover. Manual solarization was proposed in May for Bermuda grass and successfully executed later that month; to further address Bermuda, herbicide treatment was advised and reported in December, 2024.

Figure 26. Laguna Altura South as of November 2024.

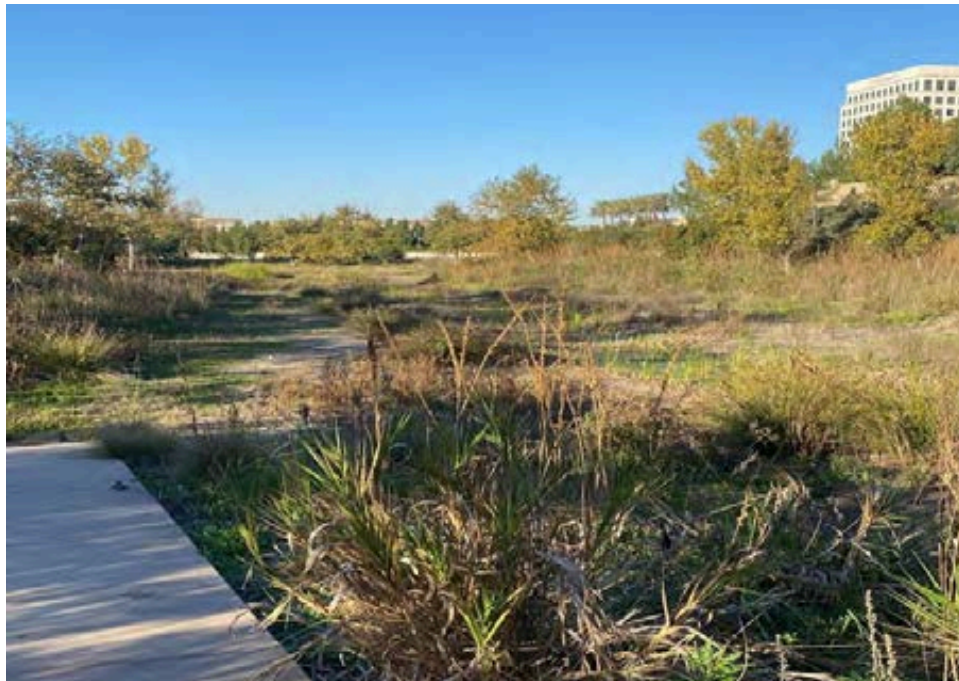
Figure 27. Overview of Los Olivos Meadow as of November 2024.

Los Olivos is a 3.78-acre basin located east of San Diego Creek and adjacent to the Los Olivos housing development. This basin has two inlet channels that flow into one pond. Los Olivos Meadows is one of the sites addressed by both Endemic and LC. Thus, vegetation cover is consistently managed, with the caveat that disturbance and plant mortality are more prevalent. Without careful restoration efforts, invasive colonization will continue to pose an issue on this site. To promote native biodiversity and cover, over 400 individuals (i.e. *Anemopsis californica*, *artemisia douglasiana*, *asclepias fascicularis*, *cyperus eragrostis*, *elymus triticoides*, *elmyus codensatus*, *epilobium canum*, *heliotropium curassavicum*, *mimulus guttatus*, *muhlenbergia rigens*, *salvia mellifera*, *sisyrinchium bellum*, *stipa lepida*, *stipa pulchra*) were planted throughout the slopes and basin at the beginning of the year. The non-native cover was controlled primarily by hand removal, hula hoeing, and digging. Prevalent invasive species included bristly oxtongue and Spanish false fleabane. Other non-natives advised for maintenance included the following: black mustard, Brazilian peppertree, burr clover, common sowthistle, common stork's bill, curly dock, prickly sowthistle, rabbitsfoot grass, tamarisk, and yellow sweetclover.

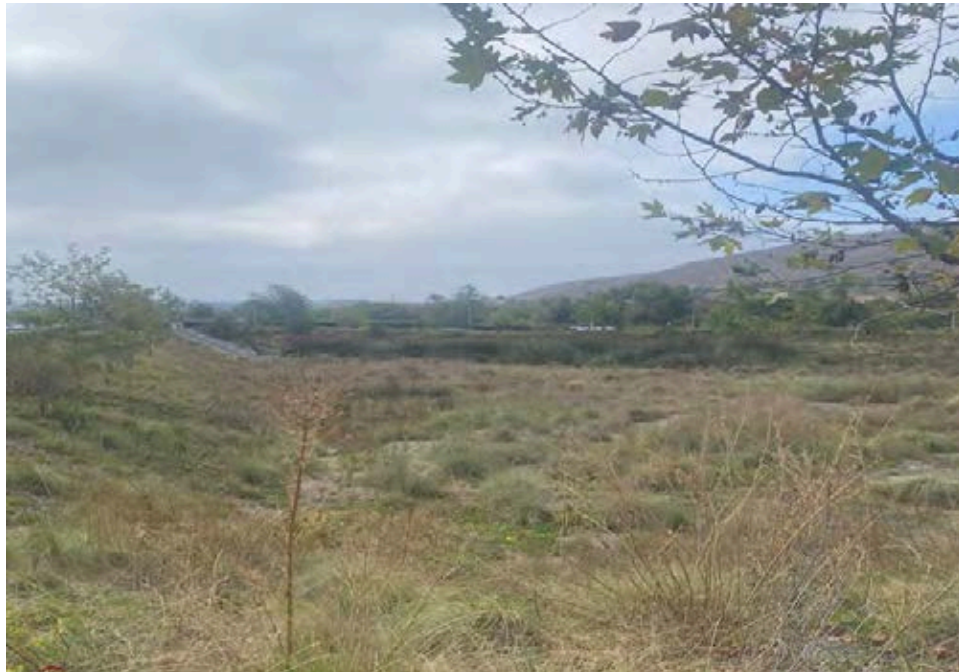
Los Olivos South is a 2.86-acre basin located east of SR-133 and adjacent to the Laguna Alta housing development. High flooding conditions and hard soil lead to notable expansion of creeping non-natives. Compounding this issue, natives of interest are syntopic and often grow intermixed. Notable natives include Saltgrass (*Distichlis spicata*) and California Dock (*Rumex californicus*). Otherwise, hand removal, digging, and hula hoeing were the primary methods to reduce non-native cover on site. The prevalent naturalized species included Bermuda grass, Spanish false fleabane, and creeping saltbush. Other non-natives advised for maintenance included the following: bristly oxtongue, burr clover, common sowthistle, curly dock, lesser swinecress, pampass grass, prickly sowthistle, seashore paspalum, St. Augustine grass, tamarisk, and yellow sweetclover. Manual solarization was proposed to treat a large patch of Bermuda grass in June and was successfully executed. Herbicide was prescribed for Spanish false fleabane and curly dock in February and Bermuda grass in May. However, no chemical pesticide applications were reported at this site between January and December 2024.

Figure 28. Overview of Los Olivos South as of November 2024.

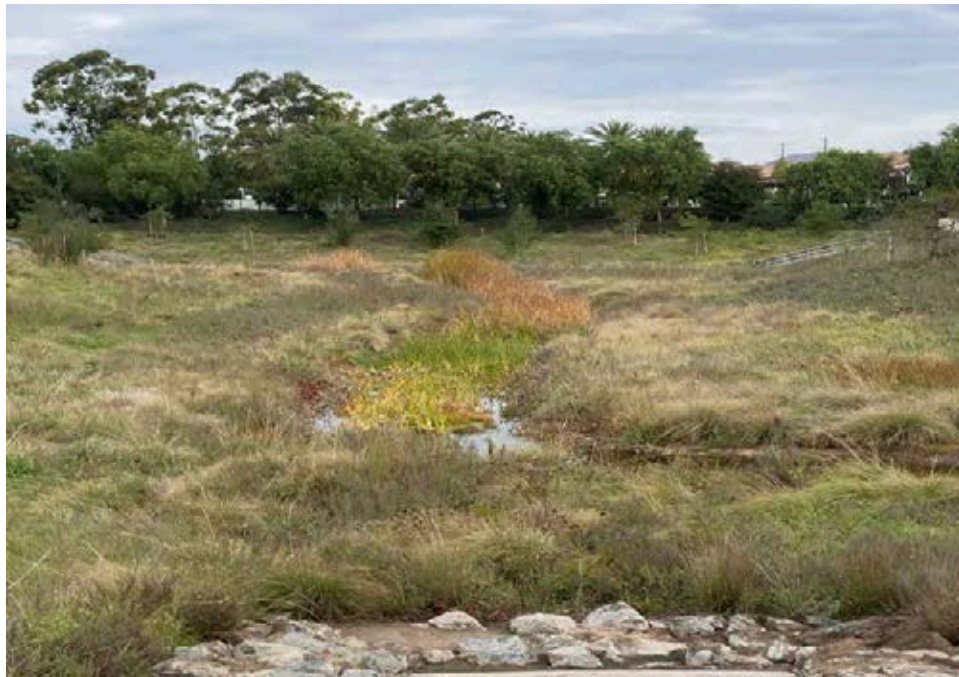
Marine Meadows is a 1.72-acre basin located west of the SR-133 and I-5 highways. The basin is adjacent to Great Park and a housing development. With the high bunchgrass cover on slopes and in the basin, non-native expansion and presence are almost non-existent. However, as a result, the site itself provides minimal habitat and utility as a wildlife resource. Here, plant diversity is incredibly low, with no more than 10 different native species in total. Hand removal and digging were the primary recommended treatments to reduce invasive plant species, with the prevalent species being common sowthistle, bristly oxtongue, and yellow sweetclover. Other non-natives observed included the following: black medic, burr clover, common soft brome, common sowthistle, hairawn muhly, Jersey cudweed, Spanish false fleabane, yellow sweetclover, and rescuegrass.

Figure 29. Overview of Marine Meadows as of November 2024.

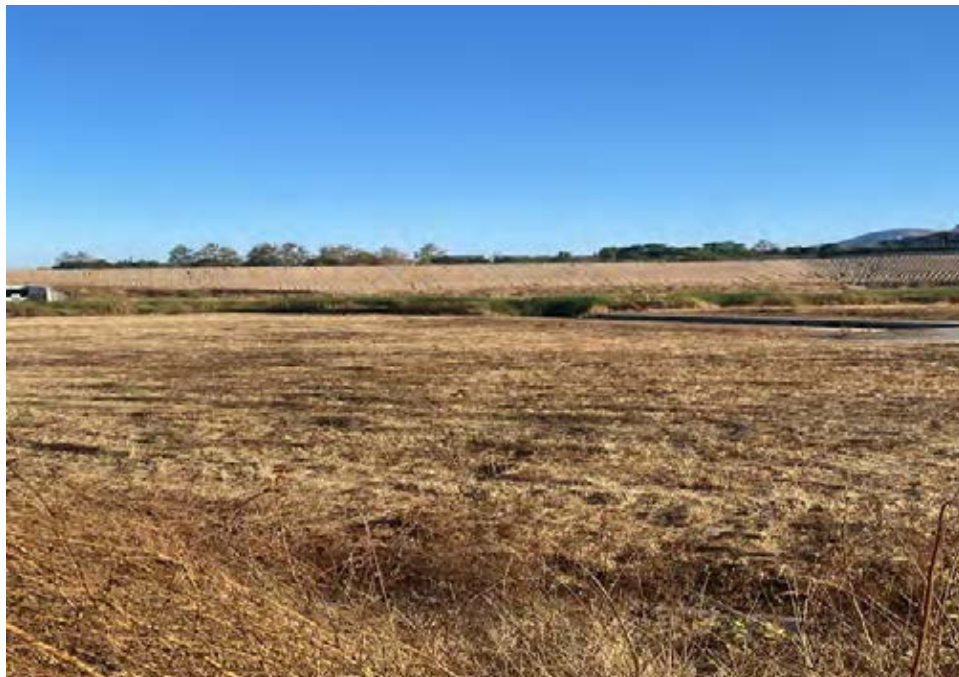
Marshburn is a 11.74-acre basin located at the intersection of Irvine Boulevard and Ridge Valley in Irvine. This basin also serves as a flood retention basin. Marshburn consists of two channels that flow into one large pond. Hand removal and digging were the primary methods advised to reduce invasive cover. The most prevalent species included curly dock and Spanish false fleabane. Other non-natives observed included the following: barnyard grass, bindii, blackwood acacia, carrotwood, castor bean, cheeseweed, Chinese flame tree, common sowthistle, everblooming acacia, flax-leaved horseweed, floating primrose-willow, Italian rye, Italian thistle, narrow-leaved goosefoot, red brome, slender wild oats, white sweetclover, and wild radish.

Figure 30. Overview of Marshburn in November, 2024.

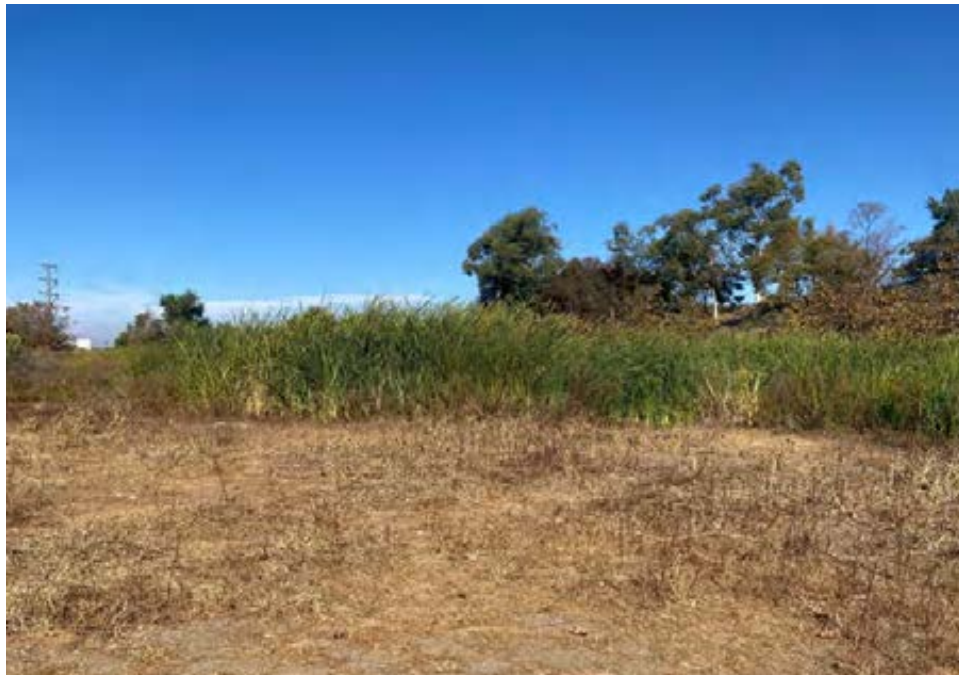
Figure 31. Overview of Old Laguna as of November, 2024.

Old Laguna is a 2.95-acre basin located west of Laguna Canyon Road and south of I-405. This basin consists of two small channels that flow into one large pond. The slopes and basin exhibited a relatively high diversity of non-native cover. Hand removal and hula hoeing were the primarily advised methods to reduce the total cover of non-native and invasive plants. Prevalent non-native species included, Spanish false fleabane, curly dock, and English plantain. Other non-native species advised for removal included the following: Bermuda grass, blue water speedwell, brass buttons, bristly oxtongue, burr clover, carrotwood, common sowthistle, common stork's bill, compact brome, floating primrose-willow, marsh parsley, Mexican fan palm musky storks bill, prickly lettuce, prickly sowthistle, rabbitsfoot grass, rat-tail fescue, shortpod mustard, watercress, and yellow sweetclover.

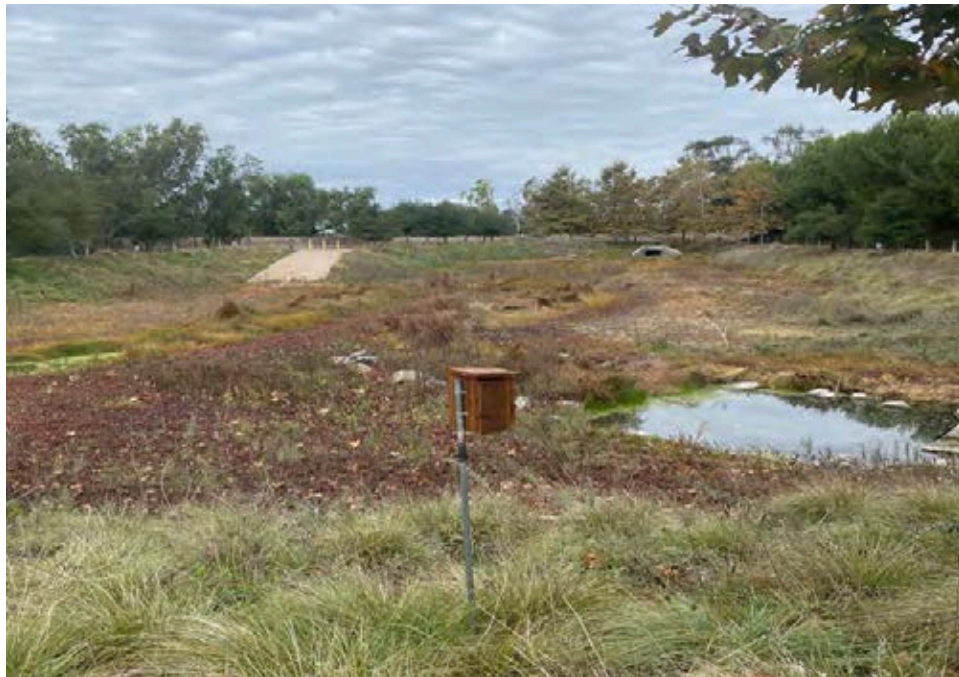
Portola Springs Meadow is a 1.01-acre basin located north of Irvine Boulevard and east of SR-133. This basin consists of two inlets. Throughout the year, the site had primarily native cover on slopes and relatively moderate non-native cover in the basin. Dense patches of naturalized plants are within the high moisture areas along the slope. Hand removal and hula hoeing were the primary methods advised to control non-native cover. Prevalent species included Mexican primrose, Spanish false fleabane, and common sowthistle. Other non-natives included the following: Bermuda grass, common purslane, common sowthistle, compact brome, creeping lantana, curly dock, flax-leaved horseweed, golden wattle, golden wreath wattle, great brome, musky stork's bill, panic veldtgrass, prickly sowthistle, rabbitsfoot grass, red brome, ripgut brome, shoestring acacia, soft chess, water beard grass, and yellow sweetclover.

Figure 32. Overview of Portola Springs as of November 2024.

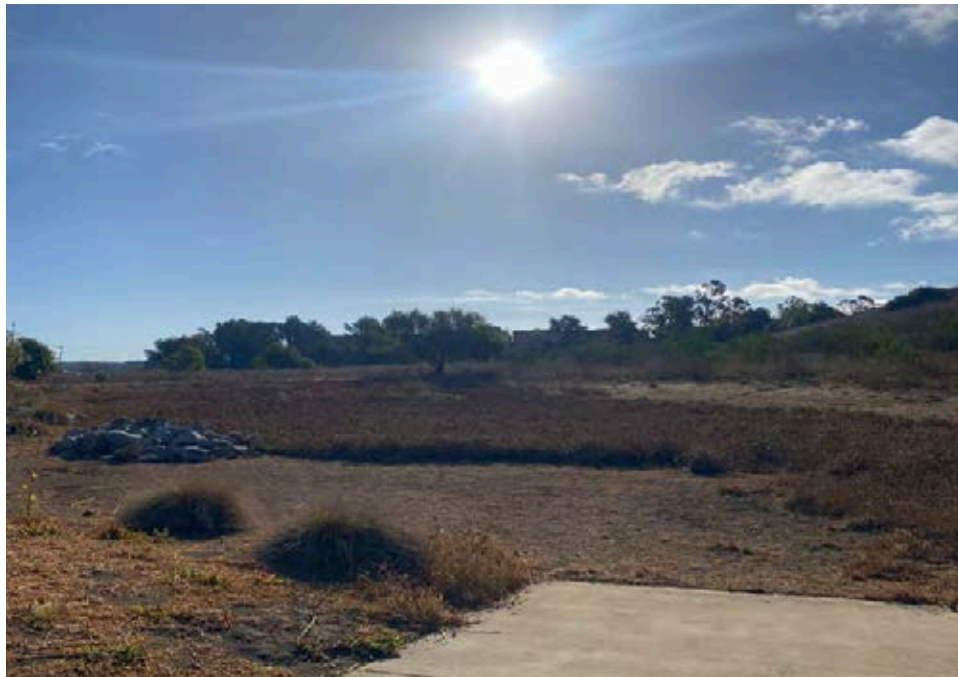
Figure 33. Overview of Quail Meadow as of November 2024.

Quail Meadow is a 1.19-acre basin north of Quail Hill Shopping Center in Irvine. This basin consists of a small sediment catchment pond at the inlet, after which water percolates into the ground. Overall, there was low non-native cover in the basin and along the slopes. Hand removal and hula hoeing were the primary methods to reduce the abundance of non-native cover. The most prevalent species were Spanish false fleabane, prickly lettuce, prickly sowthistle, and burr clover. Other non-native species advised for removal include the following: brass, buttons, bristly oxtongue, burr clover, cheeseweed, common sowthistle, common stork's bill, curly dock, English plantain, hooker's evening primrose, musky stork's bill, prickly lettuce, prickly sowthistle, rat-tail fescue, ripgut brome, slender wild oats, wall barley, wild barley, and yellow sweetclover.

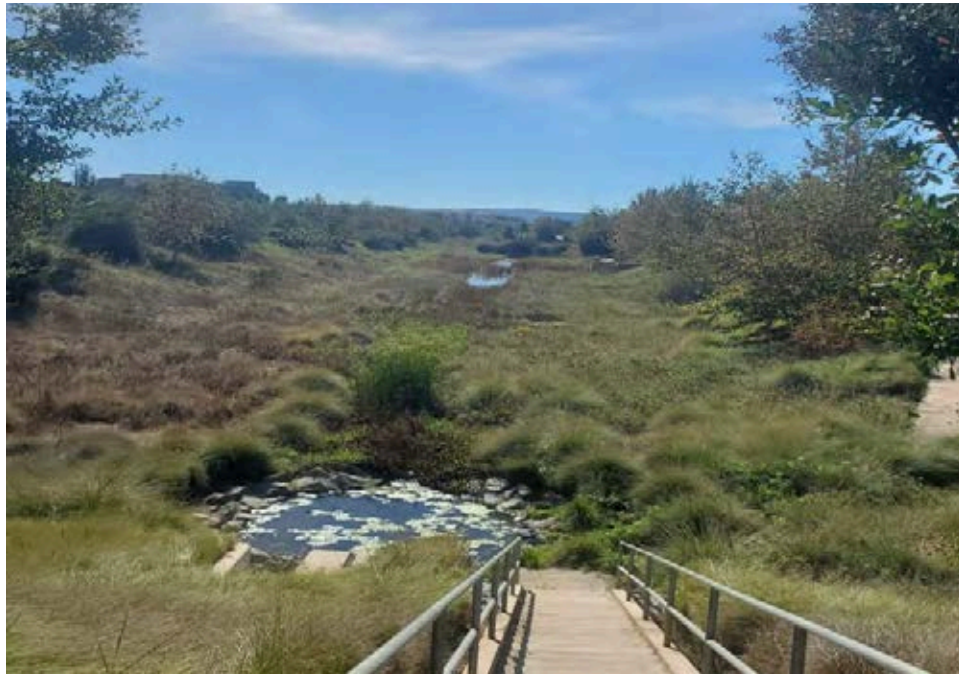
Ridge Valley A is a 6.9-acre basin located east of SR-133. It consists of two inlets that flow into one pond. High non-native cover persisted throughout the year, with fewer non-native species present during winter. Hand removal and hula hoeing were the primary advised methods to reduce non-native cover. Bristly oxtongue, curly dock, and rabbitsfoot grass were the most prevalent observed. Other non-native species advised for removal included the following: African sumac, Brazilian peppertree, bull thistle, burr clover, camphor tree, carrotwood, cheeseweed, Chinese elm, Chinese flame tree, Chinese privet, common lantana, common sowthistle, compact brome, field burrweed, flax-leaved horseweed, flaxleaf paperbark, floating primrose-willow, fountain grass, Japanese honeysuckle, jersey cudweed, Lindheimer's muhly, Mexican fan palm, Mexican primrose, moth vine, musky stork's bill, perennial pepperweed, prickly lettuce, prickly sowthistle, rescuegrass, riggut brome, shortpod mustard, Spanish false fleabane, stork's bill, tussock paspalum, water beard grass, and yellow sweetclover.

Figure 34. Overview of Ridge Valley A as of November, 2024.

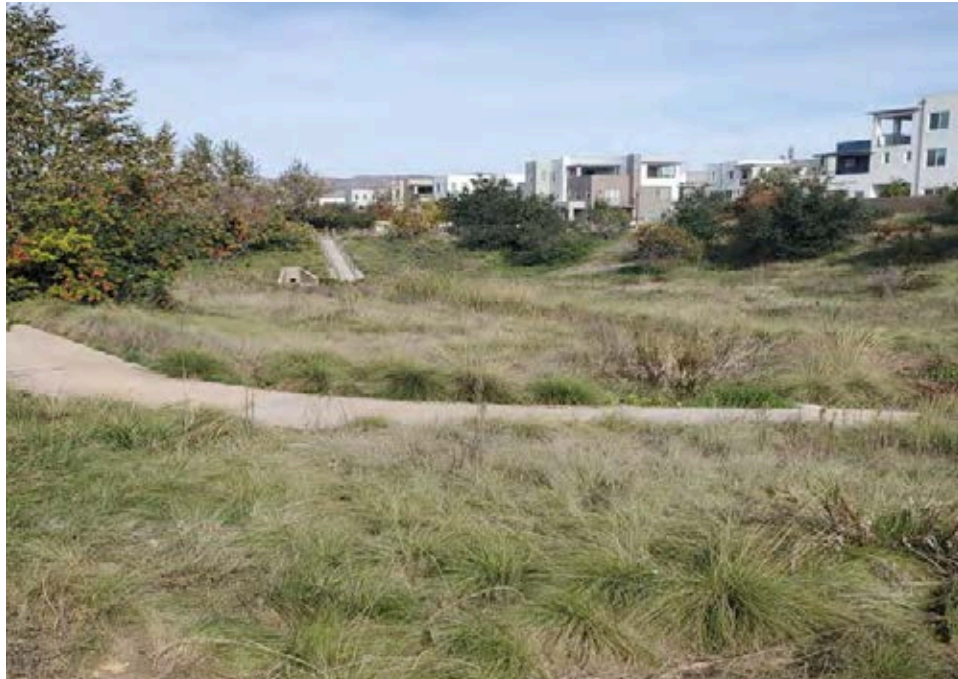
Ridge Valley B is a 1.78-acre basin located east of SR-133 and adjacent to Ridge Valley A NTS basin. Ridge Valley B consists of a channel that flows into Ridge Valley A. The northern half of the site exhibits moderate non-native cover, while the southern basin slopes and basin exhibit healthy native cover. Similar to Marine Meadows, Ridge Valley B provides poor wildlife habitat and plant diversity. Hand removal and hula hoeing were the primary removal methods advised to decrease non-native cover. Prevalent species were bristly oxtongue and Mexican primrose. Other non-natives observed included the following: bird of paradise, Brazilian peppertree, burr clover, common sowthistle, Jersey cudweed, Lindheimer's muhly, Mexican primrose, perennial pepperweed, prickly lettuce, prickly sowthistle, rabbitsfoot grass, rusty fig, scarlet pimpernel, Spanish false fleabane, tropical horseweed, tussock paspalum, watercress, and yellow sweetclover.

Figure 35. Overview of Ridge Valley B in November, 2024.

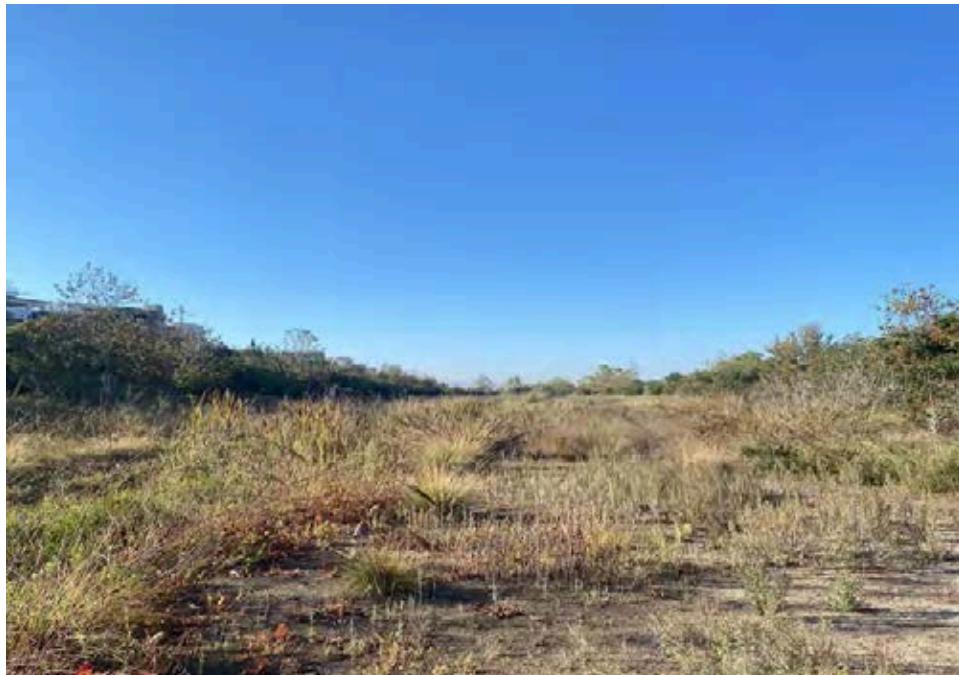
Ridge Valley C is a 4.90-acre basin located east of SR-133 and adjacent to Ridge Valley B. The basin consists of one long channel with a pond in the center. Throughout the year, most non-native coverage was along the eastern & northern aspects of the basin. Hand removal, hula hoeing, and digging were the primary removal methods advised to decrease non-native cover. Prevalent species were Spanish false fleabane, common sowthistle, and curly dock. Other non-natives observed included the following: African sumac, Brazilian peppertree, bristly oxtongue, bull thistle, burr clover, Canary Island date palm, cheeseweed, common lantana, compact brome, fountain grass, jersey cudweed, Lindheimer's muhly, Mexican primrose, pampas grass, perennial pepperweed, prickly lettuce, prickly sowthistle, shortpod mustard, snow-in-summer, water beard grass, yellow sweetclover.

Figure 36. Overview of Ridge Valley C in November, 2024.

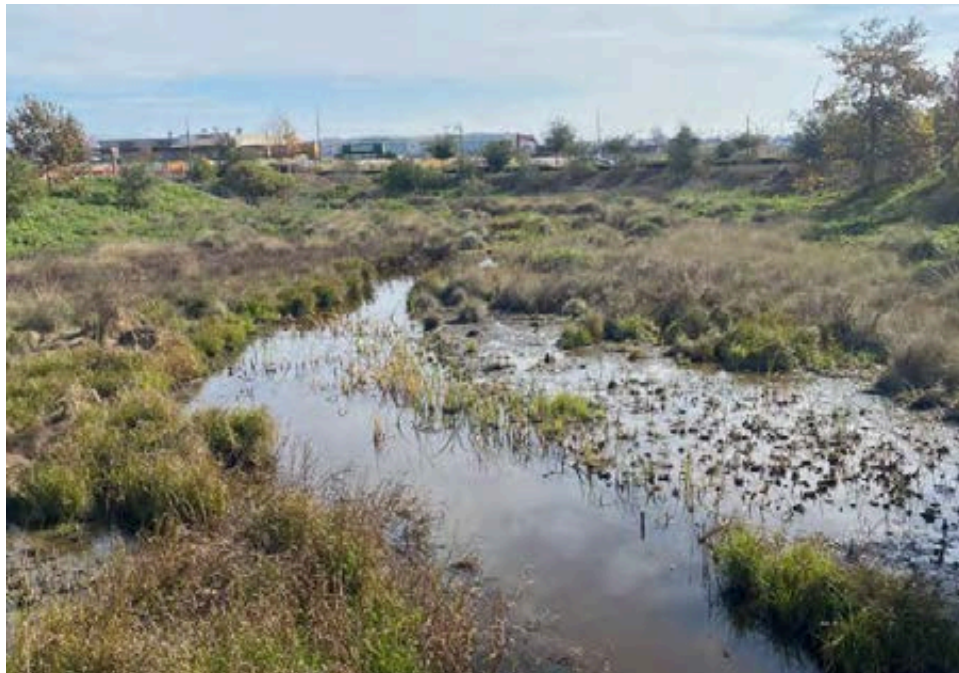
Figure 38. Overview of Sports Park as of December 2024.

Sports Park is a 2.20-acre basin located north of the I-5 freeways at the corner of Marine Way and Skyhawk. The site exhibited relatively high annual non-native cover, especially in the spring and summer. Hand removal and digging were the primary methods advised to reduce non-native cover. Prevalent species were curly dock, Spanish false fleabane, bull thistle, and Italian thistle. Other non-native species included the following: black mustard, Brazilian peppertree, bristly oxtongue, carrotwood, castor bean, Chinese elm, Chinese flame tree, common cattail, common fig, common lantana, common sowthistle, fountain grass, hairawn muhly, Maltese star thistle, Mexican fan palm, Mexican primrose, prickly lettuce, prickly sowthistle, scarlet pimpernel, shortpod mustard, tree tobacco, vanilla scented wattle, yellow sweetclover.

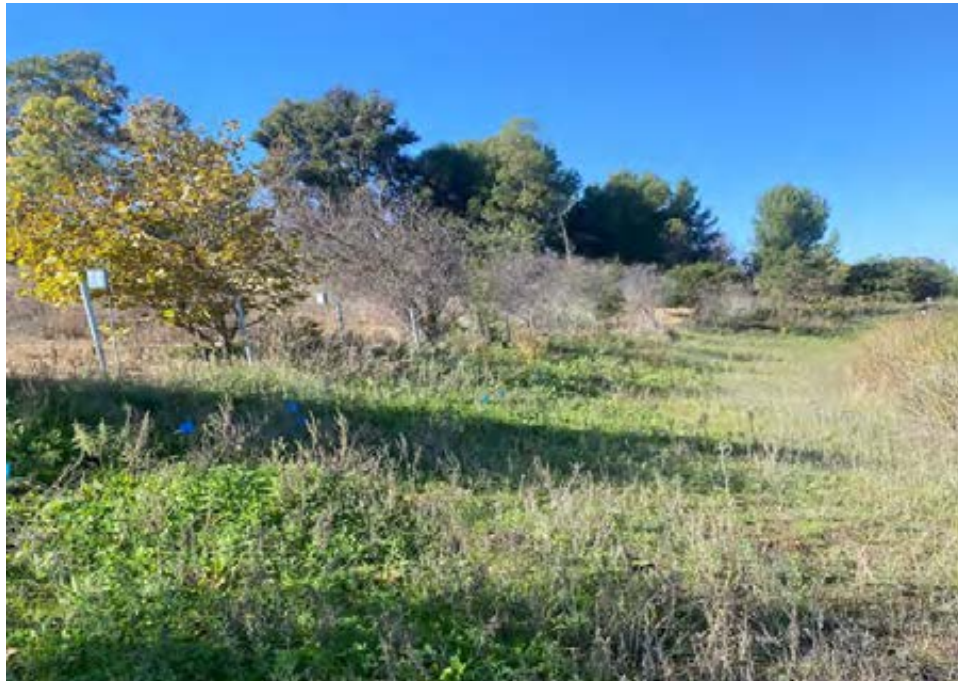
Turtle Ridge is a 1.82-acre basin located south of Shady Canyon Drive. It is adjacent to an open field and residential housing and consists of a pond surrounded by vegetated slopes. Its proximity to weedy slopes has led to significant degradation. In its current state, Turtle Ridge suffers from high competition between native and naturalized annuals, leading to difficulty addressing interspersed non-natives without risking trampling and extirpating the few remaining natives. The lack of native perennials relative to other sites has exacerbated this issue. Hand removal and tilling were the primary methods advised to reduce non-native cover. Prevalent species were prickly sowthistle, bristly oxtongue, and compact brome. Other non-natives advised for maintenance included the following: African asparagus, blue water speedwell, Brazilian peppertree, bulrush, burr clover, common soft brome, common sowthistle, Italian rye, Mexican primrose, Peruvian peppertree, prickly lettuce, rabbitsfoot grass, rat-tail fescue, red brome, ripgut brome, scarlet pimpernel, slender wild oats, Spanish false fleabane, watercress, yellow sweetclover

Figure 39. Overview of Turtle Ridge in November, 2024.

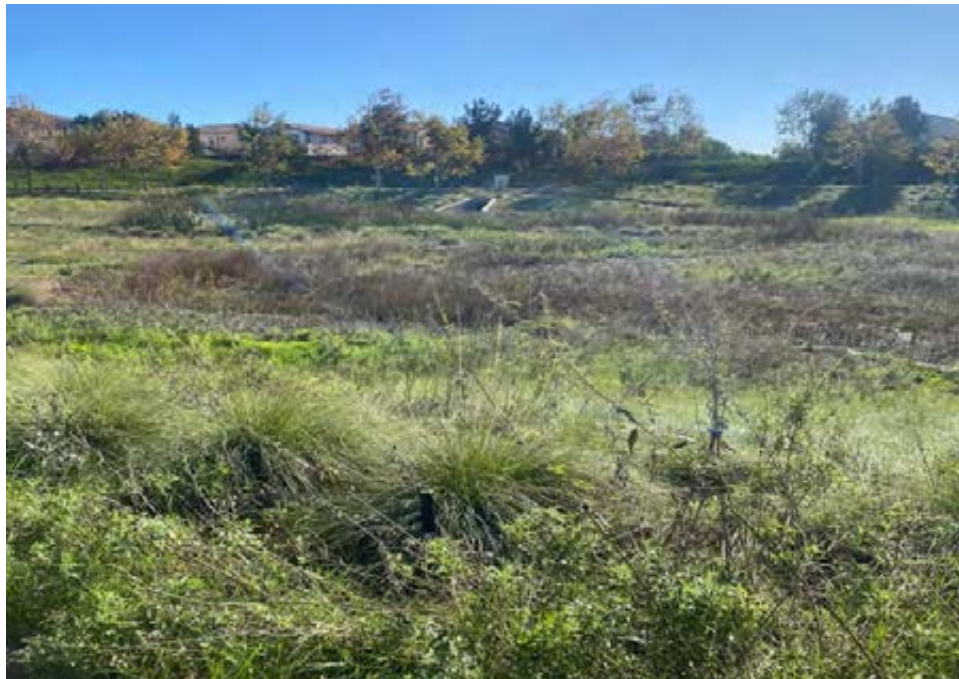
Eastwood Meadow is a 1.87-acre basin located east of Ridgeline Drive. The site exhibited high non-native cover in open patches of the basin. Hand removal, digging, and hula hoeing were the primary methods advised to reduce non-native cover. Prevalent species include Spanish false fleabane, English plantain, and Mexican primrose. Other non-natives observed were as follows: Bermuda grass, black medic, Brazilian peppertree, bristly oxtongue, broadleaf plantain, burr clover, cheeseweed, Chinese elm, clustered dock, common cattail, common celery, common purslane, common stork's bill, curly dock, flax-leaved horseweed, goose grass, Jersey cudweed, Lindheimer's muhly, Mediterranean love grass, Mexican fan palm, mexican primrose, prickly lettuce, prostrate pigweed, rabbitsfoot grass, Shepherd's purse, smilo grass, thorny olive, tussock paspalum, white stem filaree, white sweetclover, yellow sweetclover.

Figure 40. Overview of Eastwood as of November 2024.

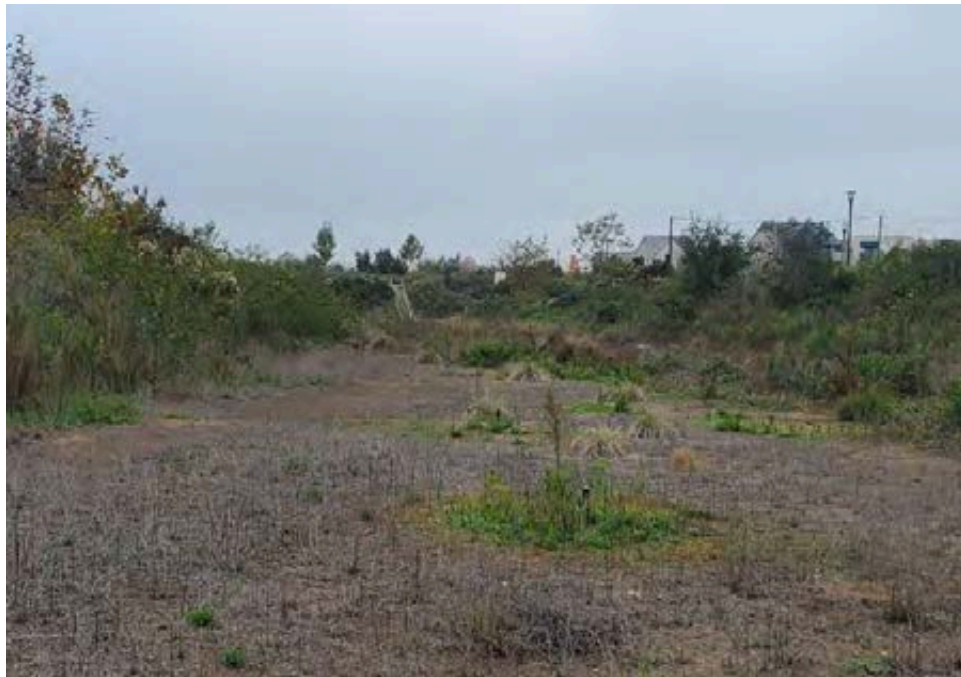
Lower Agua Chinon A is a 3.48-acre site located southeast of the Great Park Sports Complex and northeast of the I-5 freeway. During the wet months, high non-native cover persists. Once the warm months approach, the annual cover senesces and leaves large patches of bareground. Hand removal, hula hoeing, and digging were the primary methods advised to reduce non-native cover. Curly dock, umbrella sedge, and Spanish false fleabane were the most prevalent and problematic species observed. Other non-natives advised for removal included the following: annual wall-rocket, bristly oxtongue, flax-leaved horseweed, hairawn muhly, palo verde, prickly sowthistle, rabbitsfoot grass, seashore paspalum, shortpod mustard, St. Augustine grass, wild radish, yellow sweetclover.

Figure 41. Overview of Lower Agua Chinon A as of December 2024.

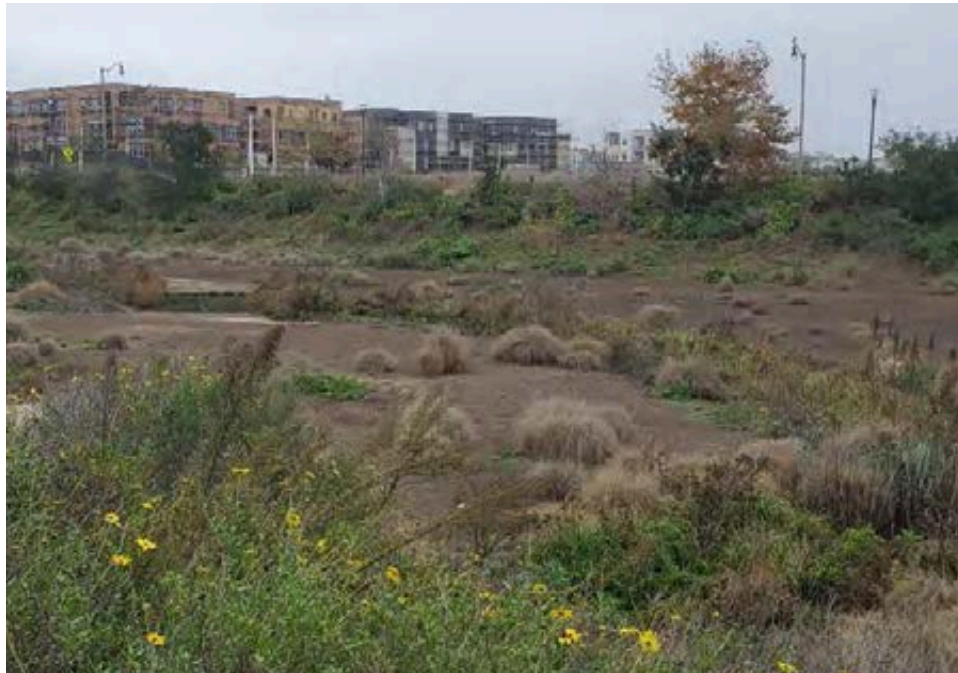
Lower Agua Chinon B is a 2.44-acre site located southeast of the Great Park Sports Complex and is adjacent to District 5A/Lower Agua Chinon A. Non-native cover and persistence more or less resembles Lower Agua Chinon A. Notably, basin slopes seem to have a higher comparative rate of native recruitment and survival. Overall, hand removal and hula hoeing were the primary methods advised to reduce non-native cover. Yellow sweetclover and Spanish false fleabane were the most prevalent non-native species observed. Within the waterways, a new detection has elicited particular concern. Seashore paspalum (*Paspalum vaginatum*), rated by the Orange County CNPS as a high risk of invasiveness, is a relatively new weed in Orange County. This detection is concerning, as it is the farthest north documented instance in the county. The species has formed deep carpets, choking out almost all native growth in the waterways. Herbicide was advised as an early eradication measure to mitigate further range expansion. Other non-natives advised for removal included the following: black mustard, bristly oxtongue, bull thistle, common sowthistle, common stork's bill, curly dock, flax-leaved horseweed, fountain grass, hairawn muhly, Italian thistle, jersey cudweed, lesser swinecress, palo verde, prickly sowthistle, scarlet pimpernel, shortpod mustard, tree tobacco, and white sweetclover.

Figure 42. Overview of Lower Agua Chinon B as of December 2024.

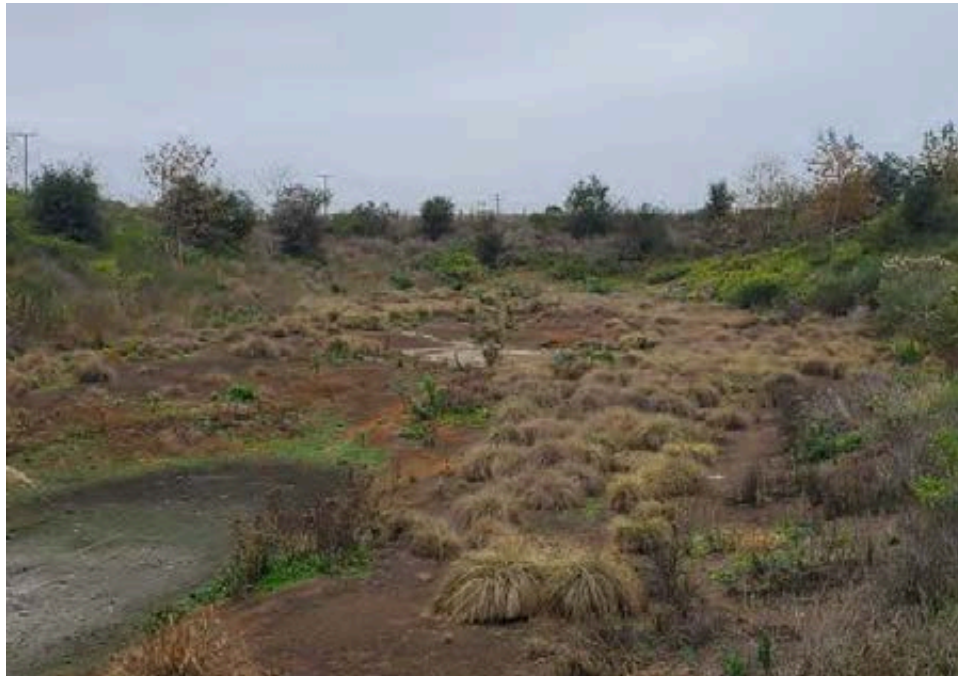
Lower Agua Chinon C is a 3.21-acre site located southeast of the Great Park Sports Complex and adjacent to District 5B. Throughout the year, slopes had high native cover, and the basin bottom had large bare patches. Significant naturalized plant growth only occurred along the margins where water from the irrigation was available. Hand removal was the primary method advised to reduce non-native cover. Shortpod mustard, Spanish false fleabane, and prickly sowthistle were the most prevalent non-native species observed. Other non-natives advised for removal included the following: black mustard, bull thistle, common fig, curly dock, hairy bittercress, Jersey cudweed, lesser swinecress, prostrate pigweed, tamarisk, tomato plant, tree tobacco, tropical horseweed, yellow sweetclover.

Figure 43. Overview of Lower Agua Chinon C/District 5C as of December 2024.

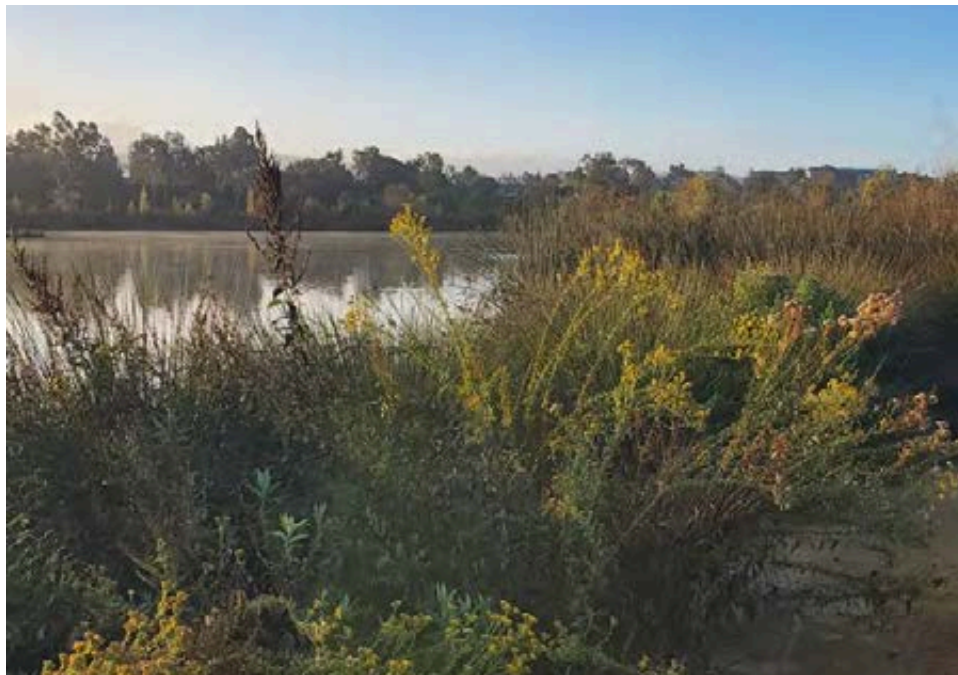
Figure 44. Overview of San Joaquin Marsh Zone 1 as of November 2024.

San Joaquin Marsh Landing Zone 1 is a 94.61-acre portion of the San Joaquin Marsh and Wildlife Sanctuary. It serves as a restoration area and natural treatment system for water from San Diego Creek. Hand removal and hula hoeing were the primary methods advised to reduce non-native cover. Spanish false fleabane and perennial pepperweed were the most prevalent non-native species. Other non-natives advised for removal were as follows: African sumac, Bermuda grass, black mustard, Brazilian peppertree, carrotwood, castor bean, common stork's bill, curly dock, dwarf nettle, fern pine, Jersey cudweed, lesser swinecress, Maltese star thistle, Mexican fan palm, poison hemlock, prickly sowthistle, rabbitsfoot grass, shortpod mustard, tomato plant.

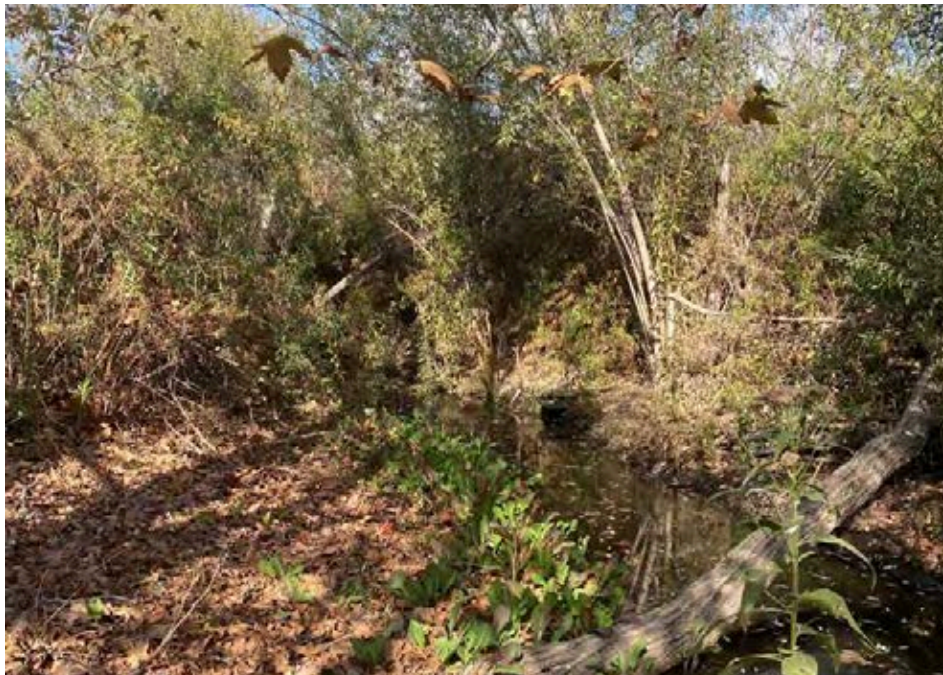
Figure 47. Overview of San Joaquin Marsh Zone 4 as of November 2024.

San Joaquin Marsh Landing Zone 4 is a 67.49-acre section of the San Joaquin Marsh and Wildlife Sanctuary. It serves as a restoration area and natural treatment system for the water from the San Diego Creek. Obscure trails and reduced human traffic have aided with the prevention of trail-based invasion. Otherwise, tree canopies harbored large amounts of non-native saplings. Hand removal and hula hoeing were the primary advised methods to control non-native species. Spanish false fleabane, curly dock, and common fig were the most prevalent invasive species. Other non-native species advised for removal included the following: bull thistle, Callery pear, camphor tree, carrotwood, cheesewood, common fig, common sowthistle, common stork's bill, curly dock, dwarf nettle, lesser swinecress, London rocket, Mexican fan palm, petty spurge, poison hemlock, prickly sowthistle, Shamel ash, stork's bill sp., Virginia creeper. The herbicide usage reported indicates a chemical treatment application in April.

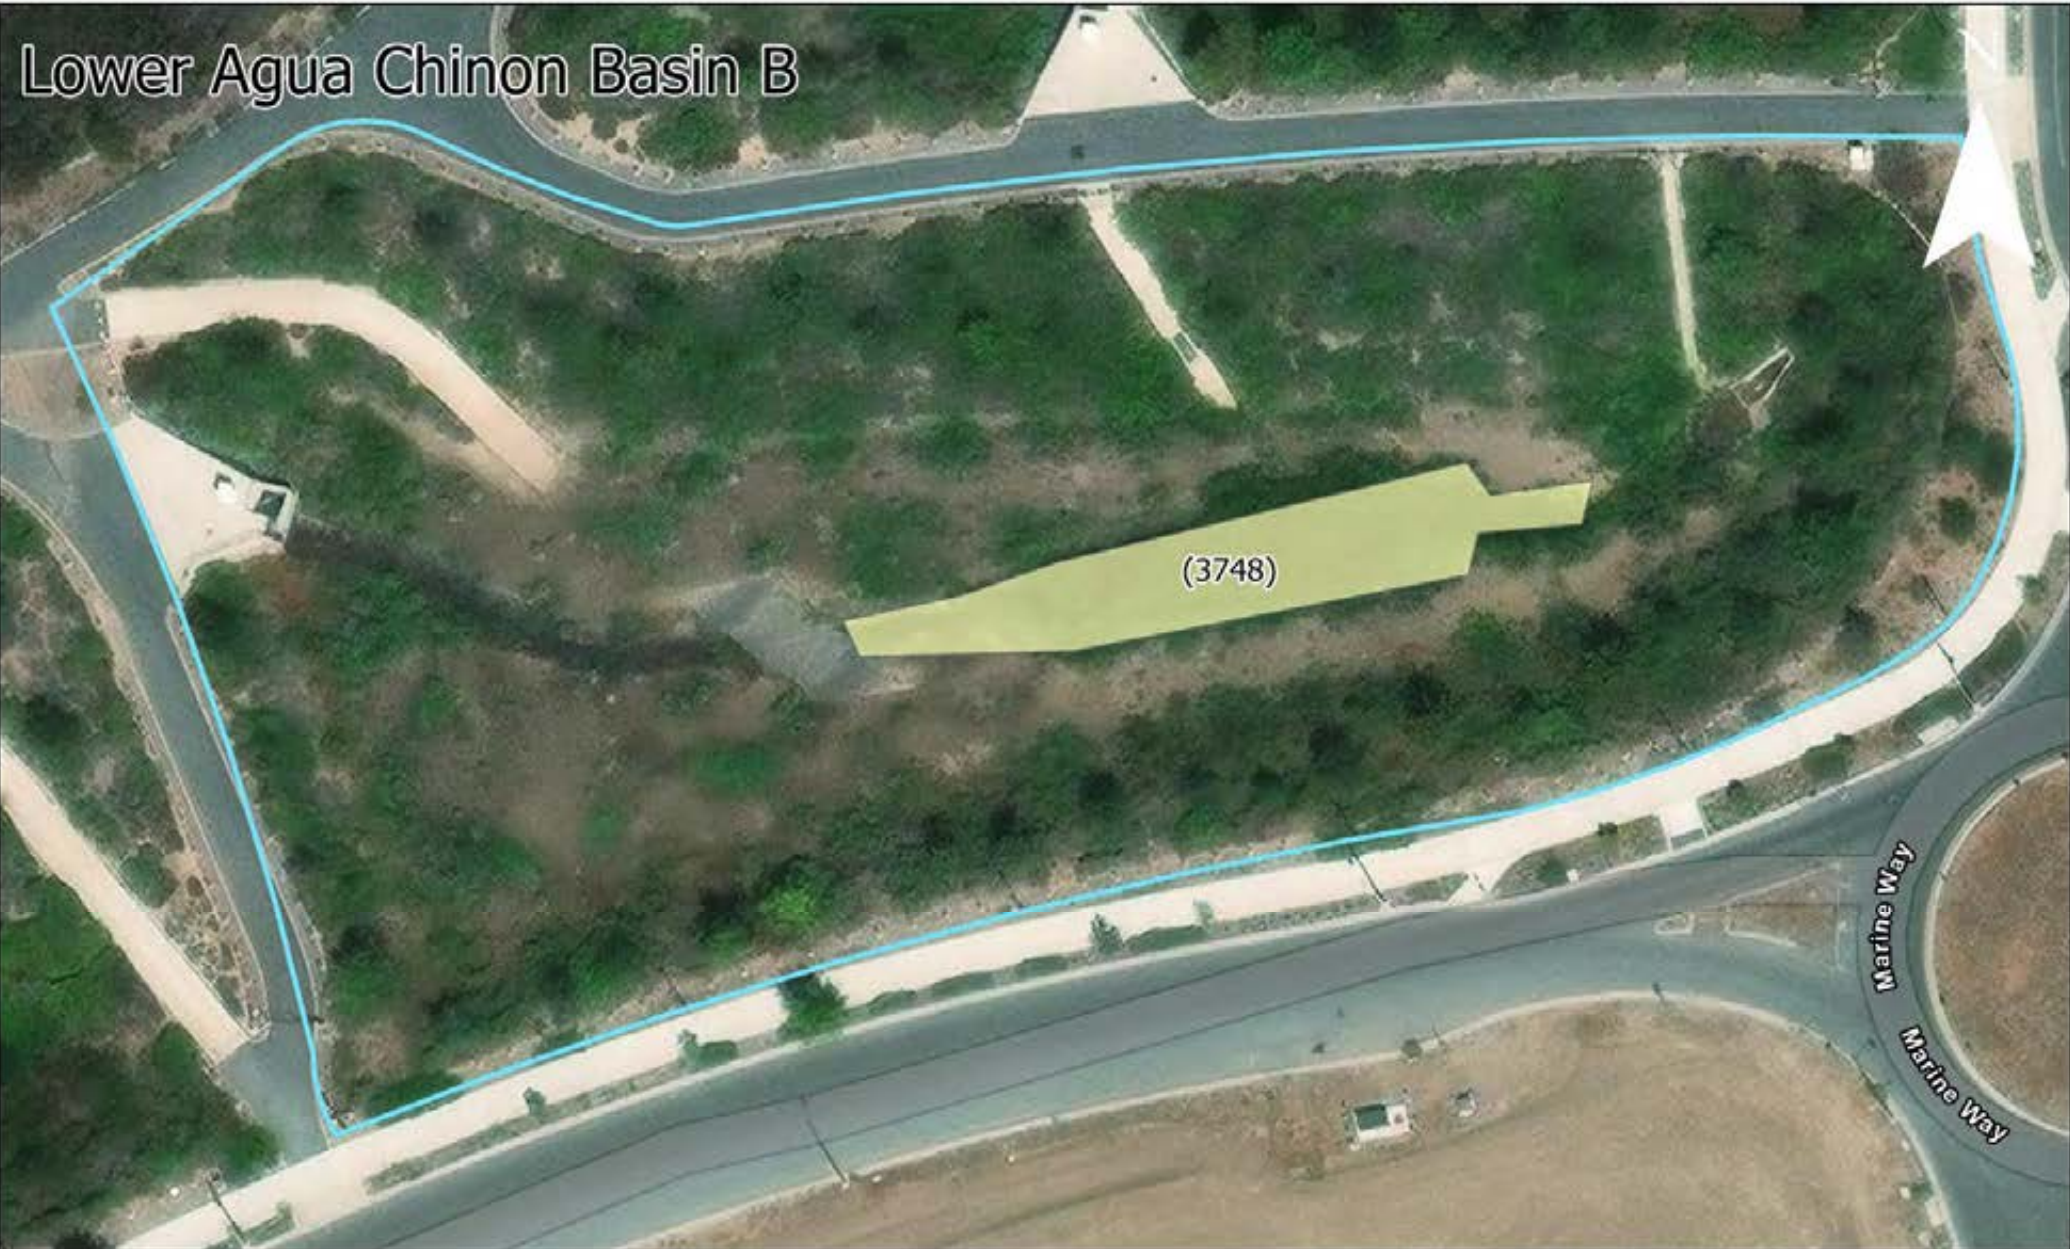
Lower Agua Chinon Basin B

(3748) [Herbicide] Seashore Paspalum
