Integrated Pest Management Plan for the Irvine Ranch Water District

2024 Annual Report

Provided By:
Endemic Environmental Services Inc.

Prepared For:
Irvine Ranch Water District

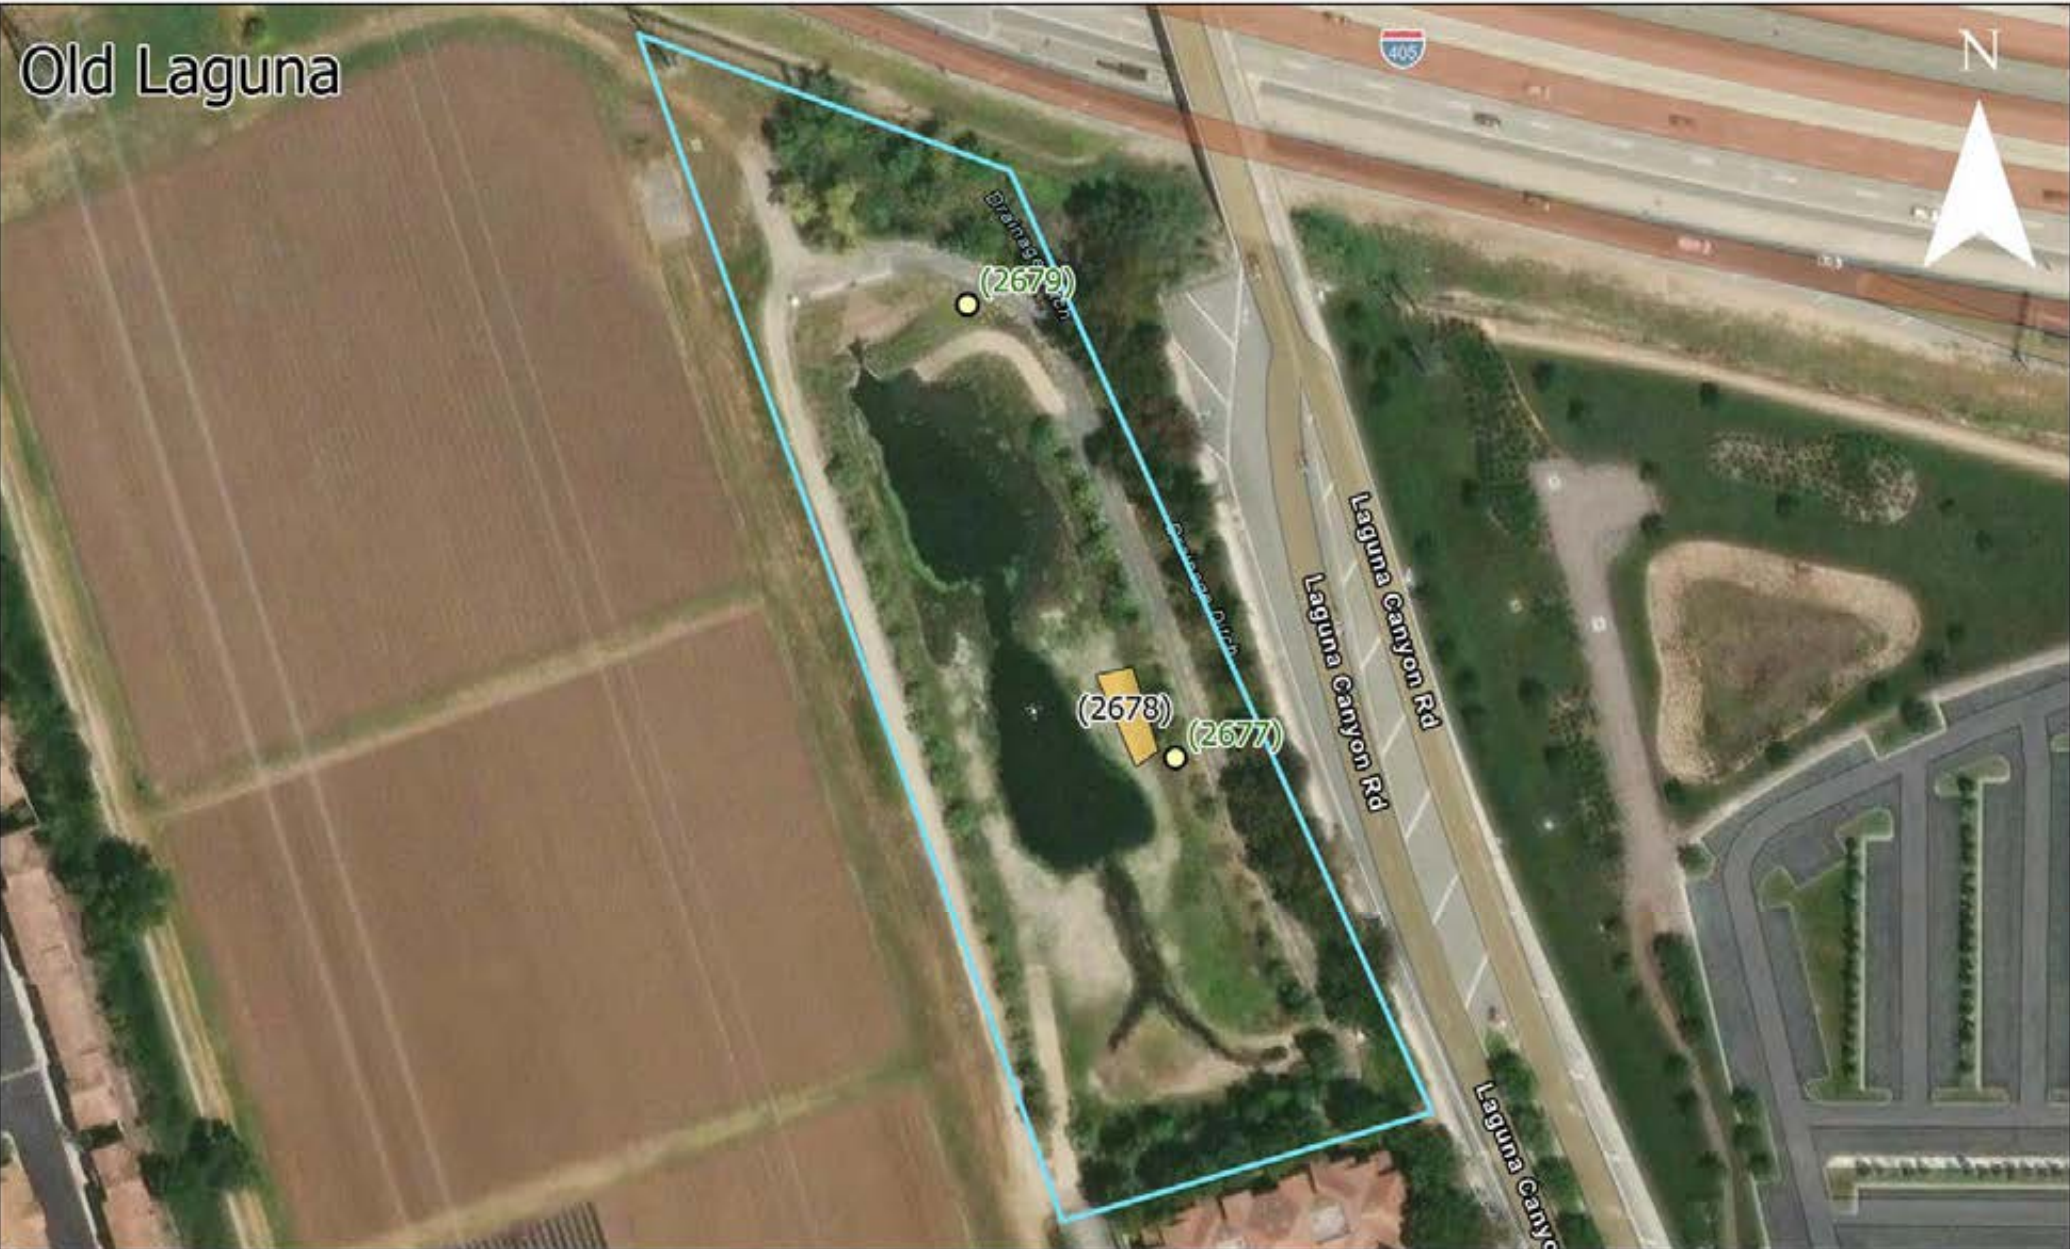
Old Laguna

- (2677) [Herbicide] Spanish False Fleabane, Curly Dock
- (2679) [Herbicide] Curly Dock

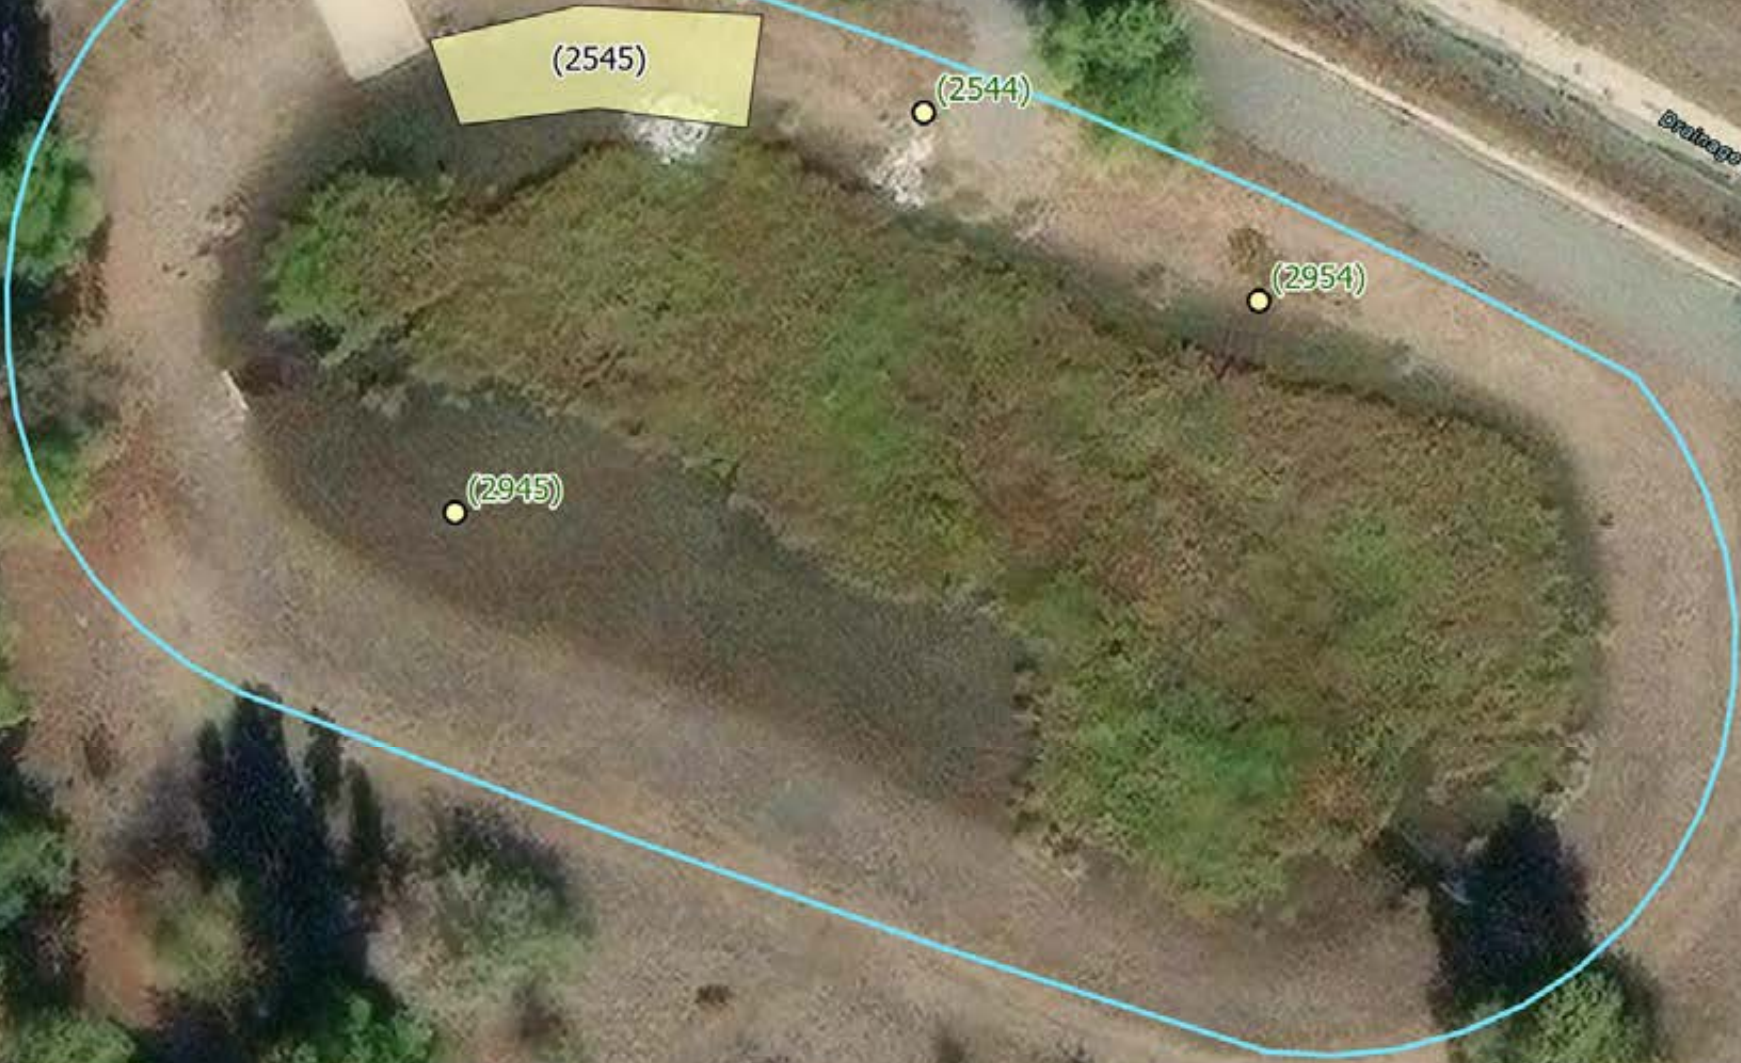
Drainage Ditch

- (2544) [Herbicide] Curly Dock
- (2945) [Herbicide] Curly Dock
- (2954) [Herbicide] Spanish False Fleabane

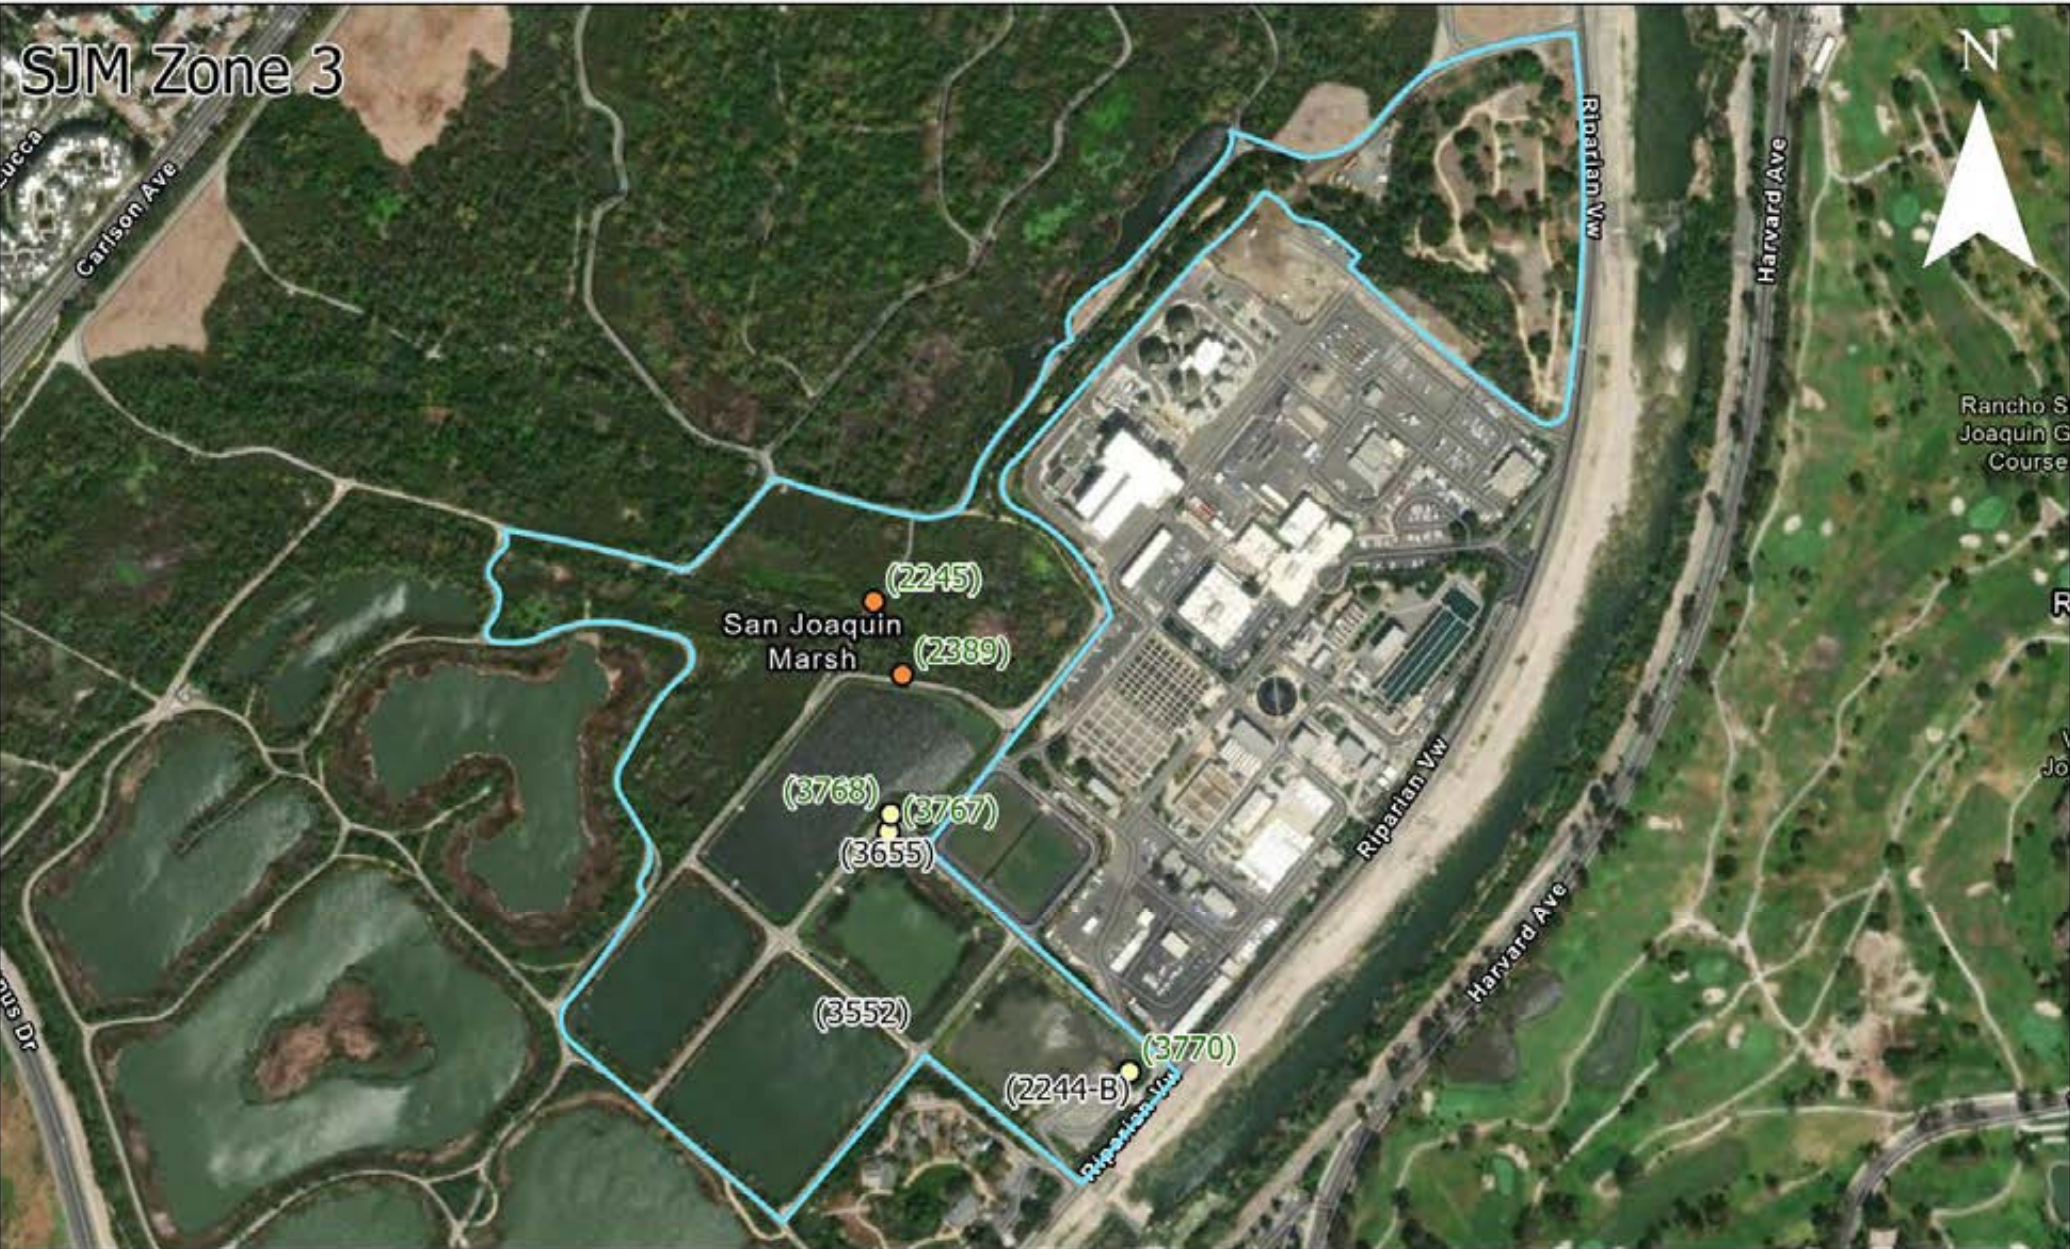
SJM Zone 3

- (2245) [Herbicide] Spanish False Fleabane
- (2389) [Herbicide] Spanish False Fleabane
- (3767) [Herbicide] Spanish False Fleabane
- (3768) [Herbicide] Spanish False Fleabane
- (3770) [Herbicide] Curly Dock

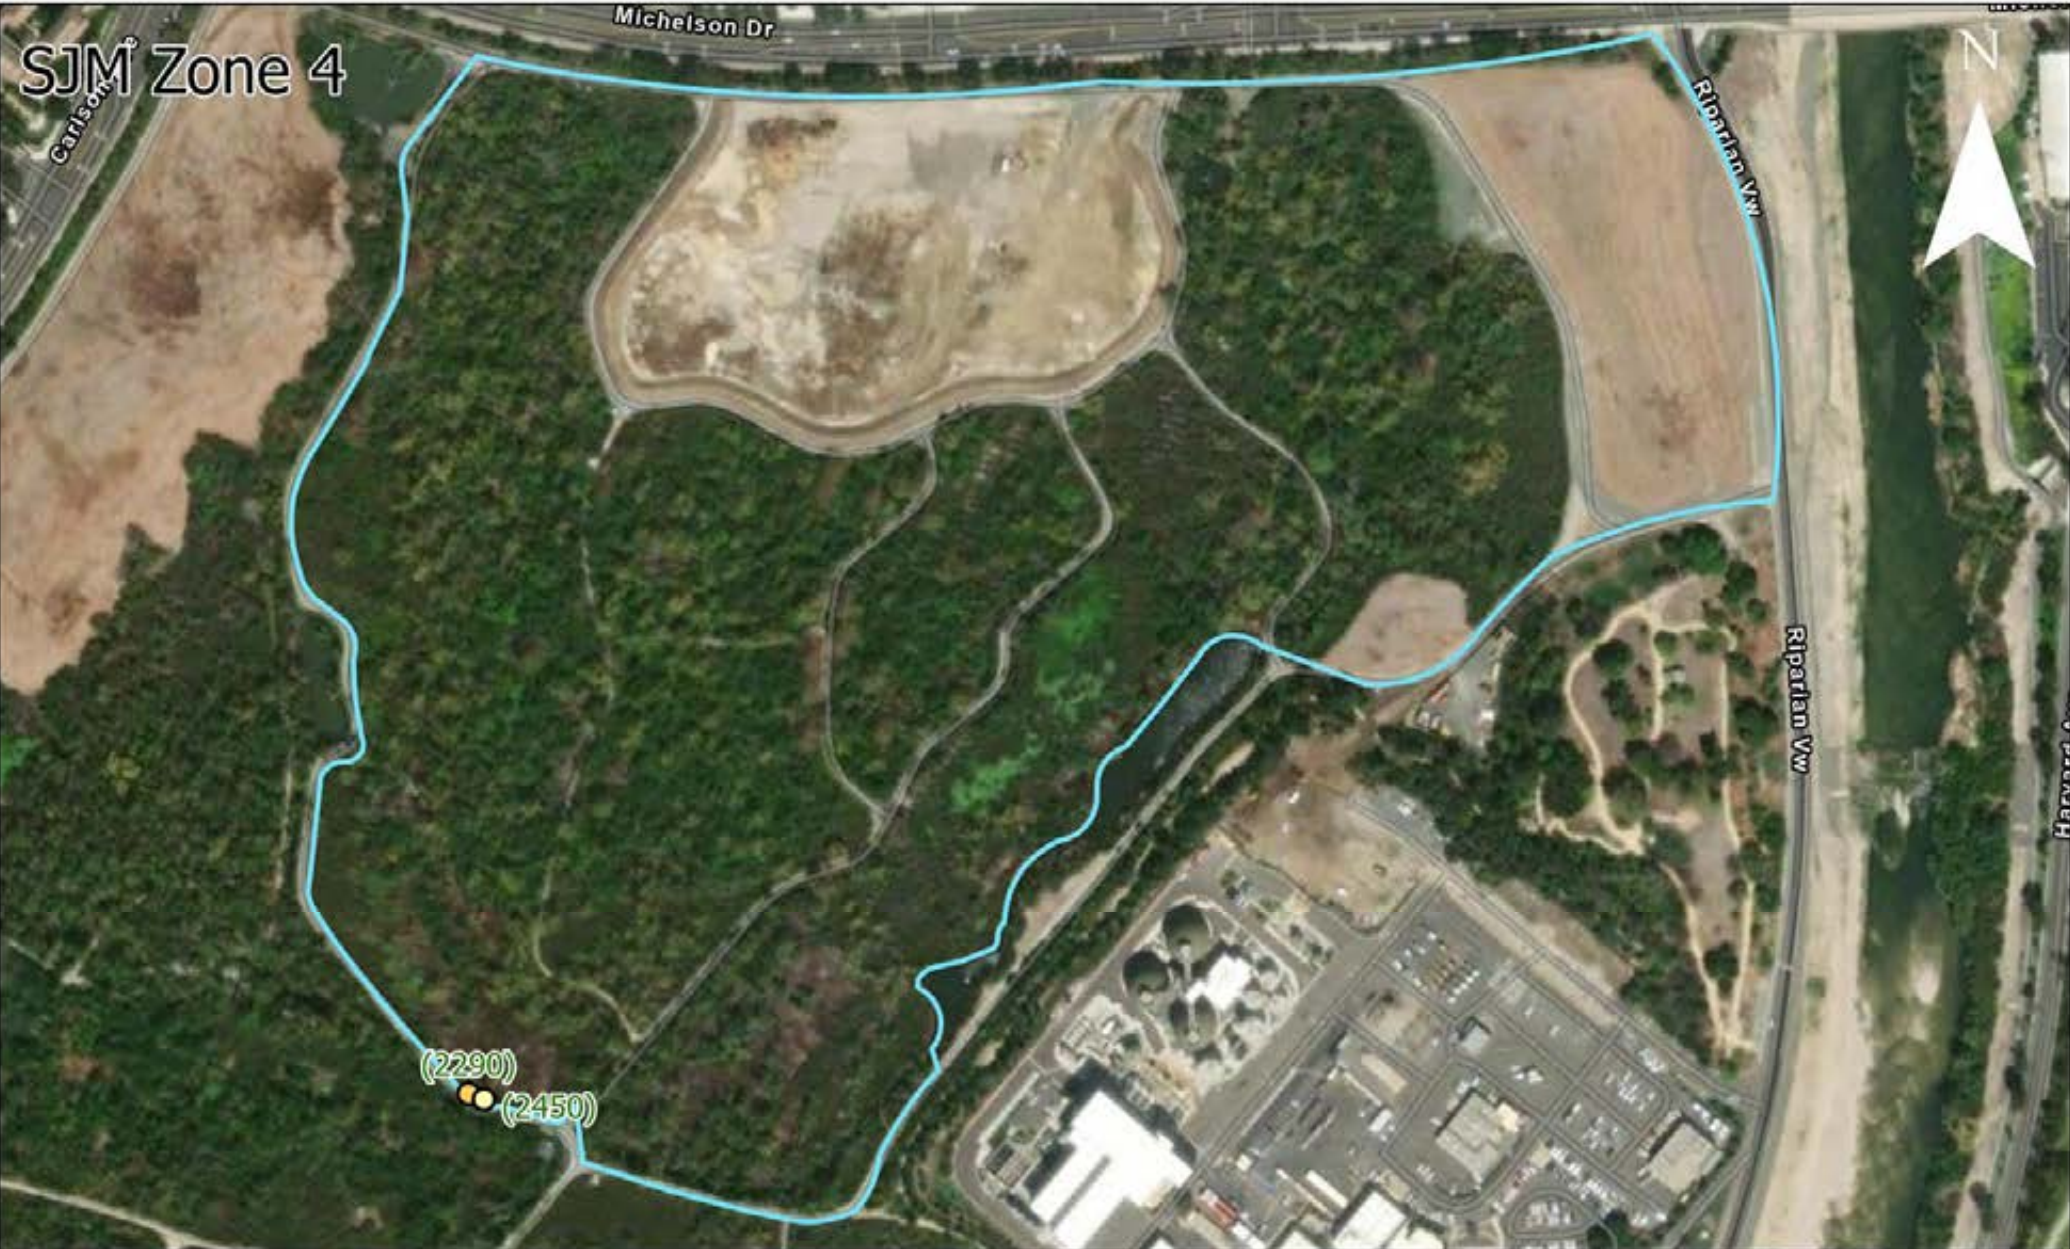
SJM Zone 4

- (2290) [Herbicide] Curly Dock
- (2450) [Herbicide] Curly Dock

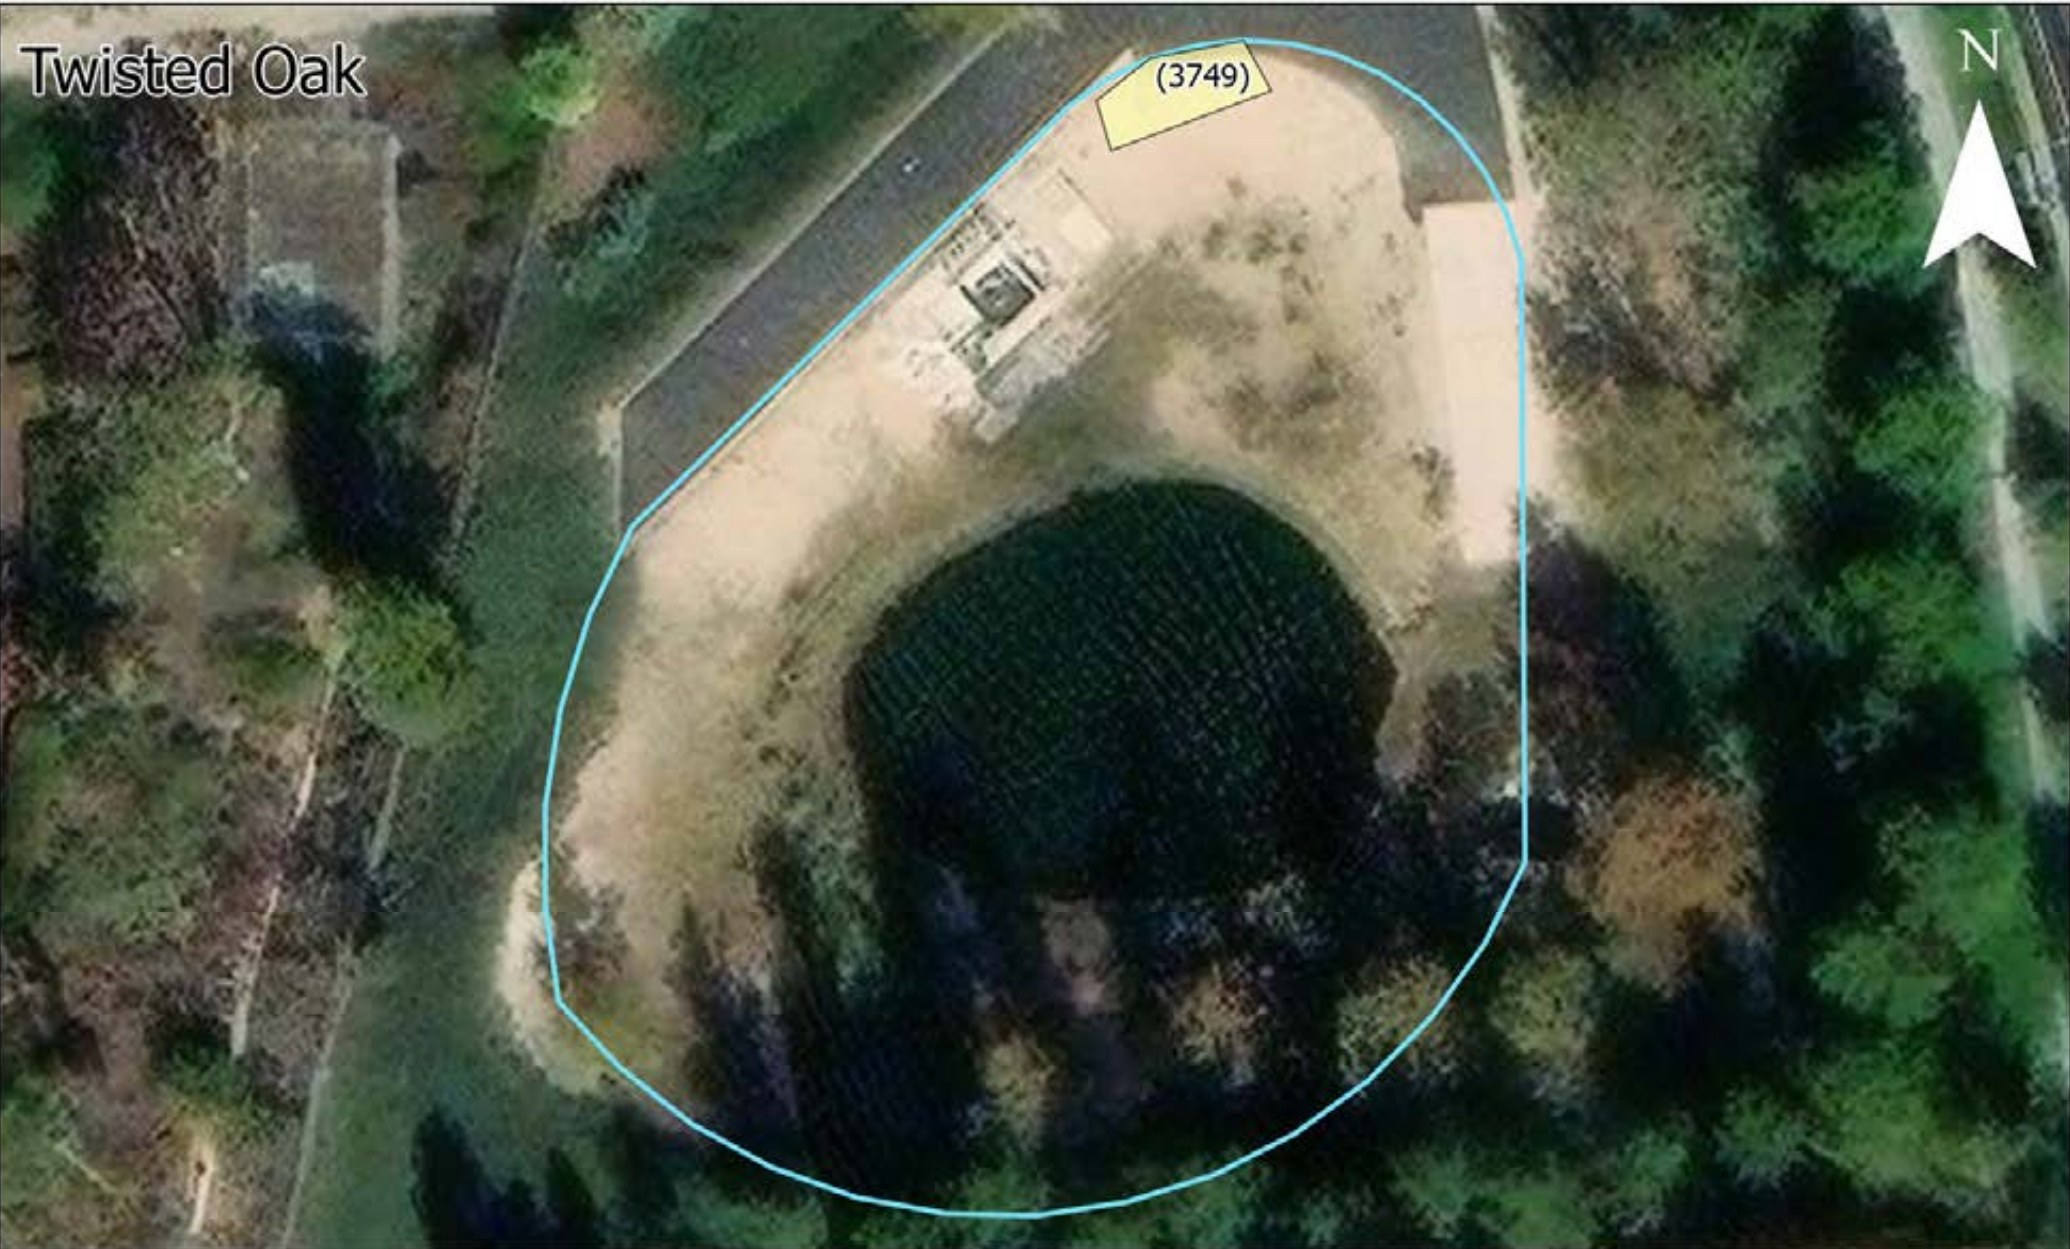
(3749) [Herbicide] Bermuda Grass

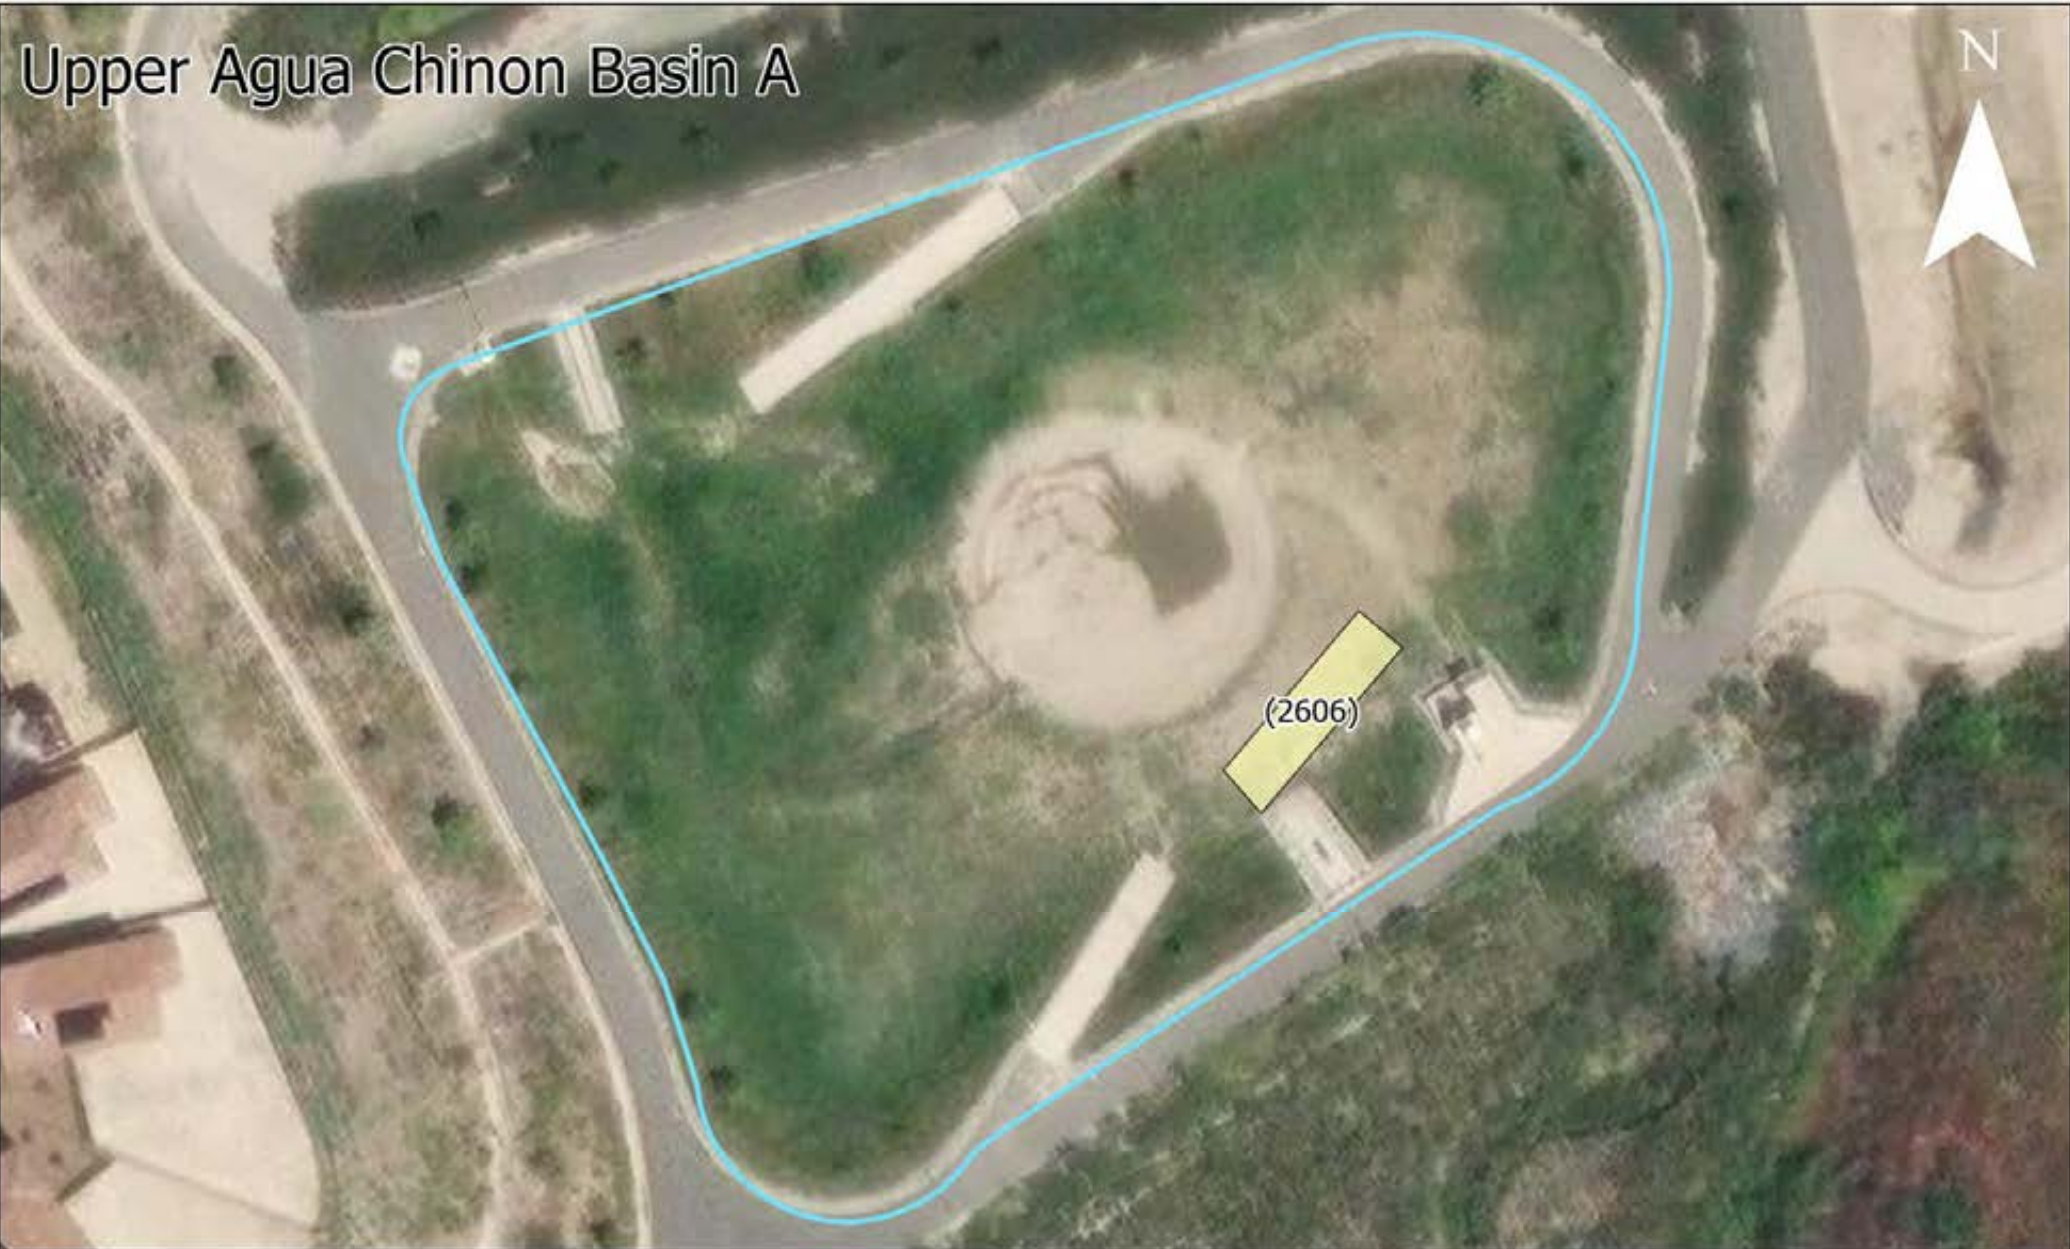
Upper Agua Chinon Basin A

(2606) [Herbicide] Spanish False Fleabane

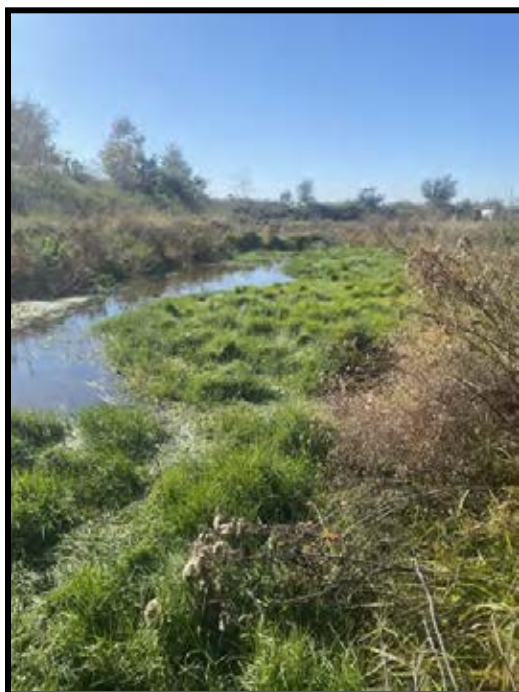
Figure 1: *Paspalum vaginatum* covering waterway at Lower Agua Chinon Basin B (LACB B)

With the growth habit of Seashore Paspalum being conducive to rapid expansion, recruitment of native riparian and saltmarsh species is extremely common, leading to extensive failures of restoration projects and degradation of established projects (UC-IPM, 2016). Lastly, turf-forming adaptations pose a heavy risk for reduced water flow and channel habitat in NTS basins. Manual removal of pre-existing colonies likely exacerbated the propagation and spread of young PAVA stands in IRWD sites.

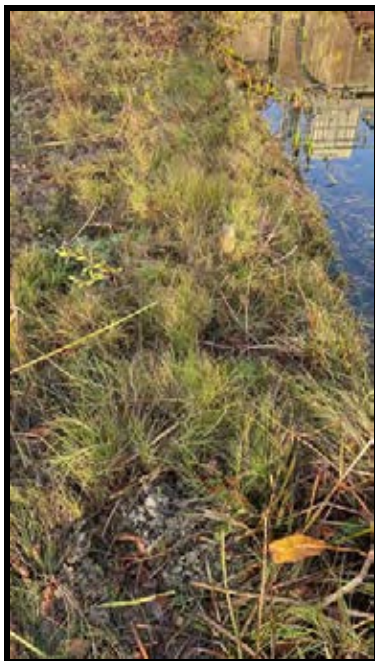
Figure 2: *Paspalum vaginatum* forming smaller, but still prevalent mats at Los Olivos South
