**Annual Surveillance Report**  
**January 2018 through December 2018**  
**Sand Canyon Dam**  
**DSOD Dam No. 1029-002**  
**Irvine, CA**  
**June 14, 2019**

**Project No. 397B-IRW**

Subject: Sand Canyon Dam, DSOD Dam No. 1029-002  
Annual Surveillance Report from January 2018 through December 2018

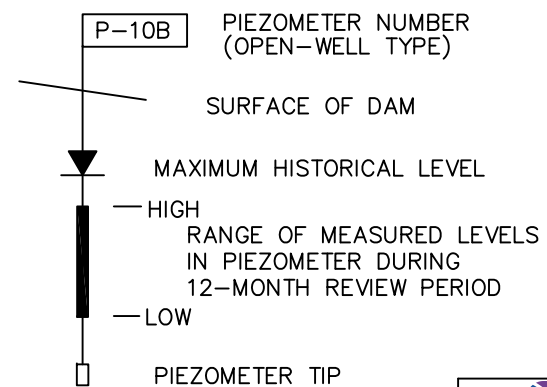
SECTION A-A'

Piezometers P-2A, P-2B, P-5, P-10A, and P-10B are located at or near the section of the dam overlying the maximum depth of the foundation alluvium (Section A-A' on Figure 2). Piezometer P-2A is nested in the same well as Piezometer P-2B and they are situated on the crest of the dam. During July through September 2017 period, water level in P-2A was temporarily higher than the water surface elevation of the reservoir. This temporary condition occurred because, during the period starting from April to July 2017, the elevation of the reservoir water surface had been lowered

Piezometers P-2A and P-10A are installed in the dam embankment, and generally respond to reservoir water surface fluctuations. A reading of the water level in Piezometer P-2A taken on April 4, 2010 showed a sudden increase, followed by the water level readings returning to below Elevation 173 feet. This single measurement is likely erroneous. A reading taken on May 23, 2017 in Piezometer P-10A showed a sudden decrease, followed by higher water level readings. This single measurement is likely erroneous. The water levels observed in these piezometers during this 12-month review period were consistent with historical levels.

Piezometers P-2B, P-5, and P-10B are installed in the foundation alluvium. Piezometers P-2B and P-10B show little response to reservoir water surface fluctuations, while Piezometer P-5 shows very little if any correlation. Readings taken on October 29, 2013, August 26, 2014, March 26, 2015, April 29, 2015, August 26, 2015, and November 24, 2015 in Piezometer P-10B indicated sudden increases in the water level in that piezometer. Following those high readings however, the water level returned to below Elevation 140 feet. Therefore, those measurements were likely erroneous. The water levels observed in these piezometers during this 12-month review period were generally consistent with historical levels.
