Annual Surveillance Report
January 2018 through December 2018
Santiago Creek Dam
DSOD Dam No. 75-000
Irvine, CA
June 26, 2019

**ANNUAL SURVEILLANCE REPORT
JANUARY 2018 THROUGH DECEMBER 2018
FOR
SANTIAGO CREEK DAM
DSOD DAM NO. 75-000
IRVINE, CALIFORNIA**

Subject: Santiago Creek Dam, DSOD Dam No. 75-000,
Annual Surveillance Report, January 2018 through December 2018

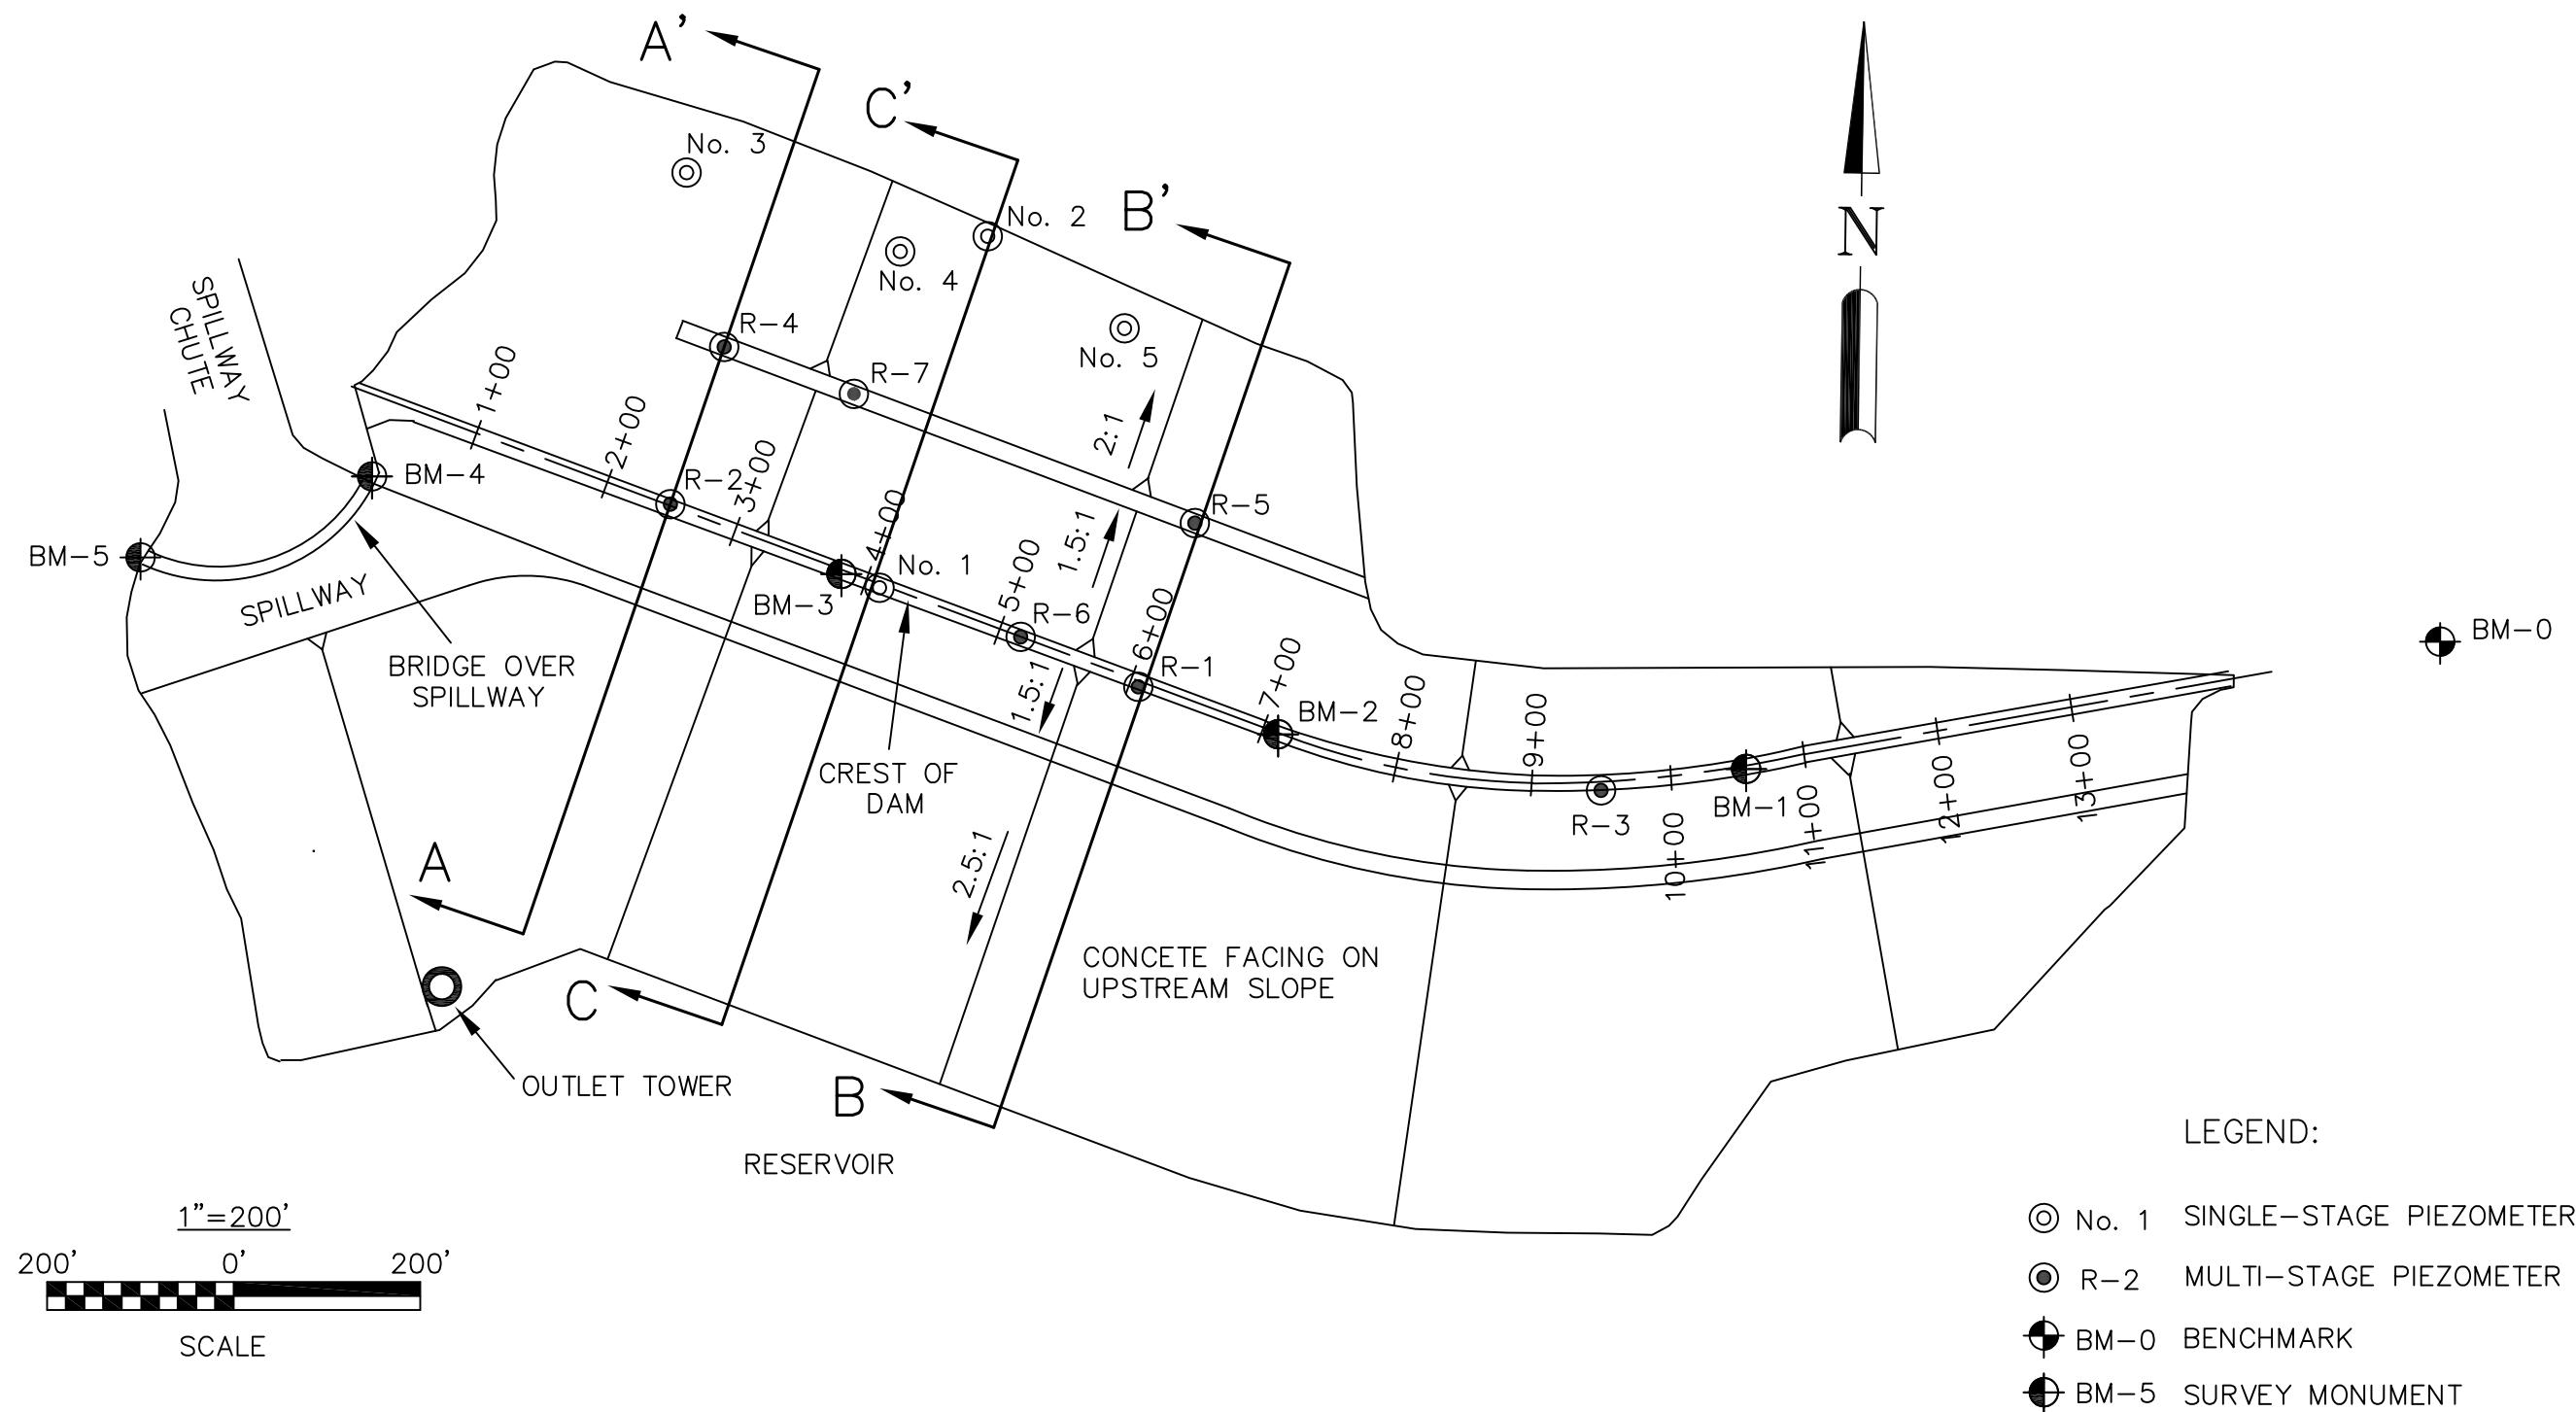
SITE AND INSTRUMENTATION PLAN		
PROJECT NO.	DATE	FIGURE
397E-IRW	JUNE 2019	1A

Figure 1A is a site and instrumentation plan showing the layout of the dam and appurtenances, as well as the locations of the piezometers and survey monuments. Figures 1B, 1C and 1D are representative cross-sections of Santiago Creek Dam. Piezometers No. 1 and No. 2 are single-stage piezometers that were installed in 1964. Piezometers No. 3, No. 4, and No. 5 are single-stage piezometers that were installed in 2011. Piezometers R-1 through R-6 are multi-stage piezometers that were installed in 1969. Piezometer R-7 is a multi-stage piezometer that was installed in 1990. Additional information about these piezometers is provided in Section 2.2. Seepage through the dam or its foundation is not measured since there are currently no facilities to monitor seepage through the dam or its foundation.

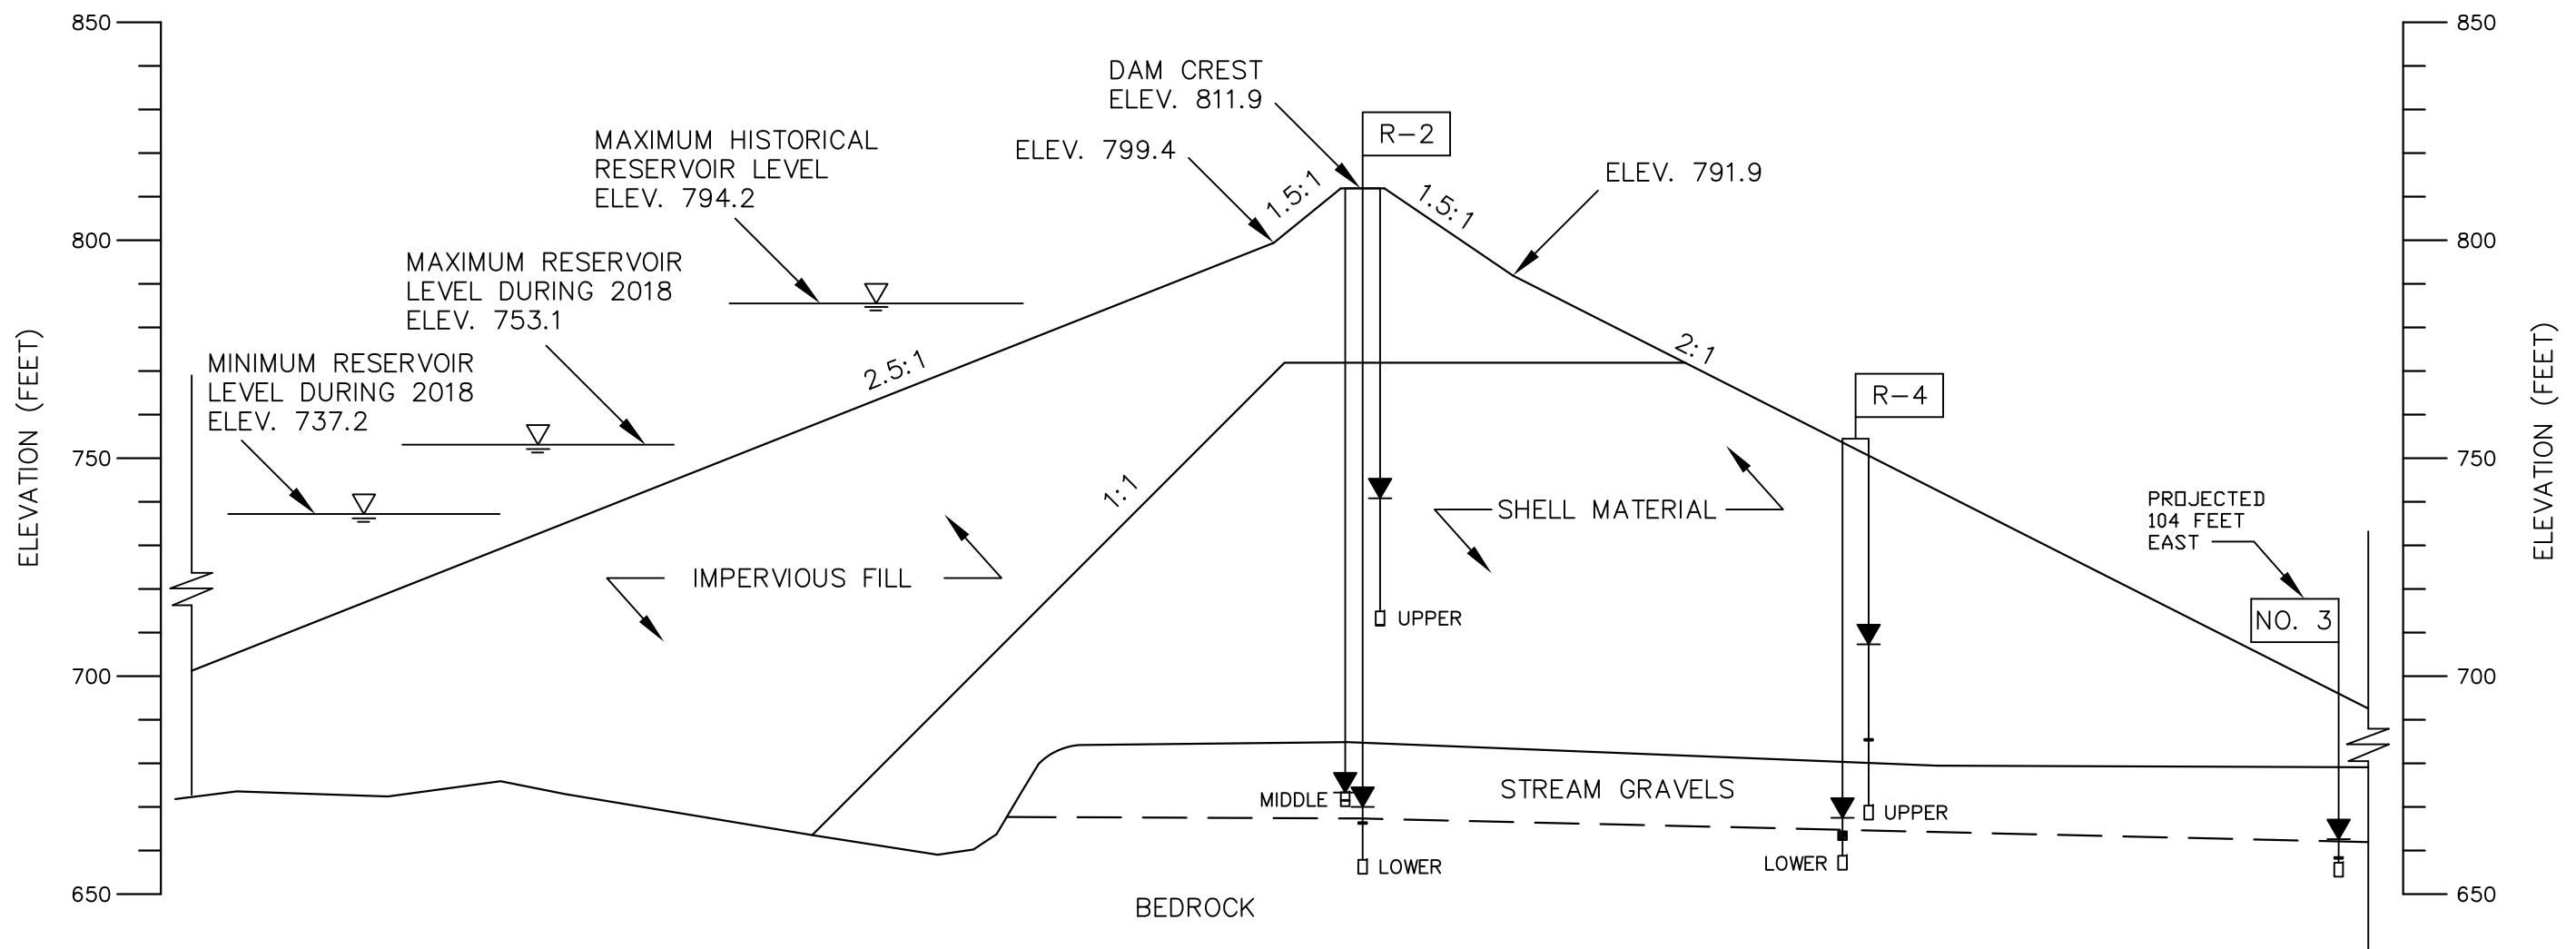
PROJECT NO.	DATE	FIGURE
397E-IRW	JUNE 2019	1B

SECTION A-A'
MAXIMUM SECTION
(APPROX. STA. 2+50)

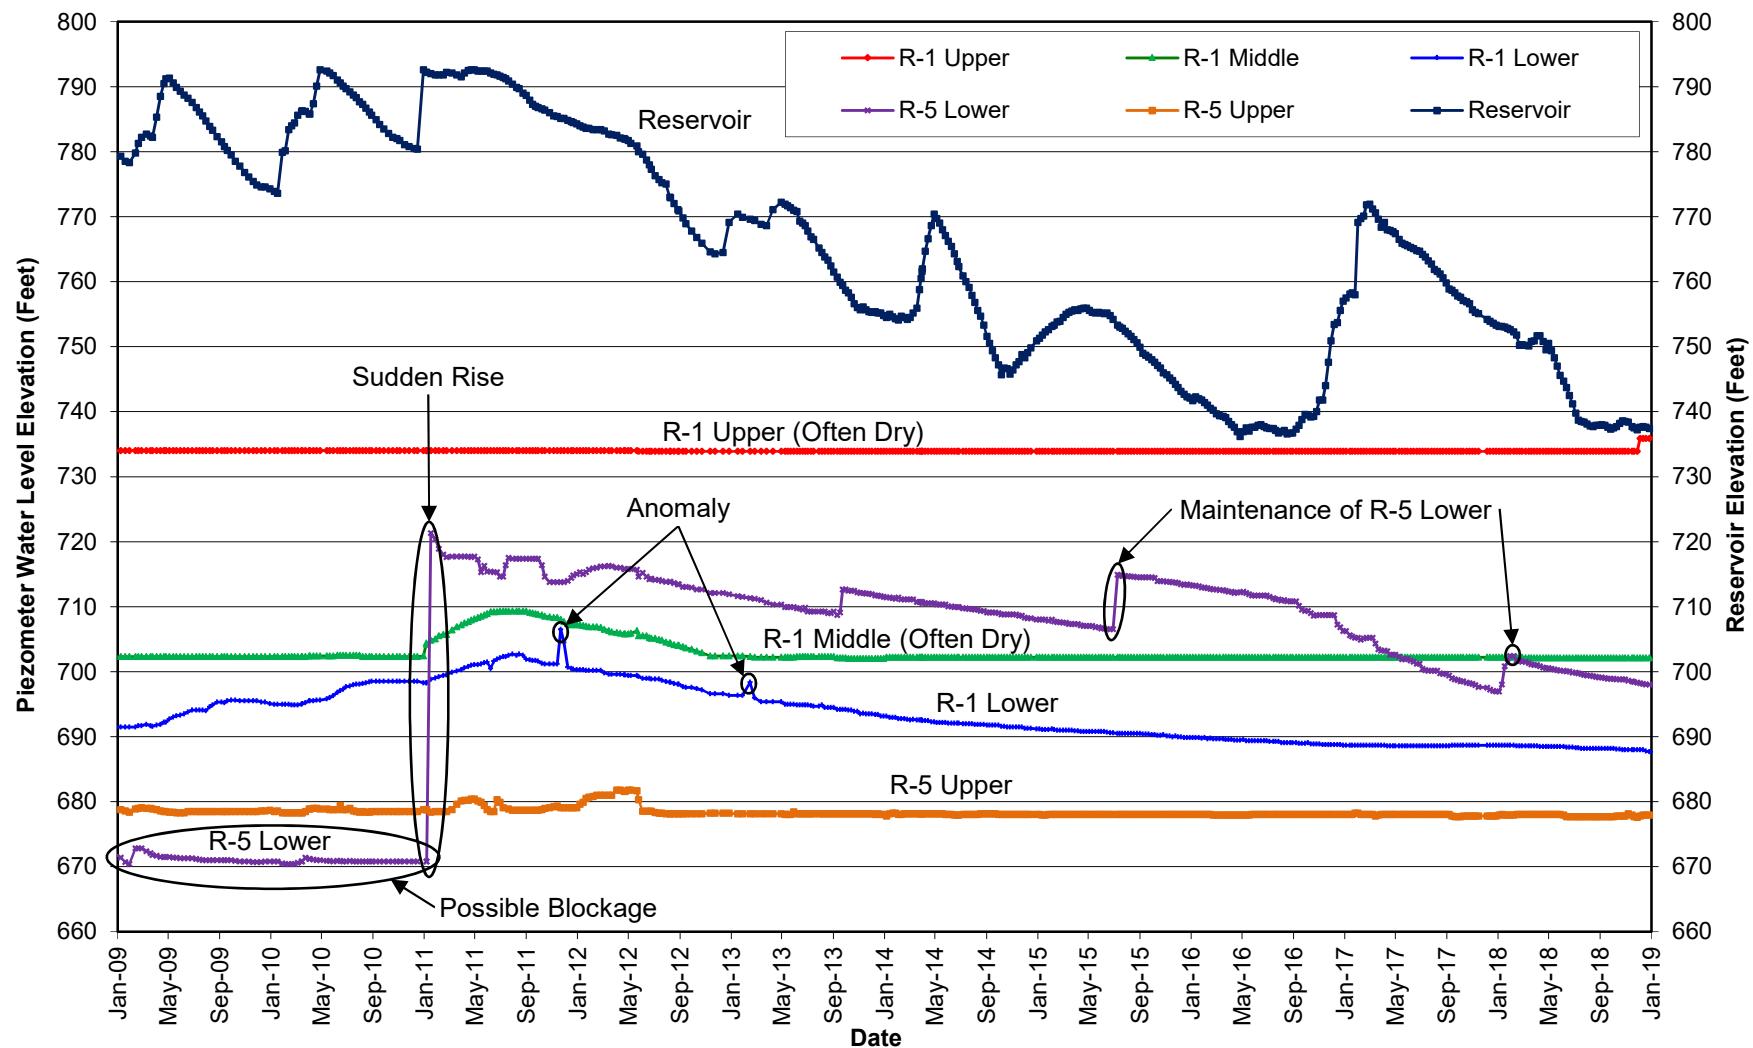
SANTIAGO CREEK DAM
10-YR HISTORICAL PIEZOMETER LEVELS
PIEZOMETERS R-1 AND R-5
JANUARY 2009 THROUGH DECEMBER 2018

Piezometer R-1 is located on the dam crest near Station 6+00. Figures 2A and 3A present time-series graphs of the water levels measured in Piezometers R-1 Upper, R-1 Middle, and R-1 Lower. Piezometer R-1 Upper was installed in the pervious shell material and was dry throughout the review period, except for a reported water level increase in December 2018. Piezometer R-1 Middle has its tip near the base of the pervious shell material and was dry throughout the review period. Piezometer R-1 Lower was installed in the underlying bedrock foundation. It should be noted that the cross-sections shown on Figures 1B, 1C, and 1D are approximate, and that the contact lines

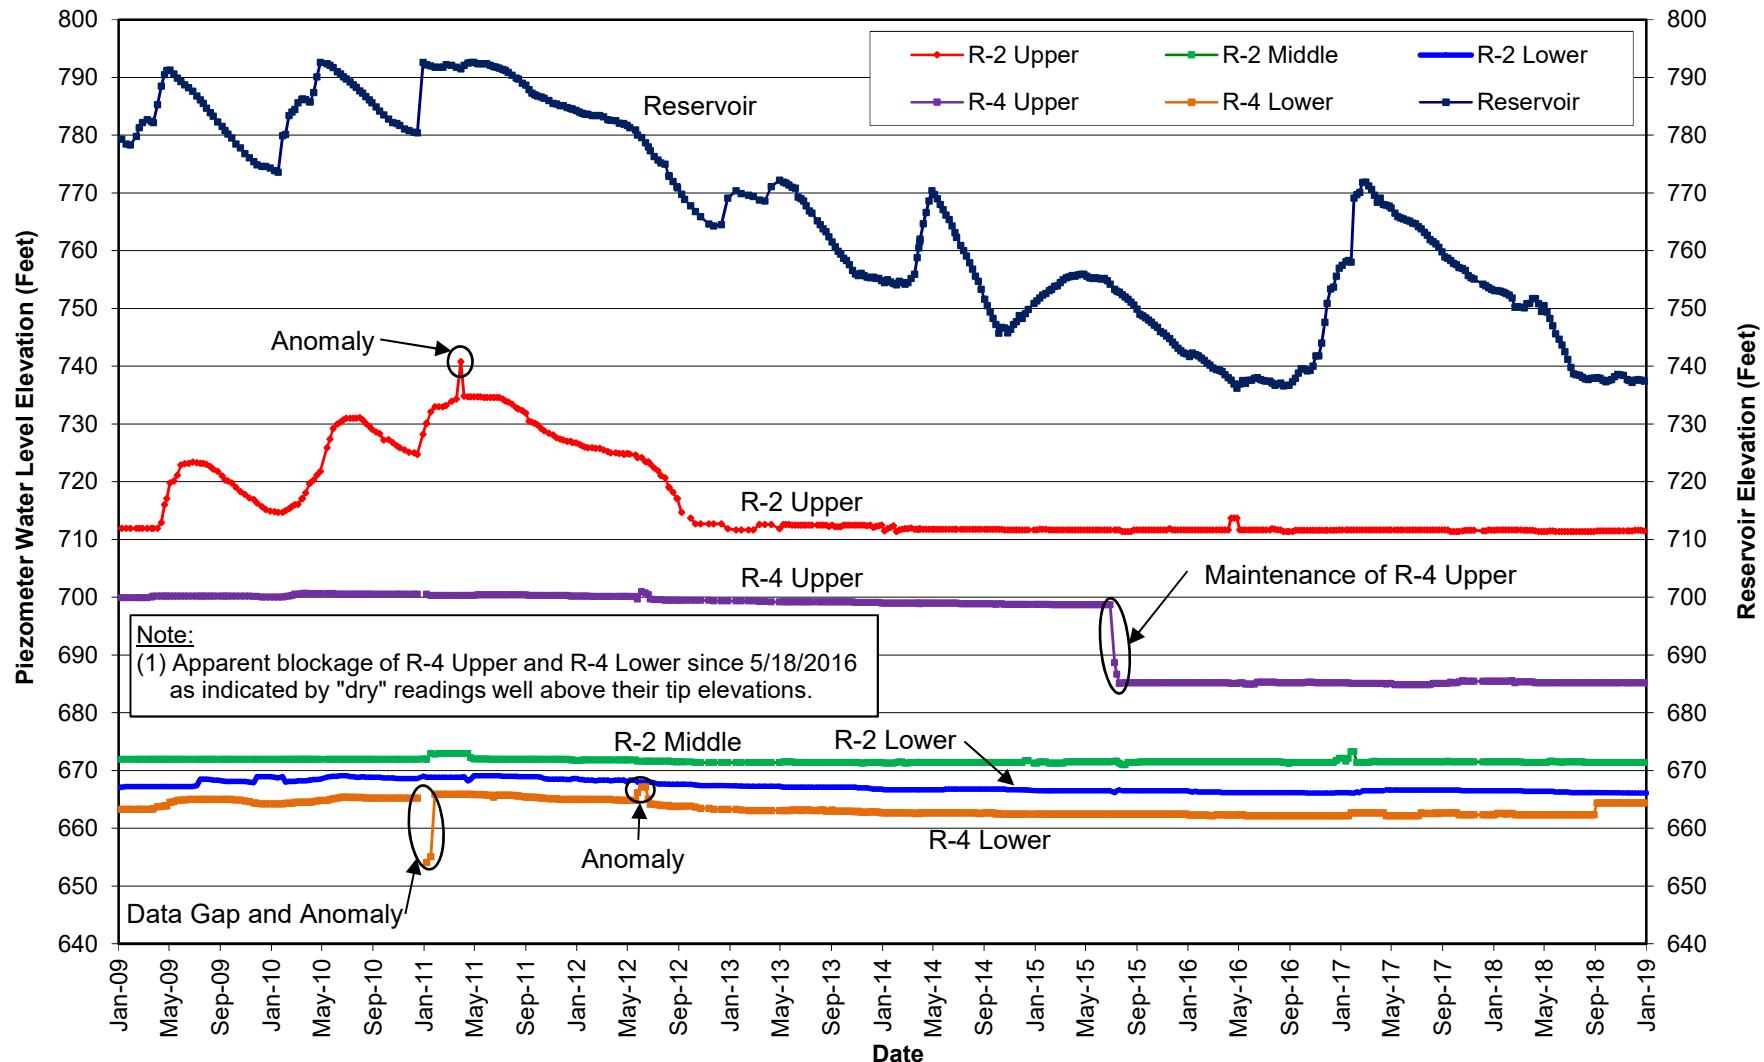
SANTIAGO CREEK DAM
10-YR HISTORICAL PIEZOMETETER LEVELS
PIEZOMETERS R-2 AND R-4
JANUARY 2009 THROUGH DECEMBER 2018

Piezometer R-2 is located on the dam crest near Station 2+50. Figures 2B and 3B present plots of the water levels measured in Piezometers R-2 Upper, R-2 Middle, and R-2 Lower. Piezometer R-2 Upper was installed in the pervious shell material, and the water level in this piezometer did not respond to reservoir fluctuations since September 2012. Water levels in R-2 Upper tend to respond to reservoir fluctuations following periods when the reservoir pool is at or above an elevation of approximately 775 feet. Piezometer R-2 Middle was installed in the foundation alluvium underlying the dam embankment and was fairly constant throughout the review period. In review of previous years recorded readings, there may be 1 to 1.5 feet of sediment accumulated in the piezometer. It is possible that the perforated zone is blocked and is therefore resulting in no response to reservoir water level changes. GENTERRA recommends a maintenance cleaning of Piezometer R-2 Middle to further evaluate the condition of the piezometer. Piezometer R-2 Lower is in the foundation bedrock, and the water level generally has not responded to reservoir water level changes since May 2013.

Piezometer R-4 is located on the downstream bench of the dam, downstream of Piezometer R-2. Figures 2B and 3B are plots of the water levels measured in Piezometers R-4 Upper and R-4 Lower. Piezometer R-4 Upper was installed in foundation alluvium. A maintenance cleaning of R-4 Upper was performed in July 2015, resulting in the water levels in this piezometer dropping by approximately 10 feet. After the cleaning, the water levels in Piezometer R-4 Upper remained between an elevation of 682 feet and 686 feet. Water levels in Piezometer R-4 Upper showed very little fluctuation throughout the current review period. Piezometer R-4 Lower was installed in the underlying bedrock and was reported during this review period as being dry from March 7, 2018 through the end of December 2018.
