DAM SAFETY PROGRAM

Guidelines & Governance

**Irvine Ranch
Water District**

January 2026

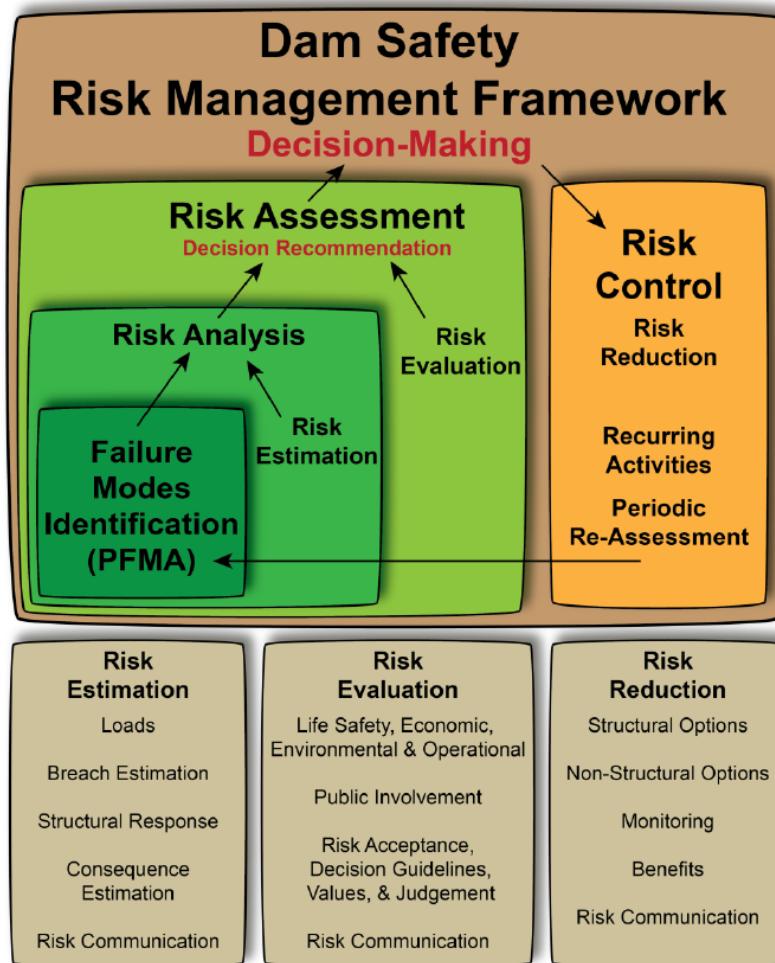
Figure 1: Dam Safety Risk Management Framework (FEMA 2015)

These components and their relationship to one another are illustrated on Figure 1.

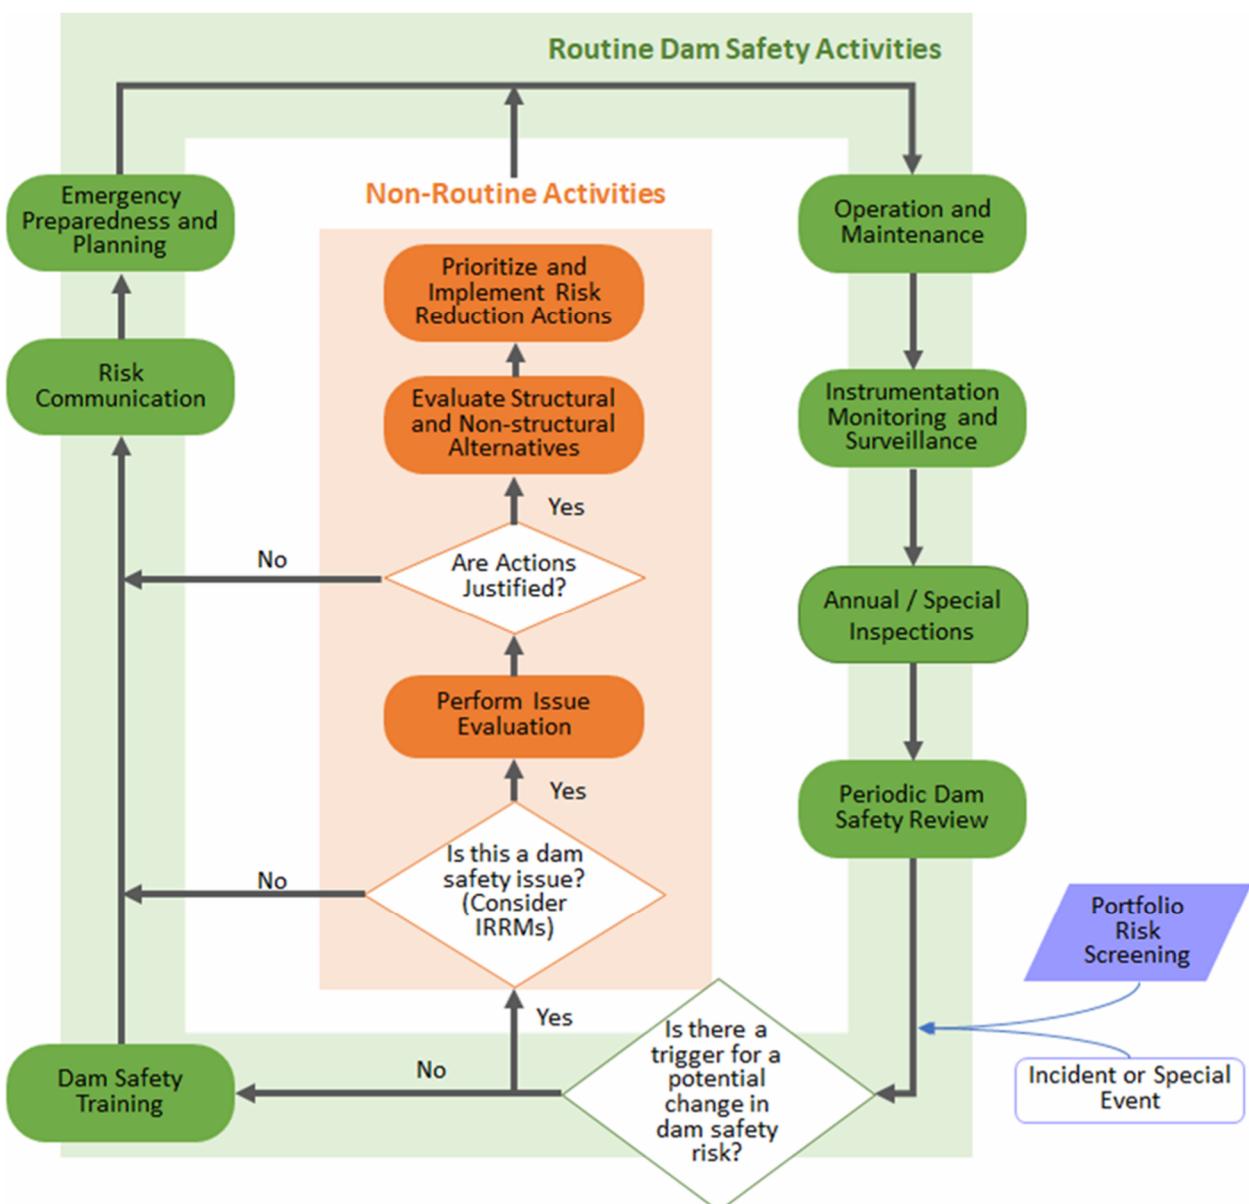
Figure 2: Routine and Non-routine dam safety activities.

IRWD's DSP consists of routine and non-routine dam safety activities. The activities are shown in Figure 1 below.

The routine dam safety activities are implemented to continuously monitor dam performance and manage dam safety risks. They include operation and maintenance, surveillance and monitoring, different types of inspections, periodic dam safety reviews (PDSRs), dam safety training, risk communication and emergency preparedness. The order or position of the routine recurring dam safety activities on the outer loop (green) is not intended to be chronological because each of the recurring activities has its own timing. PDSRs include risk assessments of existing or any newly identified PFM to re-evaluate risk using the most up to date information on loadings (hydrologic and seismic), dam performance and downstream consequences. The

Non-routine activities will be implemented to address a potential dam safety issue or specific concern. These activities include evaluating the need for interim risk reduction measures, issue evaluation(s), dam safety modification alternatives evaluation and design, and implementation of selected risk reduction measures. On an infrequent basis, dam safety emergencies may require emergency response that also triggers non-routine activities. The Dam Safety Program uses risk to make decisions about the severity of the situation and the urgency of actions, to select the recommended course of action, and to guide their implementation.

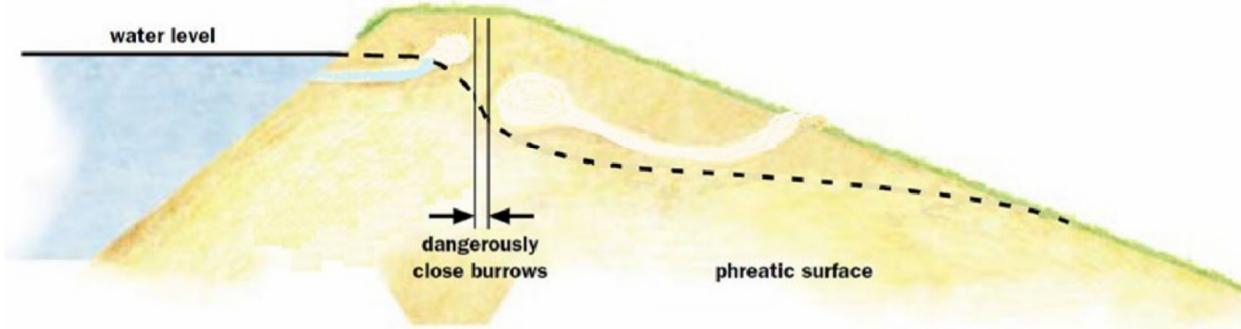
Figure 2: Section View of Dam with Animal Burrowing Activity (FEMA 473).

Additional information on the above listed species, including photos, description of food sources, behavior, and tips for the field can be obtained by reviewing the Federal Emergency Management Agency (FEMA) 473 Impacts of Animals on Earthen Dams. Animal burrowing is the primary dam safety concern. Figure 2 provides a cross section view of a sample earthen dam that shows potential animal burrowing activity in relation to possible water level through the dam. The figure illustrates how animal activity can reduce the cross section of the dam and present a dam safety concern. As such, it is critically important to control animal activity and protect the condition of the dam.

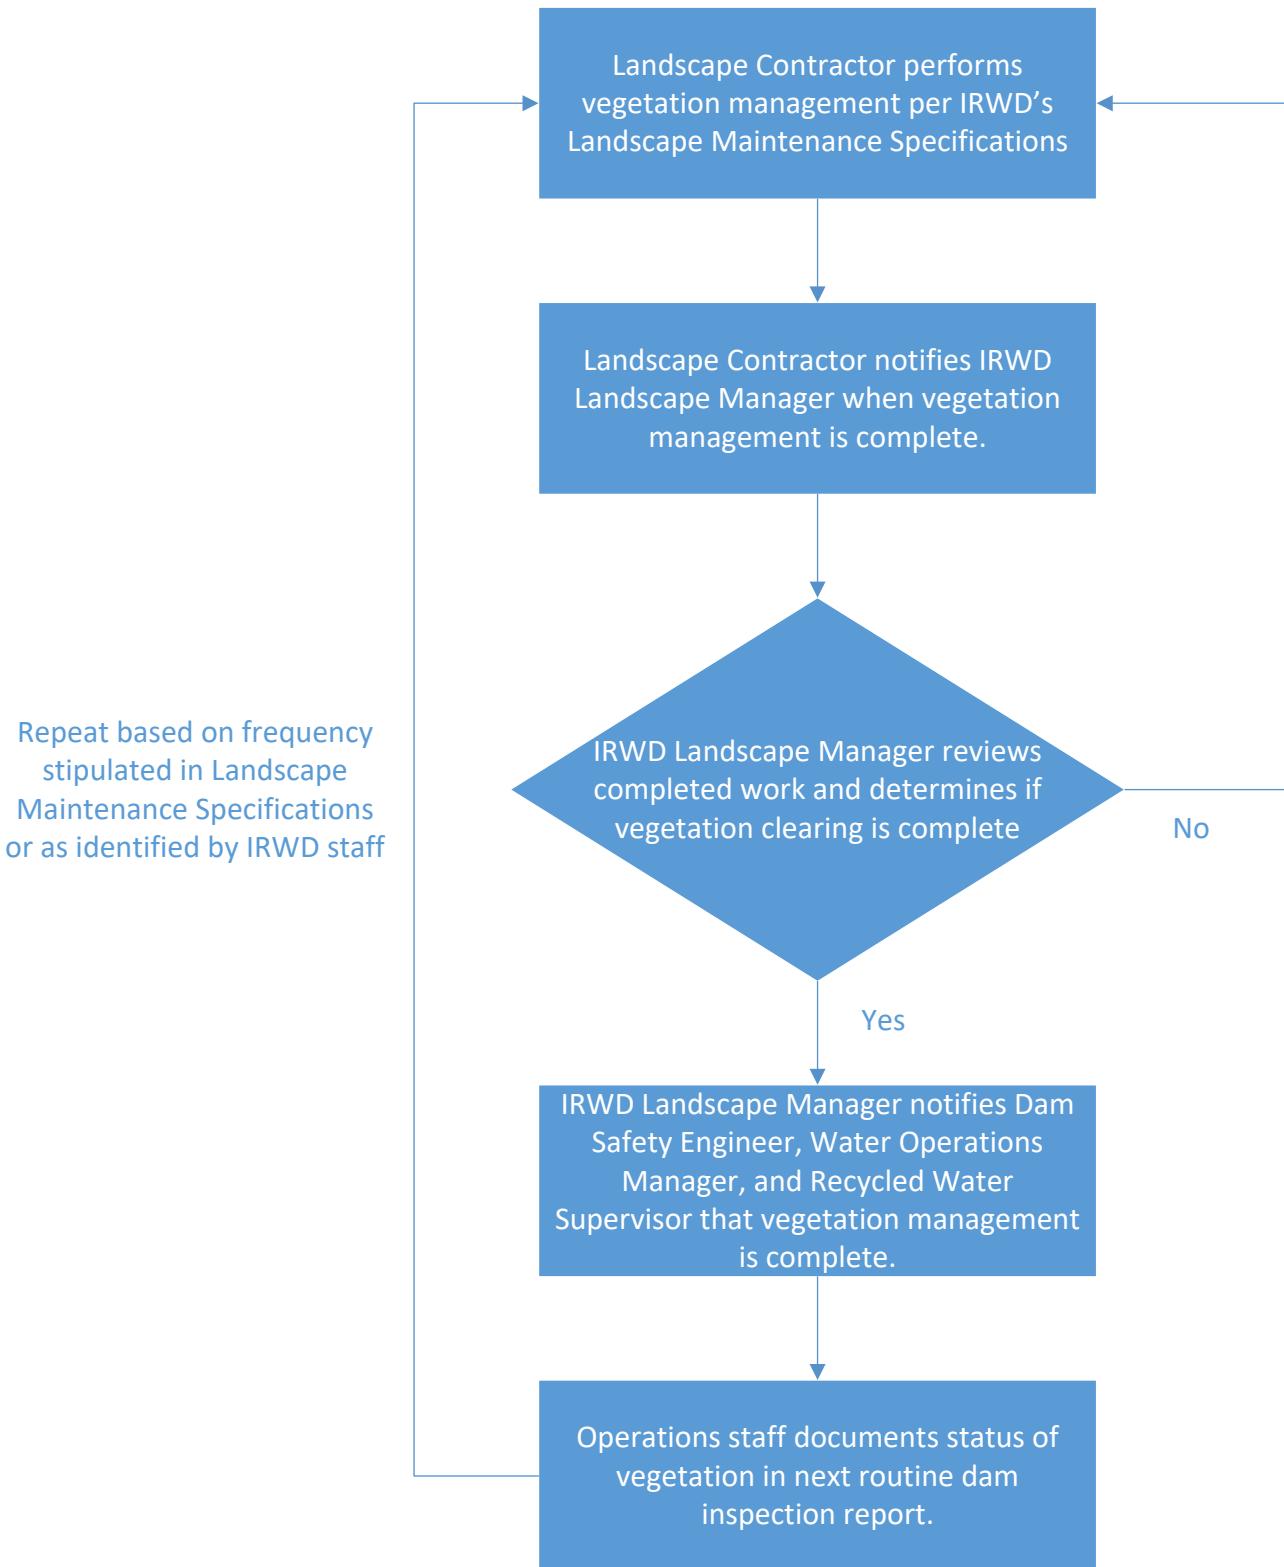
Figure 1: Vegetation Management Notification and Review Process for IRWD's Dams

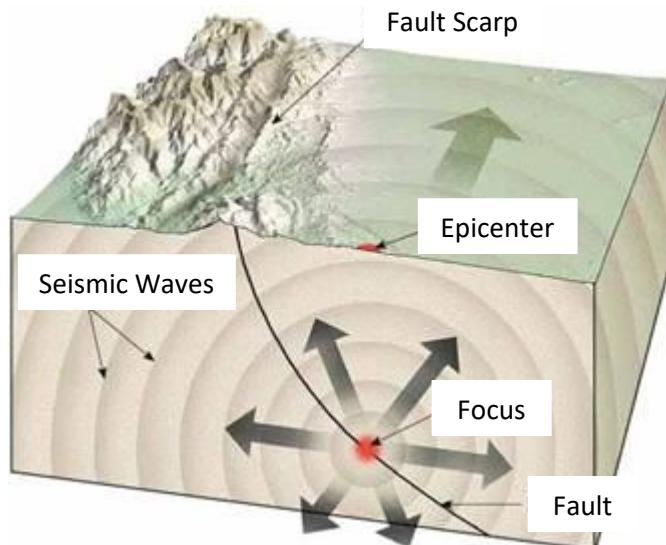
Figure 1: Anatomy of an earthquake

Focus - also referred to as the hypocenter, is the point within the earth where the earthquake rupture starts.

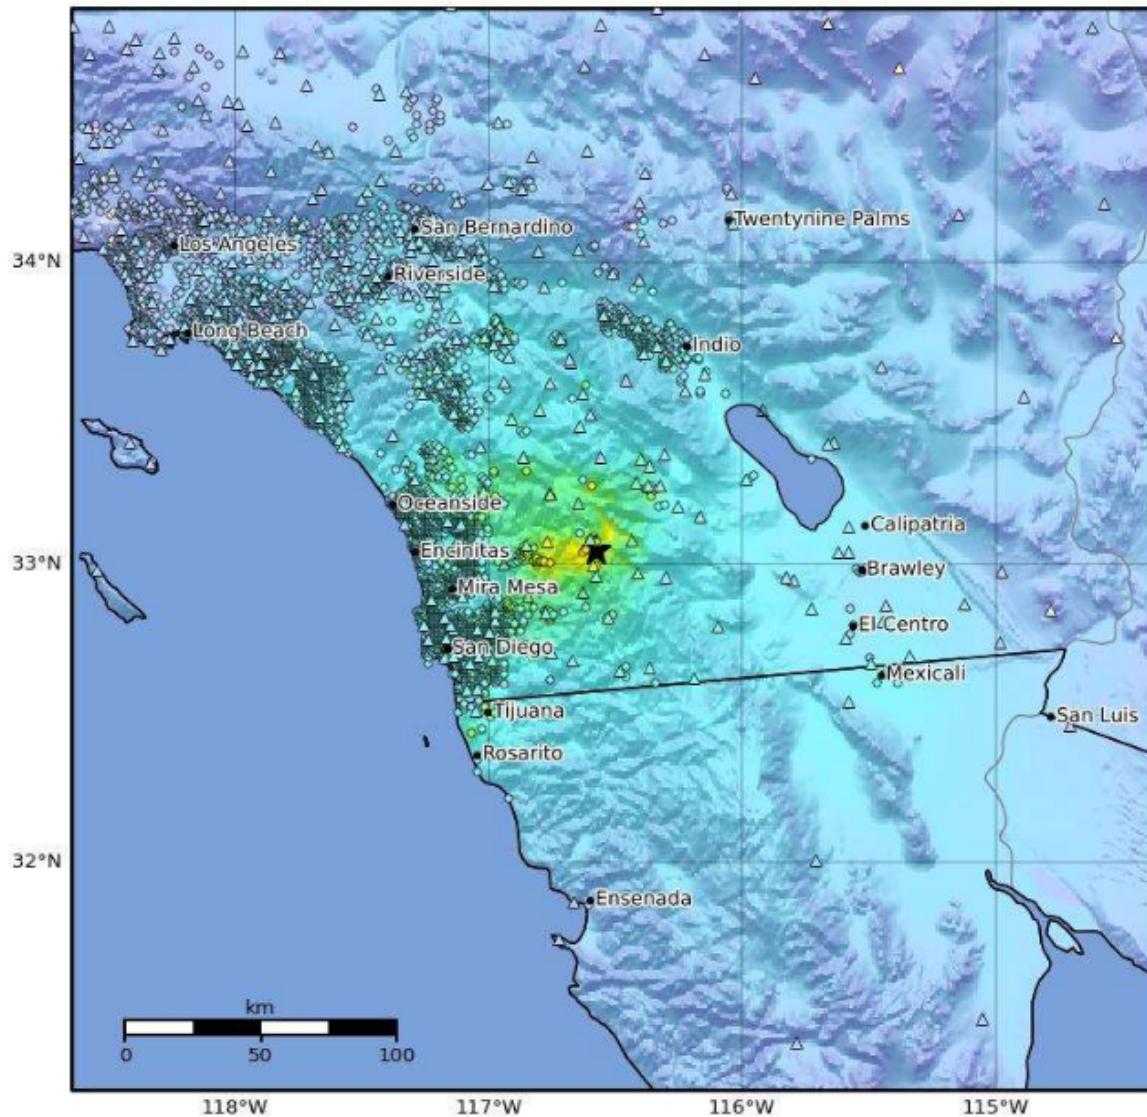
SHAKING	Not felt	Weak	Light	Moderate	Strong	Very strong	Severe	Violent	Extreme
DAMAGE	None	None	None	Very light	Light	Moderate	Moderate/heavy	Heavy	Very heavy
PGA(%g)	<0.0464	0.297	2.76	6.2	11.5	21.5	40.1	74.7	>139
PGV(cm/s)	<0.0215	0.135	1.41	4.65	9.64	20	41.4	85.8	>178
INTENSITY	I	II-III	IV	V	VI	VII	VIII	IX	X+

Figure 2: Example of earthquake intensity map and potential damage categories

combination of data from ShakeCast, ShakeMap and site-specific geology to predict the response at each dam location. Below in Figure 2 is a sample ShakeMap display and legend.

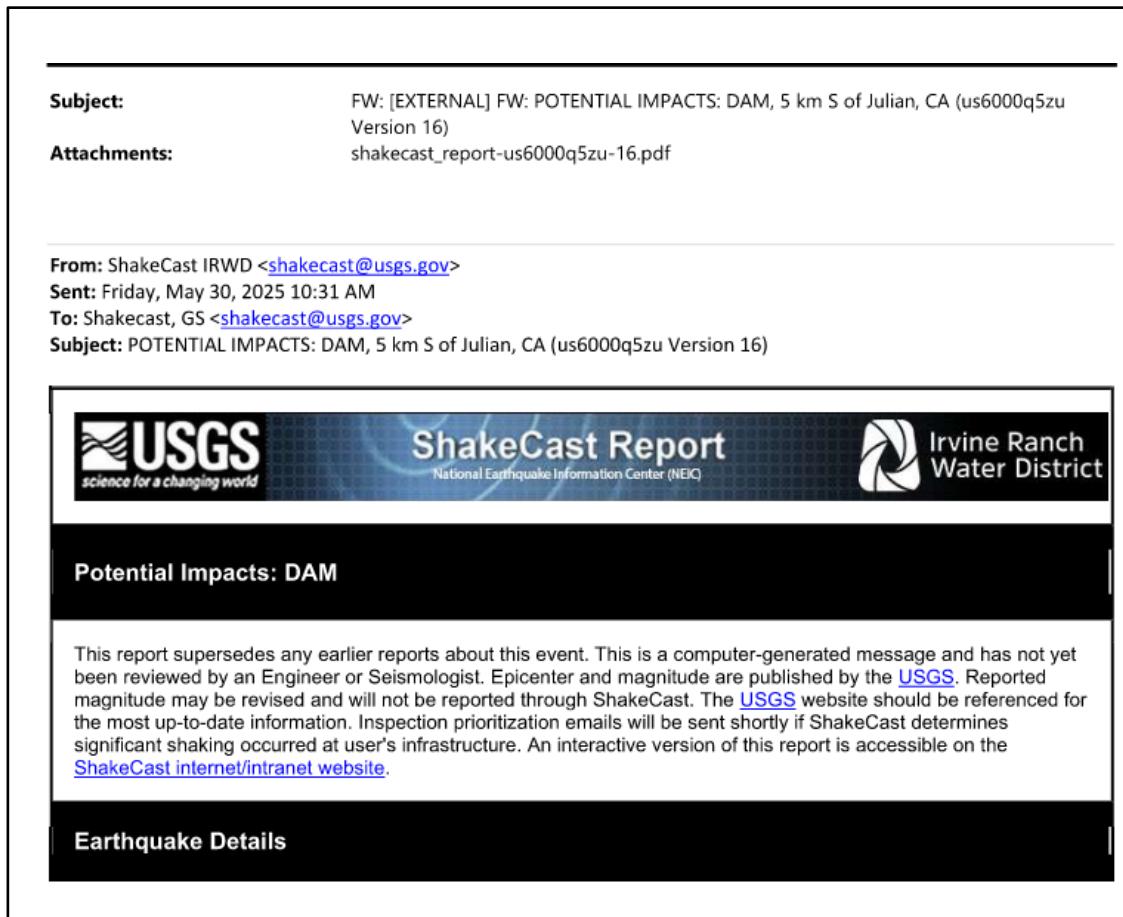
Figure 3a: Example of USGS ShakeCast Email Notification

Below in Figures 3a, 3b, and 3c are a sample USGS ShakeCast Email message, Figure 4 is a sample ShakeCast Report attachment in the email notification, and Figure 5 is a sample text message that the registered IRWD employees will receive for qualifying earthquake events within the defined boundary.

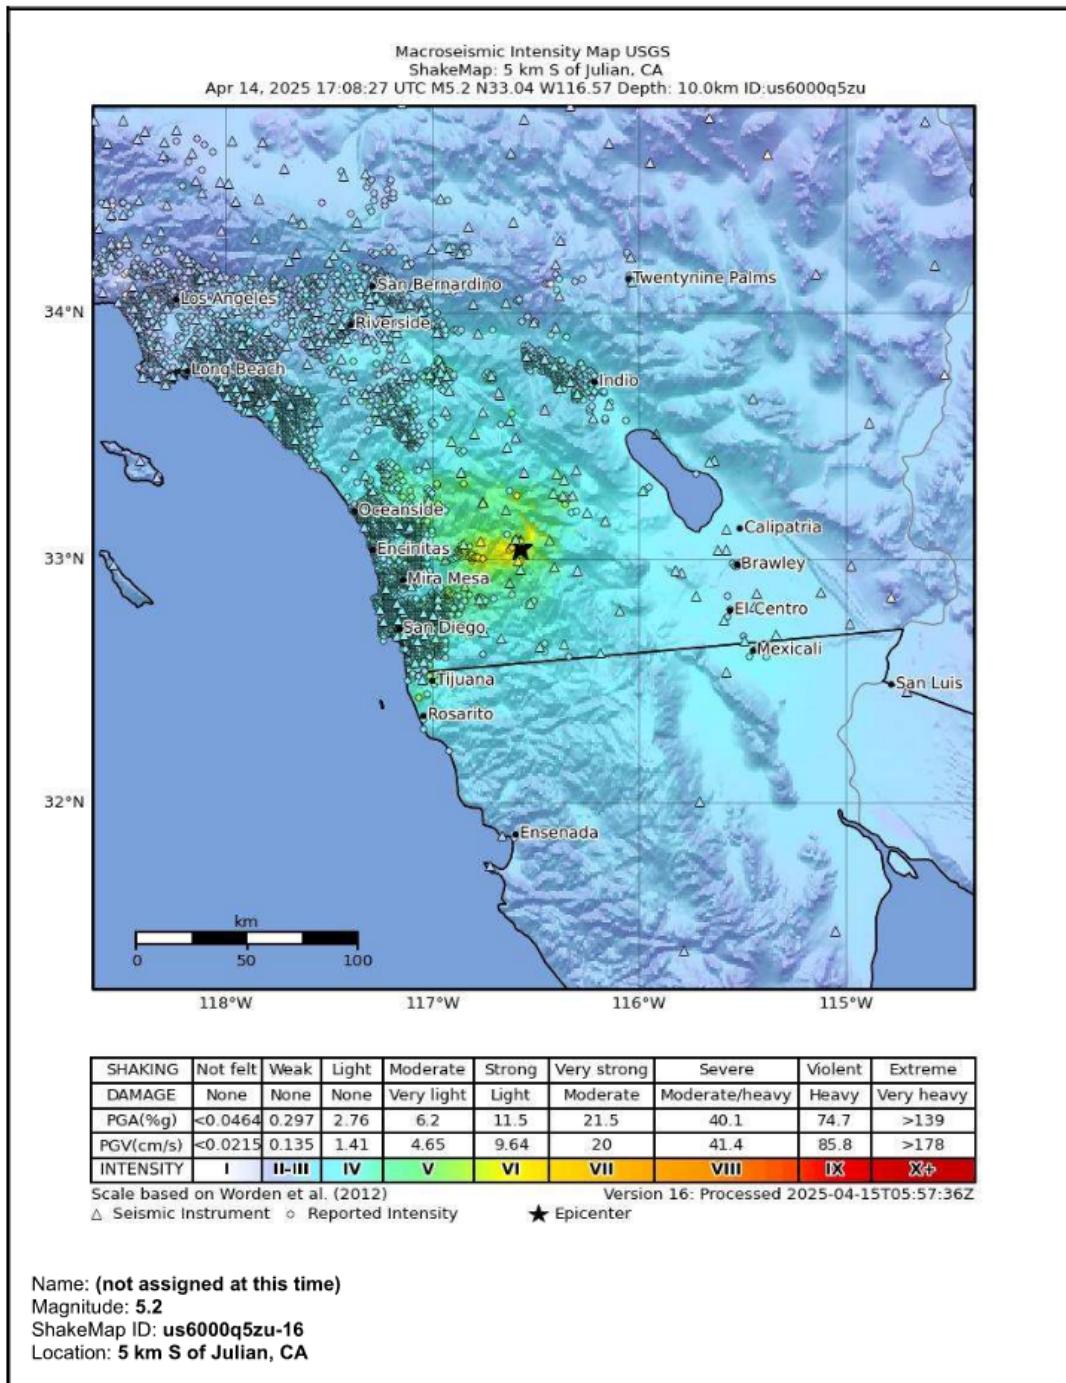
Figure 3b: Example of USGS ShakeCast Email Notification

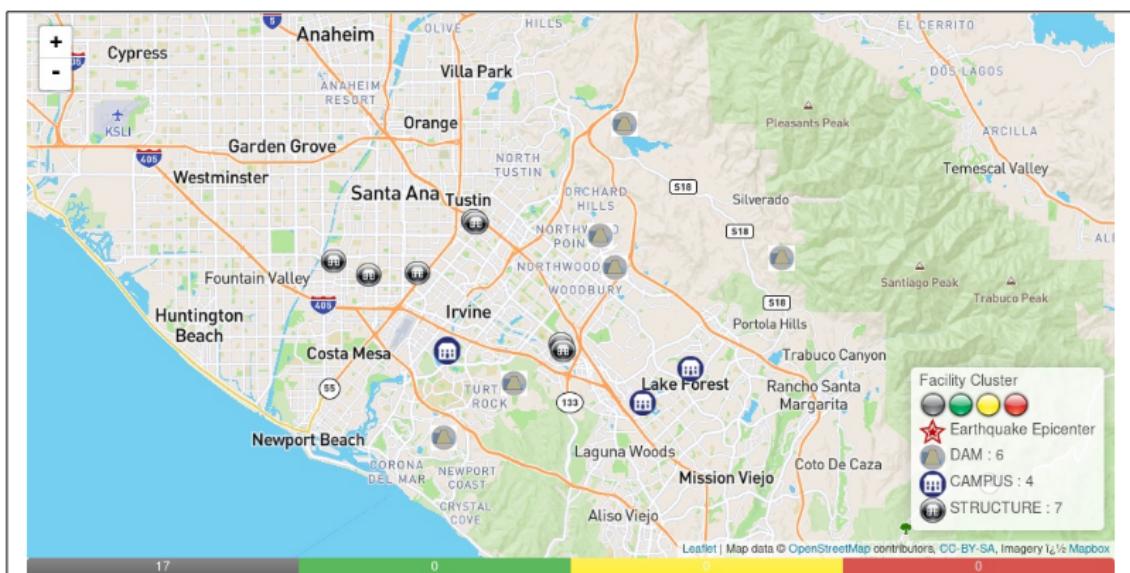
Figure 4: USGS Shakecast Report attached to Email Notification

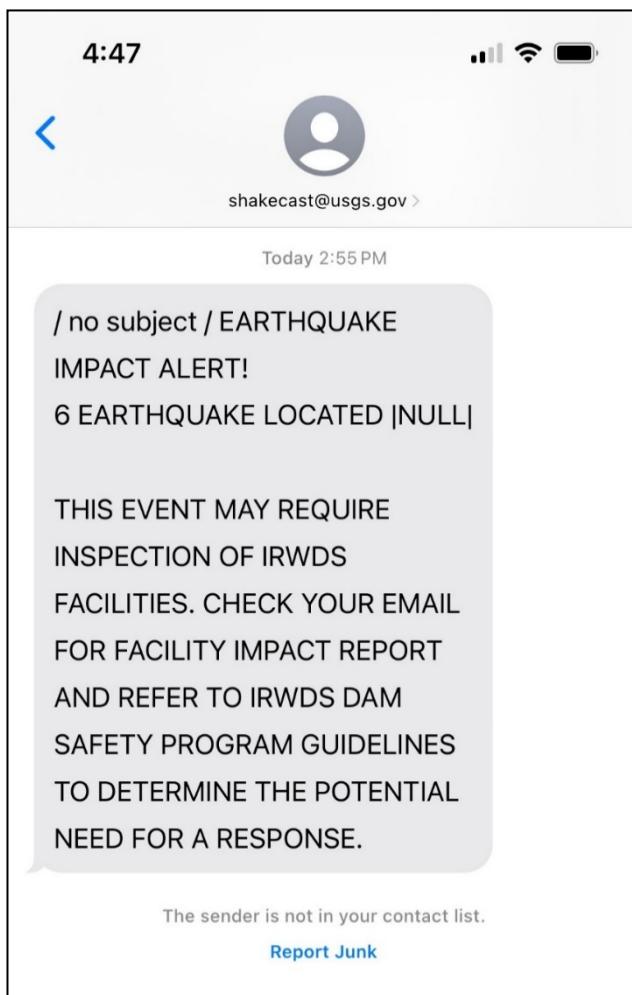
Figure 5: Example of USGS ShakeCast Text Notification

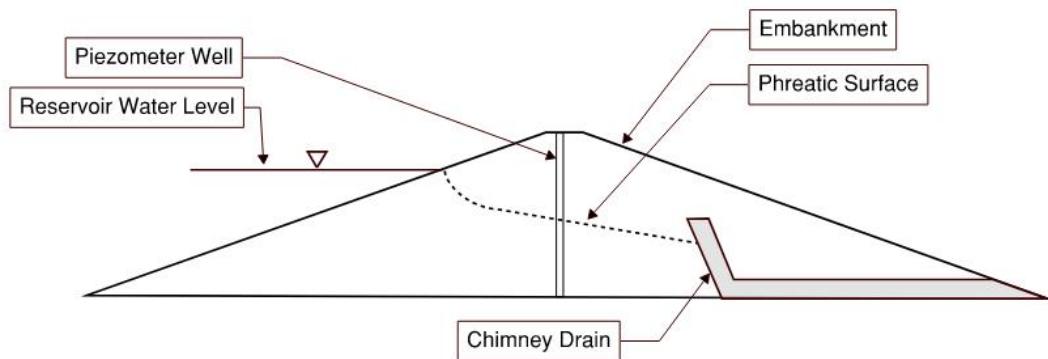
Figure 1: Embankment Features Related to Seepage

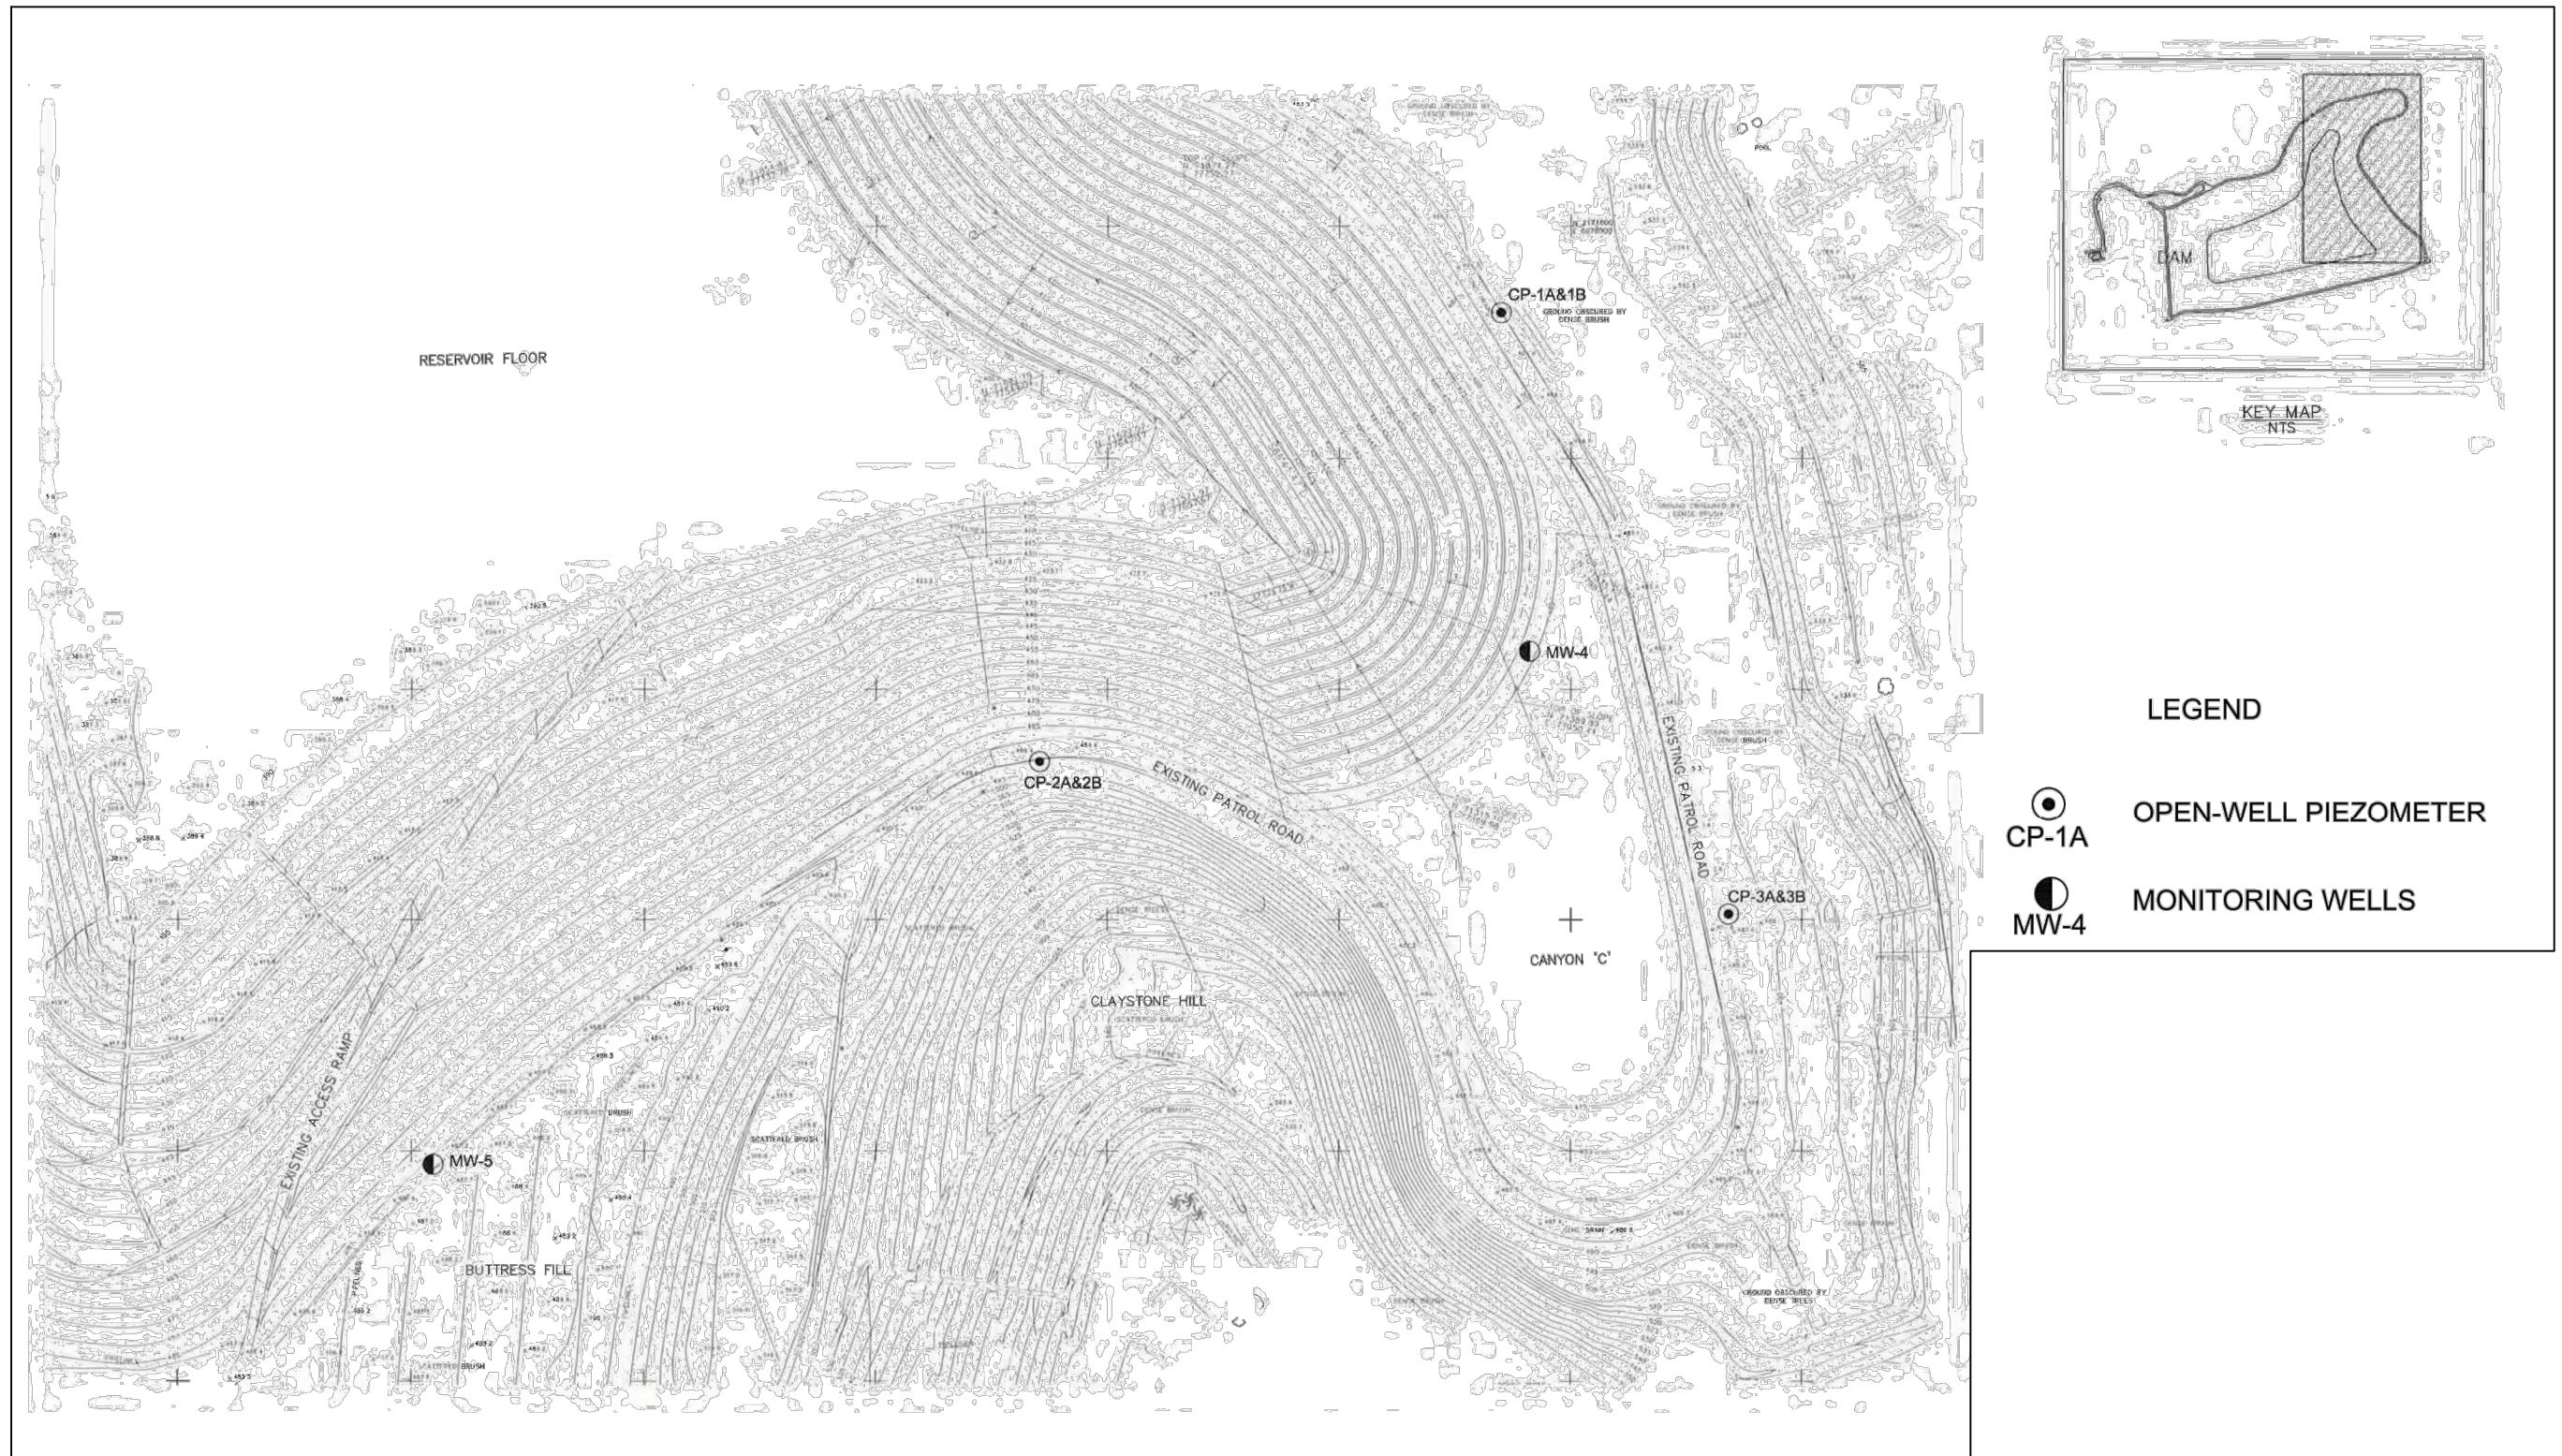
Fig. 4

Annual Surveillance Report from Jan. 2021 to Dec. 2021
San Joaquin Dam and Reservoir
Irvine, CA

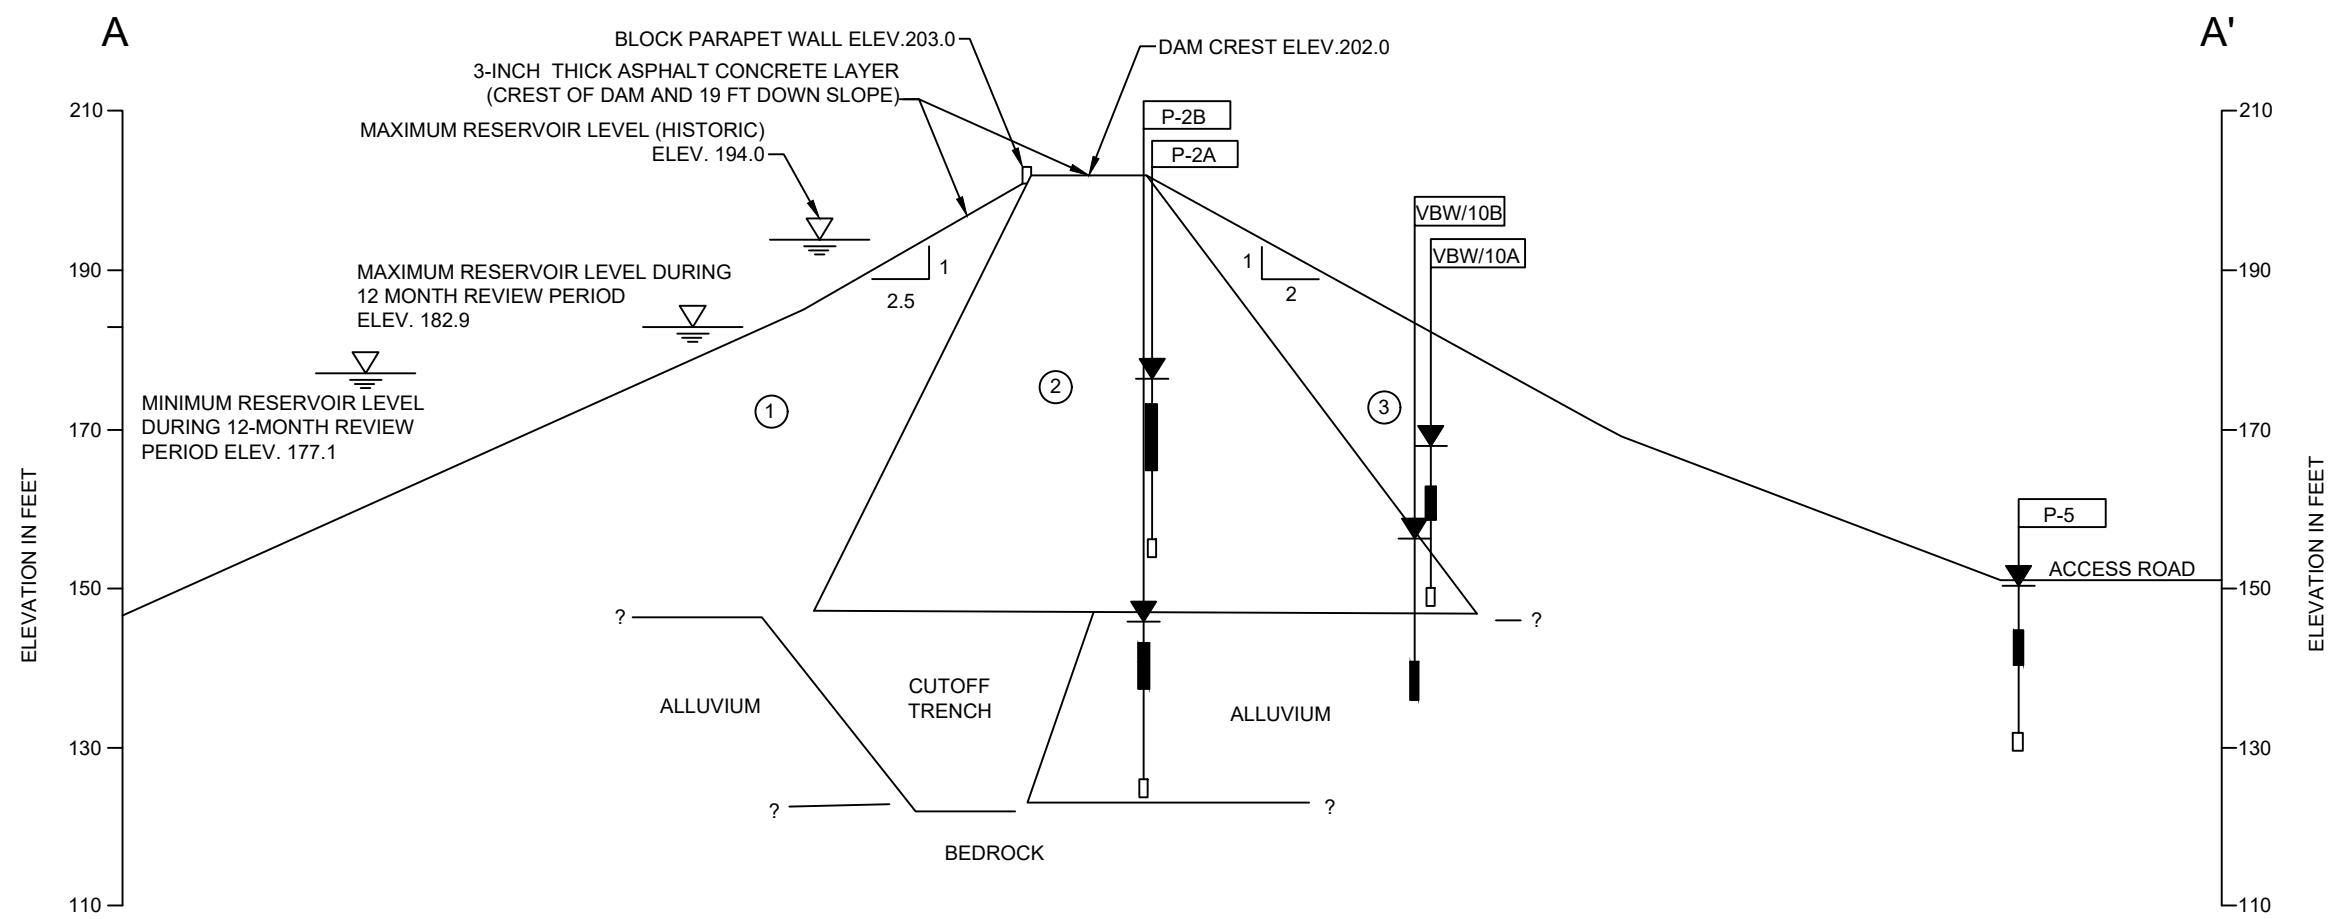
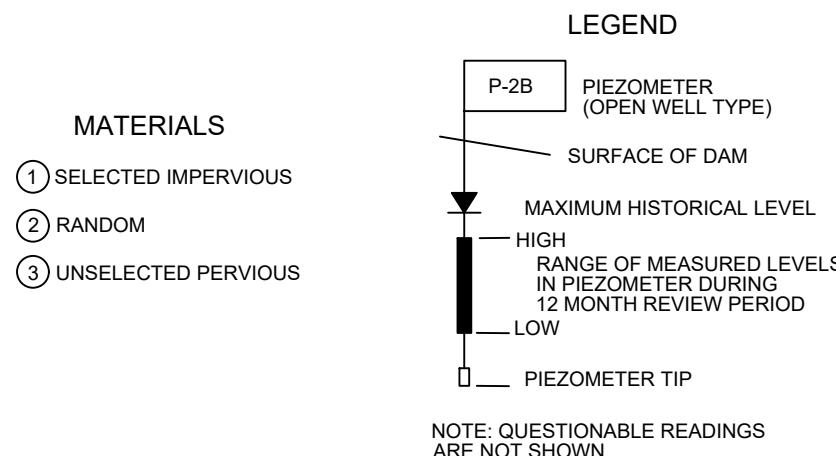
Fig. 2

Annual Surveillance Report from Jan. 2021 to Dec. 2021
Sand Canyon Dam
Irvine, CA

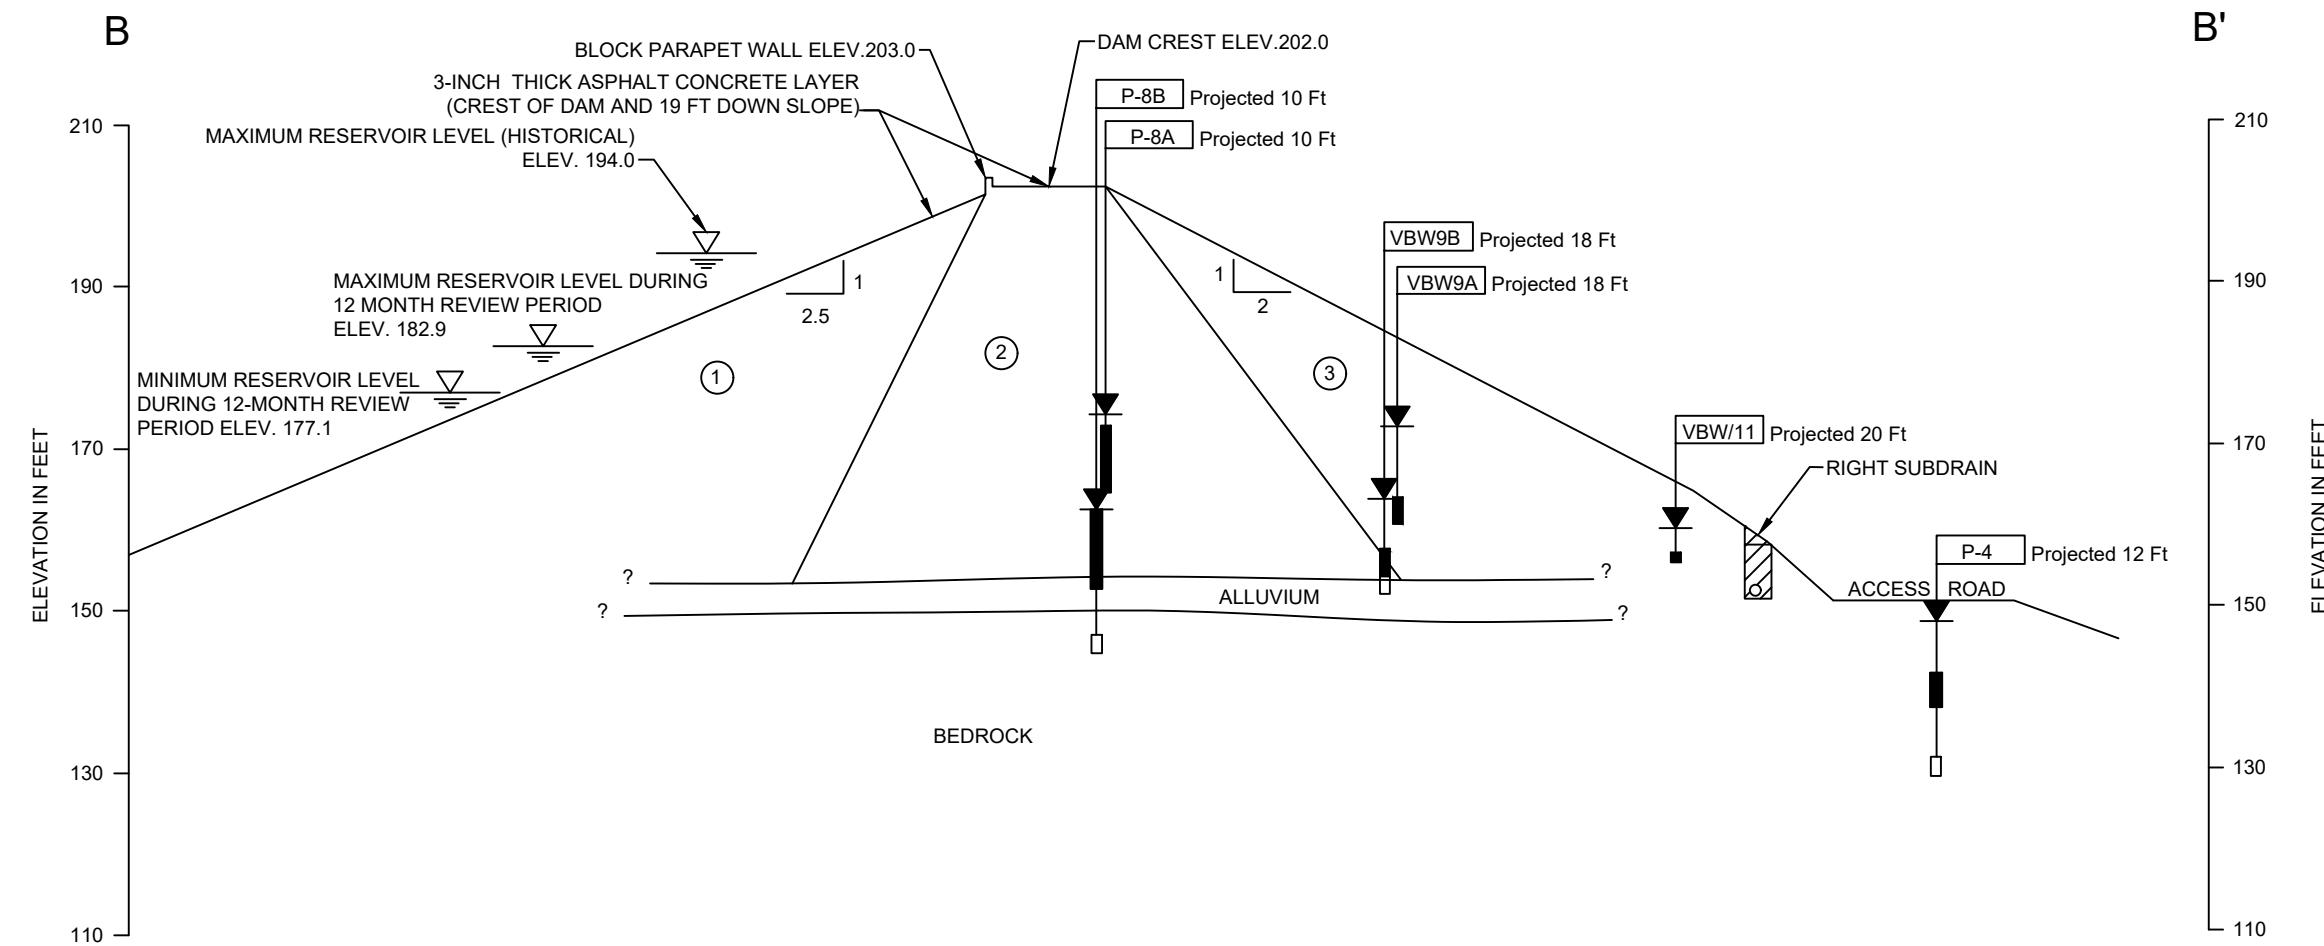
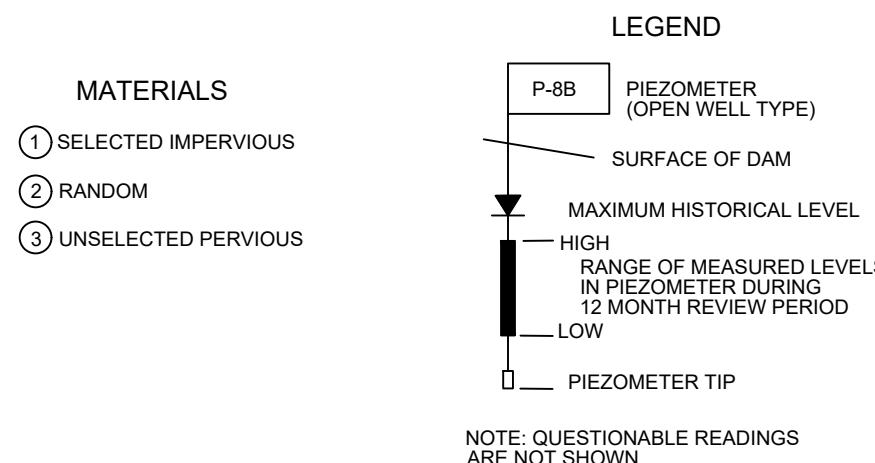
Fig. 3

NOTES:
 (1) SEE FIGURE 1 FOR LOCATION OF SECTION
 (2) ELEVATIONS ARE IN FEET RELATIVE TO NGVD29
