DAM SAFETY PROGRAM

Guidelines & Governance

**Irvine Ranch
Water District**

January 2026

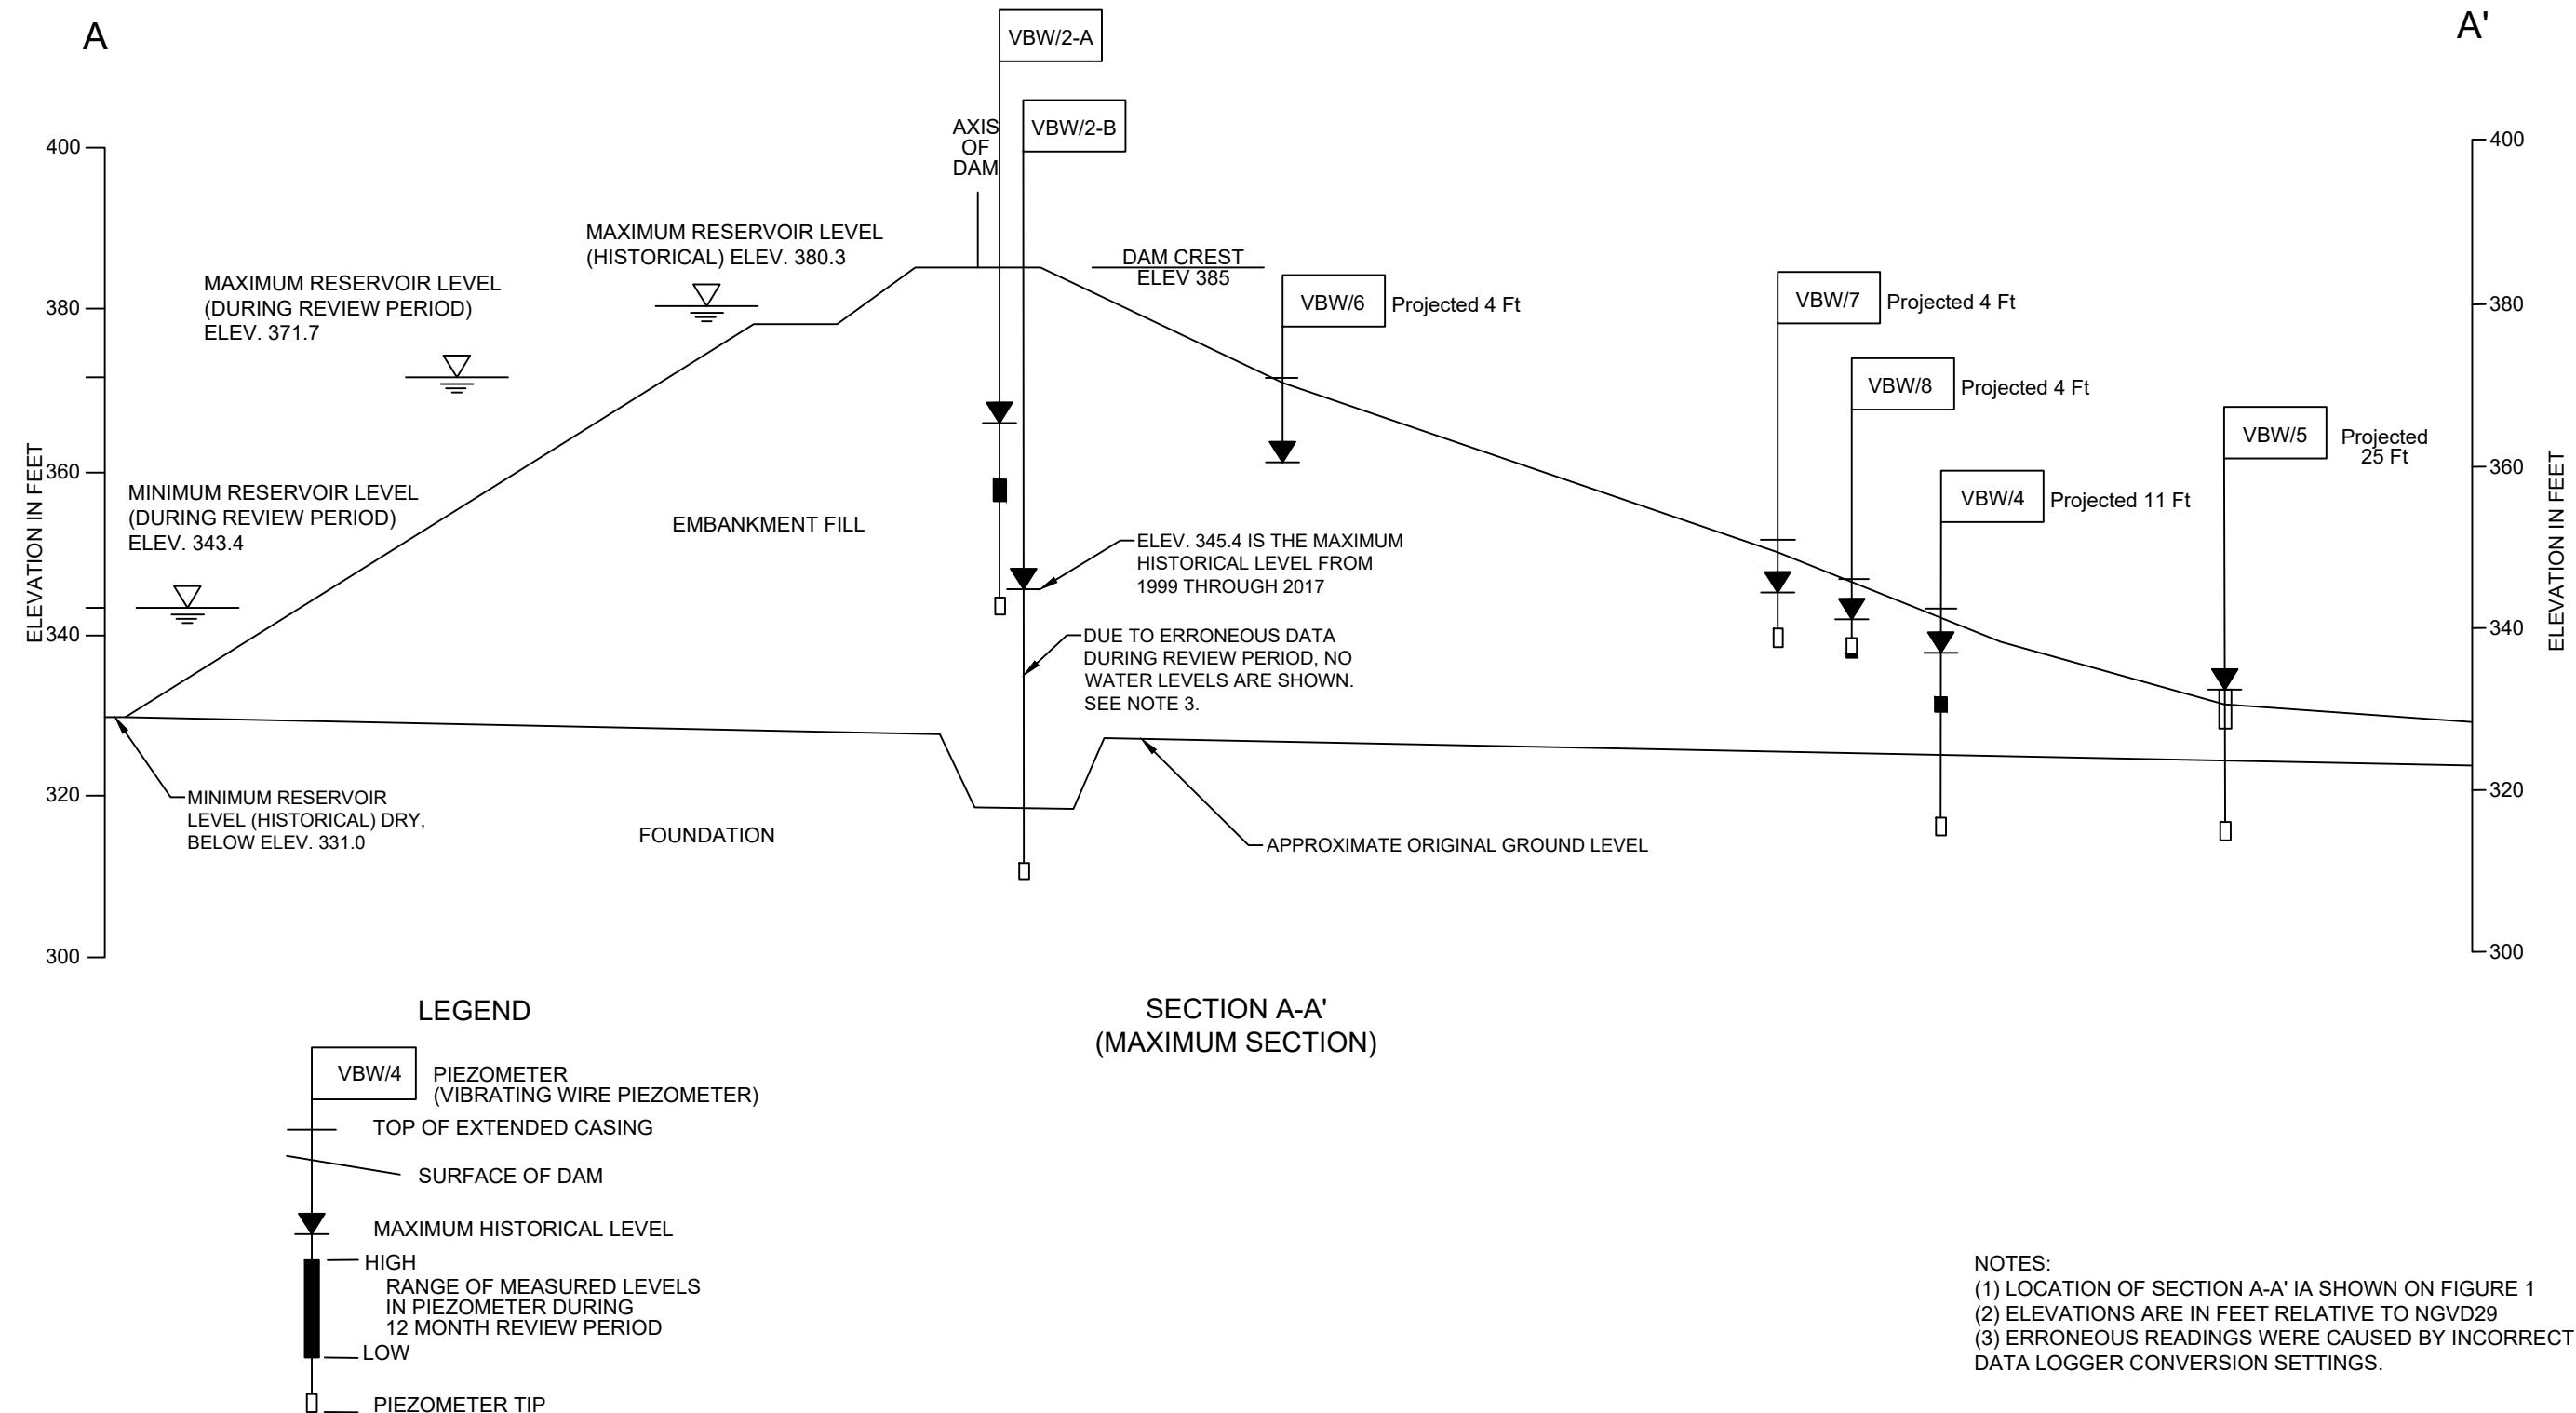
Fig. 1A

Annual Surveillance Report from Jan. 2021 to Dec. 2021
Syphon Canyon Dam
Irvine, CA

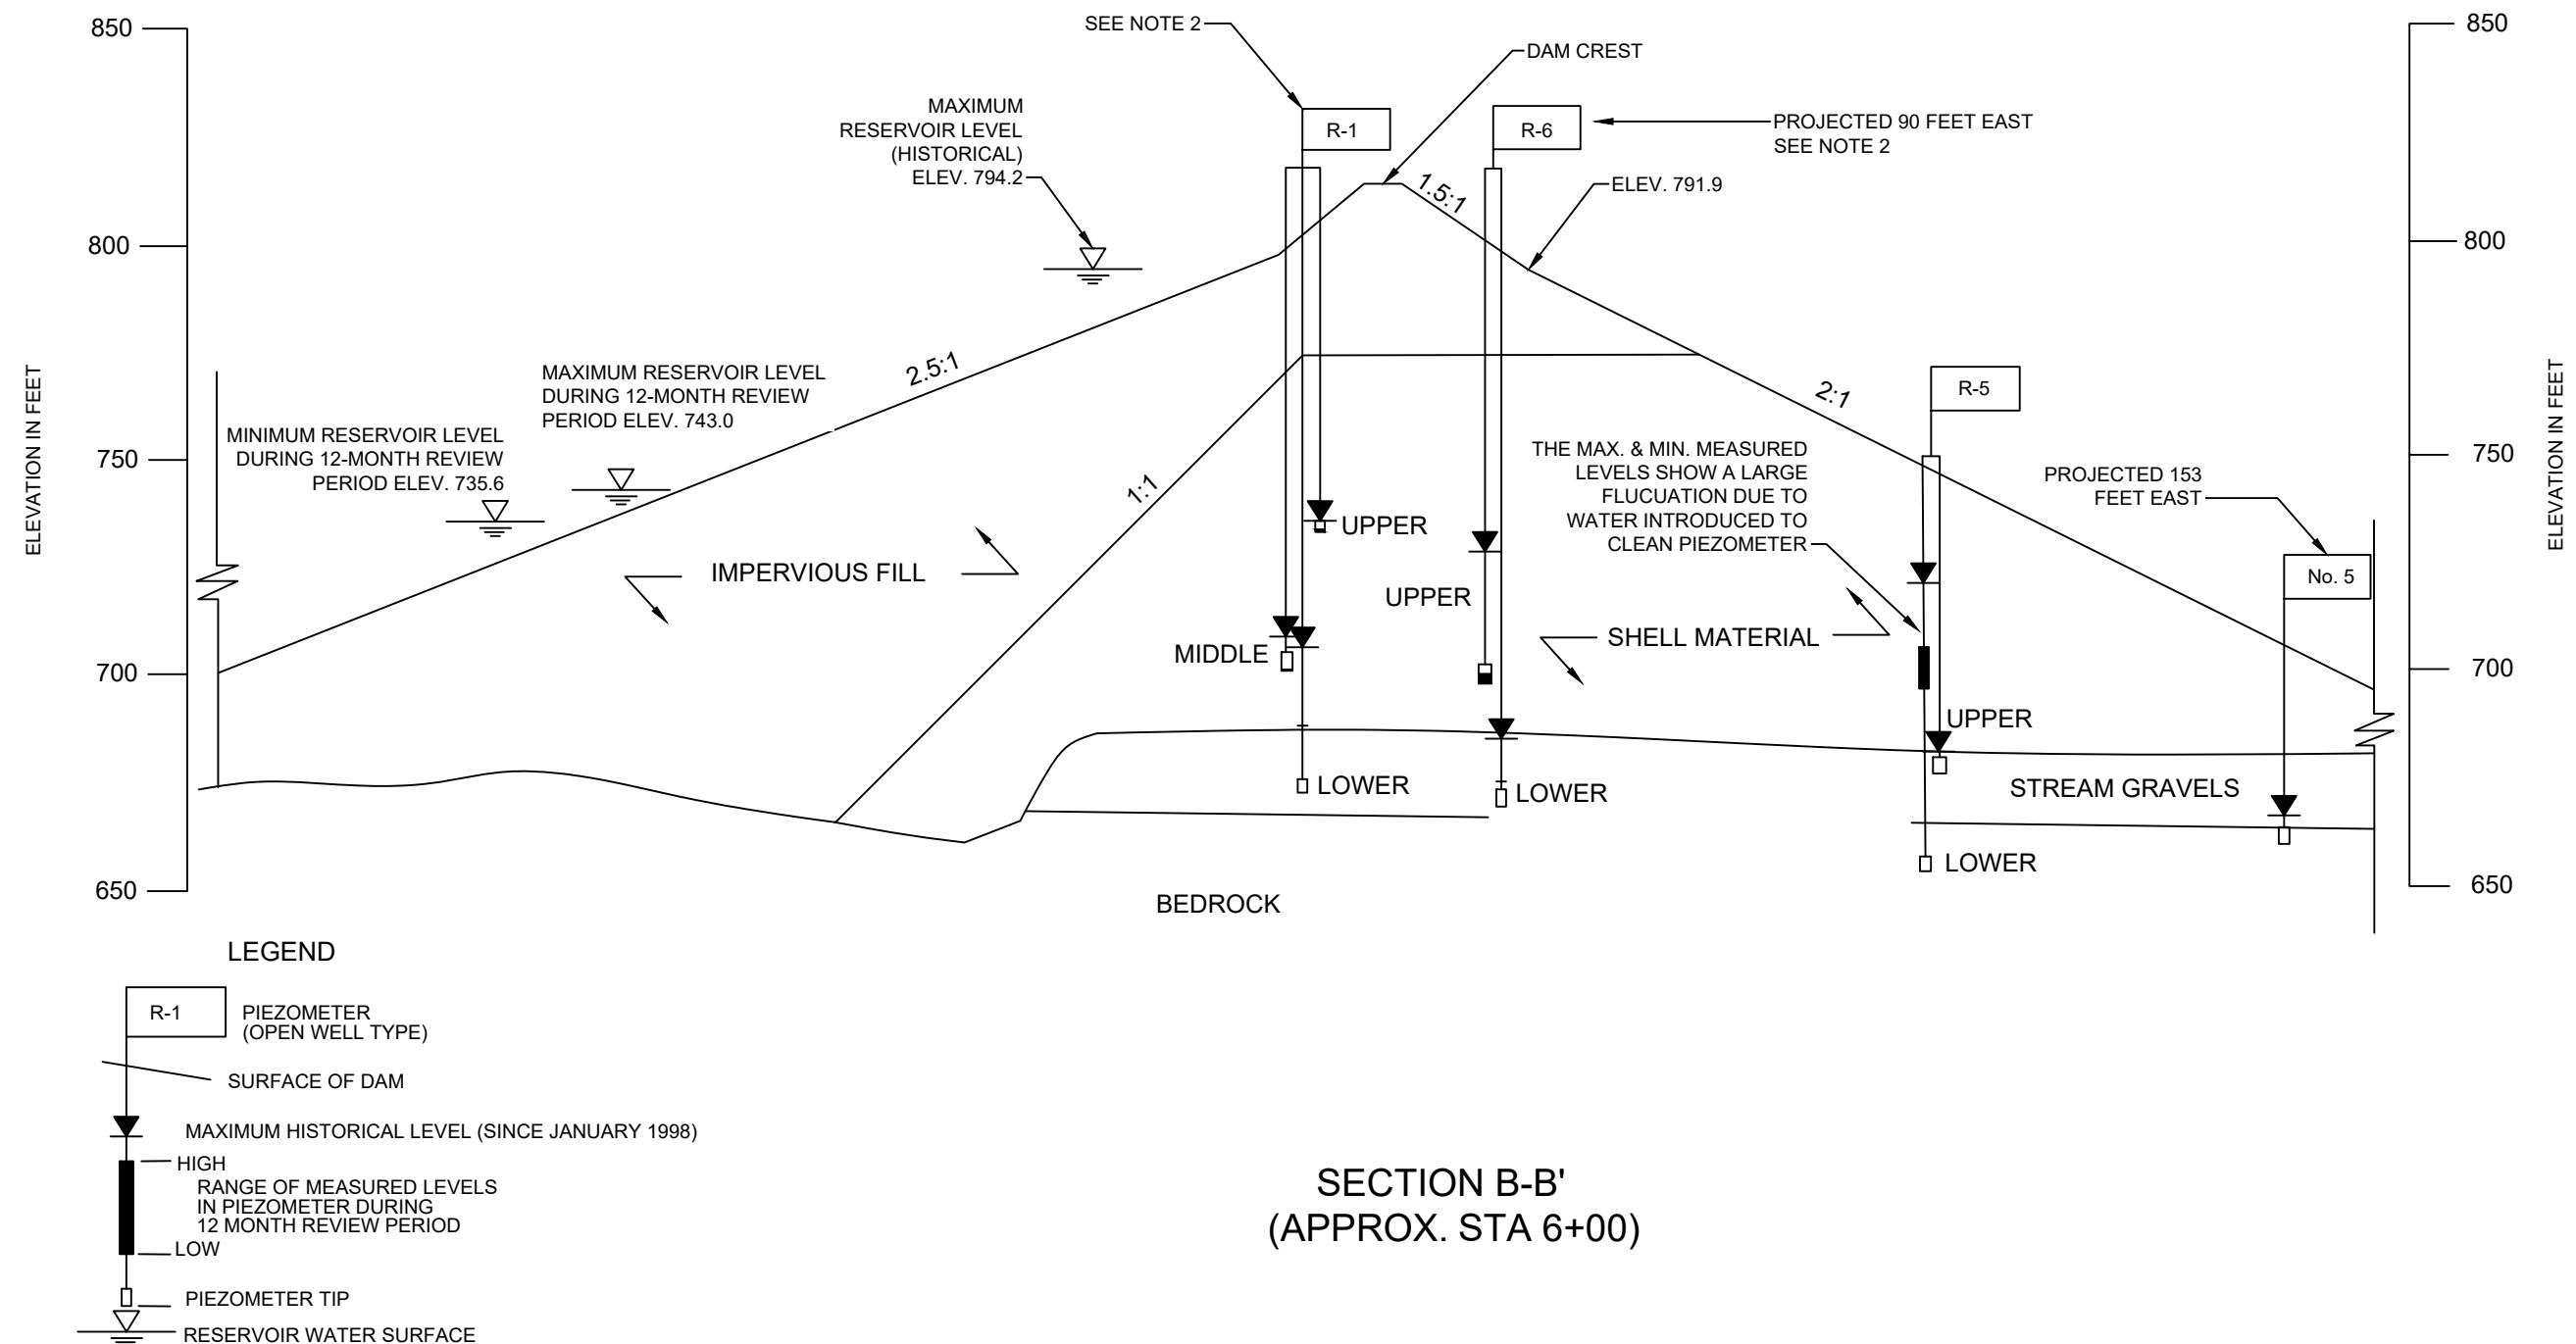
Fig. 1C

- (1) SEE FIGURE 1A FOR LOCATION OF SECTION
- (2) PIEZOMETERS R-1 AND R-6 ALIGN HORIZONTALLY WITH THE CENTER OF THE DAM CREST AND HAVE BEEN DISPLACED FOR PRESENTATION PURPOSES
- (3) QUESTIONABLE READINGS ARE NOT SHOWN

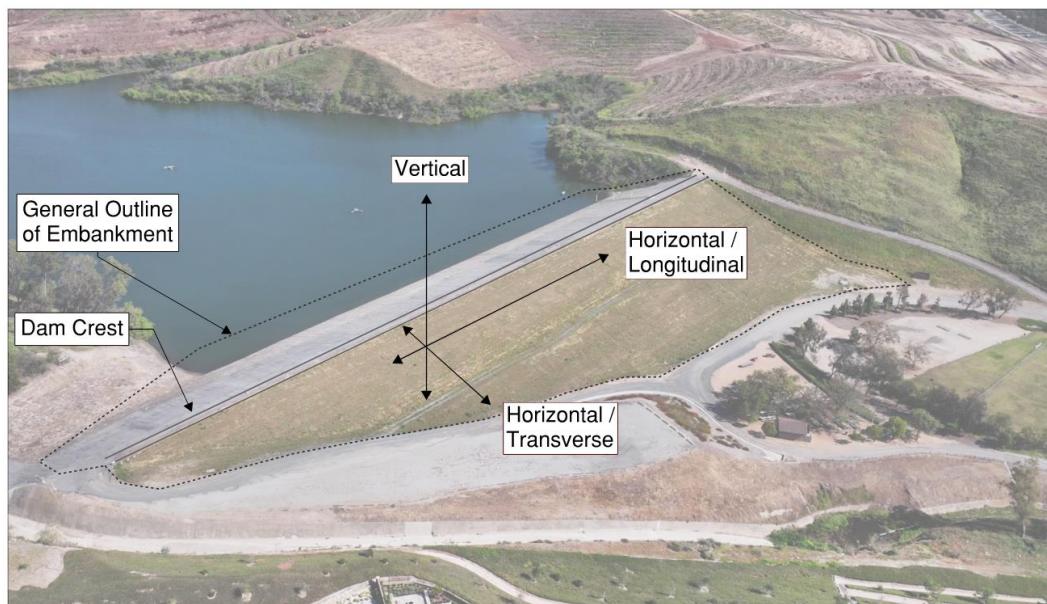
Continuing Education - The act of refreshing on existing knowledge or expanding an individual's knowledge in a particular field or topic.

Movement - the change in location or displacement of material or markers in the vertical and/or horizontal direction. Description of the movement is shown in the below exhibit.

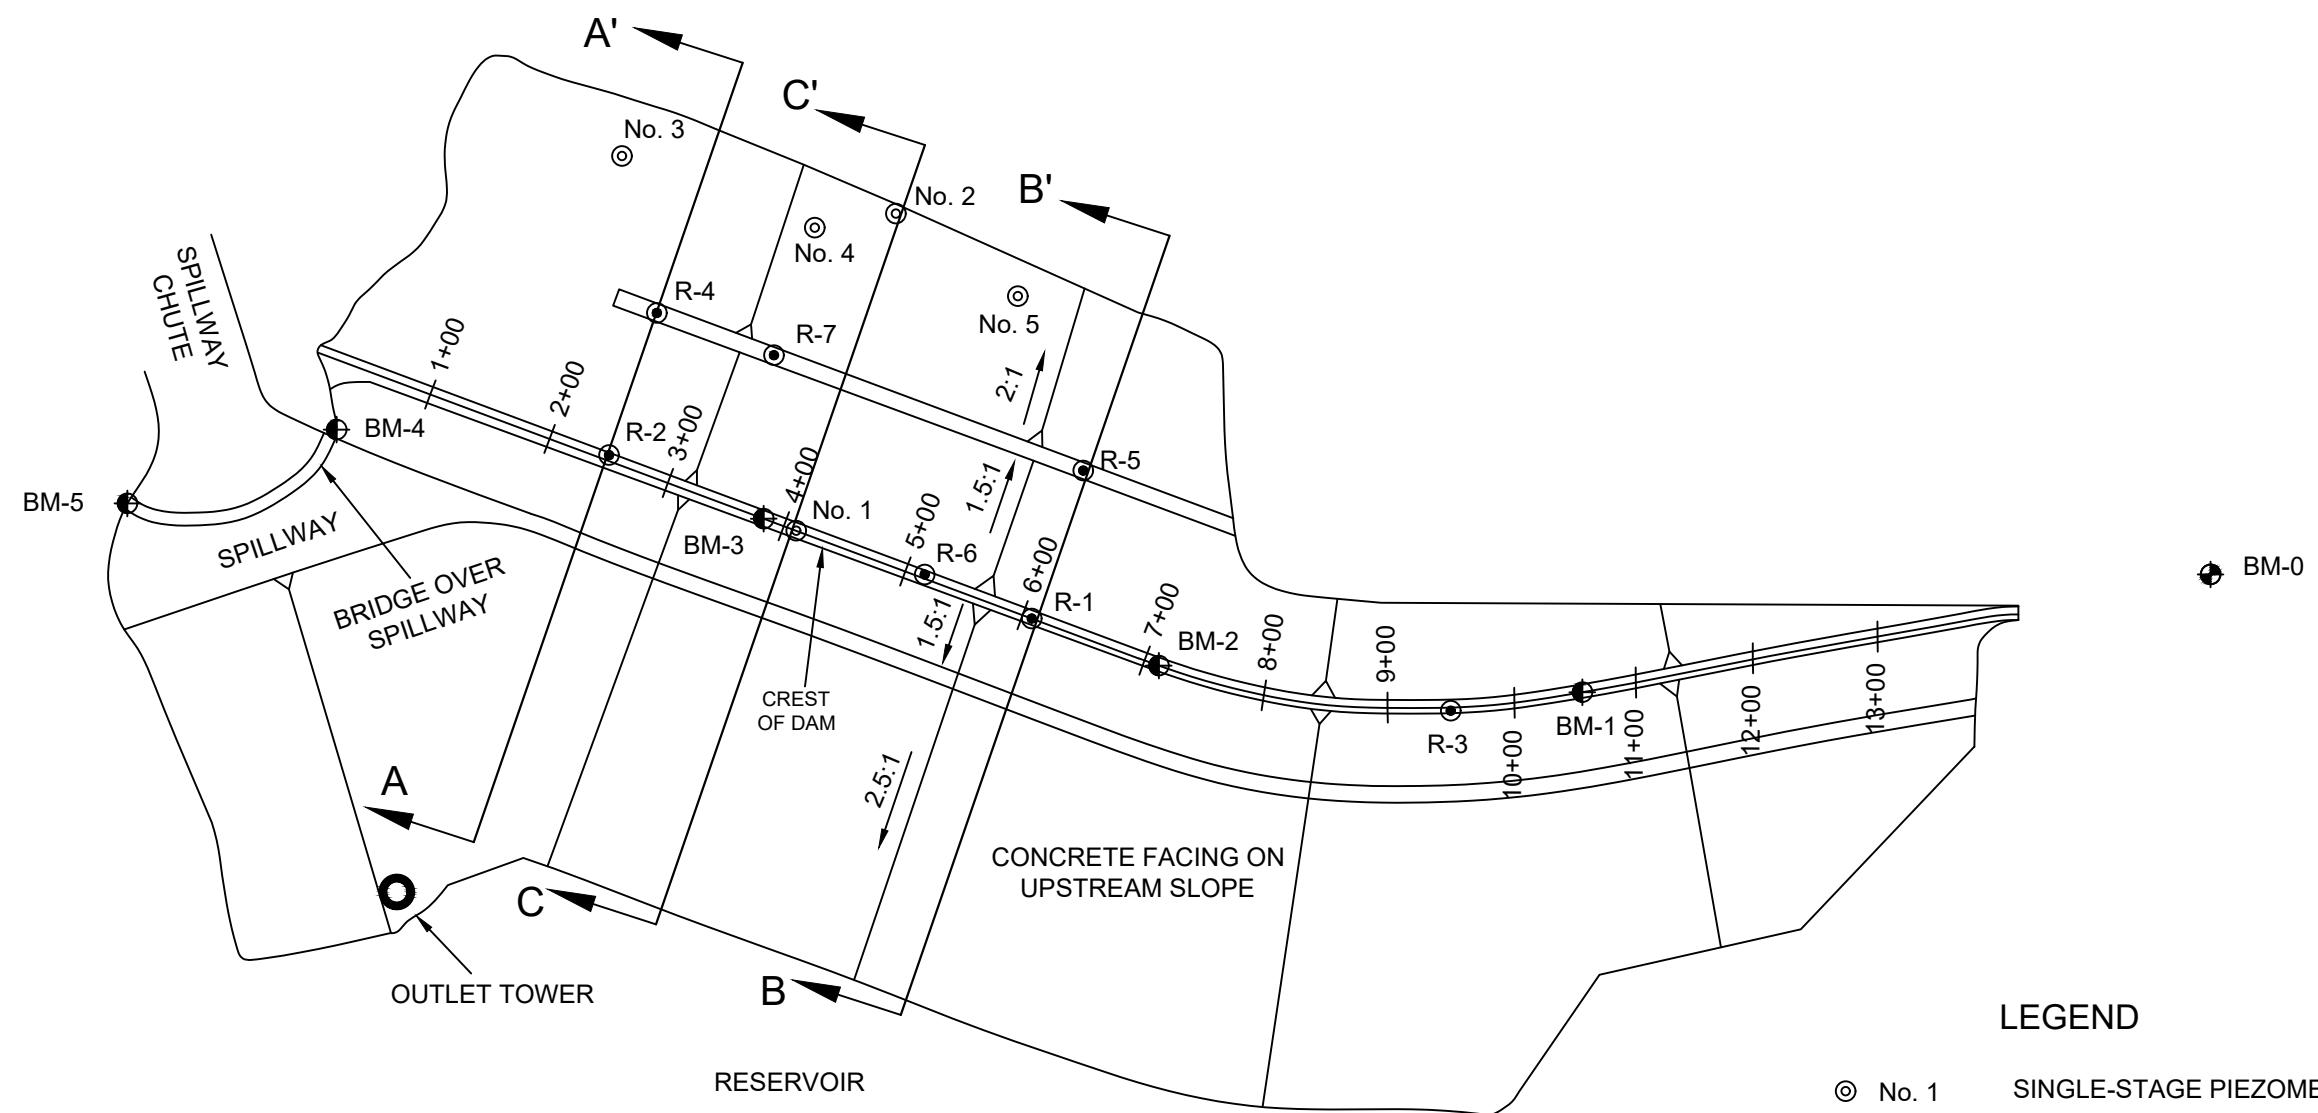
- No. 1 SINGLE-STAGE PIEZOMETER
- R-2 MULTI-STAGE PIEZOMETER
- ◆ BM-5 SURVEY MONUMENTS
- ◆ BM-0 BENCH MARK

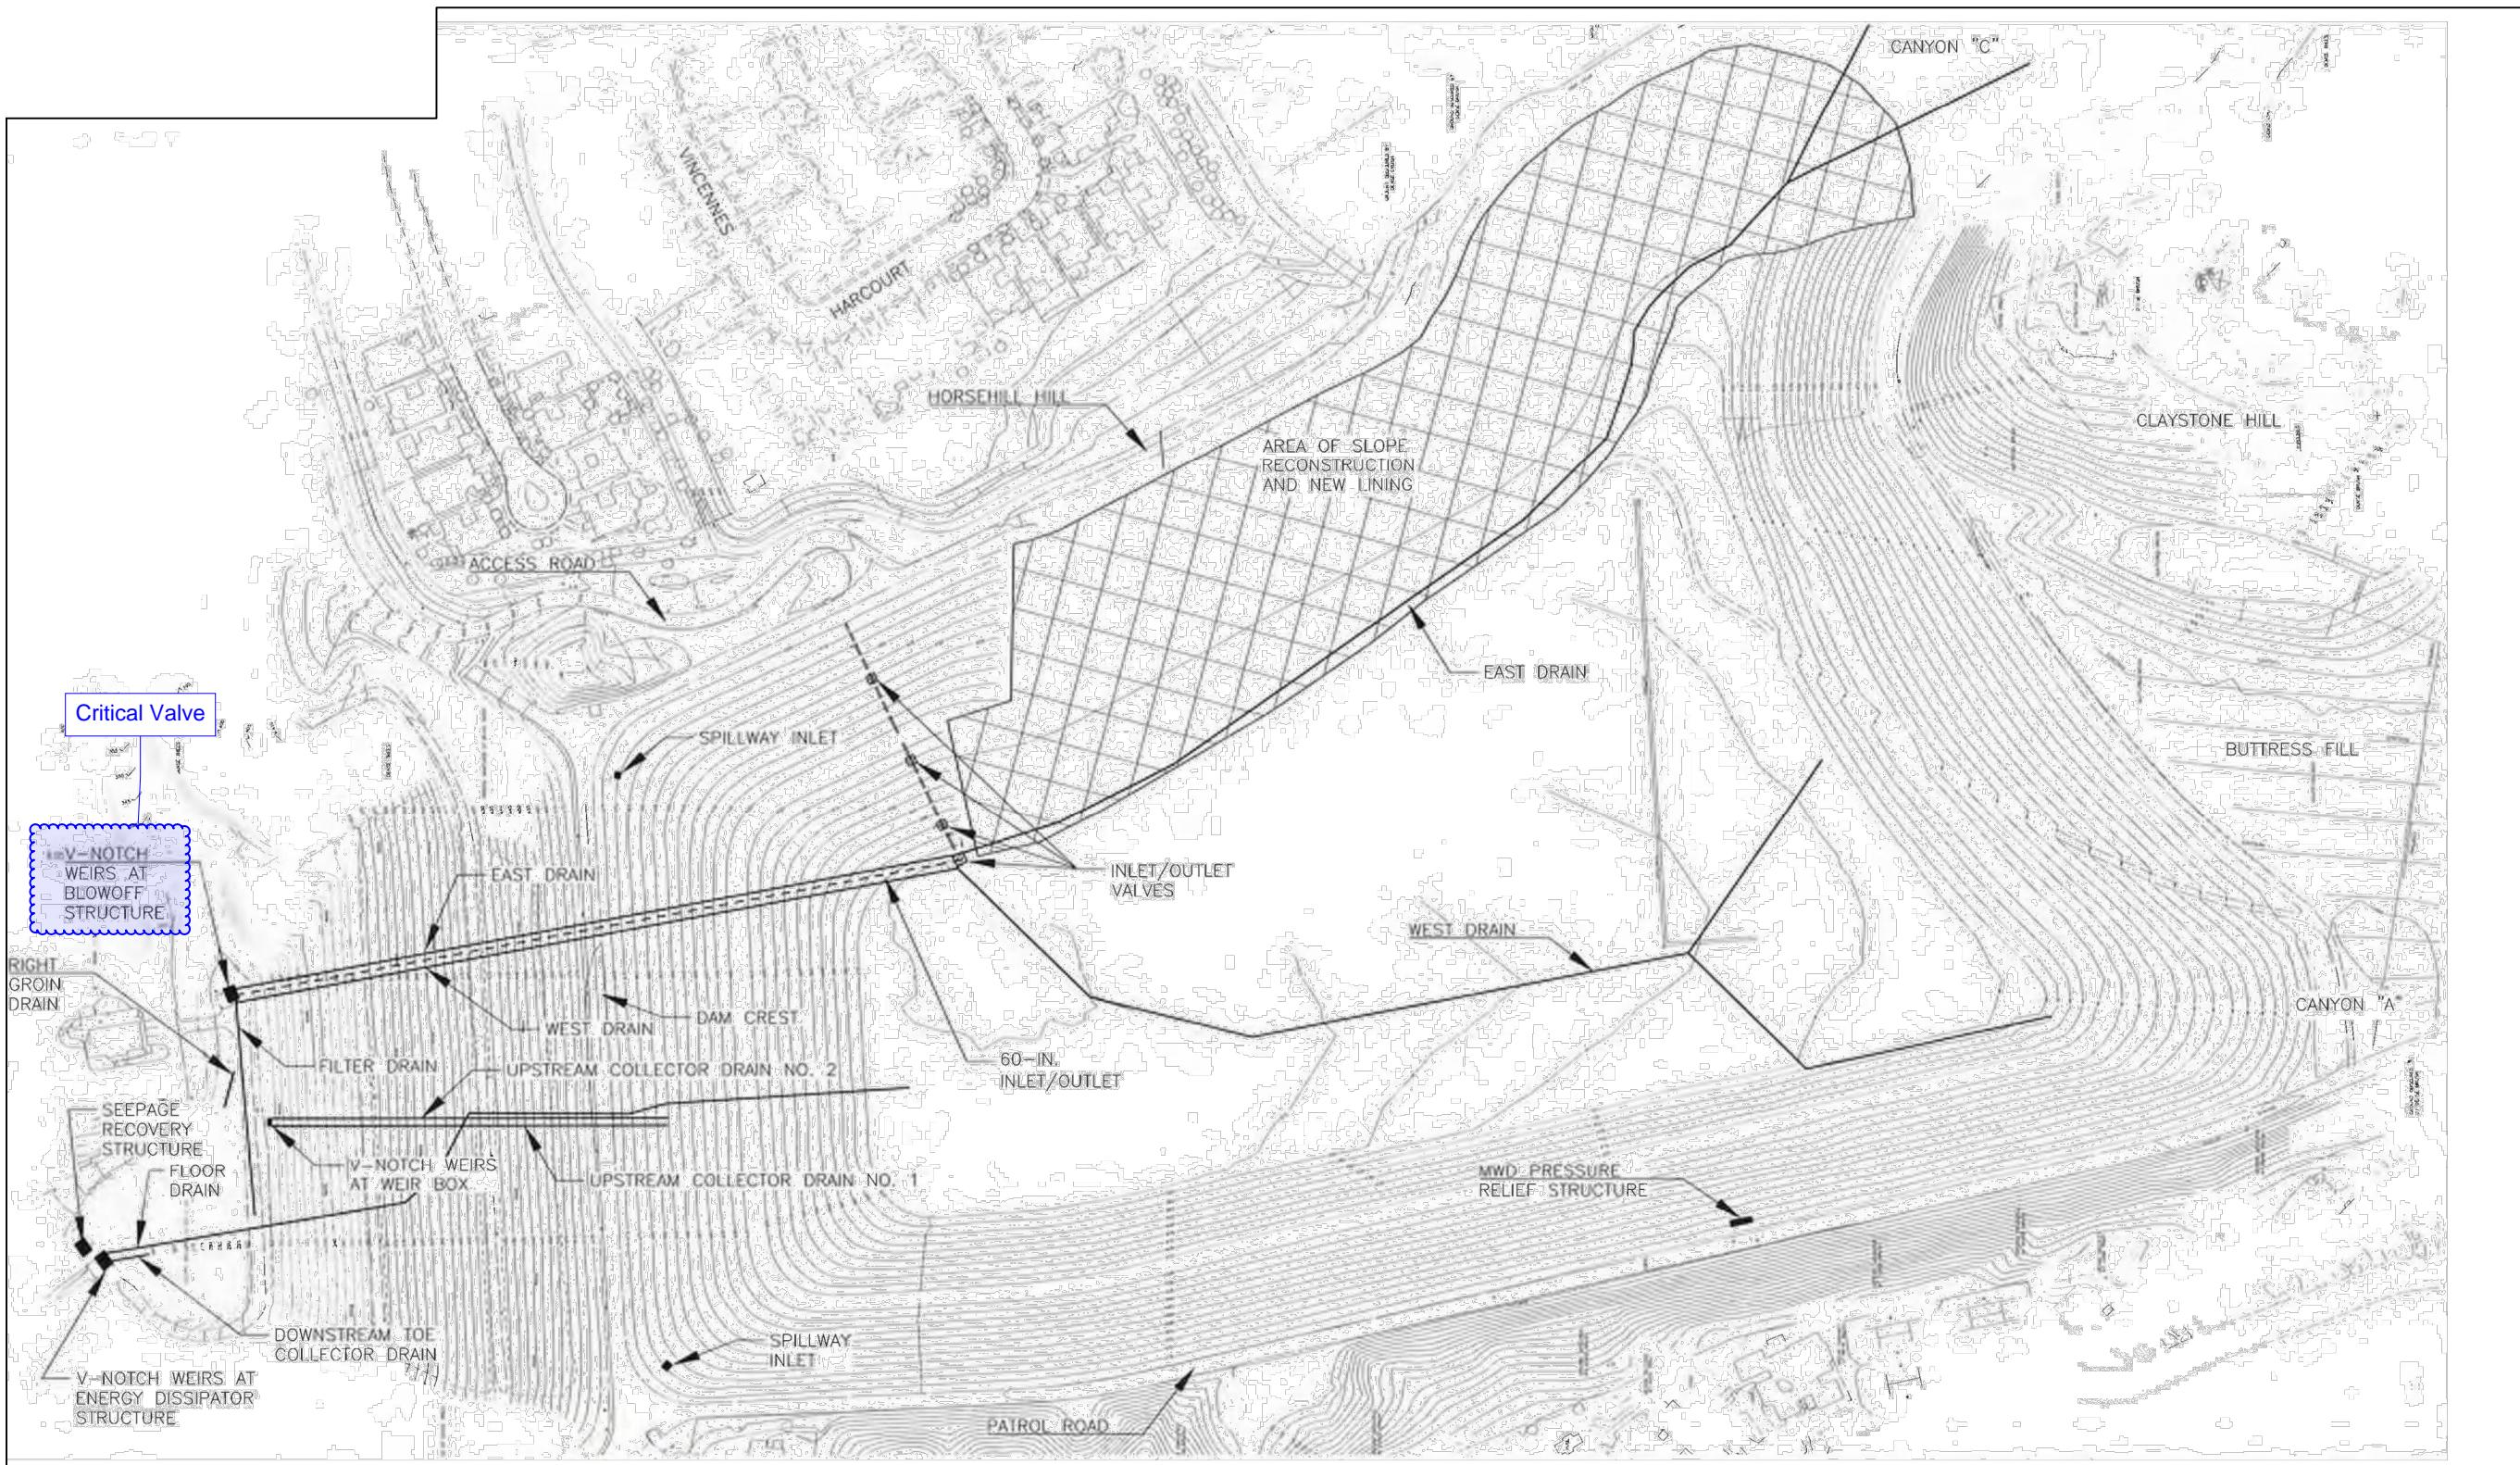
Annual Surveillance Report from Jan. 2021 to Dec. 2021
San Joaquin Dam and Reservoir
Irvine, CA

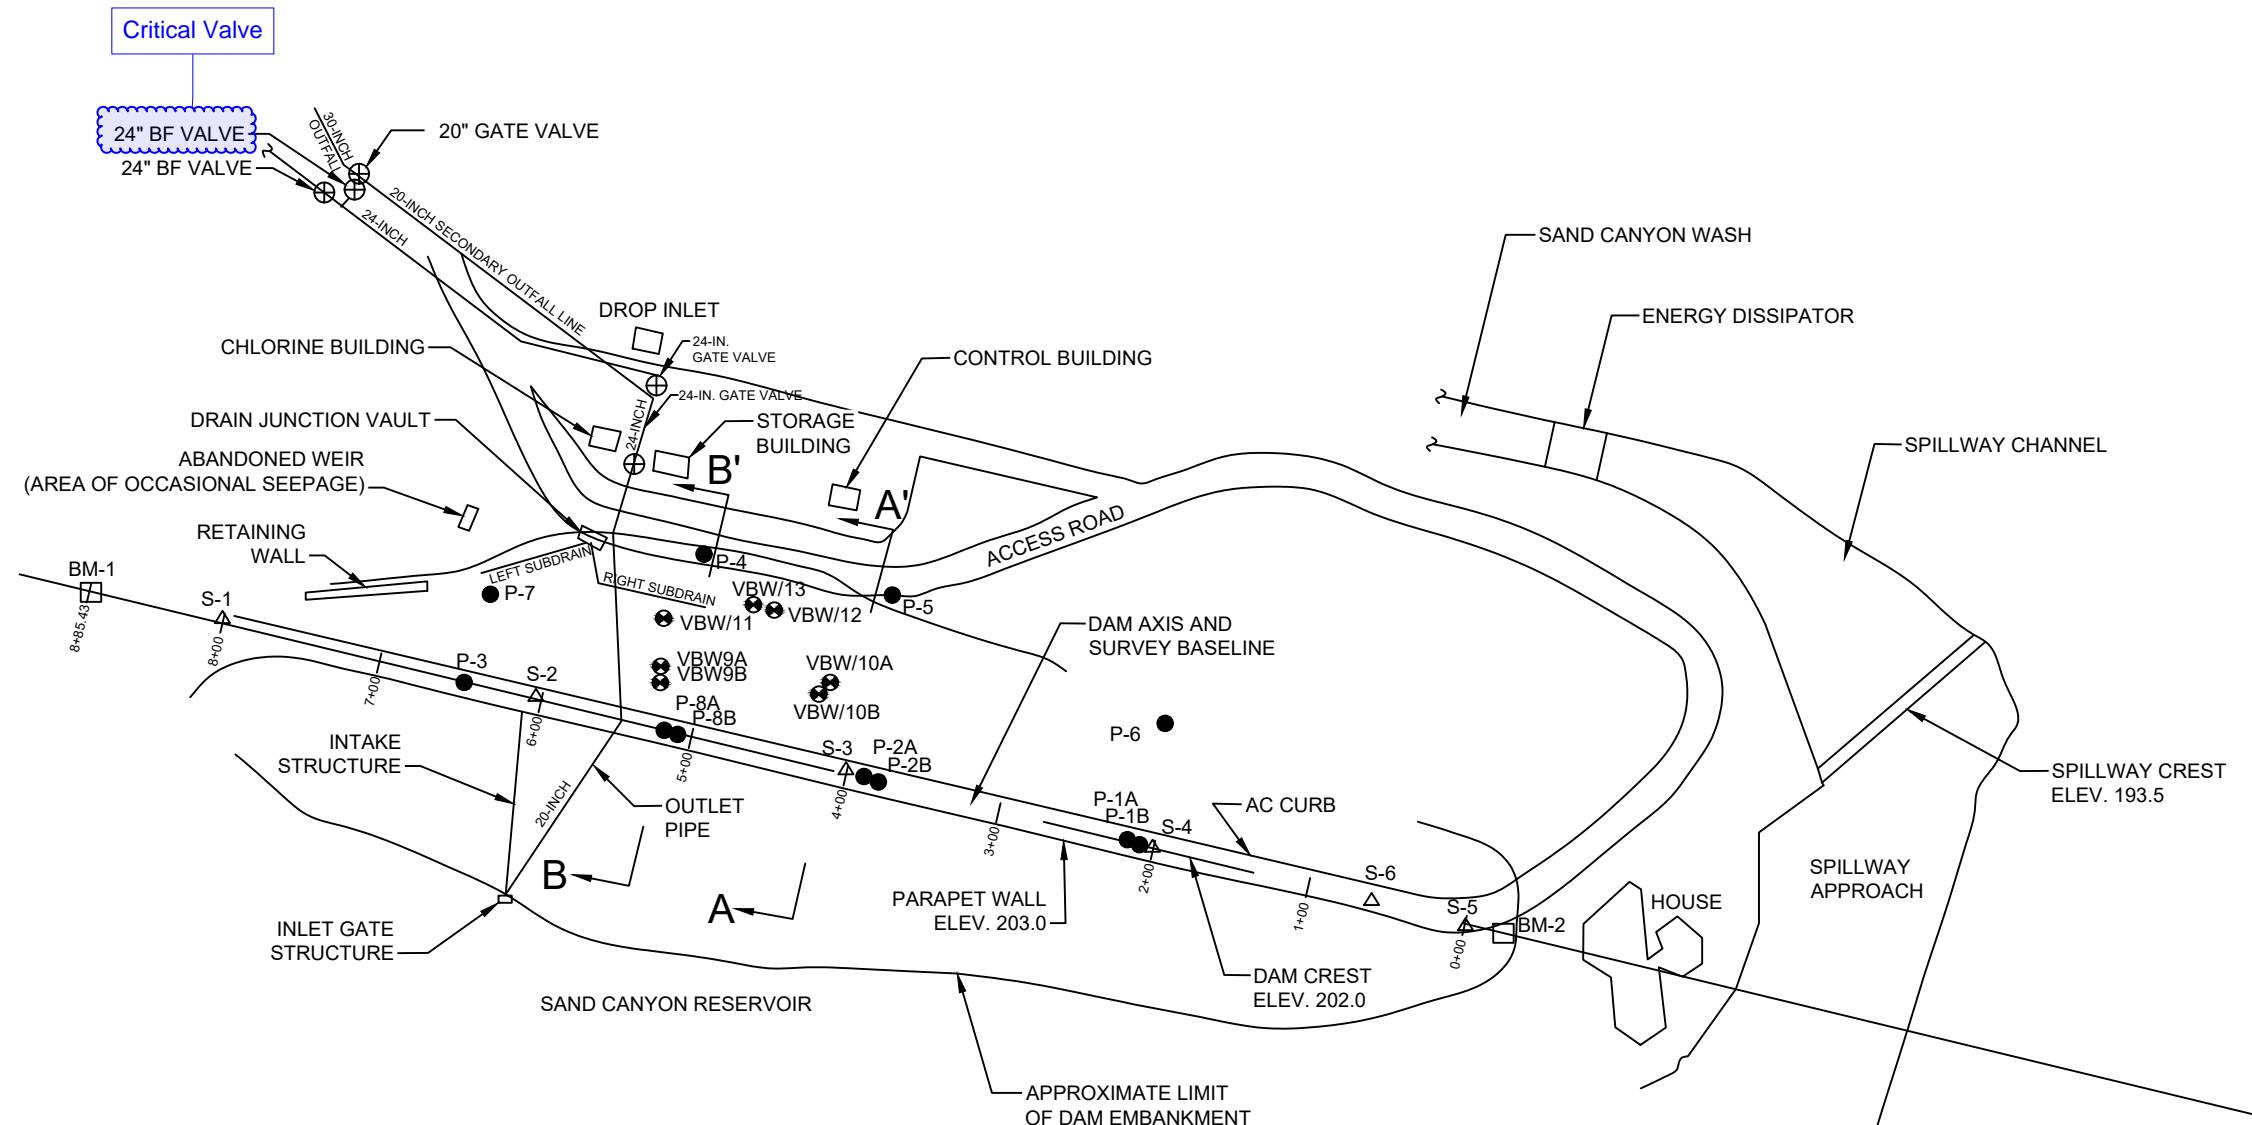
Annual Surveillance Report from Jan. 2021 to Dec. 2021
Sand Canyon Dam
Irvine, CA

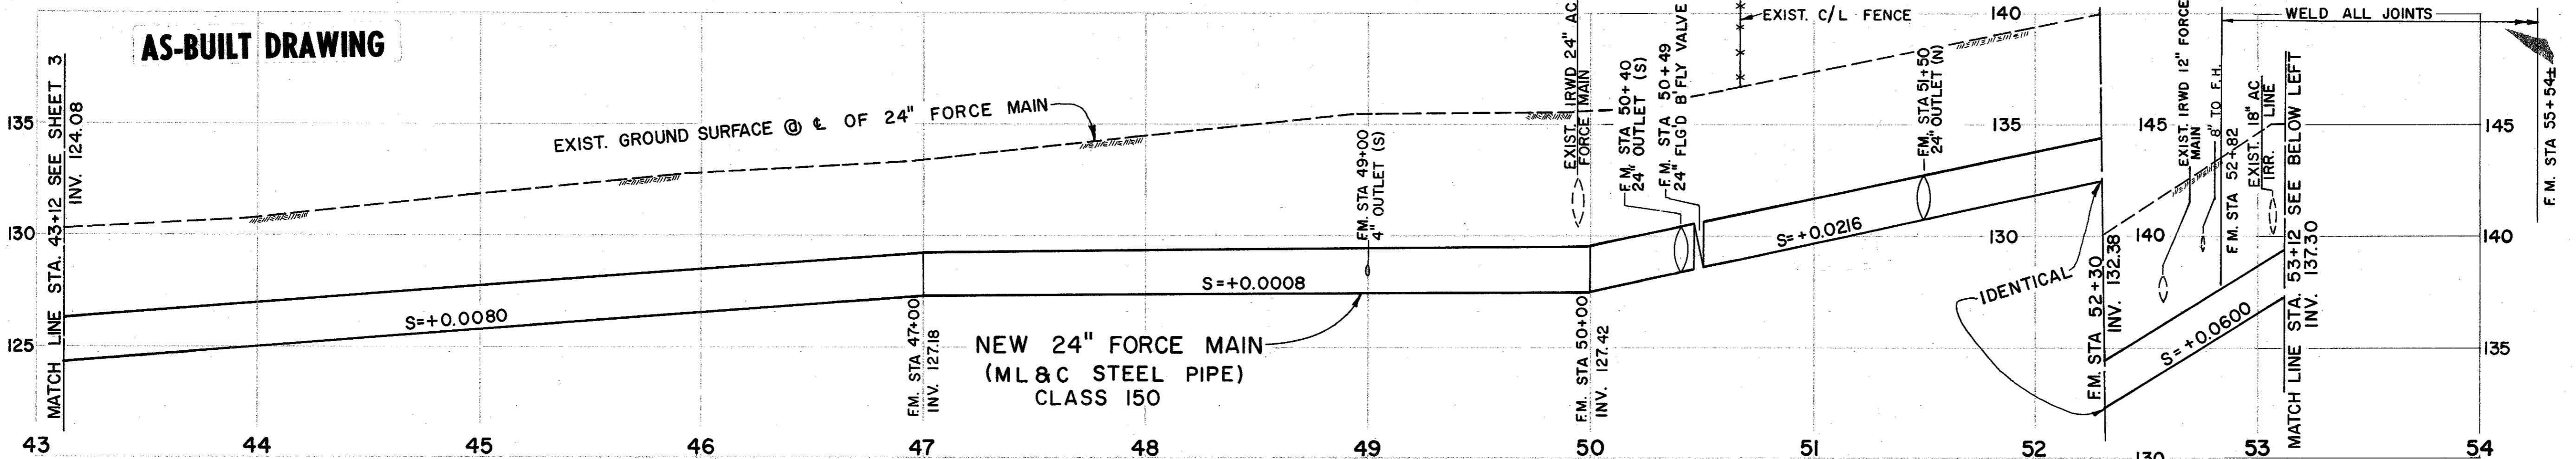
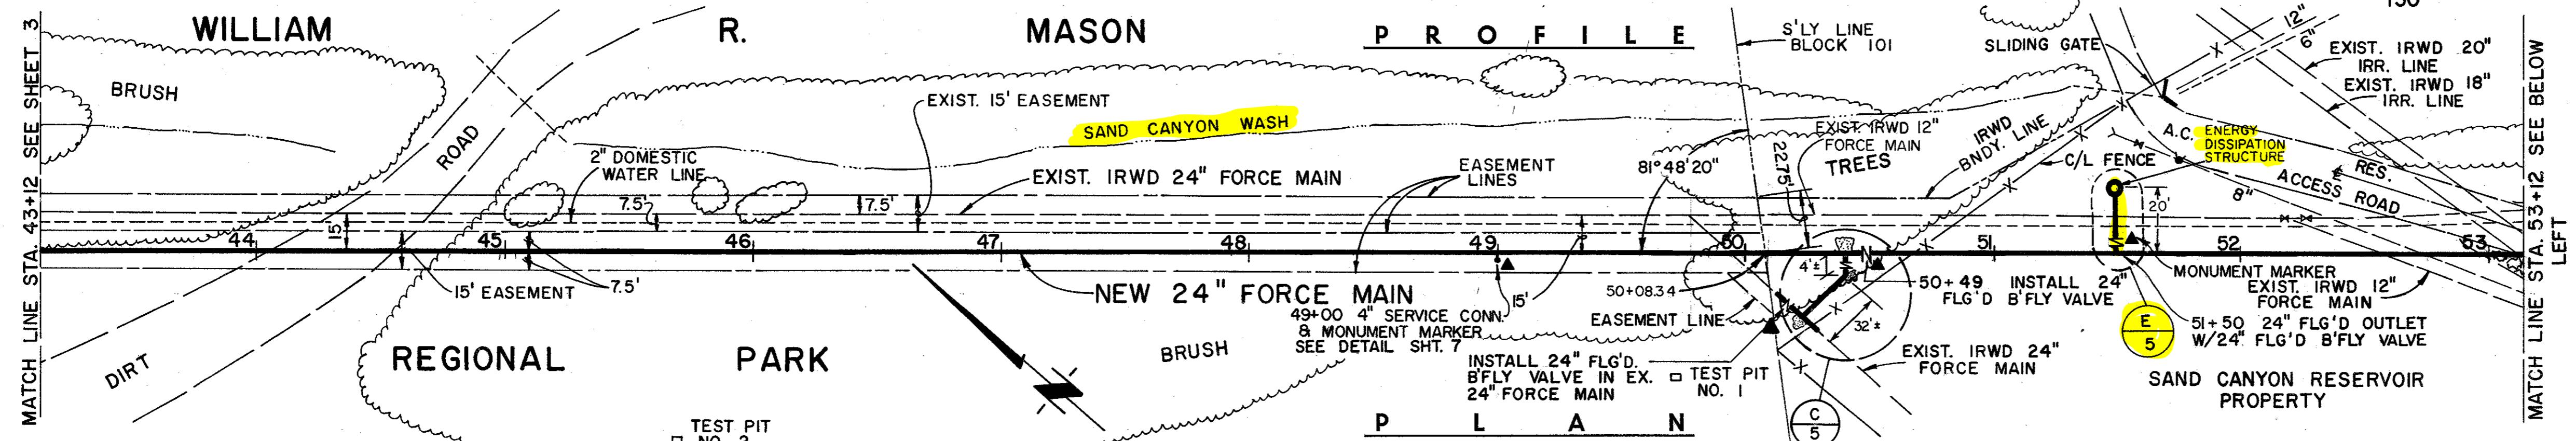
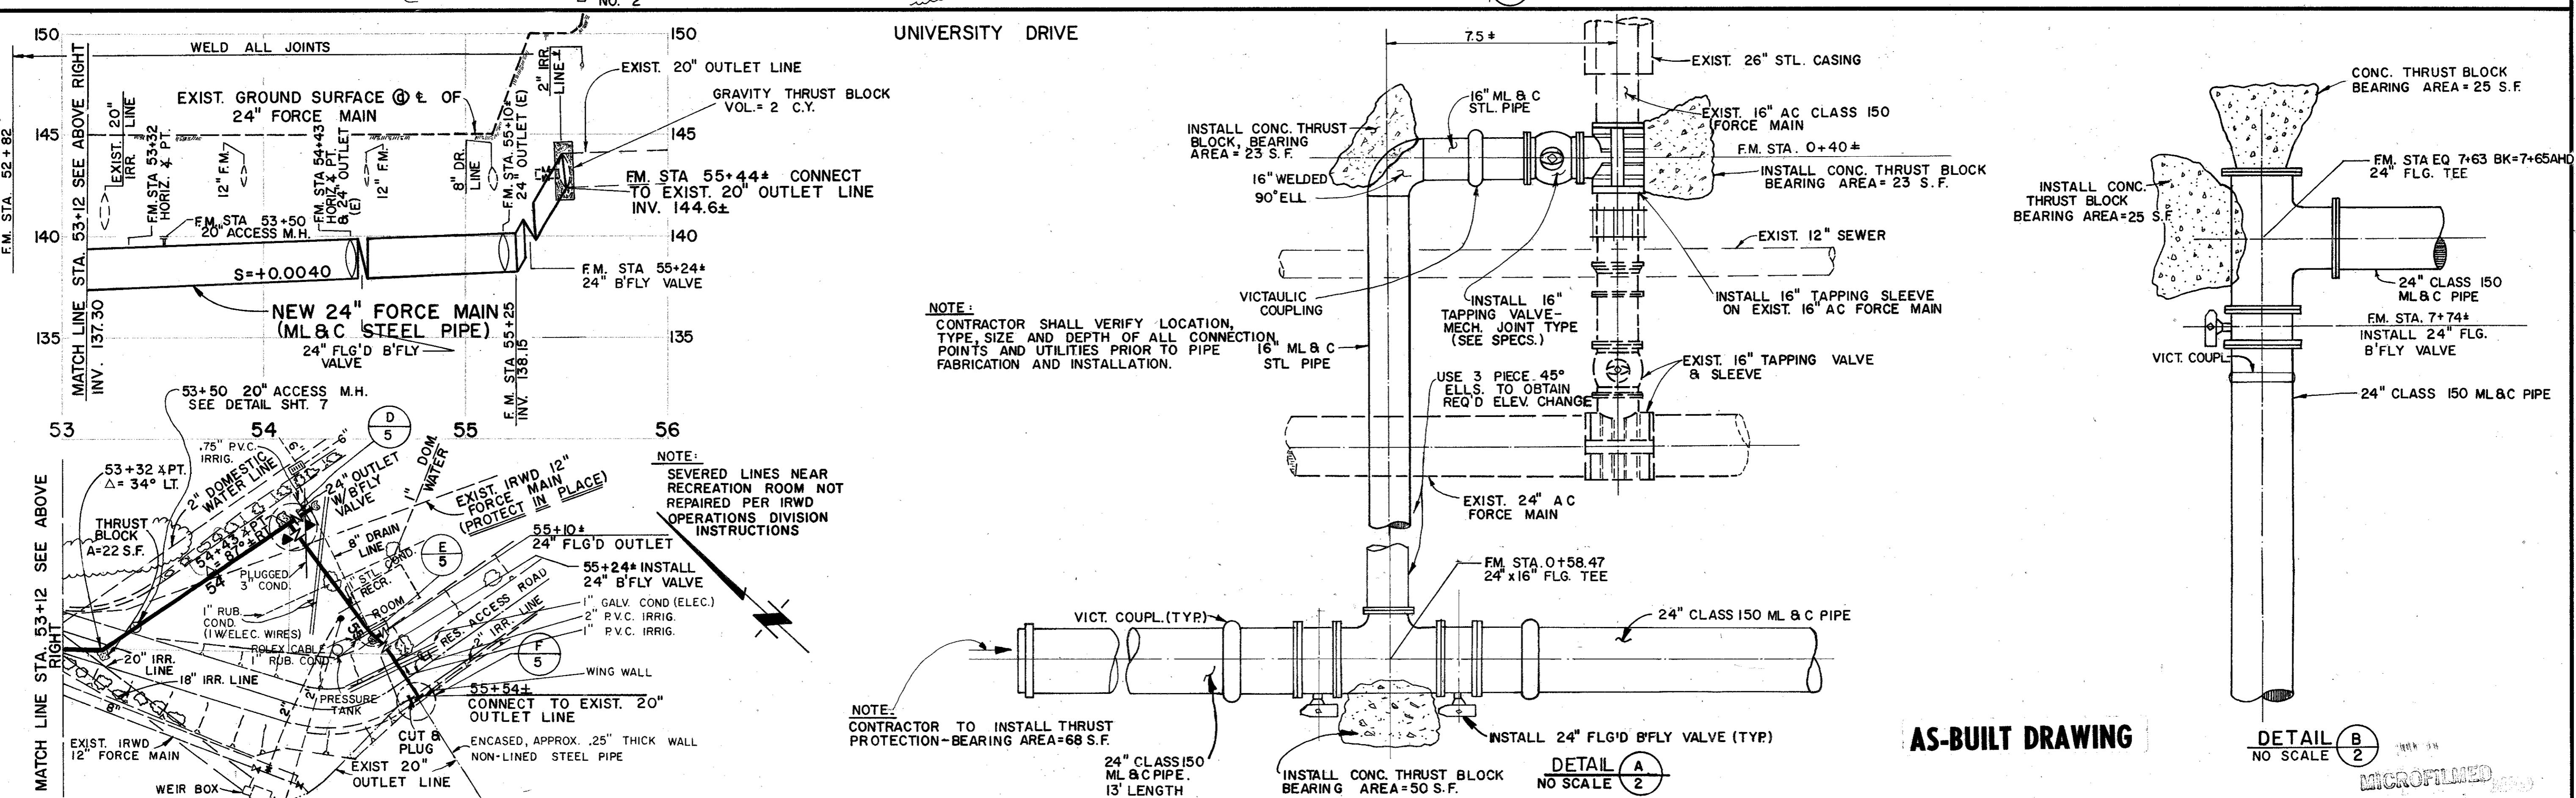
IRVINE RANCH WATER DISTRICT MUD CANYON RESERVOIR RECLAIMED WATER FORCE MAIN MISCELLANEOUS DETAILS	SHEET 5 OF 8 SHEETS
---	---

NOTE: CONTRACTOR SHALL VERIFY LOCATION, TYPE, SIZE, AND DEPTH OF ALL PIPING AND UTILITIES PRIOR TO PIPE FABRICATION AND INSTALLATION.

MATCH LINE STA. 53+12 SEE BELOW
LEFT

DETAIL B
