DAM SAFETY PROGRAM

Guidelines & Governance

**Irvine Ranch
Water District**

January 2026

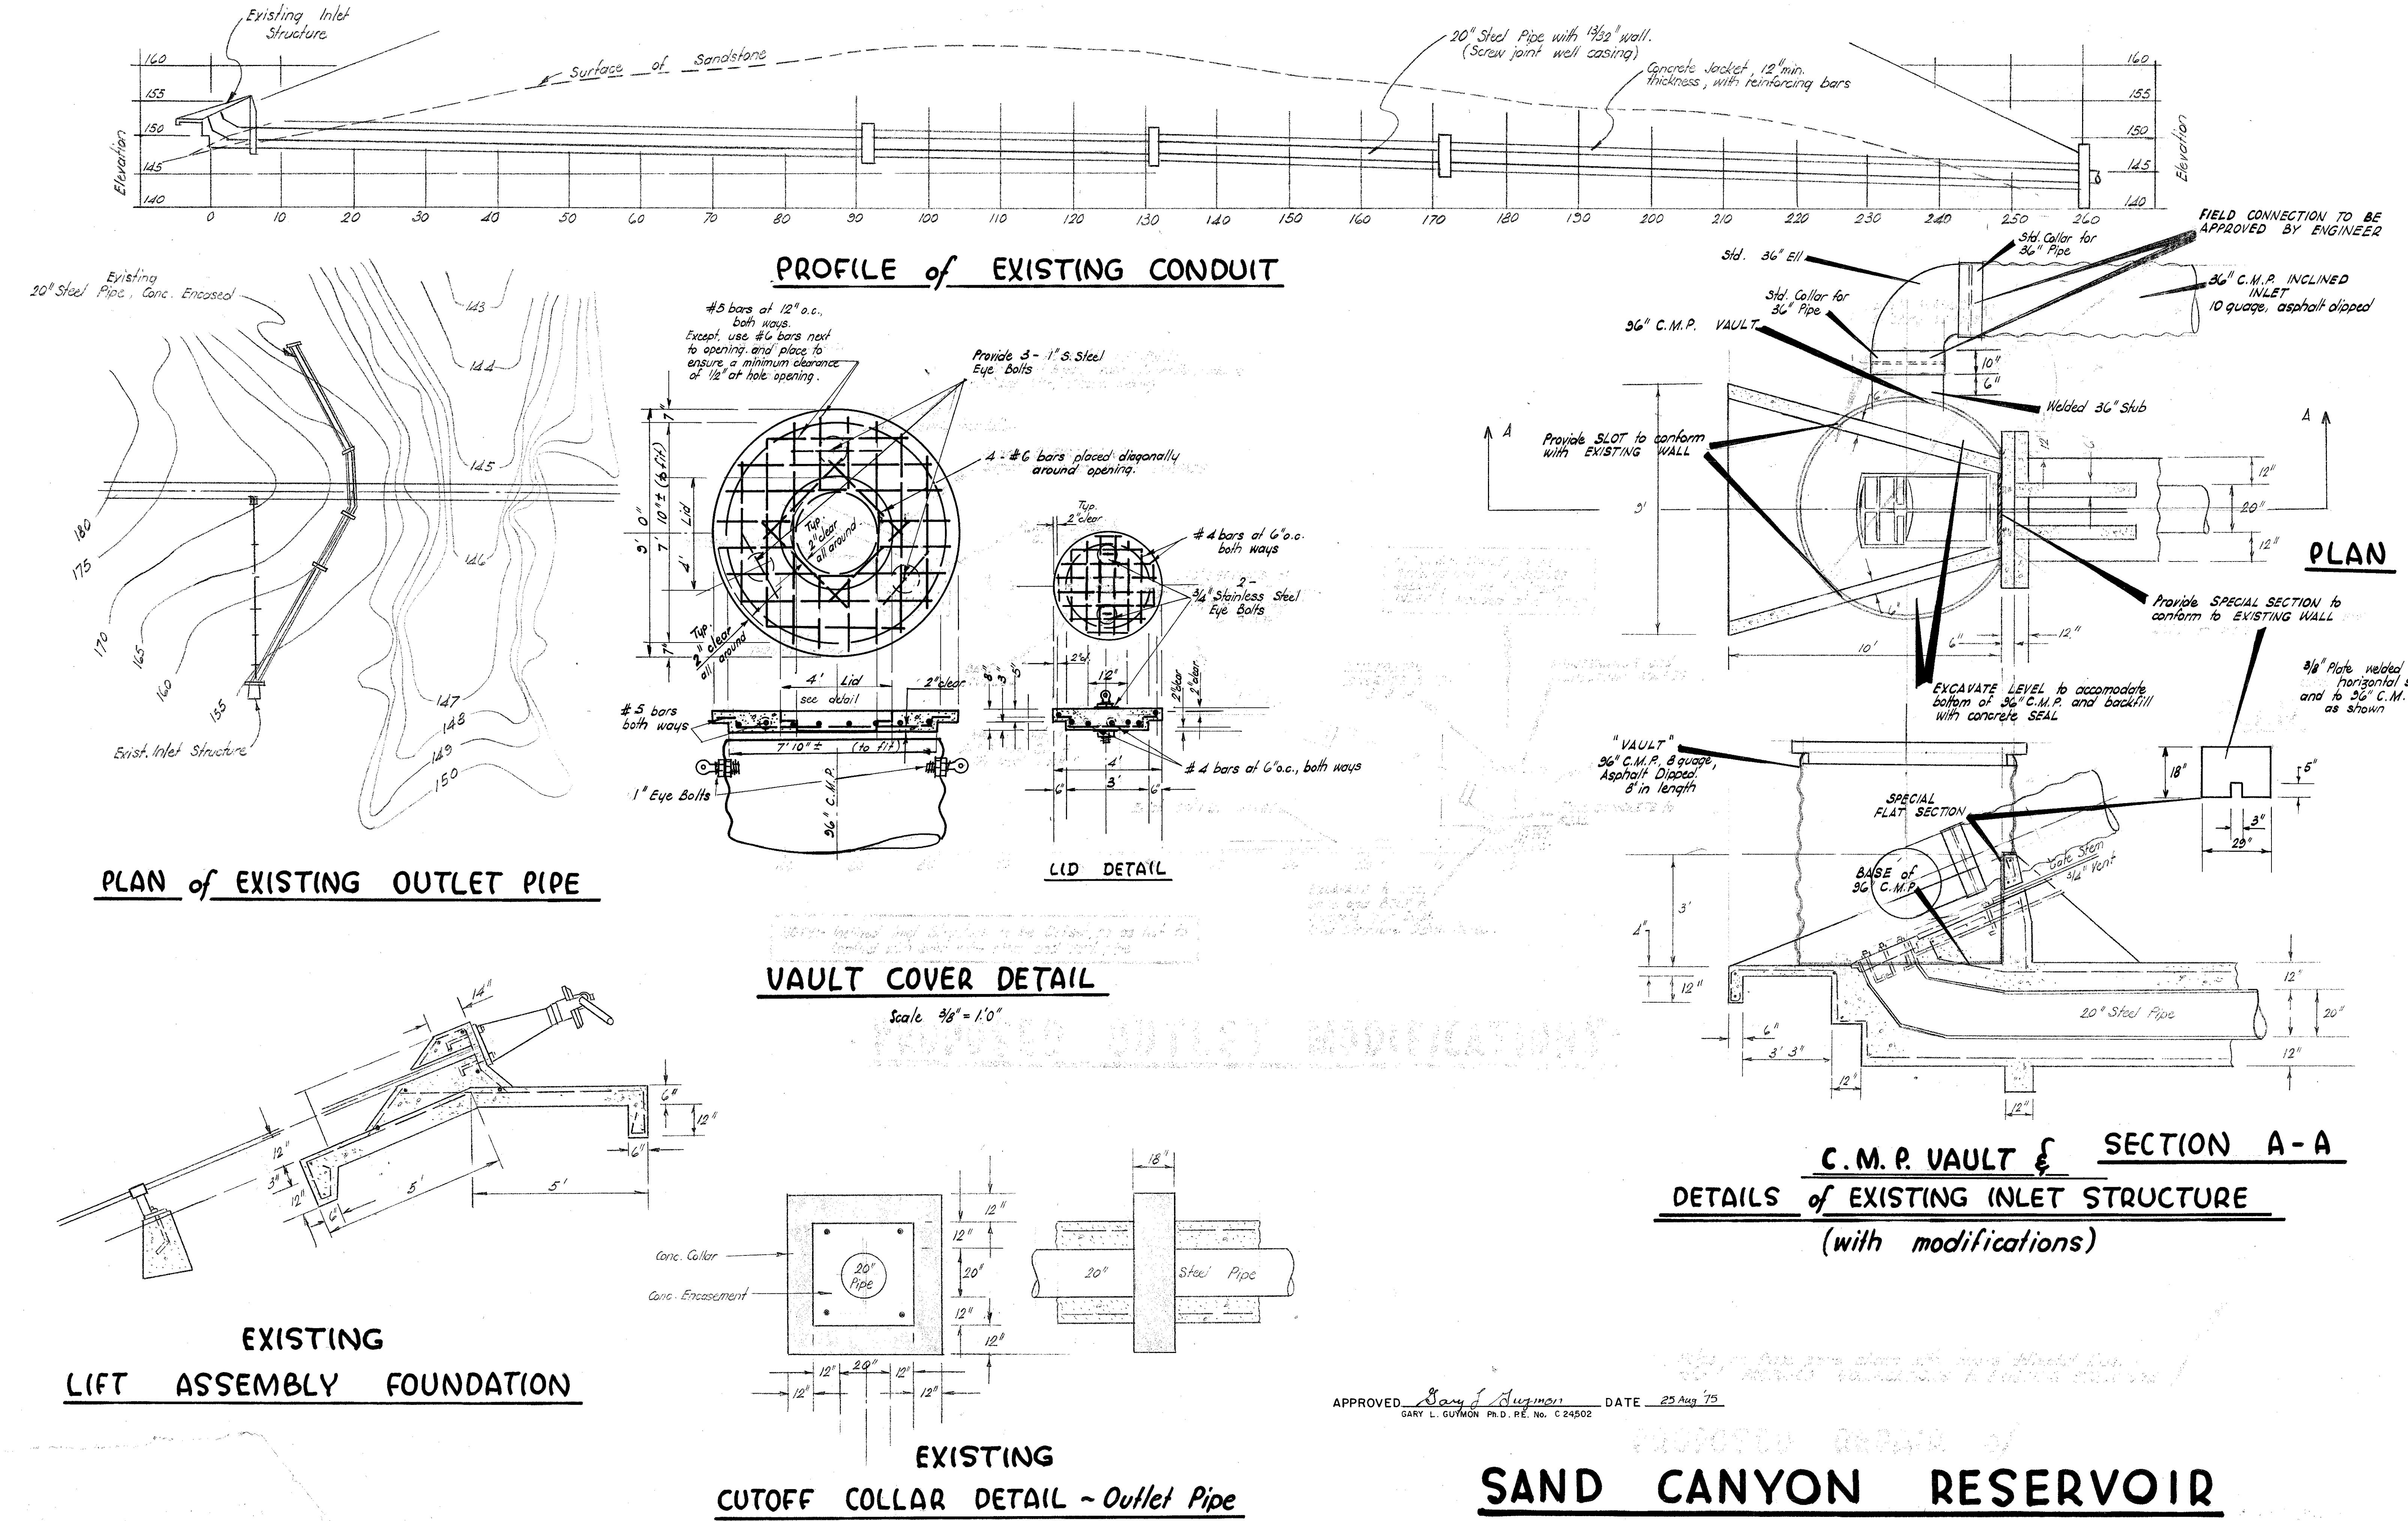
SAND CANYON RESERVOIR OUTLET WORKS

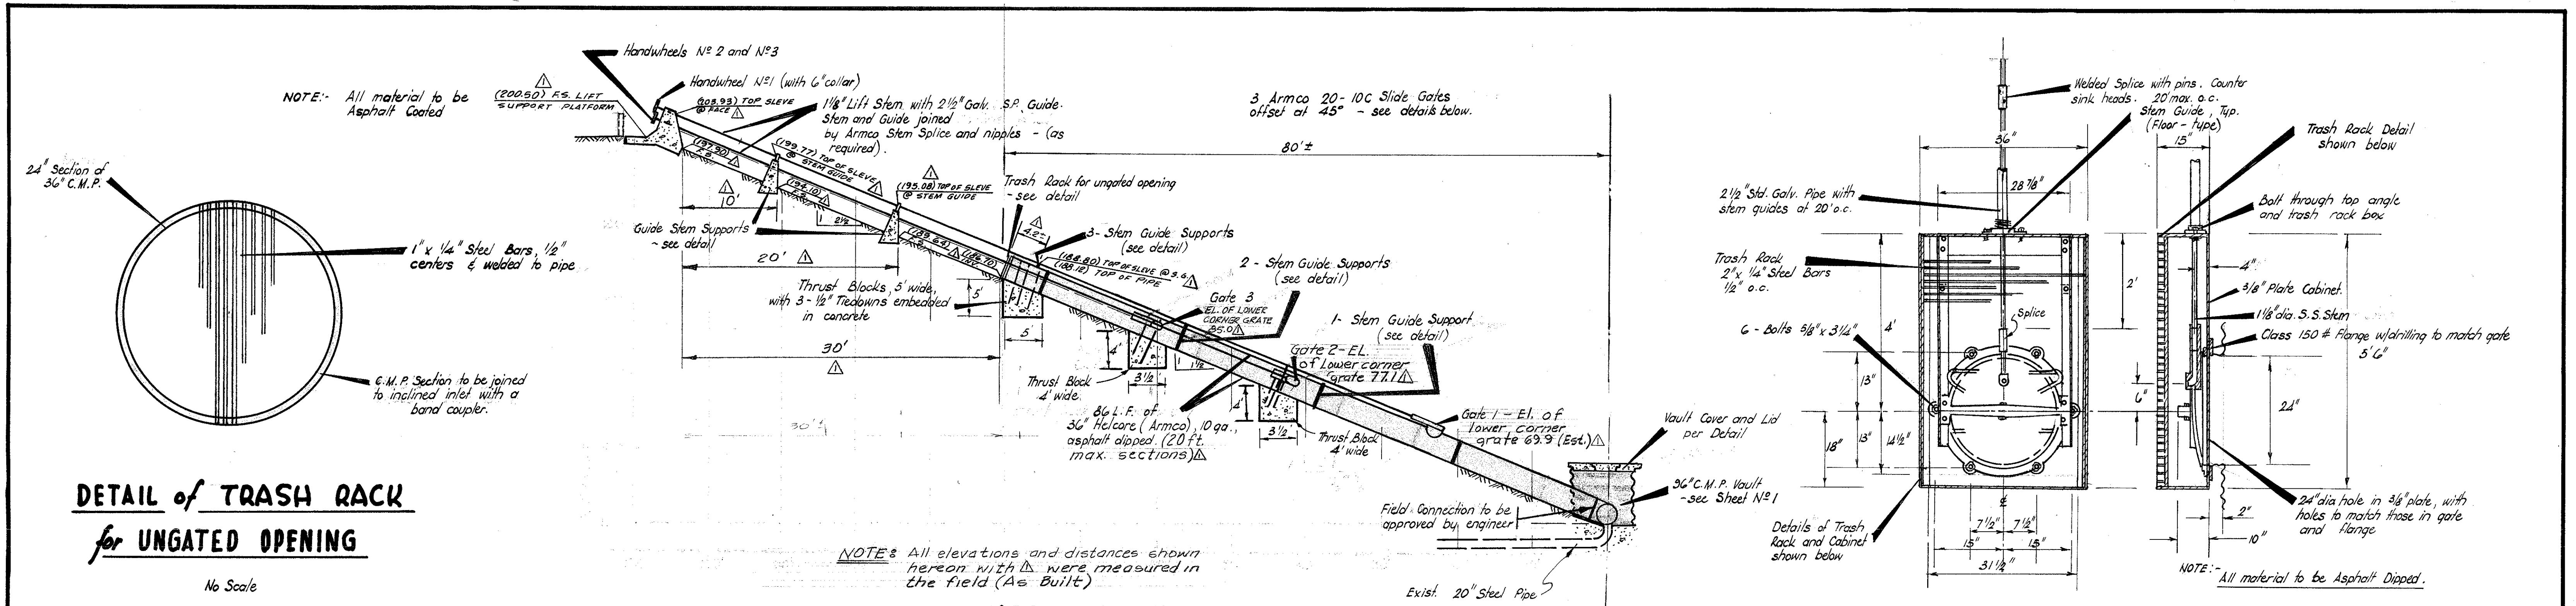
DETAIL of TRASH RACK for UNGATED OPENING

DETAIL of GATE ASSEMBLIES

(3 REQUIRED)

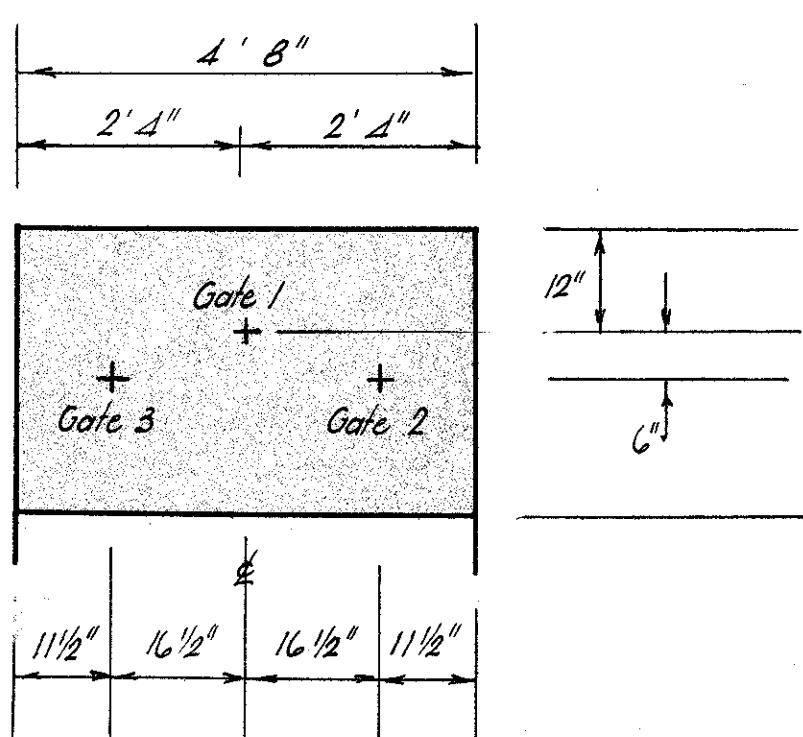
TEMPLATE for POSITIONING HANDWHEEL LIFTS

1. Surface of Reservoir slope shall be cleaned of all debris and 36-inch C.M.P. provided with smooth solid base.
2. All machine bolts, nuts and washers shall be Type 316 Stainless Steel.
3. The Contractor shall verify all notes and dimensions prior to starting any work or fabrication of pipe and structures.
4. Slide Gate guides shall be installed per manufacturing recommendations. Max. spacing 20' c.c. on stem guides.

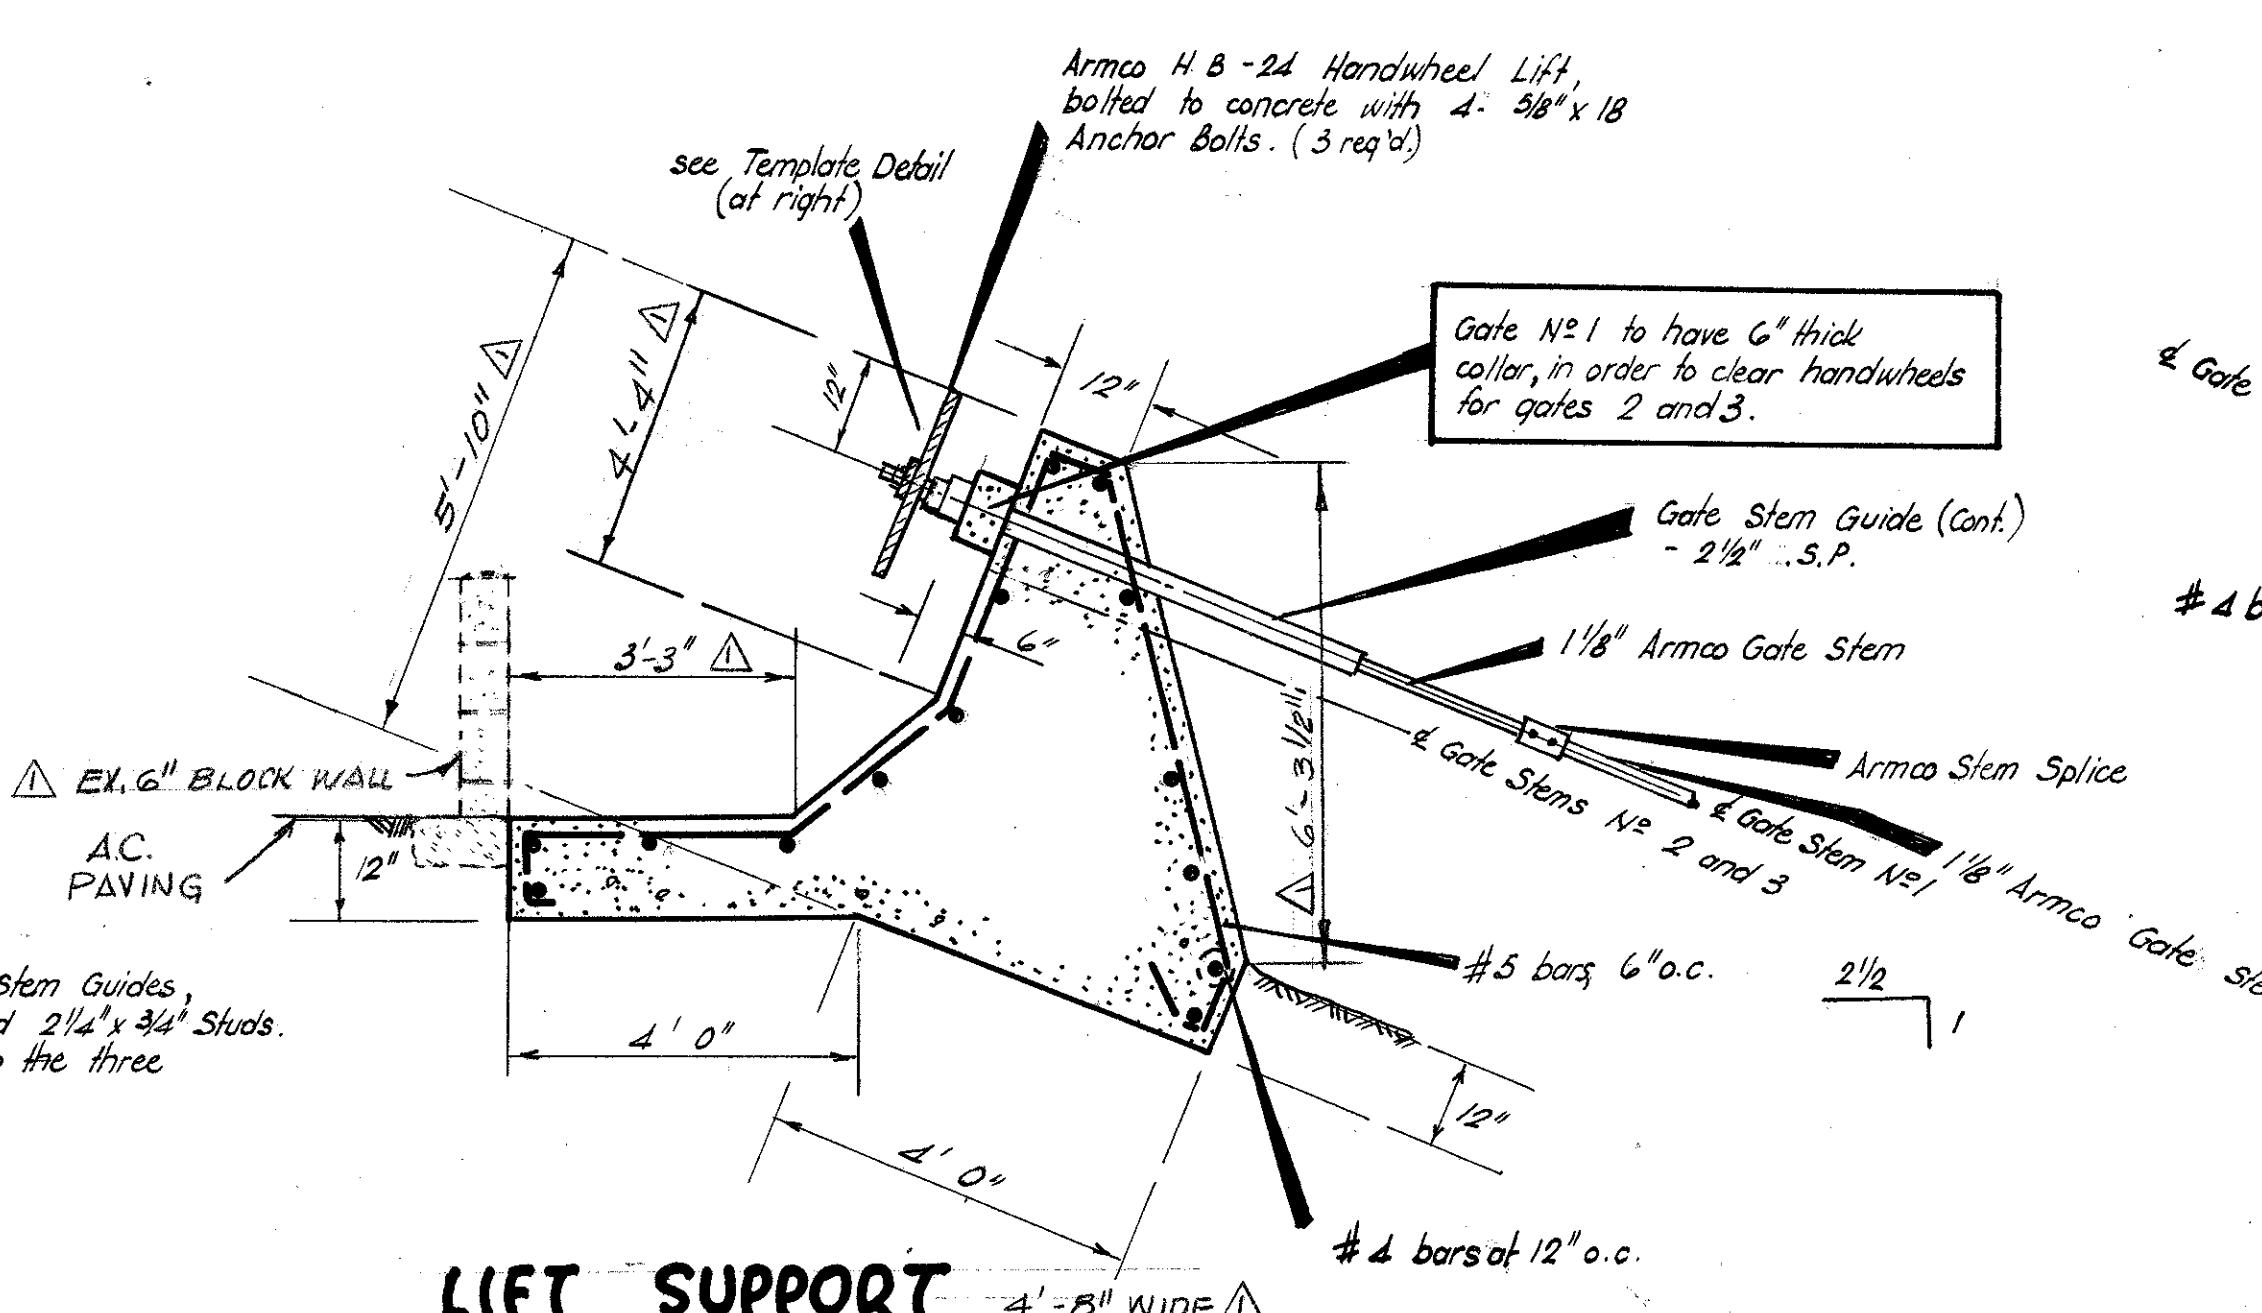
DETAIL of STEM GUIDE

STEM GUIDE SUPPORTS

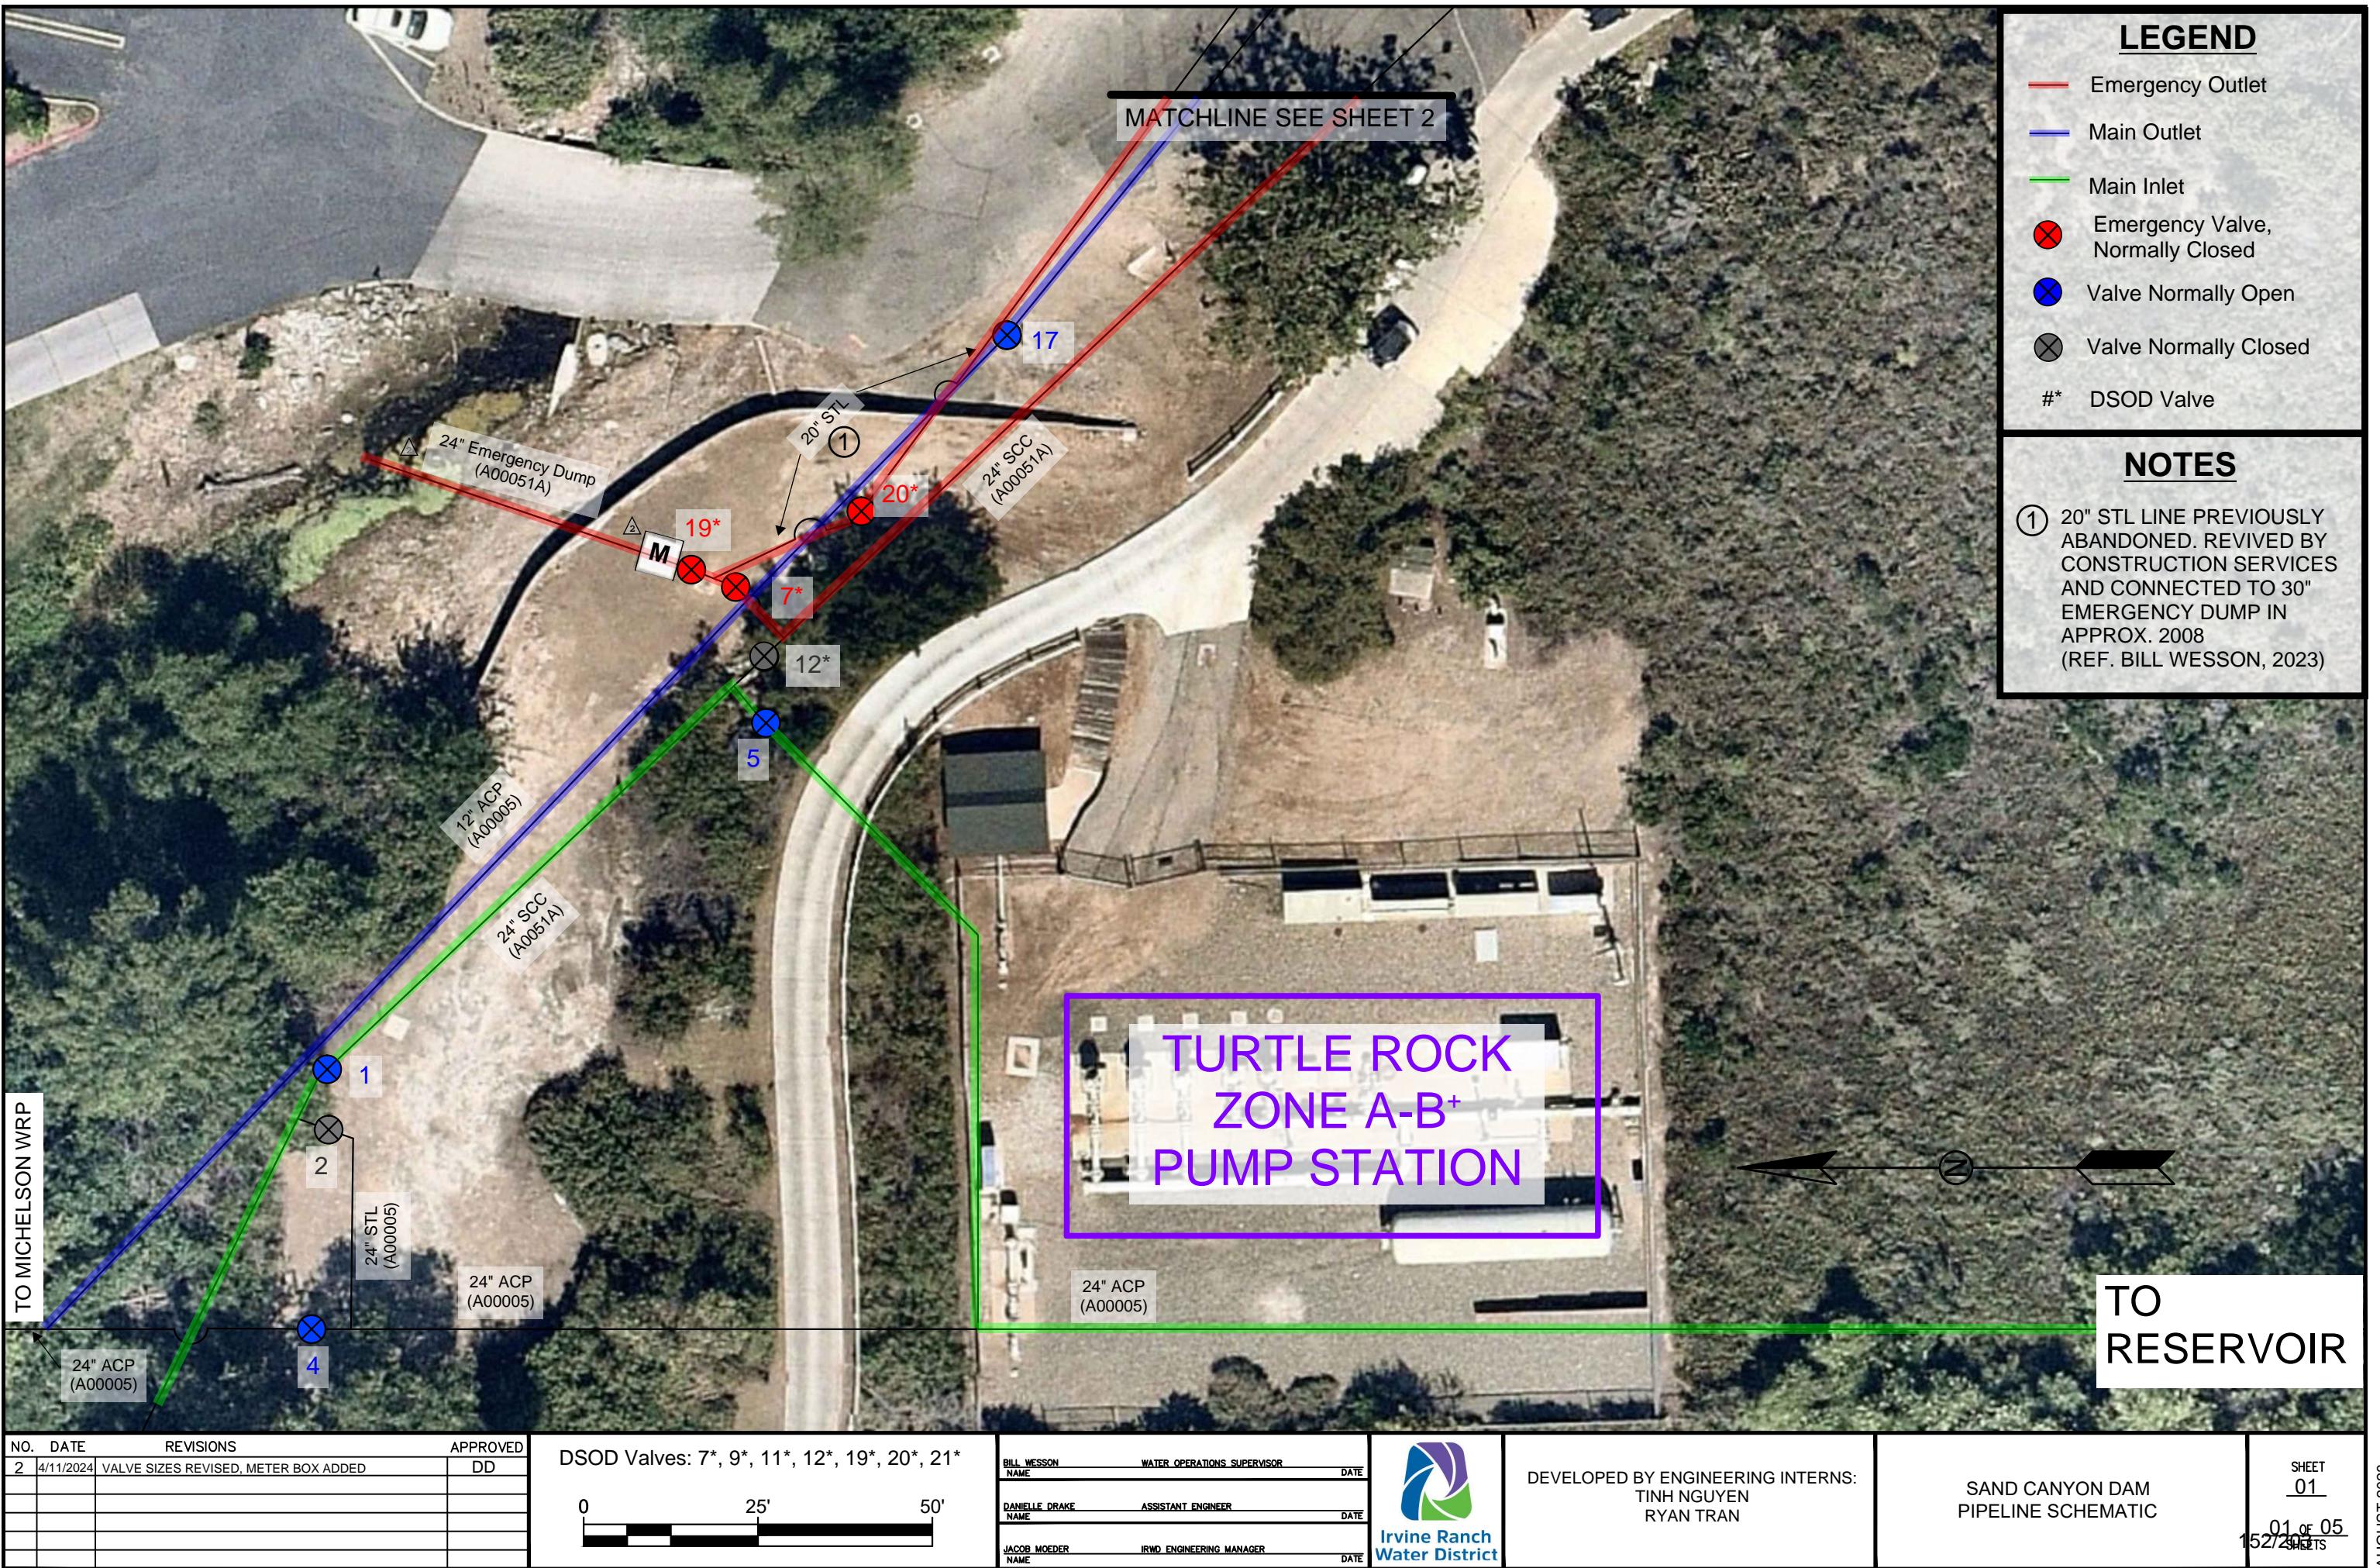
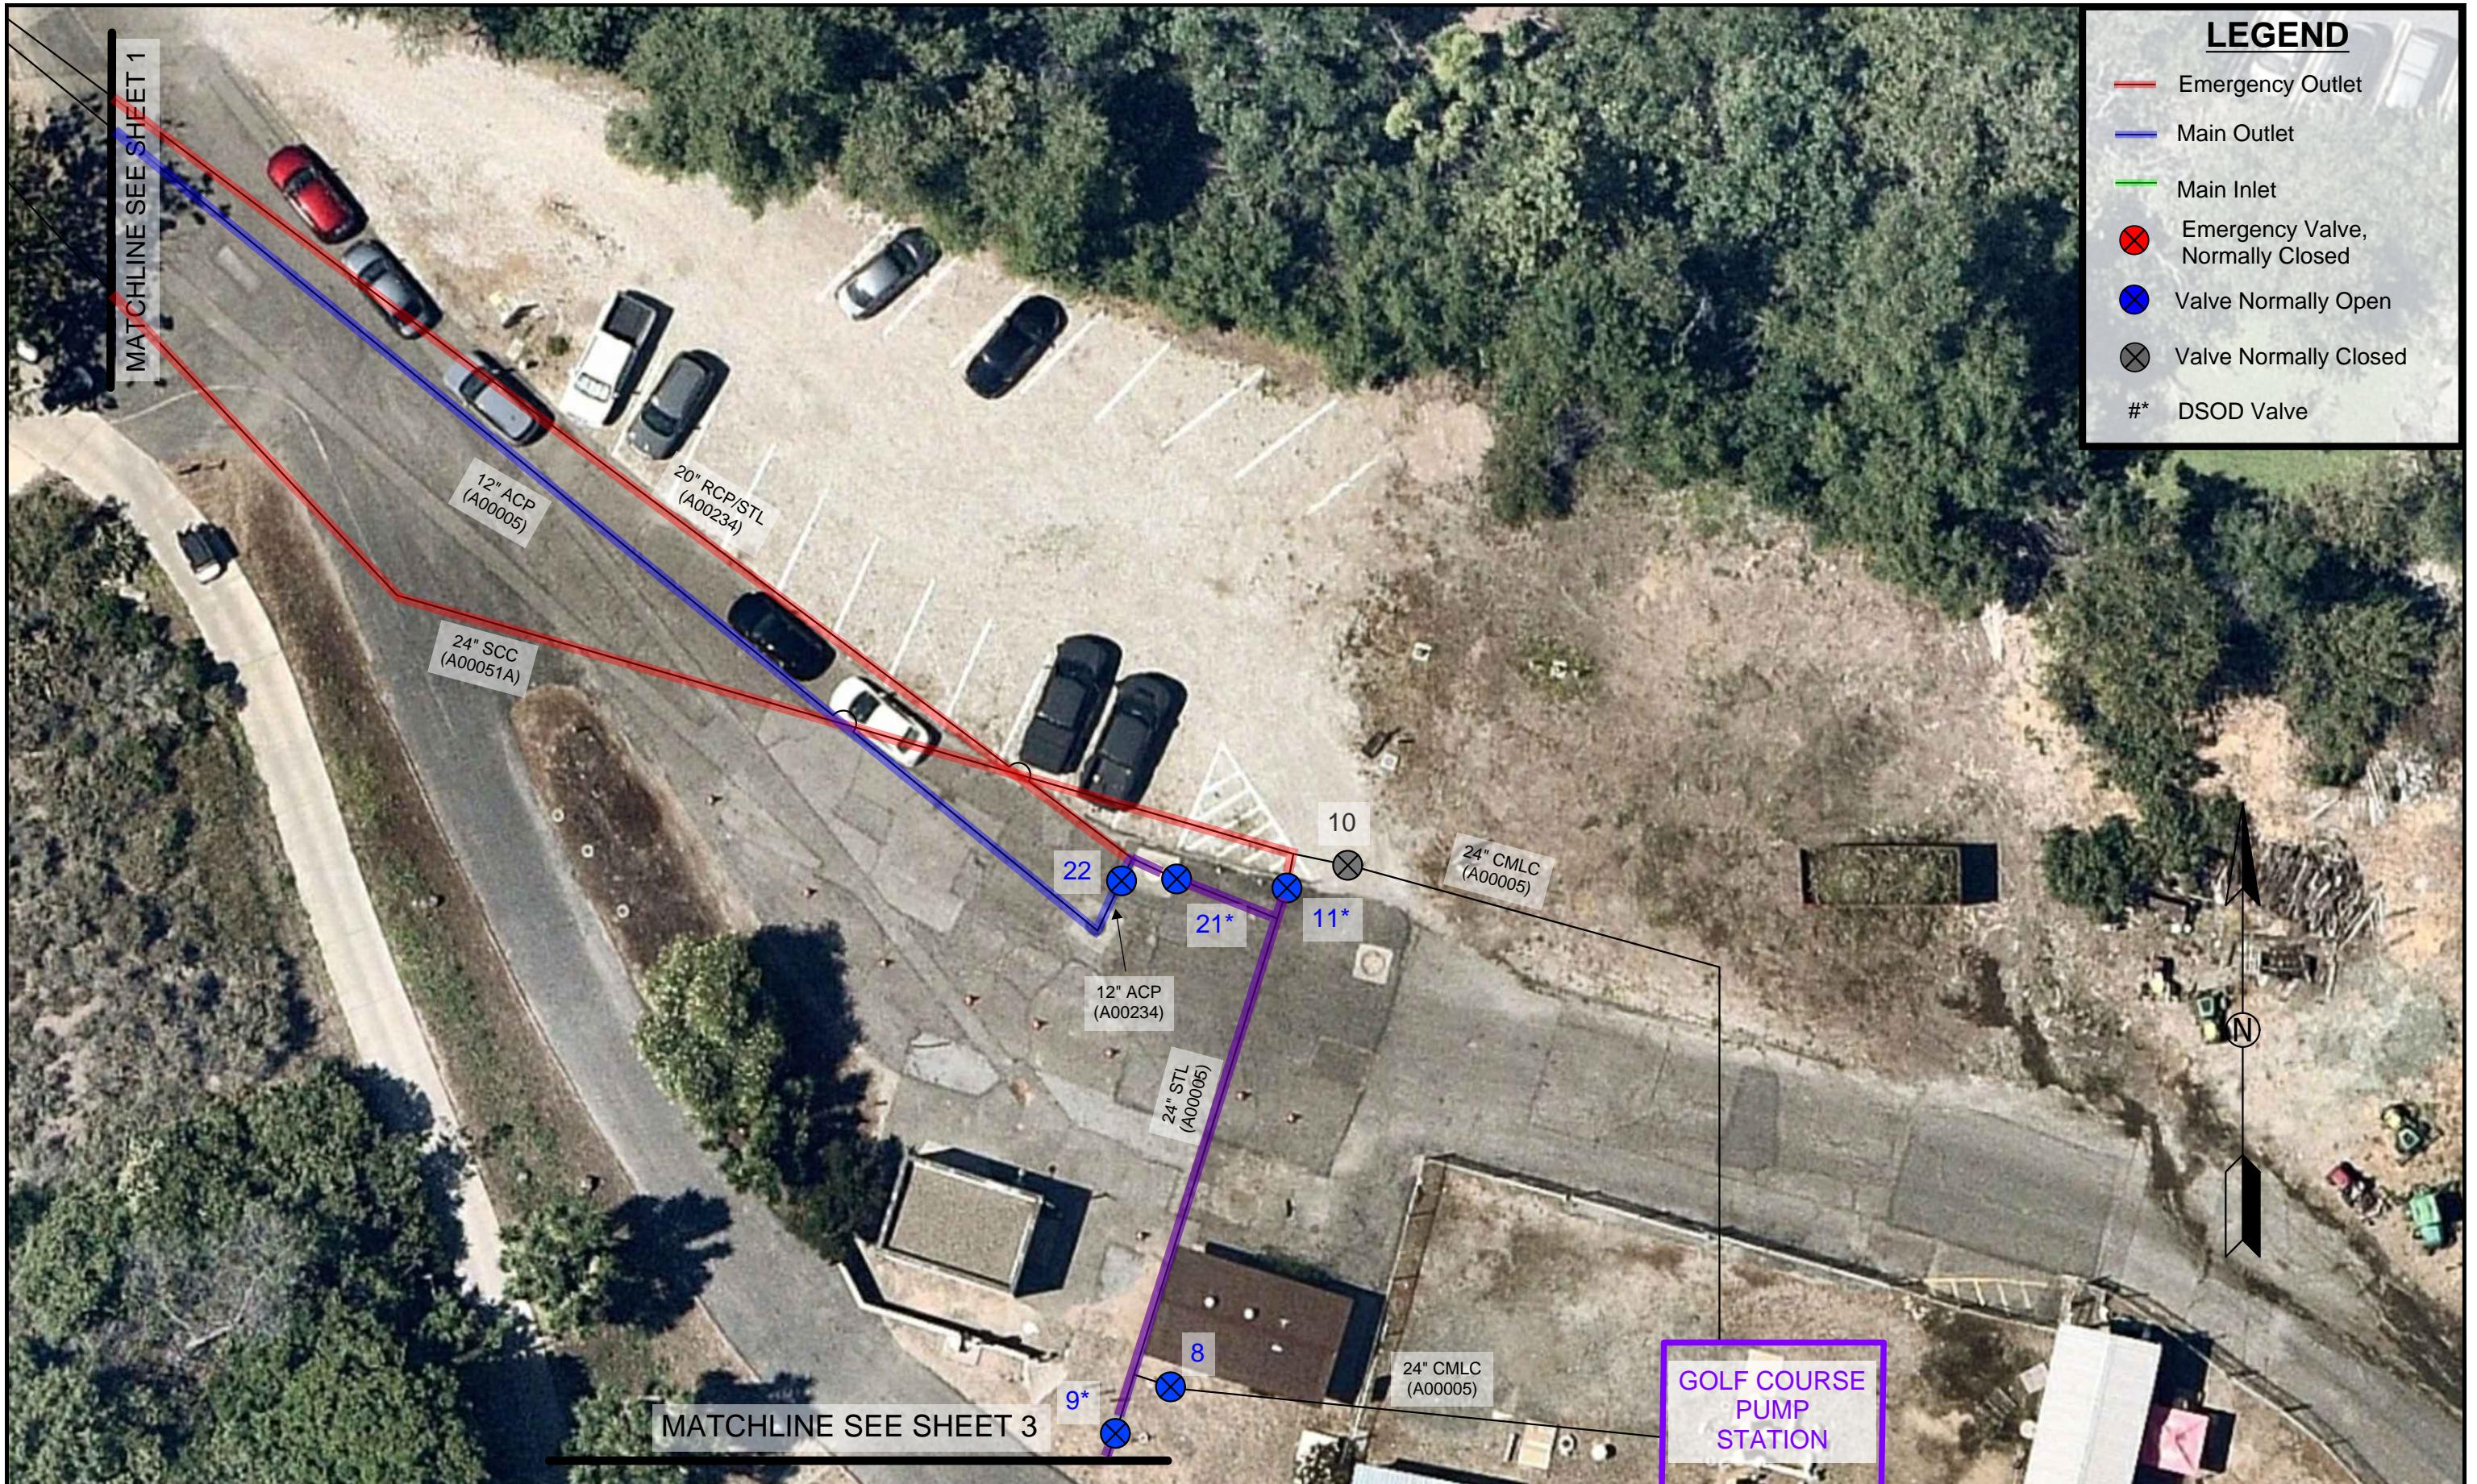
SAND CANYON DAM
PIPELINE SCHEMATIC

NO.	DATE	REVISIONS	APPROVED
		DSOD Valves: 7*, 9*, 11*, 12*, 19*, 20*, 21*	
		0	
		25'	
		50'

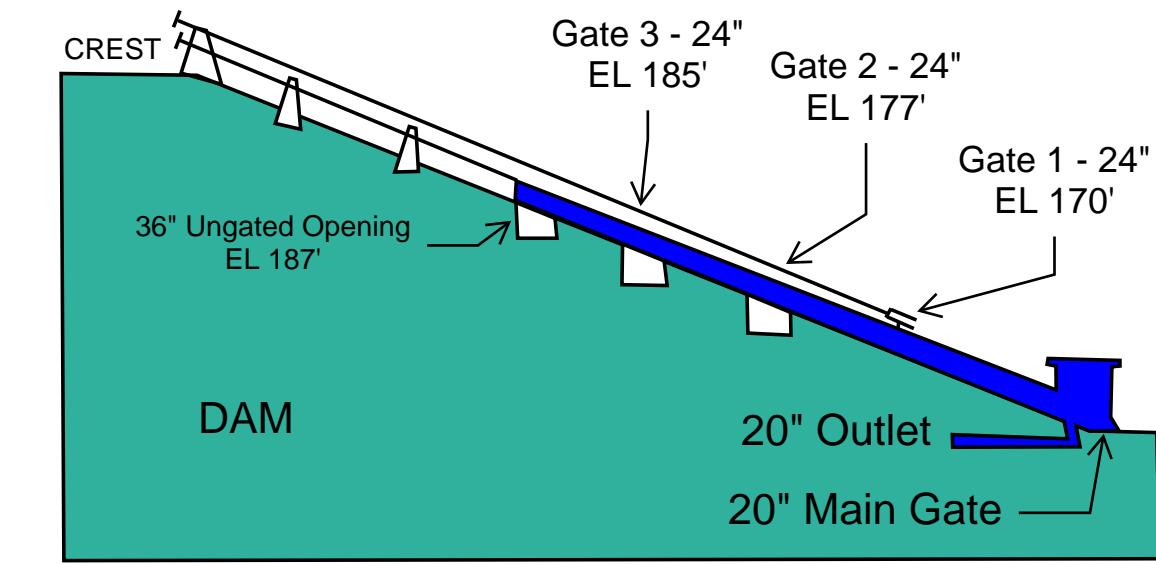
1 SAND CANYON DAM SECTION OF MULTILEVEL OUTLET

Sand Canyon Dam Gate Valve Summary

Valve	Turns	Size	Elevation
Main	102	20"	-
Gate 1	48	24"	170'
Gate 2	21	24"	177'
Gate 3	58	24"	185'

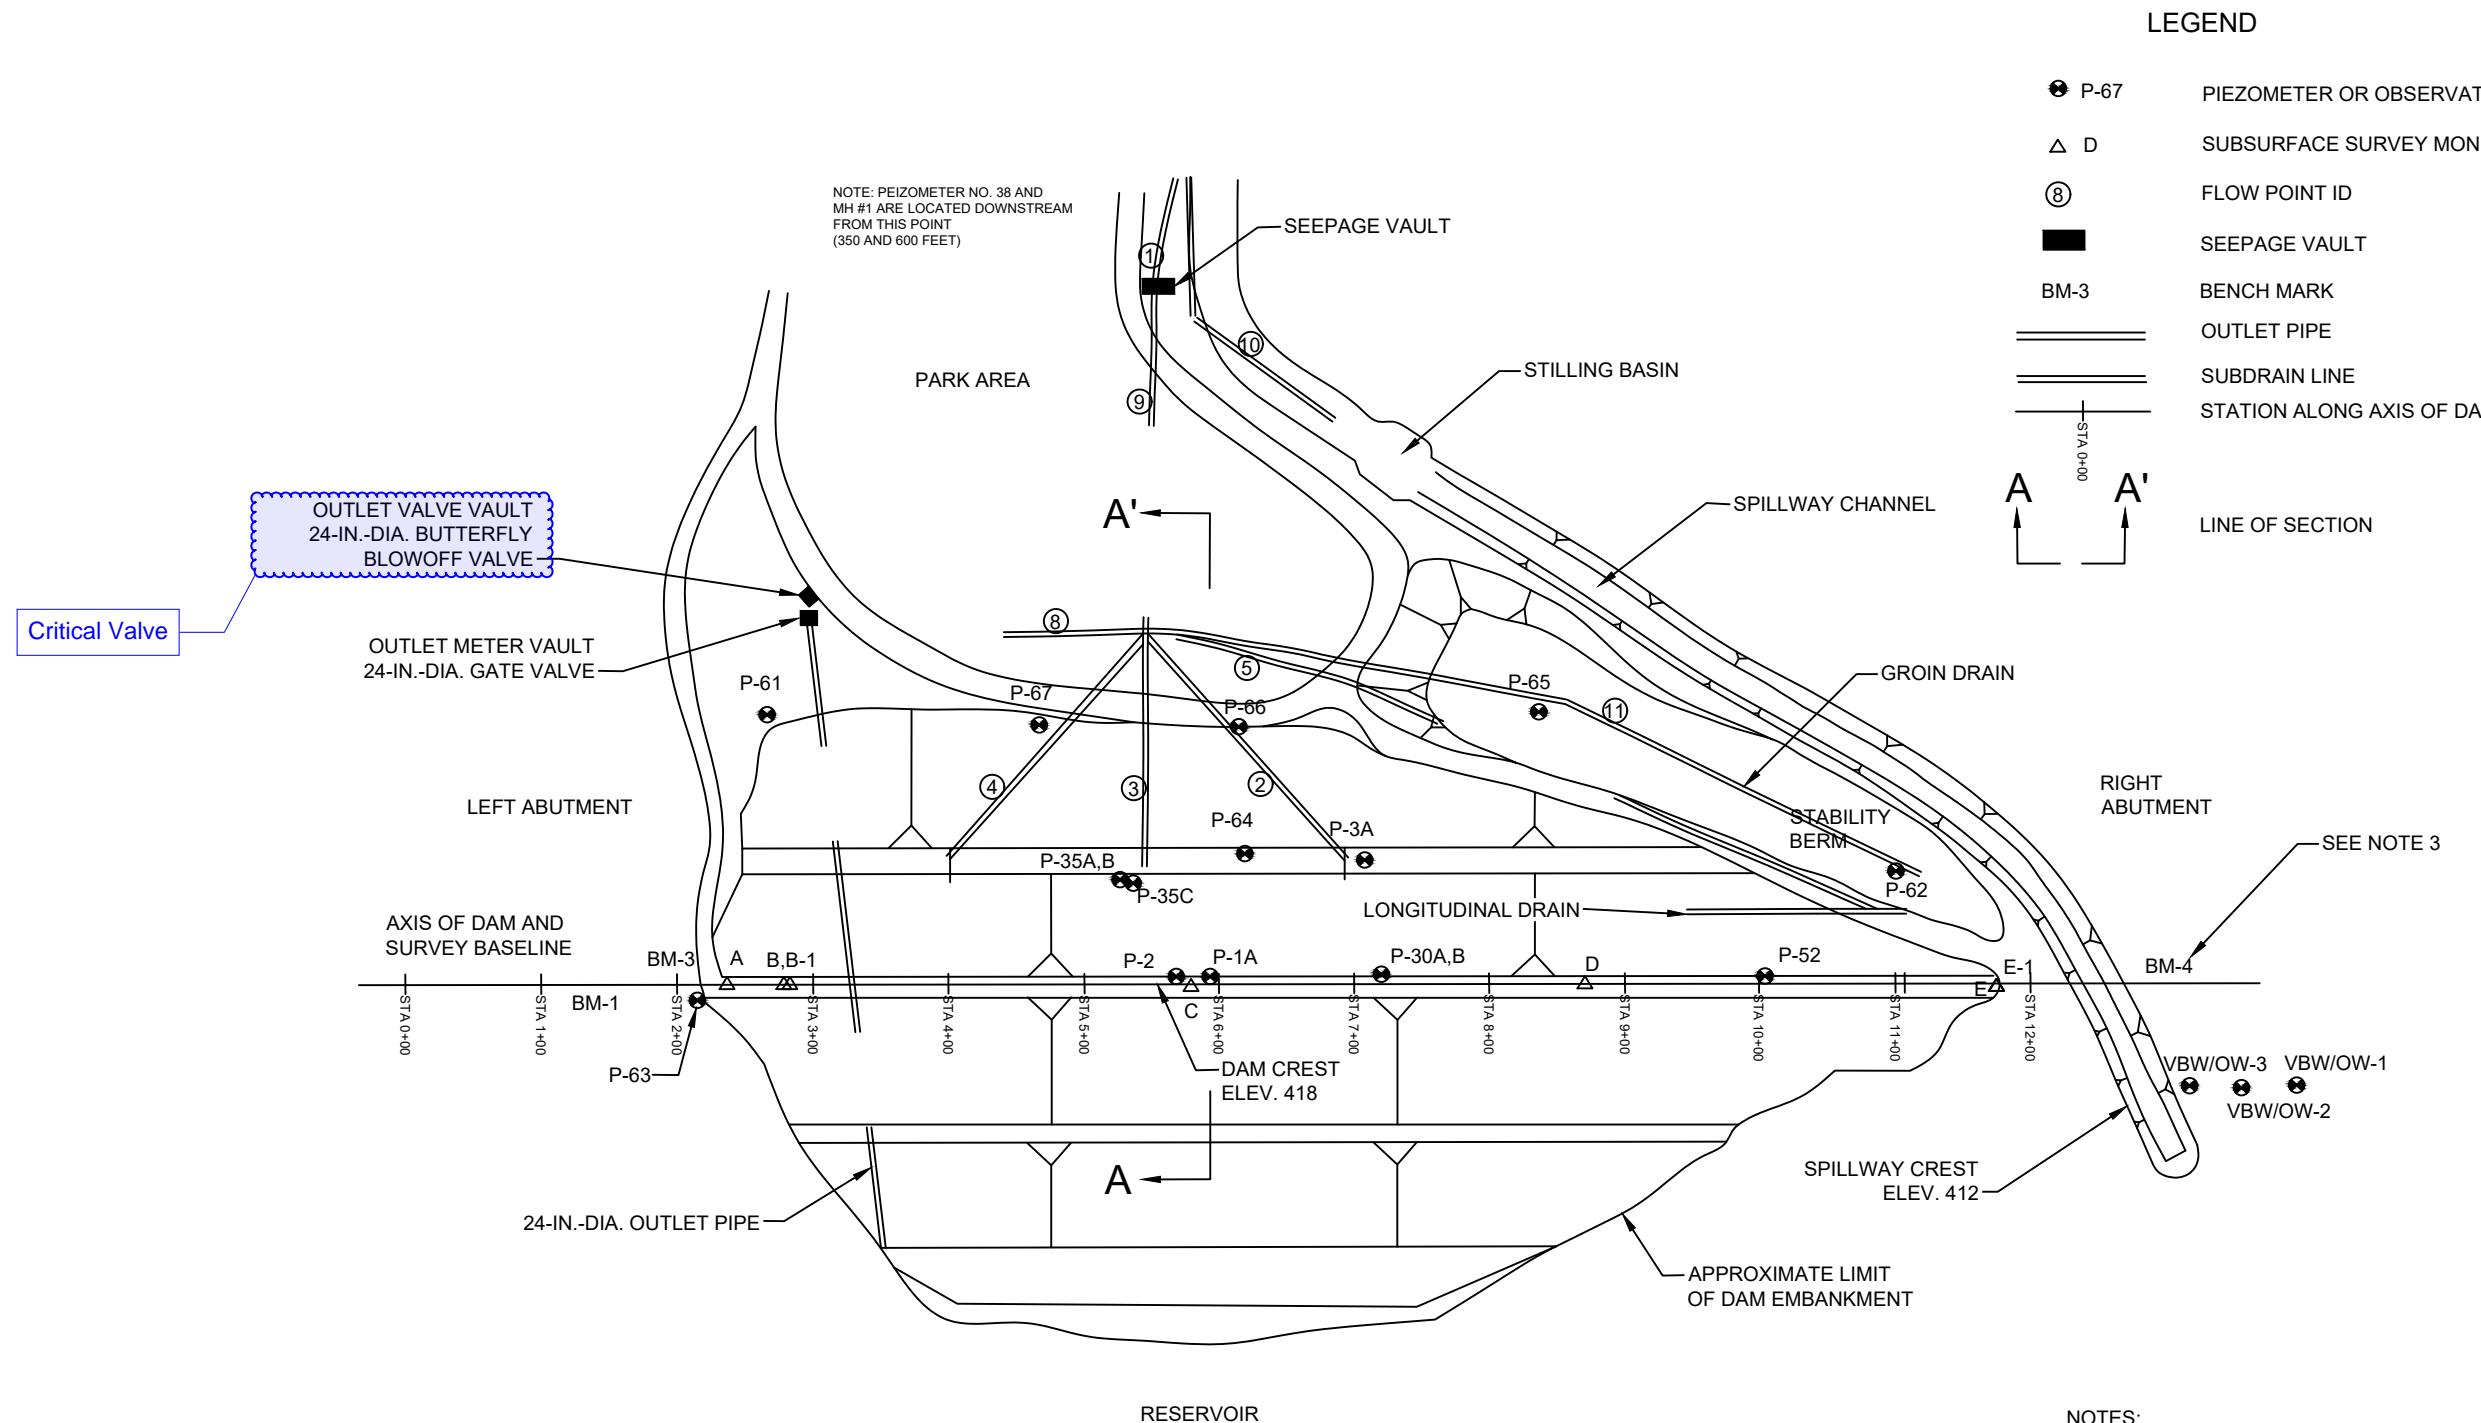
NOTES:

1. SECTION A-A' SHOWN ON FIGURE 2
2. ELEVATIONS ARE IN FEET RELATIVE TO NGVD29
3. BM-4 WAS DESTROYED BETWEEN 2015 AND 2016. BM-4 WAS RE-ESTABLISHED BY 2018
