DAM SAFETY PROGRAM

Guidelines & Governance

**Irvine Ranch
Water District**

January 2026

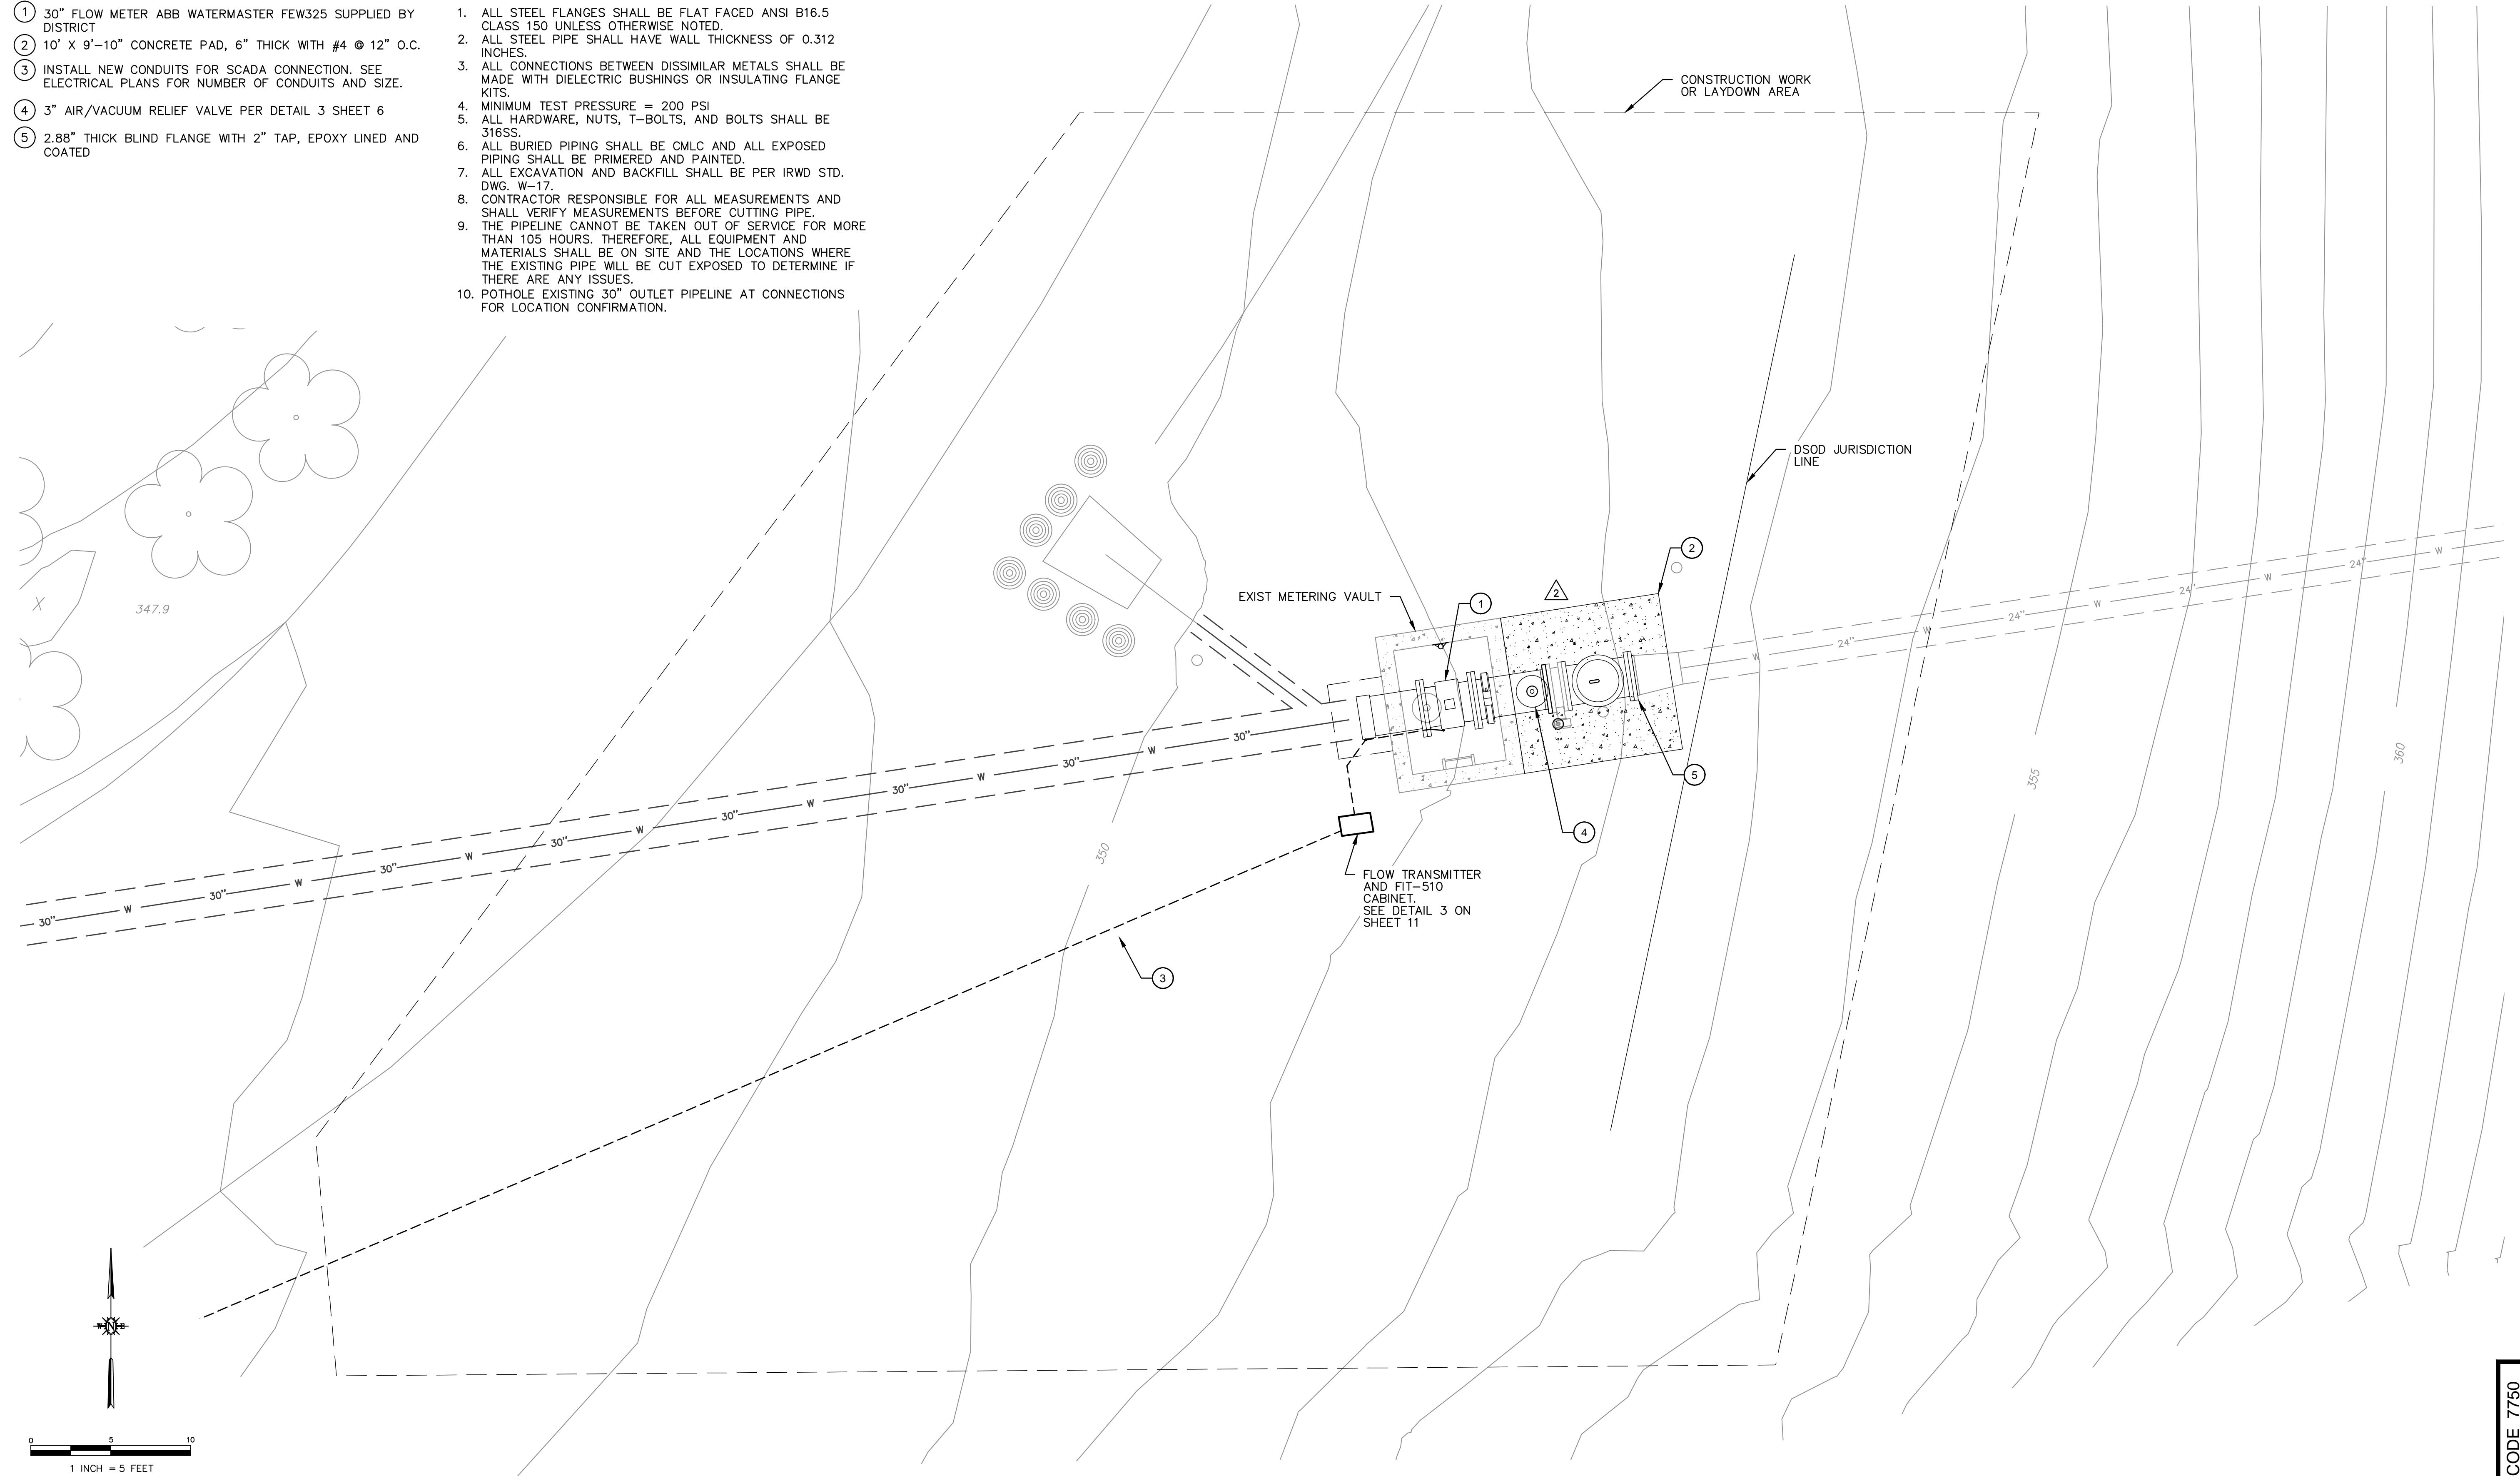
SITE PLAN

PROPOSED IMPROVEMENTS

- 1 30" FLOW METER ABB WATERMASTER FEW325 SUPPLIED BY DISTRICT
- 2 10' X 9'-10" CONCRETE PAD, 6" THICK WITH #4 @ 12" O.C.
- 3 INSTALL NEW CONDUITS FOR SCADA CONNECTION. SEE ELECTRICAL PLANS FOR NUMBER OF CONDUITS AND SIZE.
- 4 3" AIR/VACUUM RELIEF VALVE PER DETAIL 3 SHEET 6
- 5 2.88" THICK BLIND FLANGE WITH 2" TAP, EPOXY LINED AND COATED

9. THE PIPELINE CANNOT BE TAKEN OUT OF SERVICE FOR MORE THAN 105 HOURS. THEREFORE, ALL EQUIPMENT AND MATERIALS SHALL BE ON SITE AND THE LOCATIONS WHERE THE EXISTING PIPE WILL BE CUT EXPOSED TO DETERMINE IF THERE ARE ANY ISSUES.

10. POTHOLE EXISTING 30" OUTLET PIPELINE AT CONNECTIONS FOR LOCATION CONFIRMATION.

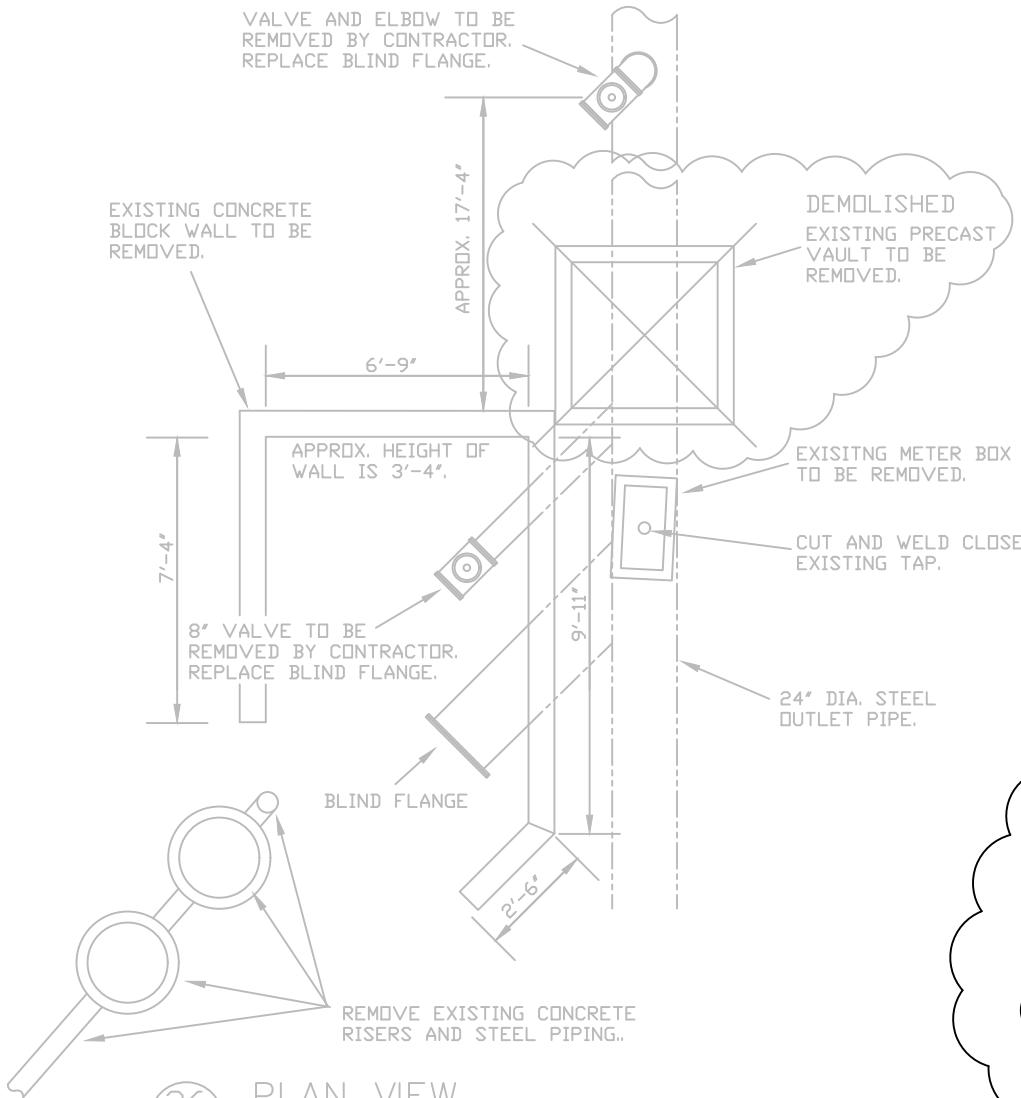
36
3
PLAN VIEW
EXISTING OUTLET VAULT AREA
SCALE: $\frac{3}{8}$ " = 1'-0"

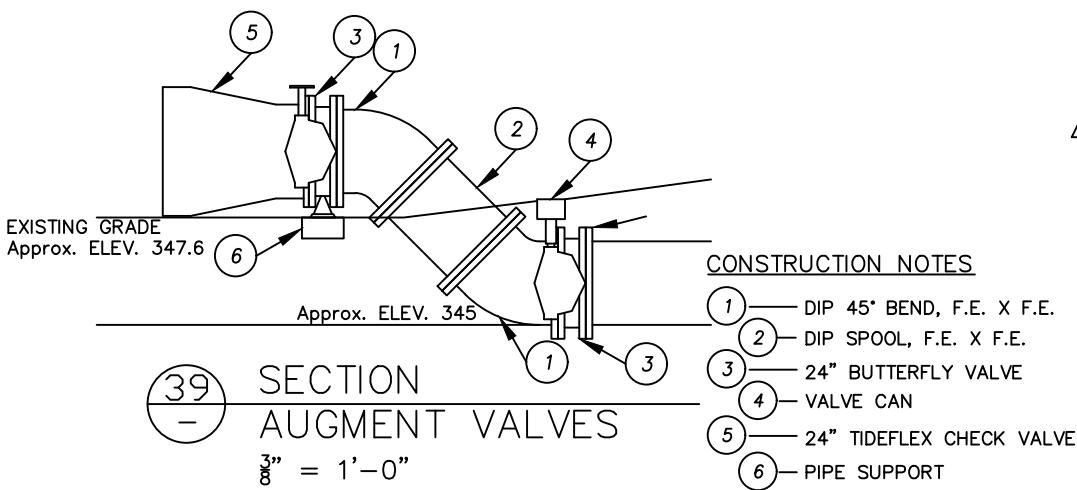
39 SECTION 1
- AUGMENT VALVES

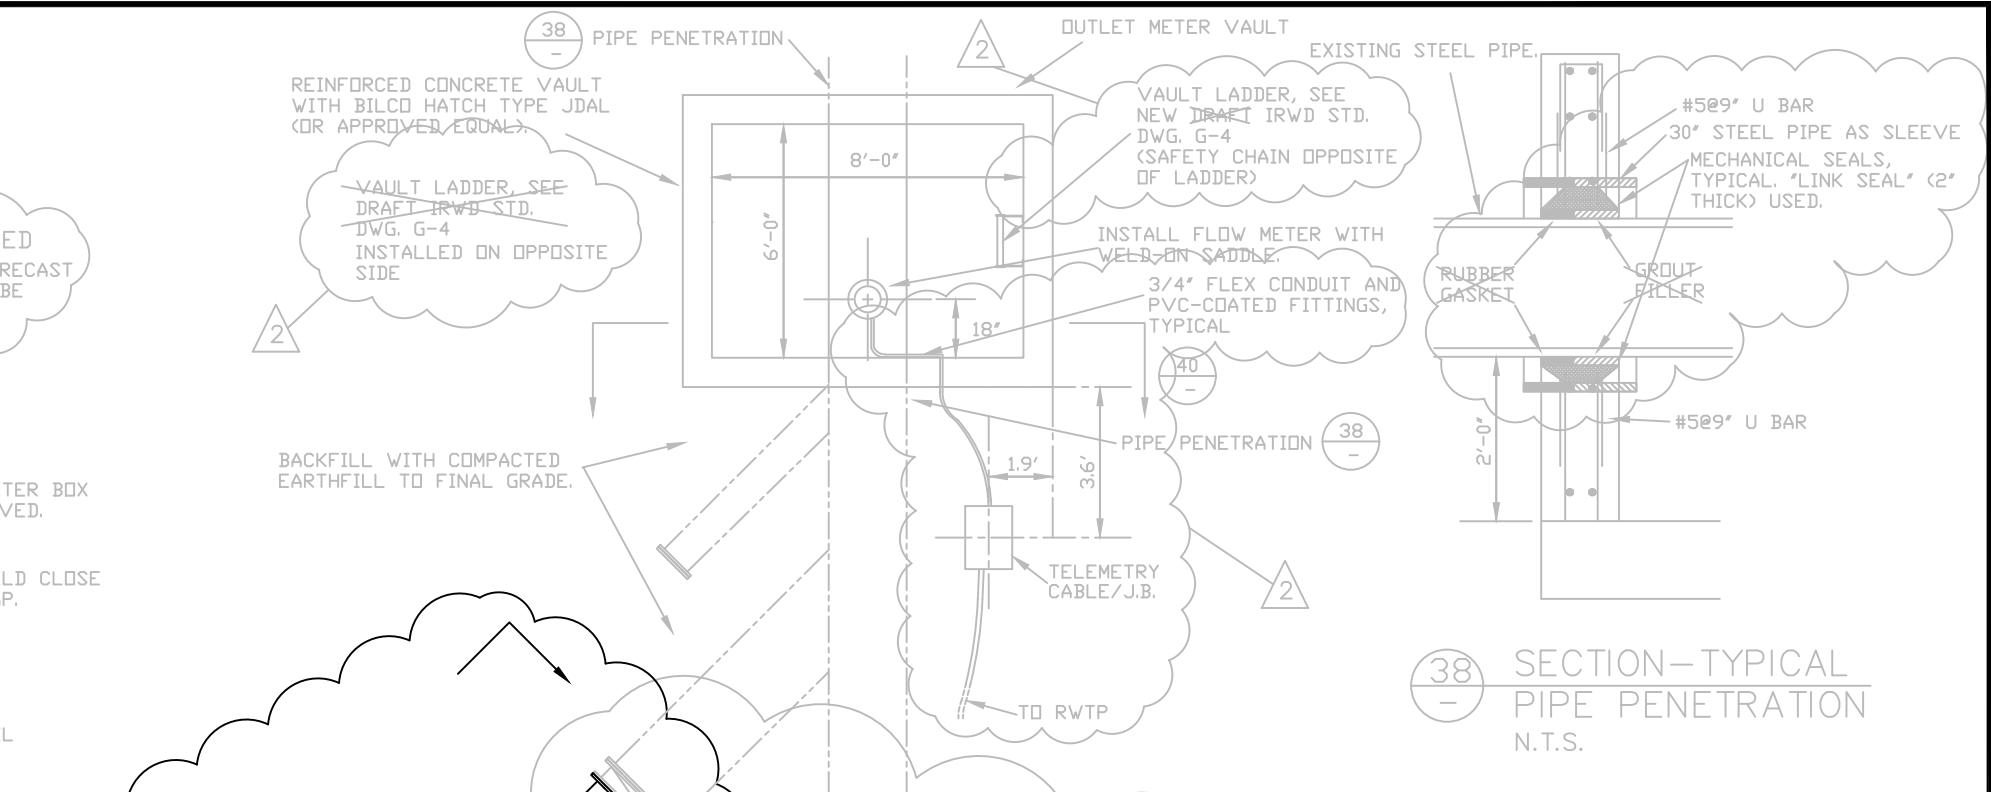
SECTION-TYPICAL
PIPE PENETRATION
N.T.S.

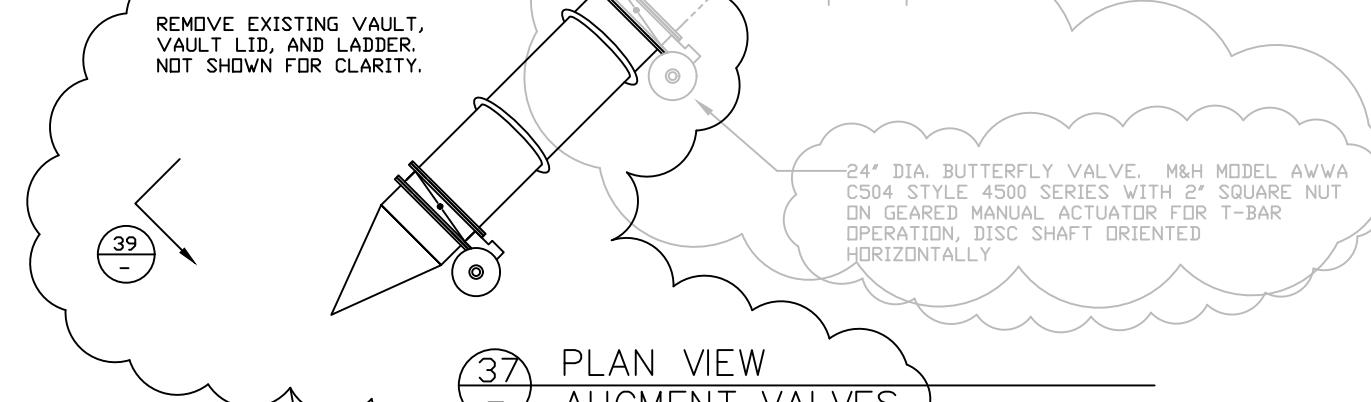
PLAN VIEW
AUGMENT VALVES
3" = 1'-0" C.P. MATCH

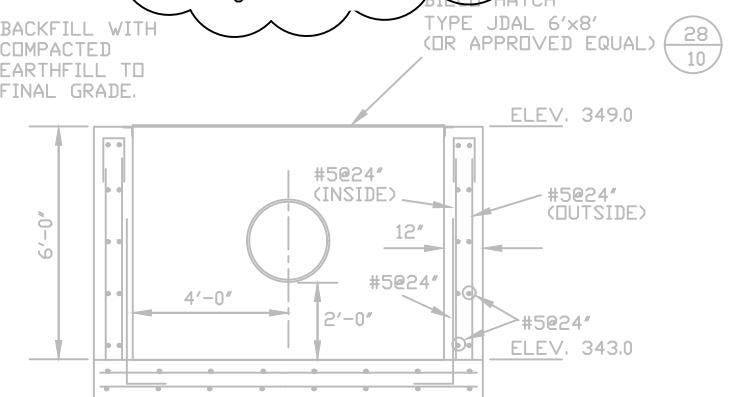
40 SECTION OUTLET METER VAUL
SCALE: $\frac{3}{8}'' = 1'-0''$

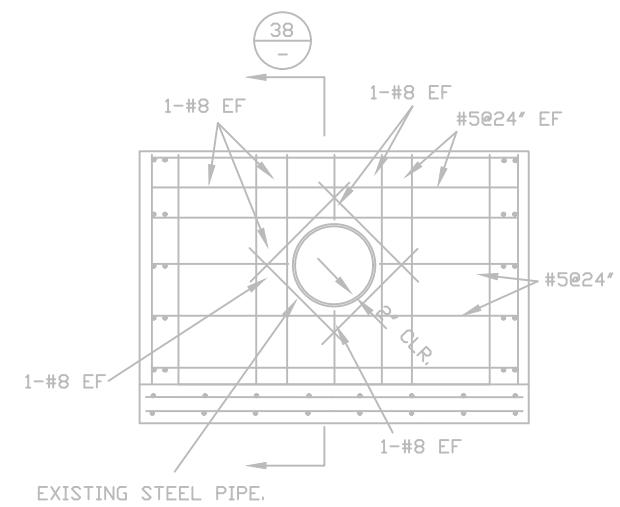
41 SECTION-TYPICAL
PIPE PENETRATION
SCALE: $\frac{3}{8}'' = 1'-0''$

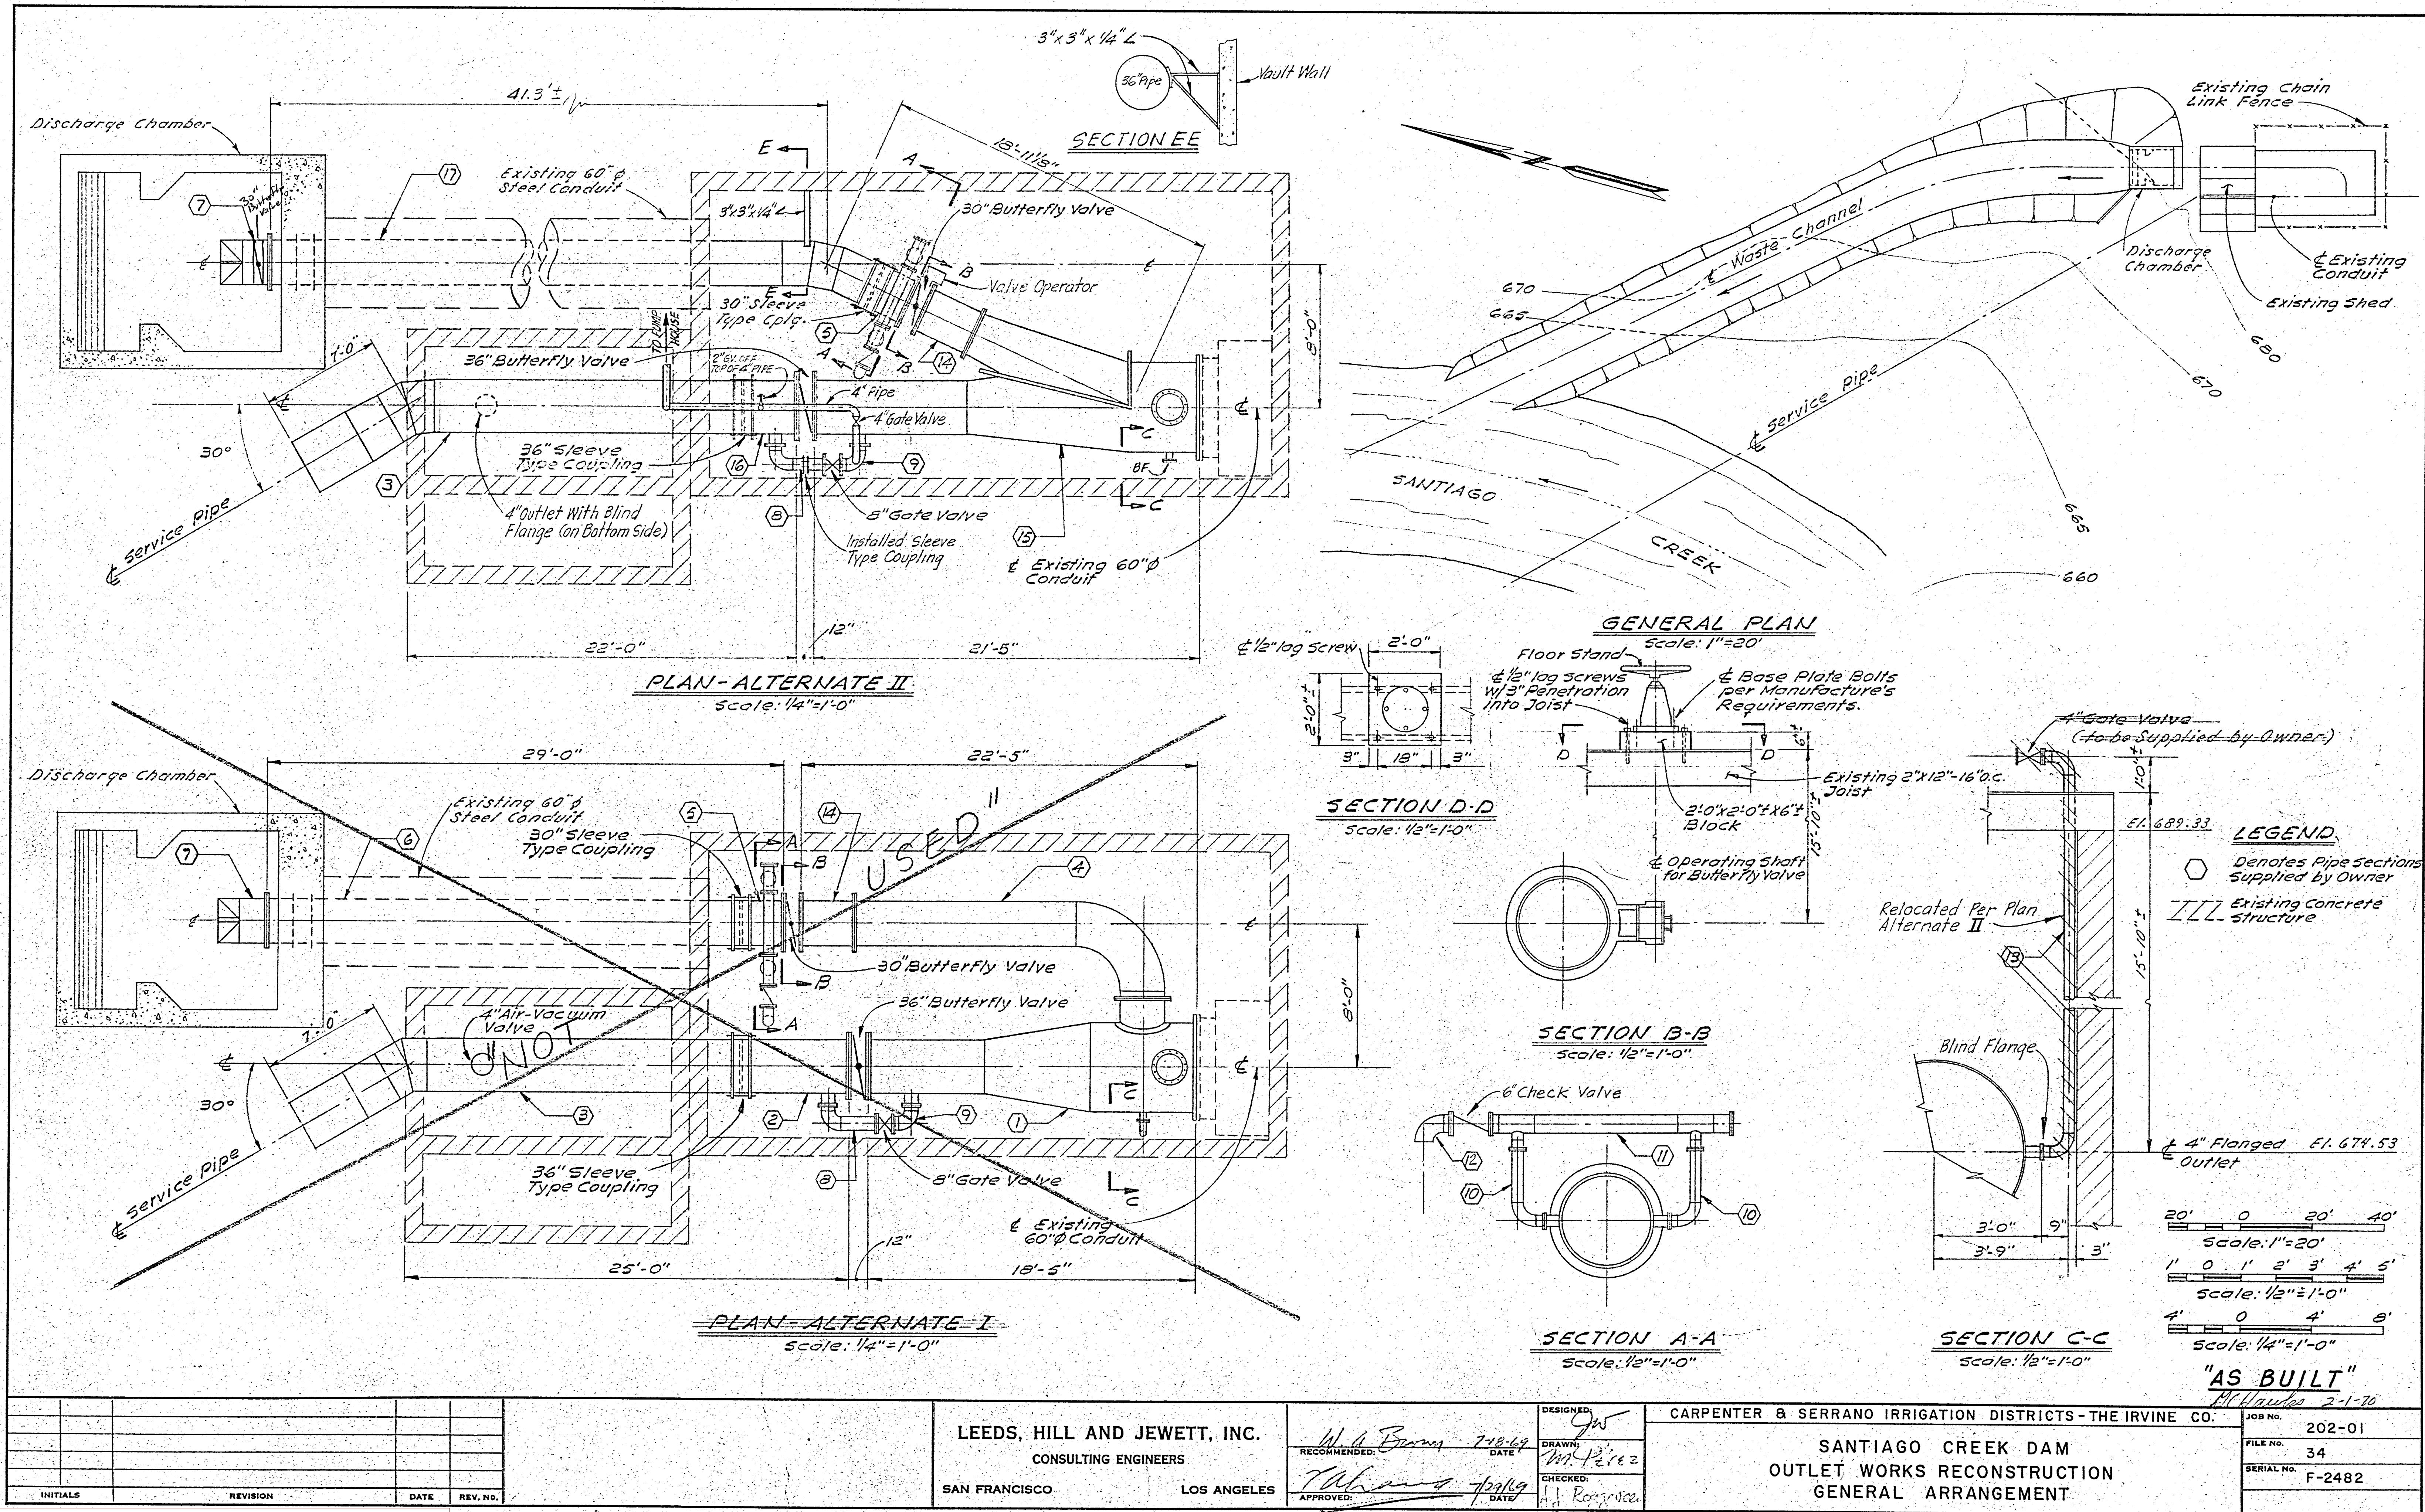
Exhibit 6.5
Location of Critical Valve at Santiago Creek Dam

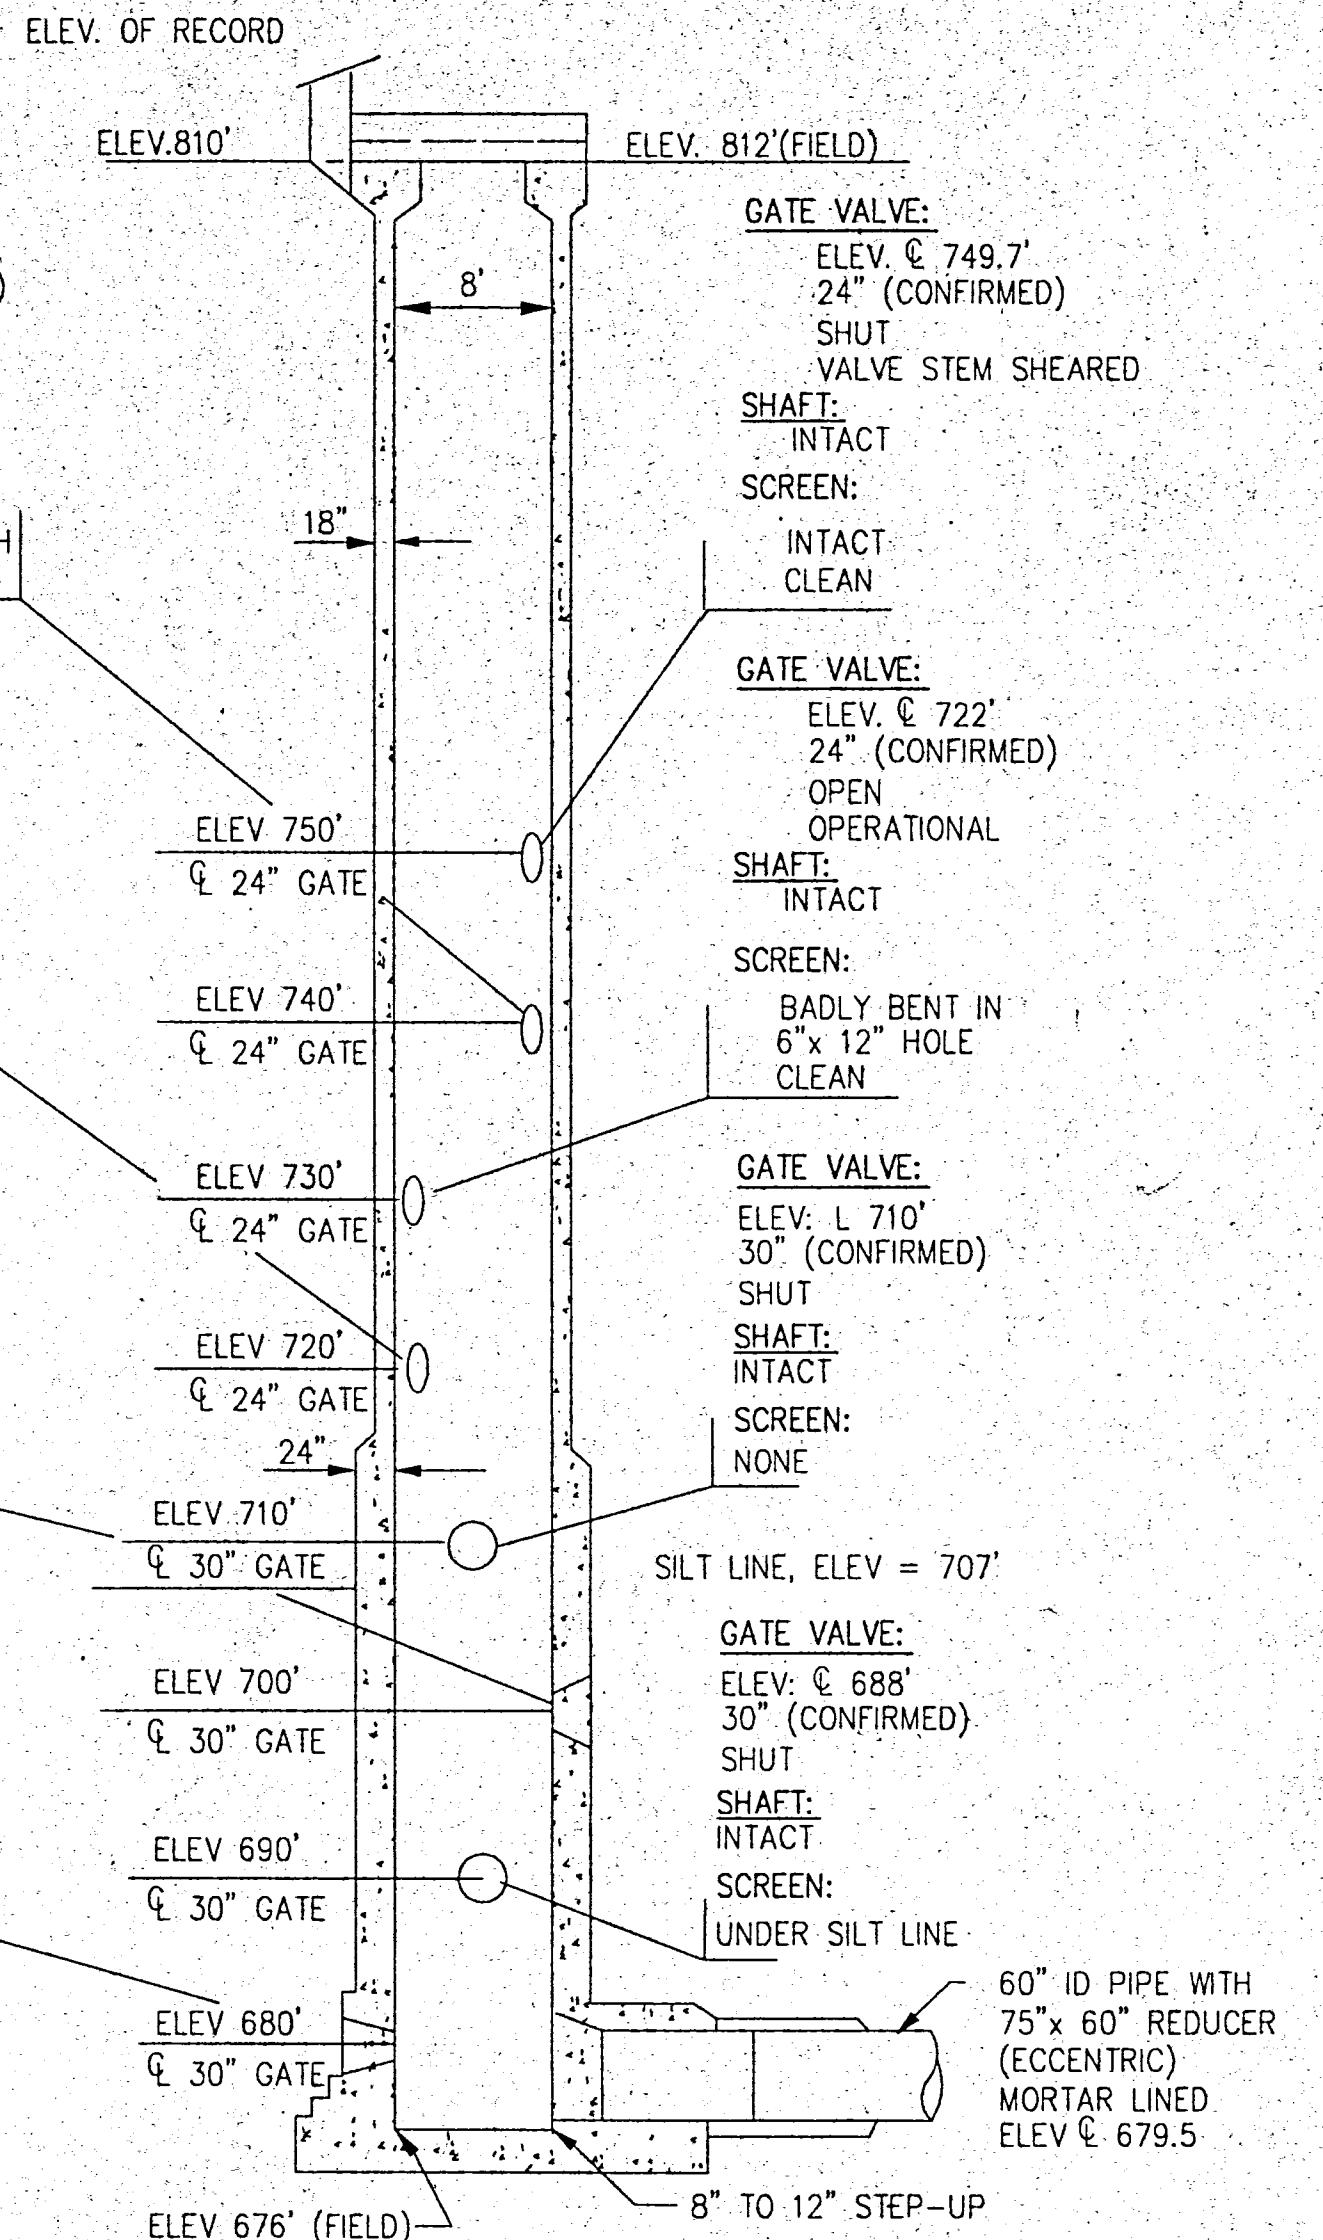
EXISTING TOWER (AS BUILT)

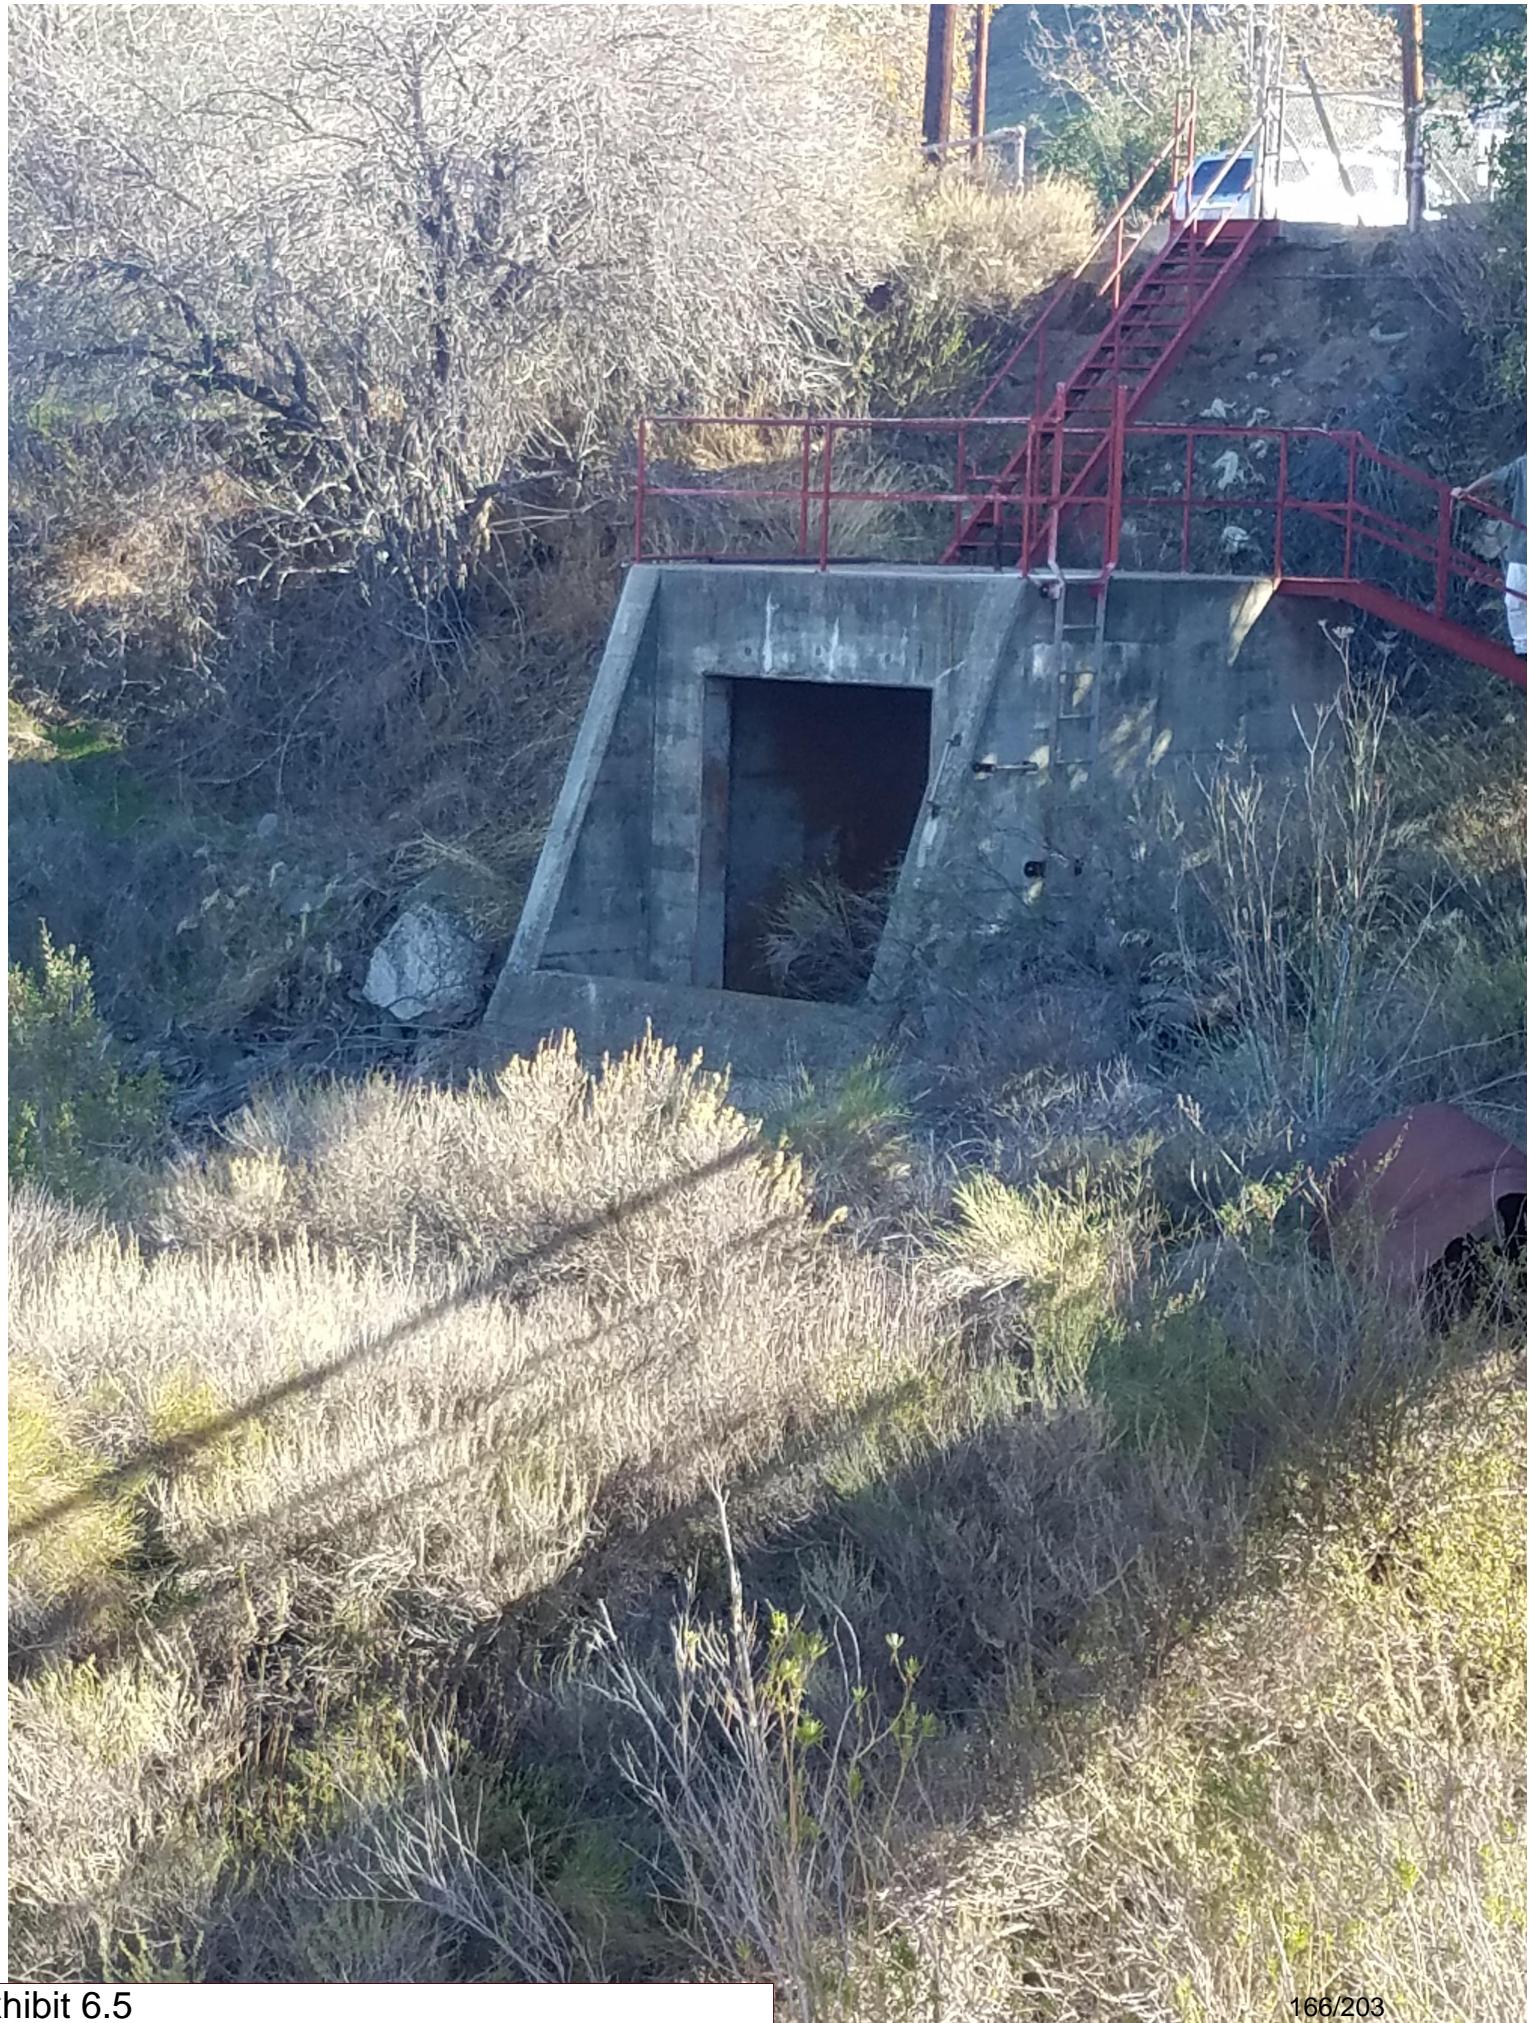
Exhibit 6.5
Location of Critical Valve at Santiago Creek Dam

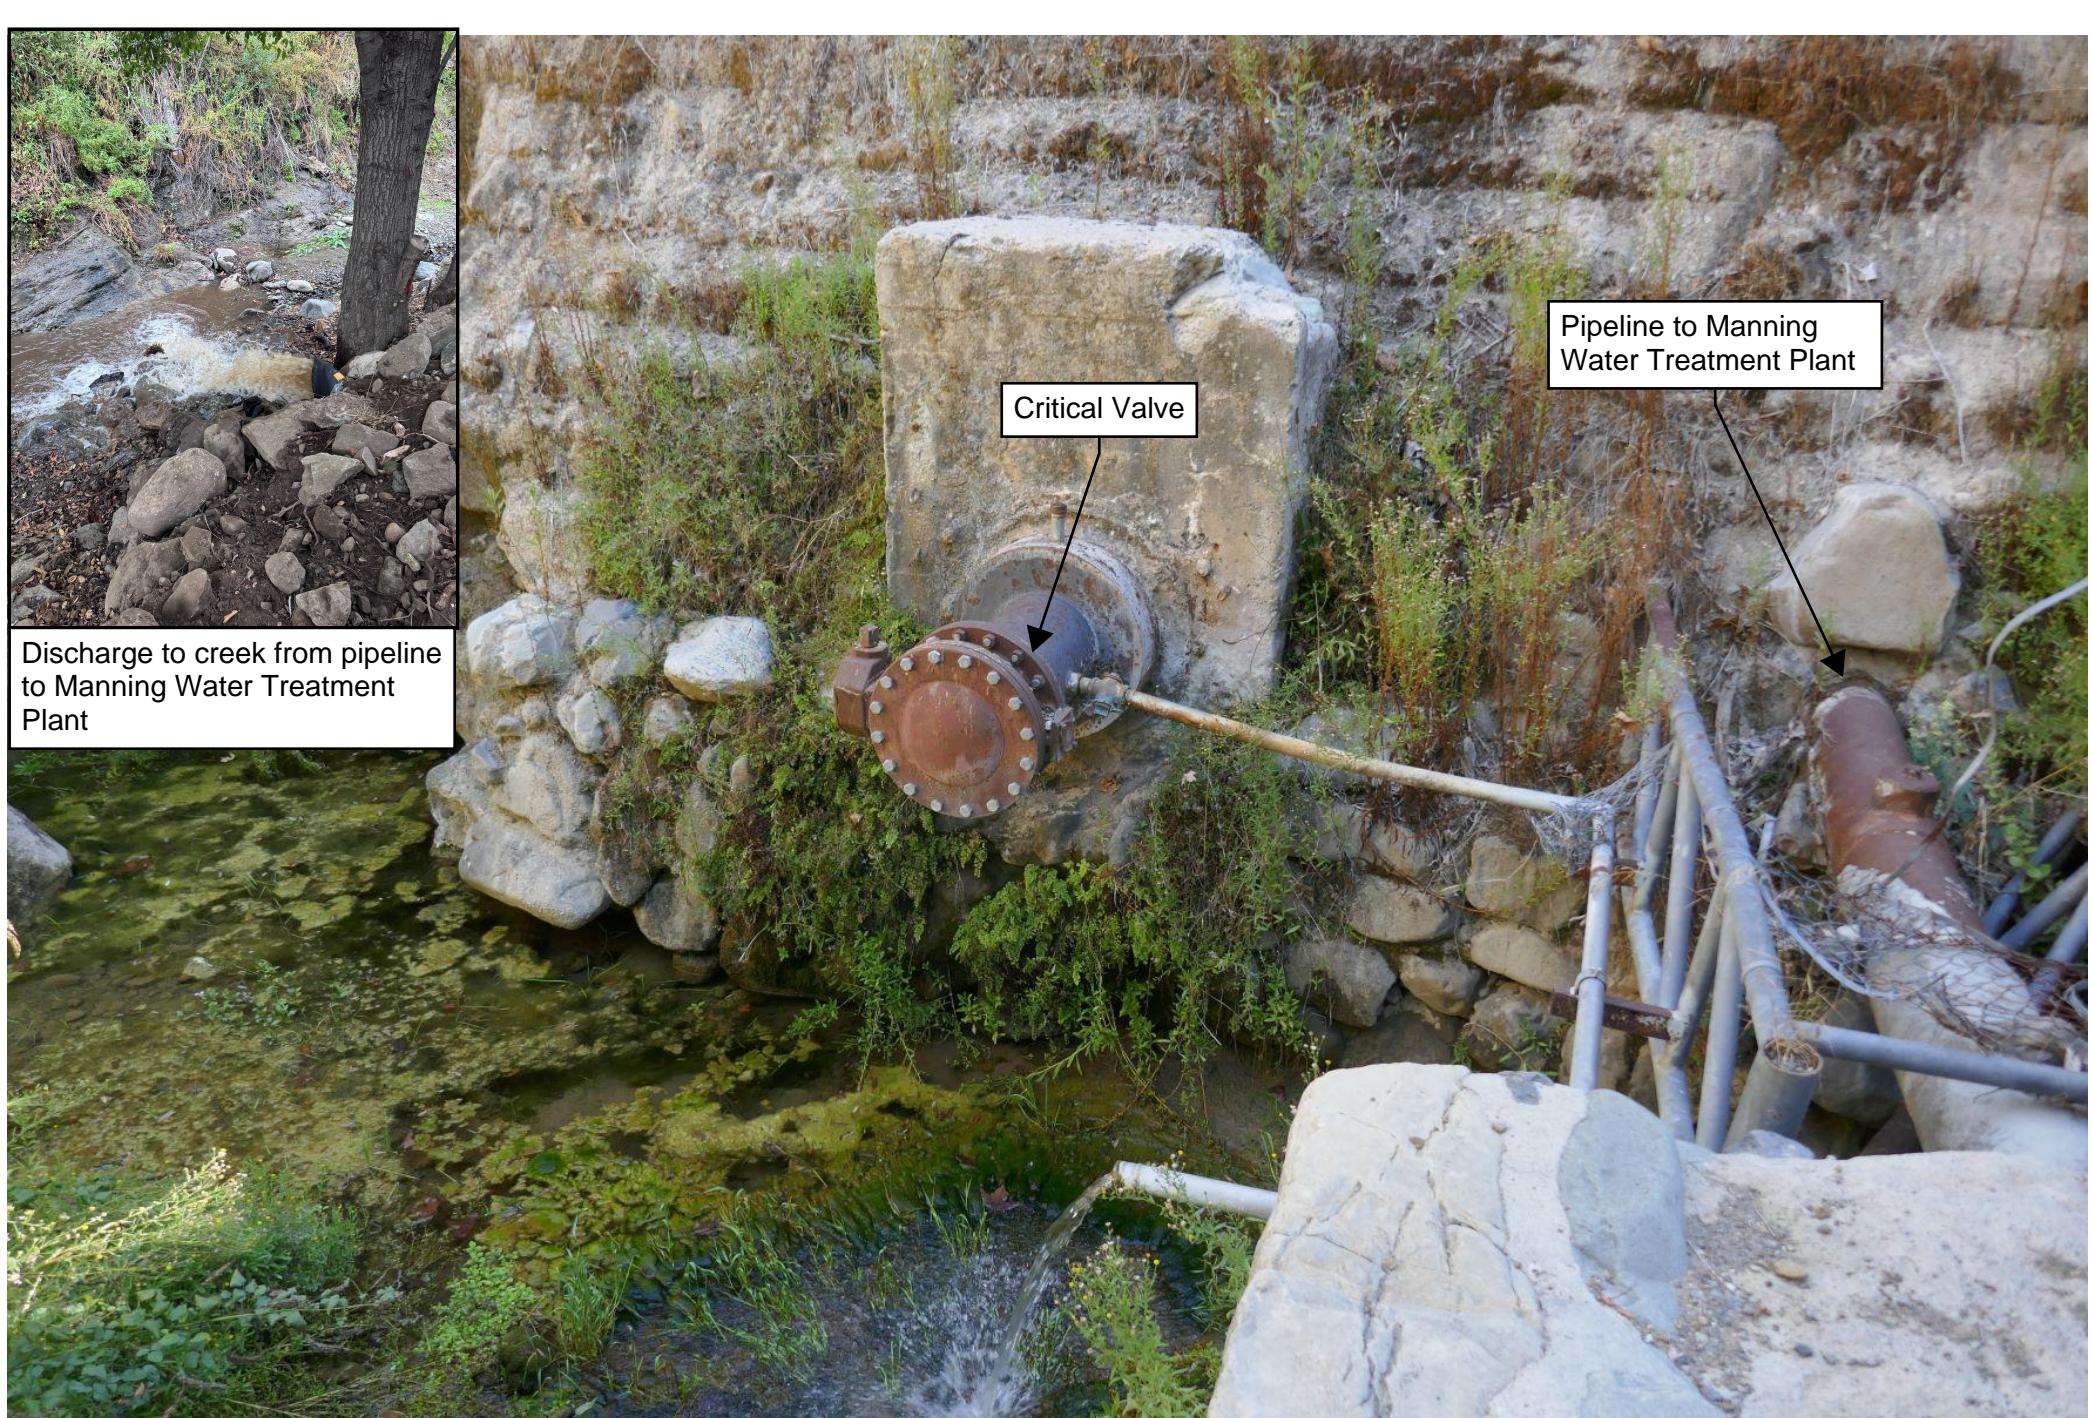
Exhibit 6.6
Location of Critical Valve at Harding Canyon Dam

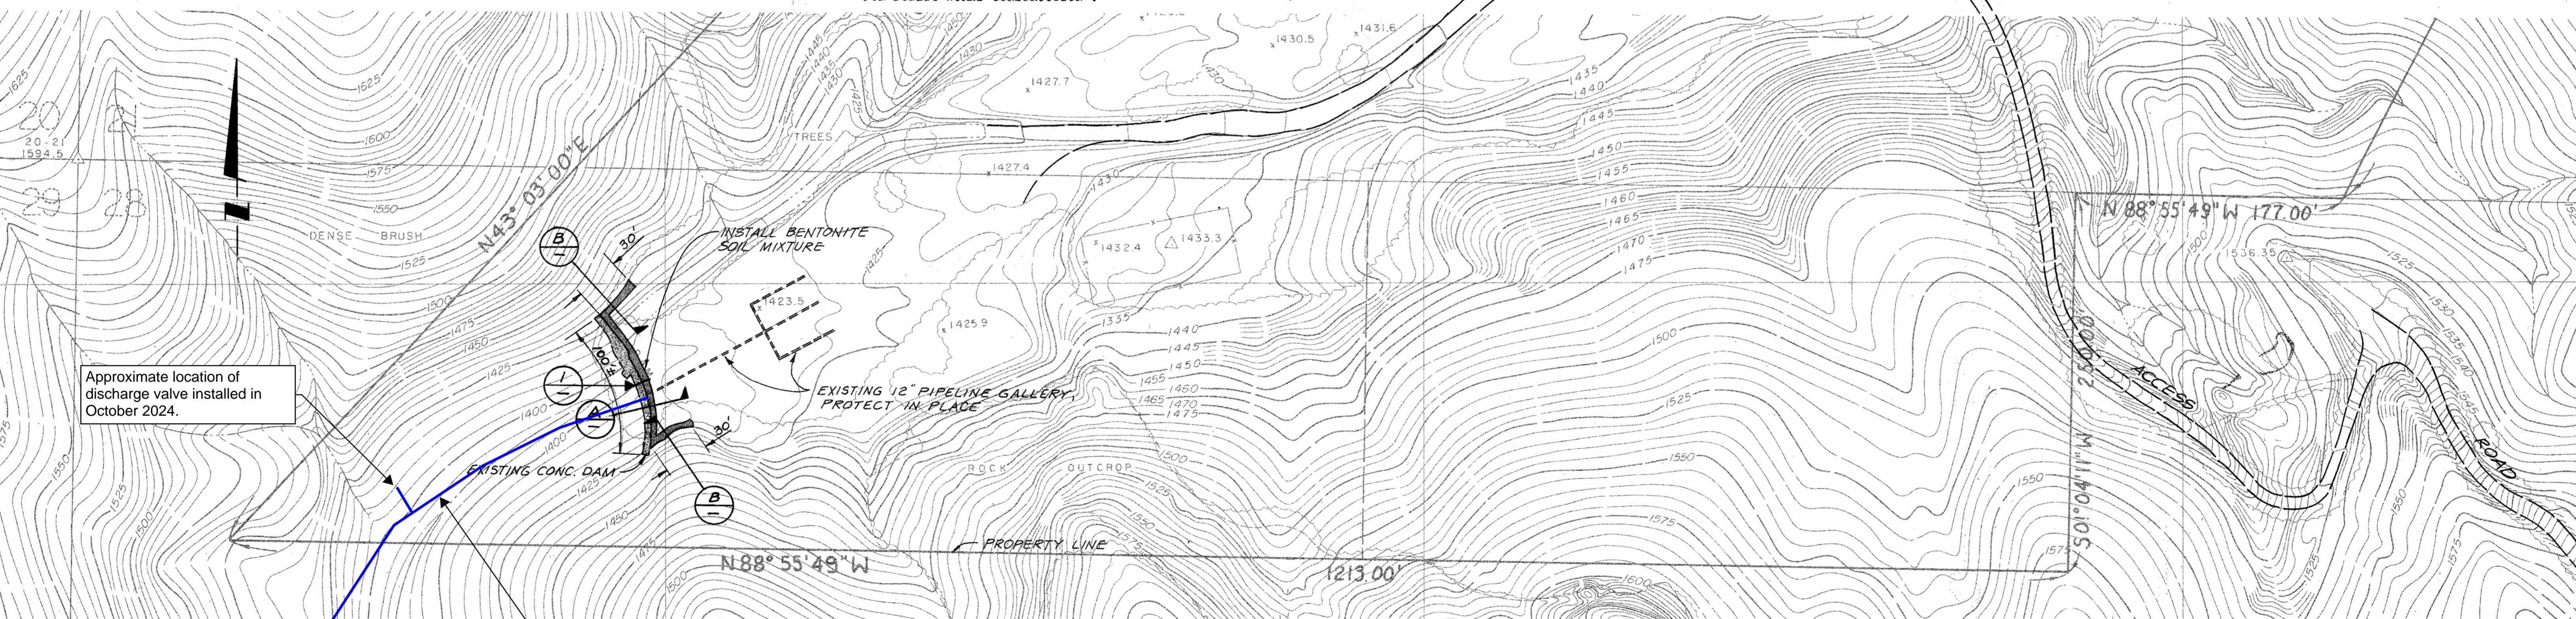
SITE PLAN

**INSTALLATION OF BENTONITE BLANKET
AND REPLACEMENT OF DRAIN PIPING**

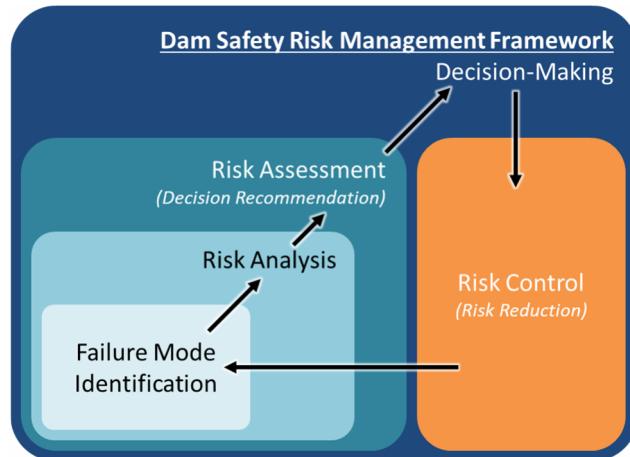
Figure 1: RIDM process.

As part of IRWD's transition to a RIDM-based DSP, IRWD is conducting additional inspections and dam safety reviews. Pursuant to this, in 2021 IRWD completed SQRA on its portfolio of five jurisdictional dams. SQRA and the subsequent identification of action items set the course for improving the understanding of IRWD's dam performance while also establishing a baseline for future PDSR. The PDSR includes developing PFM, Risk Analysis, Risk Assessment and Evaluation, and identifying opportunities to control the risk. Results from the PDSR are used to identify if dam safety concerns exist, identify action items, prioritize the action items, communicate risk to stakeholders and decision makers, and decision making.
