DAM SAFETY PROGRAM

Guidelines & Governance

**Irvine Ranch
Water District**

January 2026

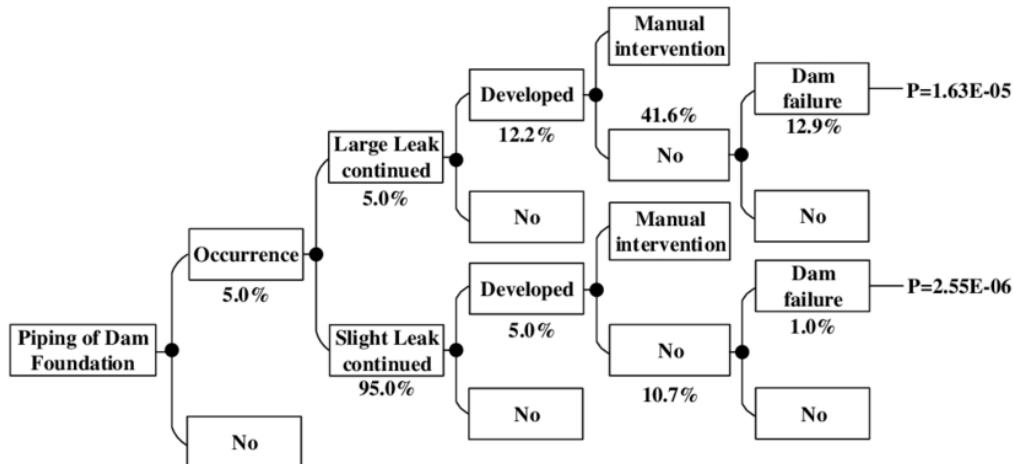
Figure 2: Sample event tree for a PFM from Army Corps of Engineers.

The following Figure 2 is an example of an event tree for a PFM.

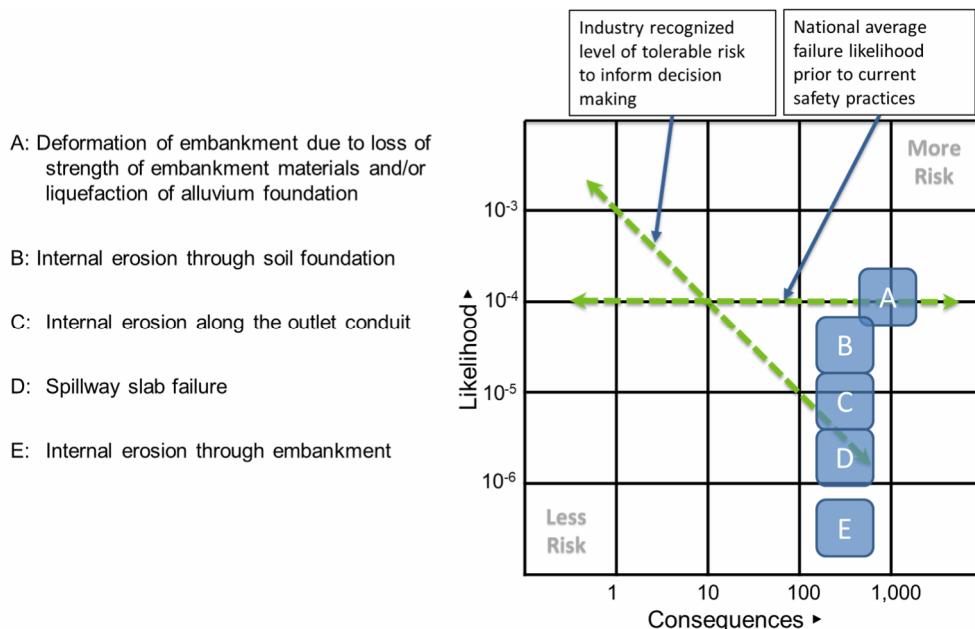
Figure 3: Sample Risk Matrix with risk estimates for various PFM's.

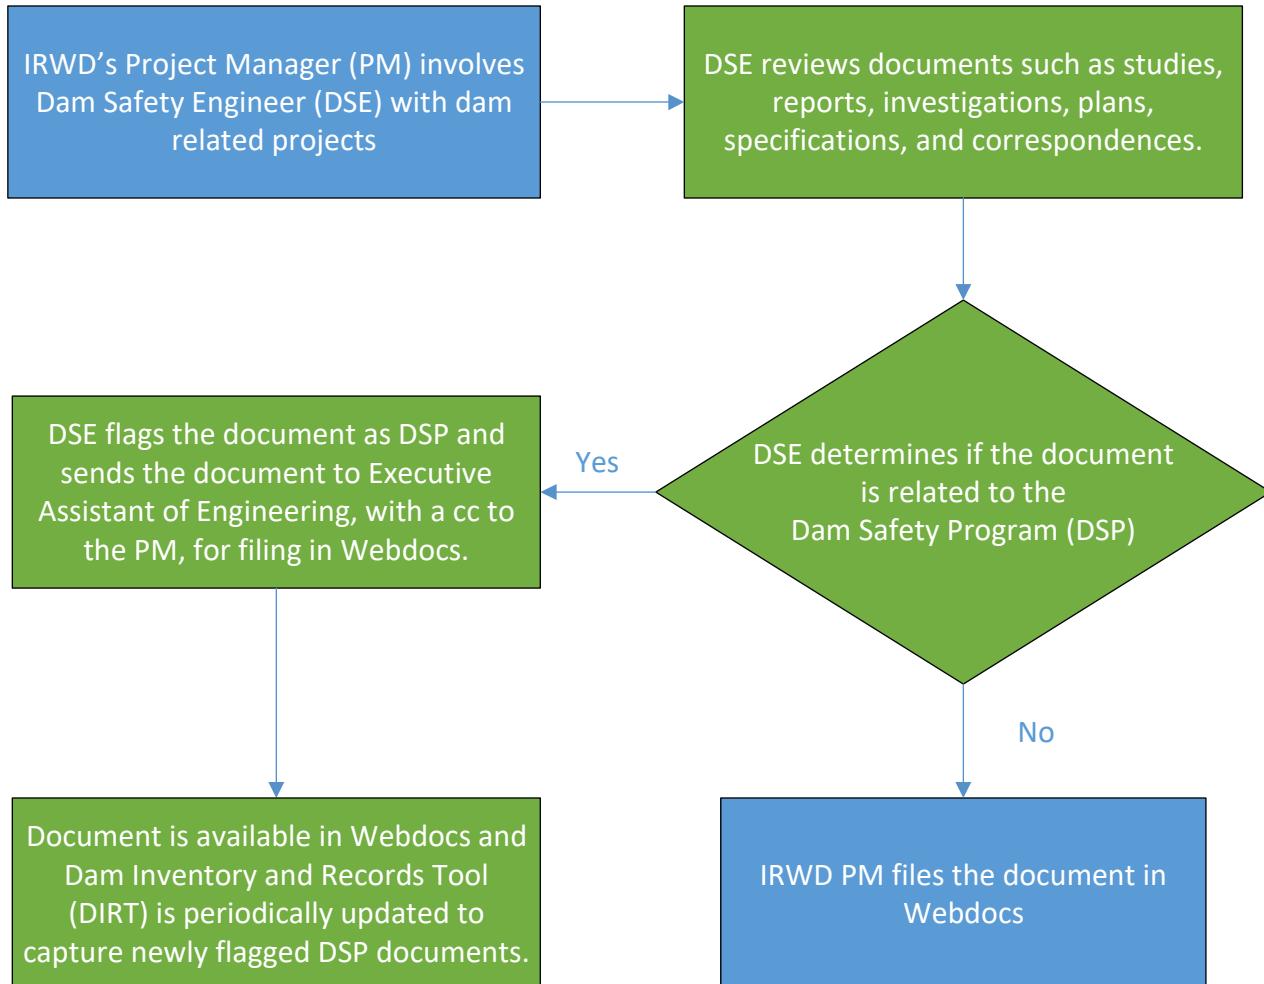
Figure 1: Data Management Process for IRWD's Dam Inventory and Records Tool

Blue = Project Manager Item

Green = Dam Safety Engineer Item

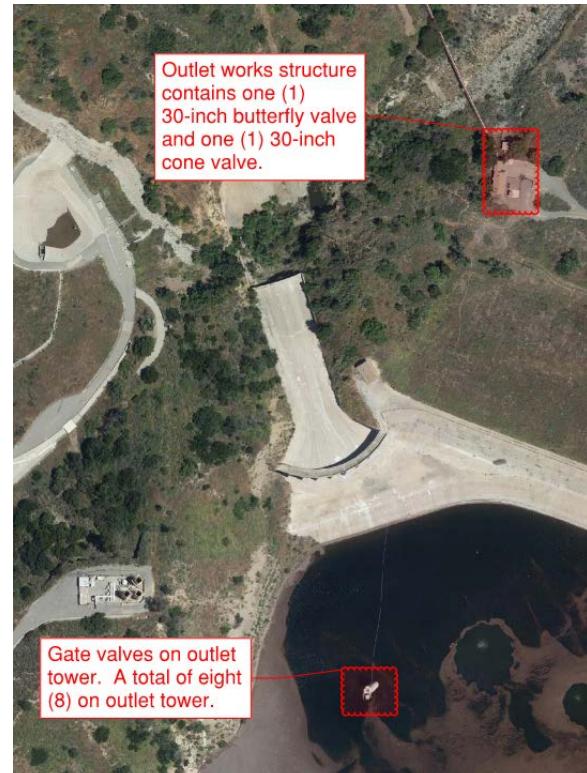
Figure 1: Santiago Reservoir valve locations for releasing water to Santiago Creek.

Item	Description	Location	Backup/Contingency	Notes
1	24" Gate Valve	Outlet Tower – Elev. 749.7'	IRWD will ensure that there is a minimum of one set of repair parts on site. This assumes valves are repaired in-place rather than a complete replacement of the valve.	
2	24" Gate Valve	Outlet Tower – Elev. 739'		
3	24" Gate Valve	Outlet Tower – Elev. 722'		
4	24" Gate Valve	Outlet Tower – Elev. 719'		
5	30" Gate Valve	<i>Outlet Tower – Elev. 710'</i>	n/a	<i>Under silt line</i>
6	30" Gate Valve	<i>Outlet Tower – Elev. 698.4'</i>	n/a	<i>Under silt line</i>
7	30" Gate Valve	<i>Outlet Tower – Elev. 688'</i>	n/a	<i>Under silt line</i>
8	30" Gate Valve	<i>Outlet Tower – Elev. 679.5'</i>	n/a	<i>Under silt line</i>
9	30" Butterfly Valve	Outlet works structure	IRWD will procure and store on site a replacement actuator.	<ul style="list-style-type: none">• 4-6 week lead time for a new general stock valve.• 12-16 week lead time for a new special order valve.

10	30" Cone Valve	Outlet works structure	If the cone valve fails in the close position, the valve could be removed and the upstream butterfly valve could be used to control flow to the creek.

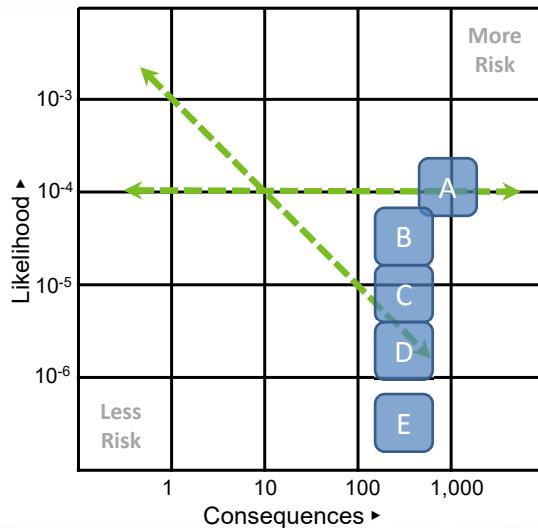
Background – Potential Failure Modes Influencing Total Risk at Rattlesnake Dam

- A: Deformation of embankment due to loss of strength of embankment materials and/or liquefaction of alluvium foundation
- B: Internal erosion through soil foundation
- C: Internal erosion along the outlet conduit
- D: Spillway slab failure
- E: Internal erosion through embankment

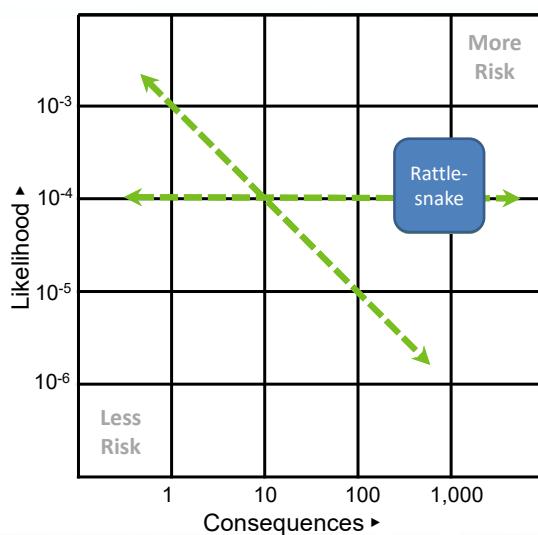
Preliminary Seismic Evaluation and Findings

- Previous studies indicate presence of alluvium foundation material, potential for liquefaction of foundation, and a wide range of material strengths.
- Additional geotechnical investigations and evaluations are needed to characterize extent and strengths of liquefiable materials.
- Permitted operating level of 406-ft may not provide adequate risk reduction.
- Preliminary slope stability analysis indicates significant risk reduction by operating at or below elevation 395-ft.

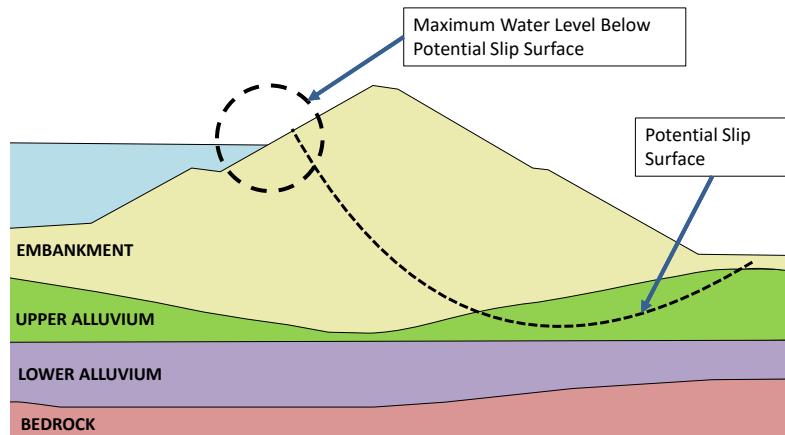
Staff intends to continue operating the reservoir at a maximum water level of ~~395-ft~~ until further notice.

Revised to 388-ft on 9/27/24

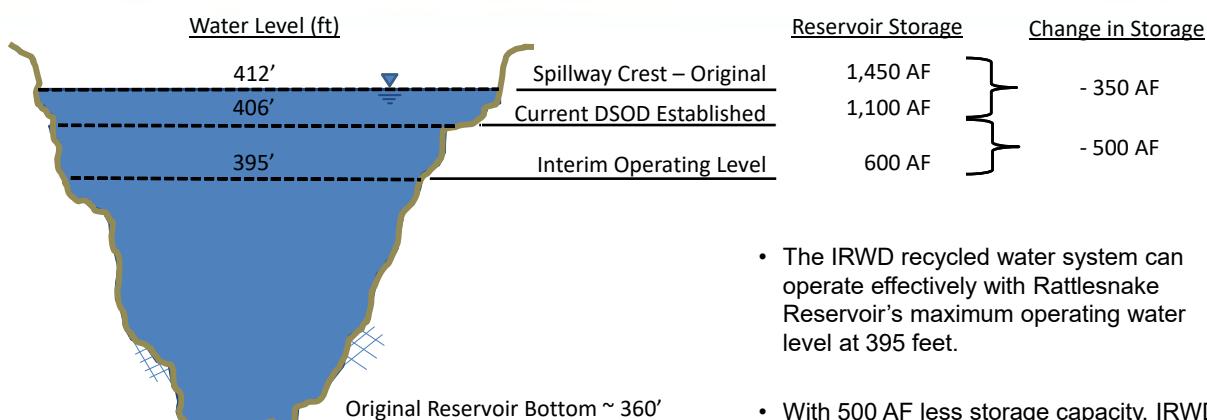
Rattlesnake Reservoir Storage

- The IRWD recycled water system can operate effectively with Rattlesnake Reservoir's maximum operating water level at 395 feet.
- With 500 AF less storage capacity, IRWD will need to buy an additional 500 AF of supplemental water. (For 2022, an estimated cost of \$400,000.)
