**Annual Surveillance Report**  
**January 2017 through December 2017**  
**Sand Canyon Dam**  
**DSOD Dam No. 1029-002**  
**Irvine, CA**  
**November 26, 2018**

Subject: Sand Canyon Dam, DSOD Dam No. 1029-002,  
Annual Surveillance Report from January 2017 through December 2017

**ANNUAL SURVEILLANCE REPORT  
JANUARY 2017 THROUGH DECEMBER 2017  
SAND CANYON DAM, DSOD DAM NO. 1029-002**

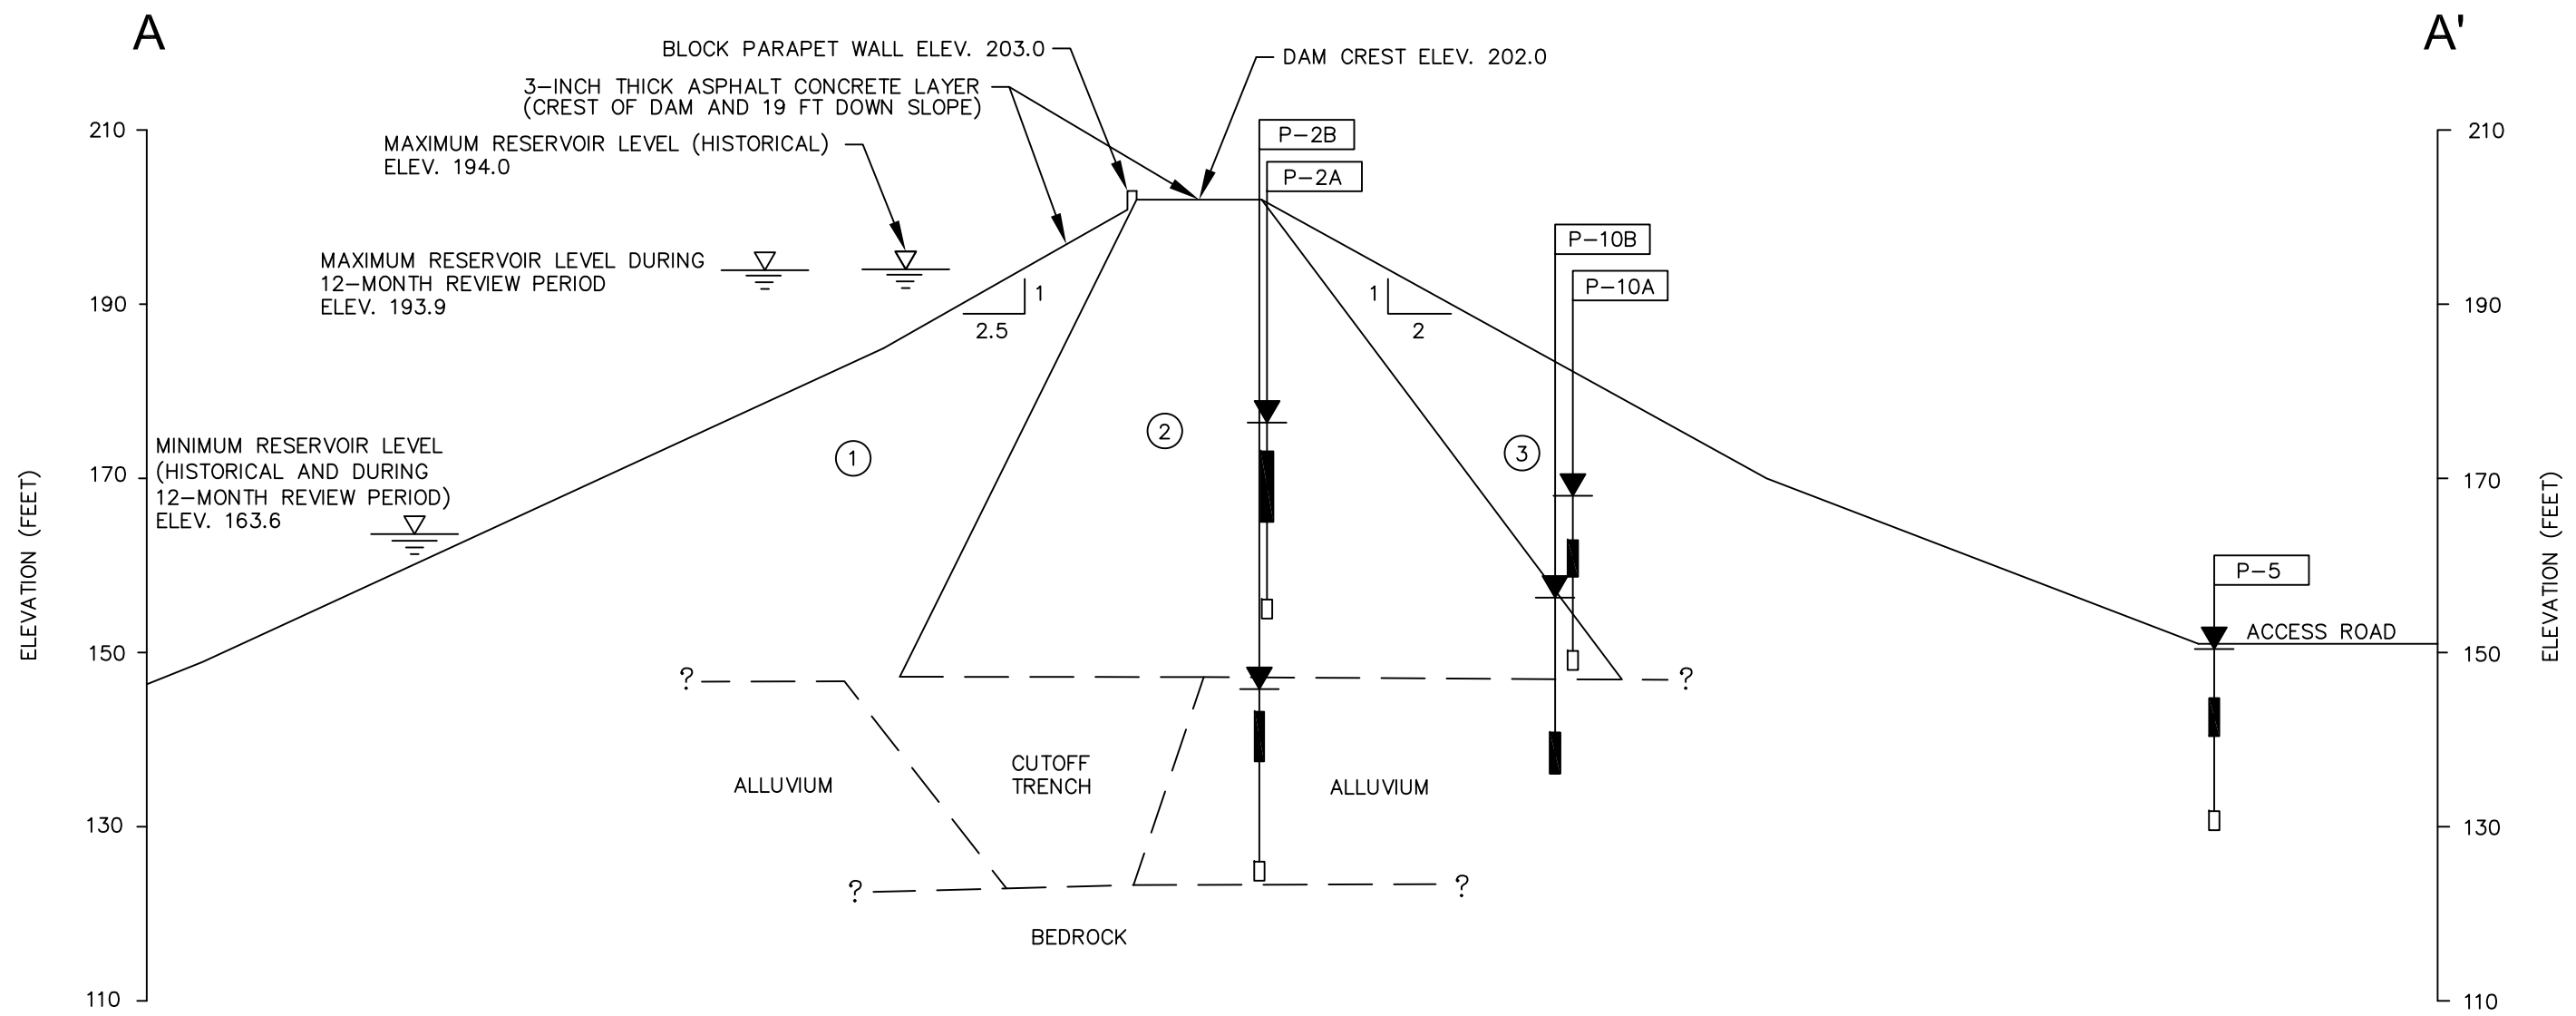
SECTION A-A'		
PROJECT NO.	DATE	FIGURE
397B-IRW	NOVEMBER 2018	2

The dam was designed as a zoned embankment with an upstream zone consisting of “selected impervious” material, a central zone of “random” material, and a downstream zone of “unselected pervious” material (Figures 2 and 3). During construction of the dam, test results indicated that the embankment is fairly homogeneous and consists, for the most part, of medium dense sandy clay and clayey sand (DSOD, 1984). The dam is reported as being founded on alluvium across the original broad stream channel, and on the sandstone of the Santiago Formation near the abutments.

Piezometers P-2A, P-2B, P-5, P-10A, and P-10B are located at or near the section of the dam overlying the maximum depth of the foundation alluvium (Section A-A' on Figure 2). Piezometer P-2A is nested in the same well as Piezometer P-2B and they are situated on the crest of the dam. Piezometer P-5 is situated near the toe of the dam. Piezometer P-10A is nested in the same well as Piezometer P-10B and they are situated along the downstream face of the dam. Graphs of the water levels during the two-year period from January 2016 through December 2017 are shown on Figure 4B, and those for a 10-year historical period from January 2008 through December 2017 are shown on Figure 5B.

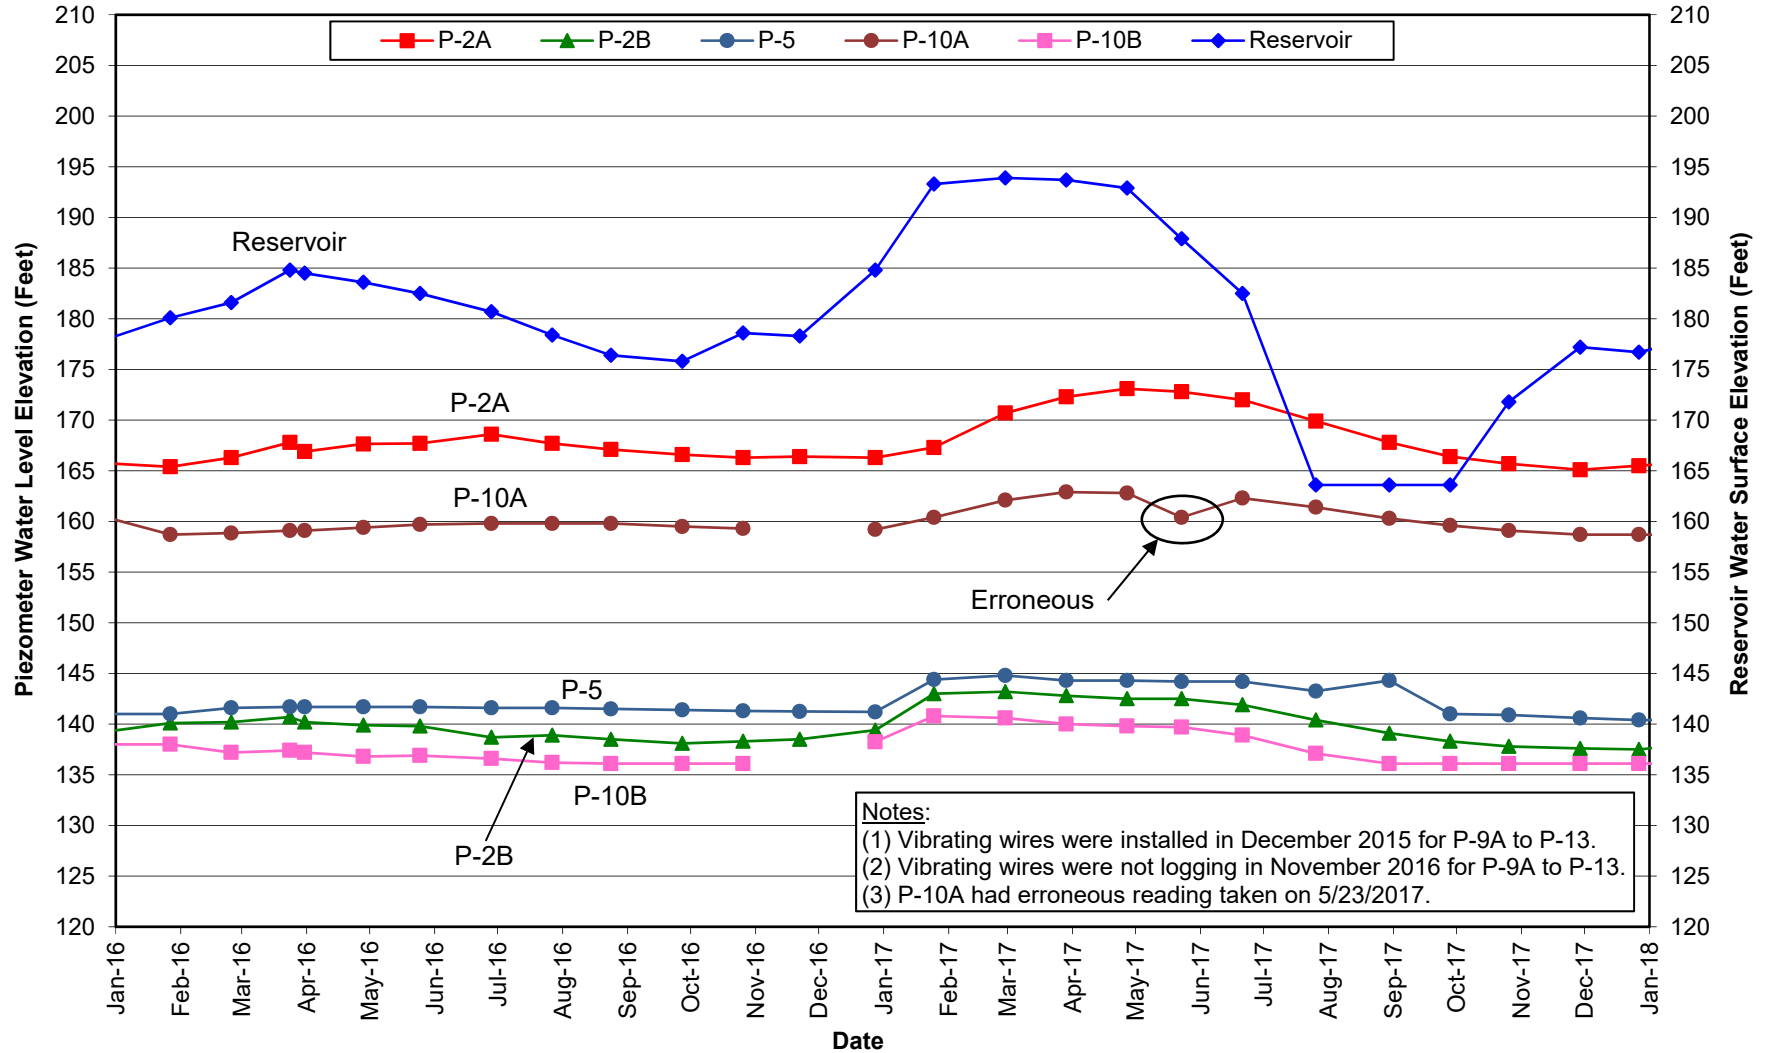
### SAND CANYON DAM 2-YR PIEZOMETER AND RESERVOIR WATER SURFACE ELEVATIONS PIEZOMETERS P-2A, P-2B, P-5, P-10A, AND P-10B JANUARY 2016 THROUGH DECEMBER 2017

Piezometers P-2B, P-5, and P-10B are installed in the foundation alluvium. Piezometers P-2B and P-10B show little response to reservoir water surface fluctuations, while Piezometer P-5 shows very little if any correlation. The water levels in Piezometer P-5 exhibited increases and decreases which may be related to rainwater. Readings taken on October 29, 2013, August 26, 2014, March 26, 2015, April 29, 2015, August 26, 2015, and November 24, 2015 in Piezometer P-10B show a sudden increase in the water level in that piezometer. Following those high readings however, the water level returned to below Elevation 139 feet. Those measurements were likely erroneous. The water levels observed in these piezometers during this 12-month review period were consistent with historical levels.

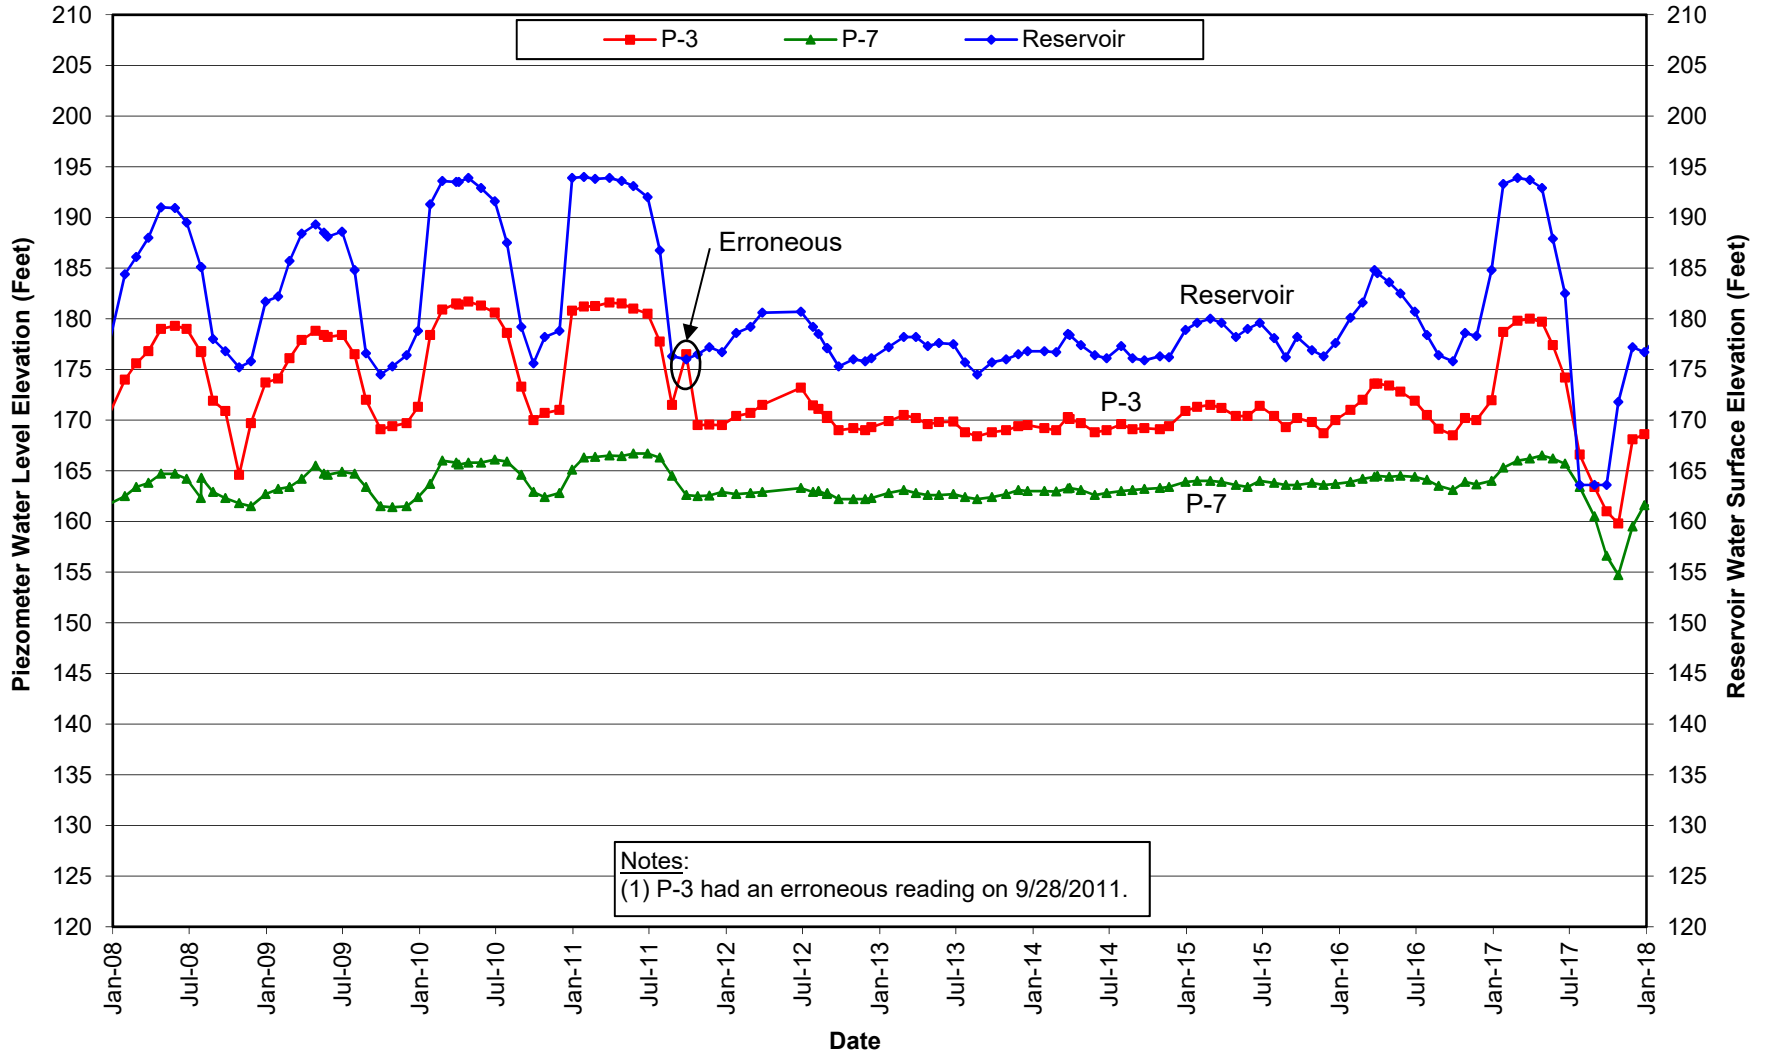
**SAND CANYON DAM  
10-YR HISTORICAL PIEZOMETER AND RESERVOIR WATER SURFACE ELEVATIONS  
PIEZOMETERS P-3 AND P-7  
JANUARY 2008 THROUGH DECEMBER 2017**

**Notes:**  
(1) P-3 had an erroneous reading on 9/28/2011.

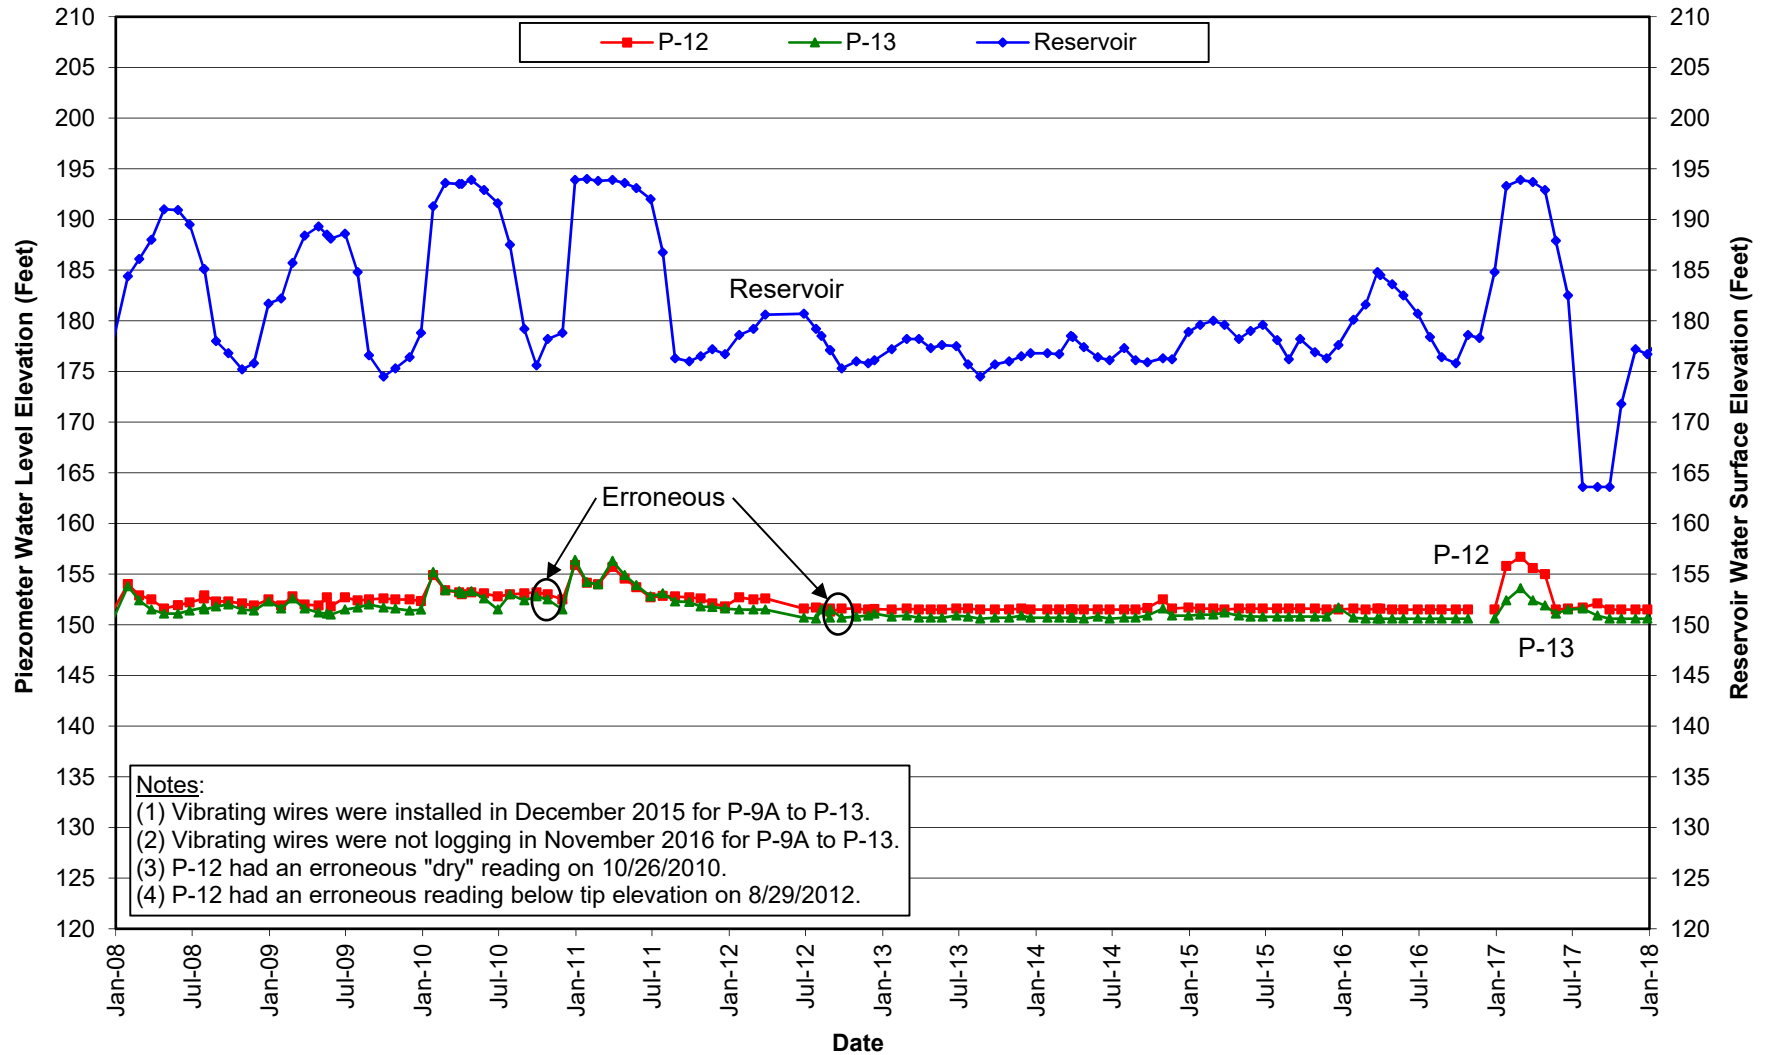
### SAND CANYON DAM 10-YR HISTORICAL PIEZOMETER AND RESERVOIR WATER SURFACE ELEVATIONS PIEZOMETERS P-12 AND P-13 JANUARY 2008 THROUGH DECEMBER 2017

Piezometers P-12 and P-13 are located on the downstream face of the dam near the toe between Sections A-A' and B-B'. Graphs of the water levels during the two-year period from January 2016 through December 2017 are shown on Figure 4E, and those for a 10-year historical period from January 2008 through December 2017 are shown on Figure 5E. The tip elevation of these two piezometers is believed to be in the dam embankment. These two piezometers are useful for monitoring the performance of the Right Subdrain. Water levels observed in these piezometers showed no response to reservoir water surface fluctuations and they are at about the same elevation (approximately 153 feet) as that of the invert of the Right Subdrain. On October 26, 2010 a dry reading was reported in Piezometer P-12 that is approximately 2 feet above the bottom of the piezometer. This reading is considered as erroneous. A reading taken on August 29, 2012 is below the bottom of the piezometer and is therefore considered as erroneous. The water levels observed in these piezometers during this 12-month review period were consistent with historical levels.

**Notes:**  
 (1) Vibrating wires were installed in December 2015 for P-9A to P-13.  
 (2) Vibrating wires were not logging in November 2016 for P-9A to P-13.  
 (3) P-12 had an erroneous "dry" reading on 10/26/2010.  
 (4) P-12 had an erroneous reading below tip elevation on 8/29/2012.

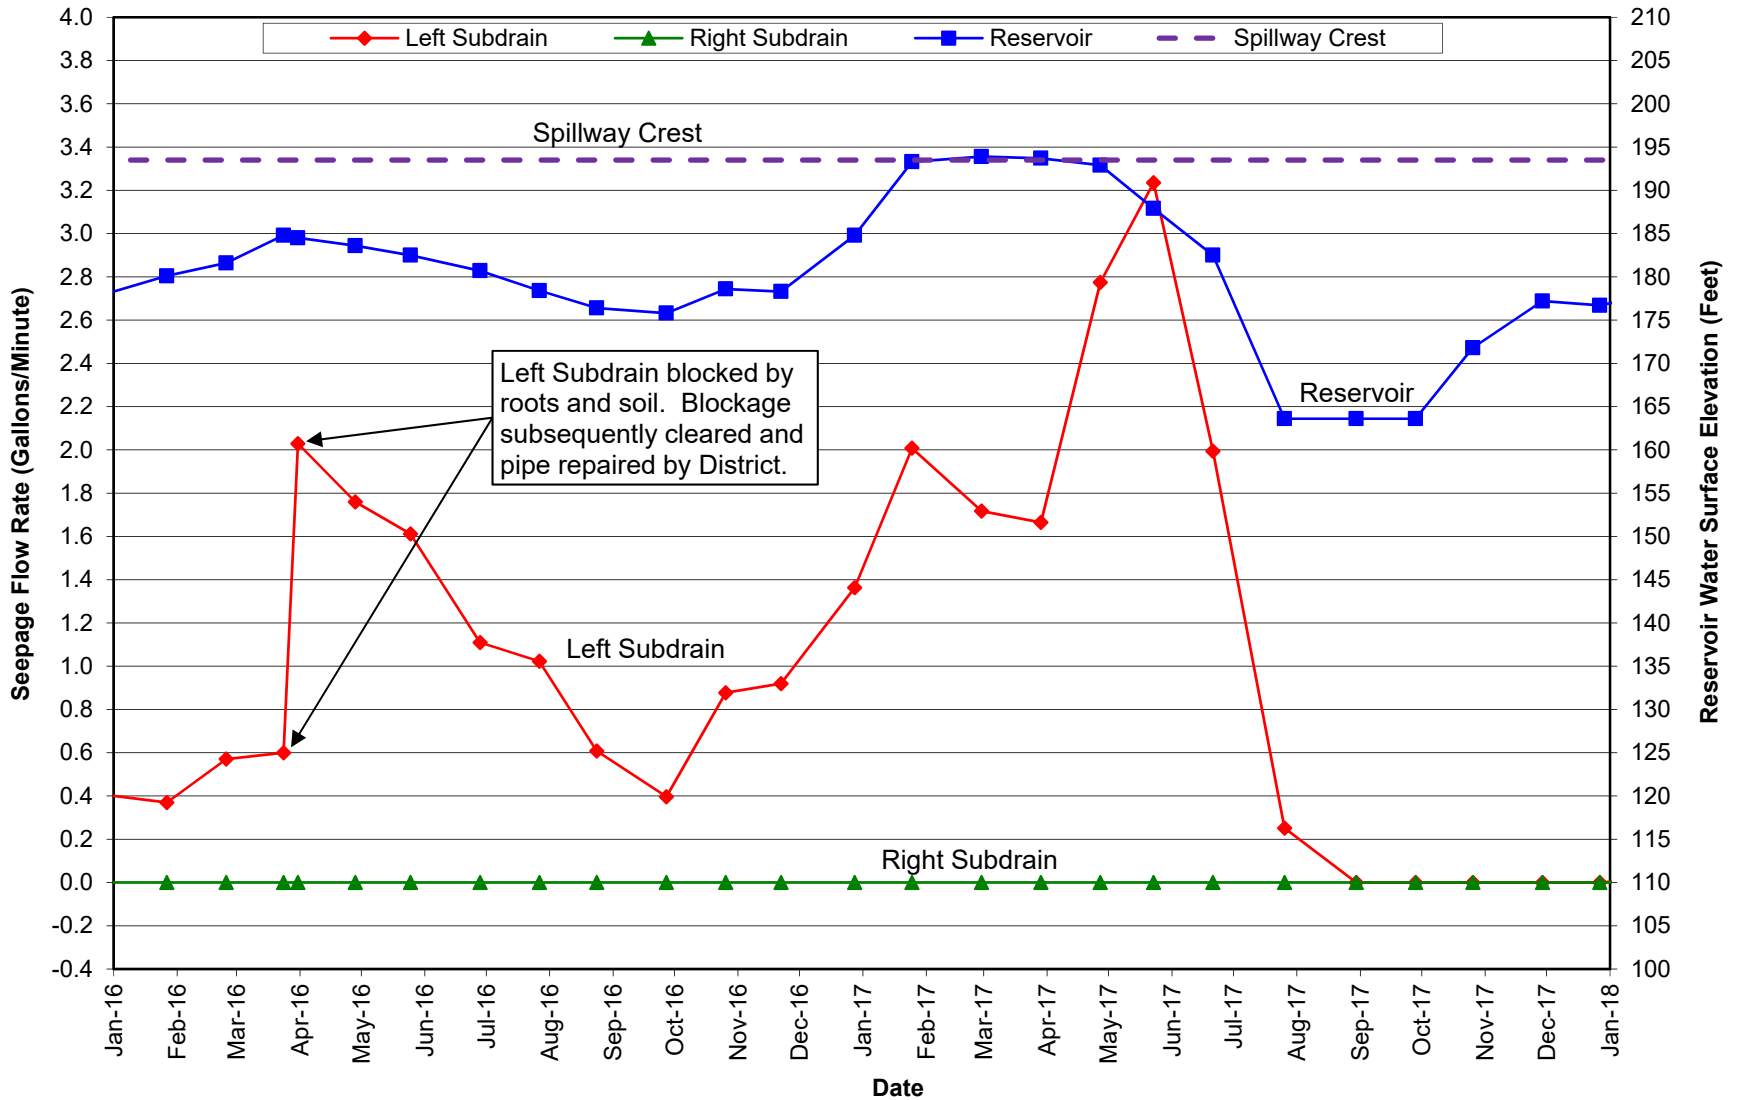
### SAND CANYON DAM 2-YR SEEPAGE FLOW RATES AND RESERVOIR WATER SURFACE ELEVATIONS JANUARY 2016 THROUGH DECEMBER 2017

During this 12-month review period, the Right Subdrain was dry, and the Left Subdrain flow rate ranged from no flow during August through December 2017, to a maximum flow rate of 3.24 gpm on May 23, 2017. Historically, the maximum flow rate of 3.96 gpm was measured from the Left Subdrain on June 28, 2000. Based on GENTERRA's review of the subdrain data, the flow rates appear to be consistent with historical flow rates and there are no indications of any adverse conditions.

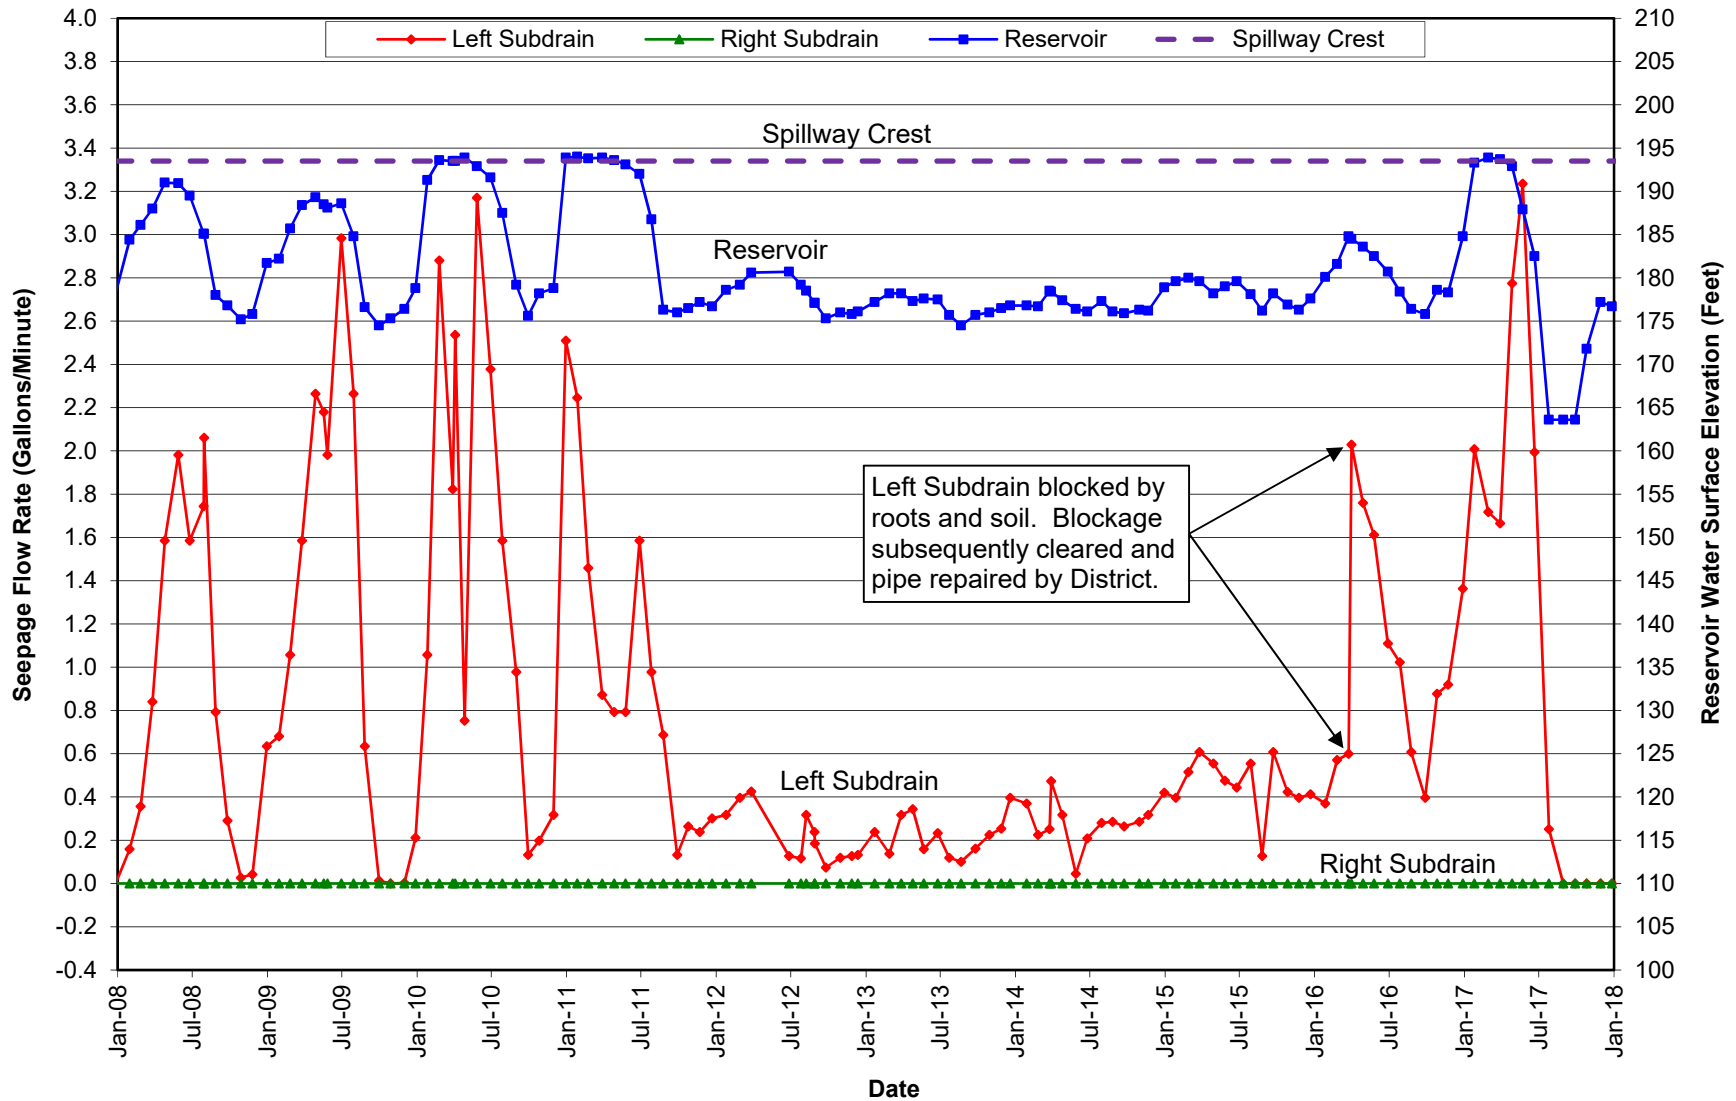
### SAND CANYON DAM 10-YR HISTORICAL SEEPAGE FLOW RATES AND RESERVOIR WATER SURFACE ELEVATIONS JANUARY 2008 THROUGH DECEMBER 2017

Since the repair of the Left Subdrain that was performed in October 1999 as a result of a sinkhole near the left abutment, the seepage flow rate through the Left Subdrain tends to increase when the reservoir water surface is above an elevation of approximately 180 feet. The flow rate then decreases to less than 0.5 gallons per minute (gpm) when the reservoir water surface is below Elevation 180 feet. The increases and decreases in flow rate may be related to rainwater. The flows should continue to be observed for clarity to check for the presence of any suspended solids that might indicate a potential piping condition.
