# Integrated Pest Management Plan for the Irvine Ranch Water District

2024 Annual Report

Provided By:  
Endemic Environmental Services Inc.

Prepared For:  
Irvine Ranch Water District

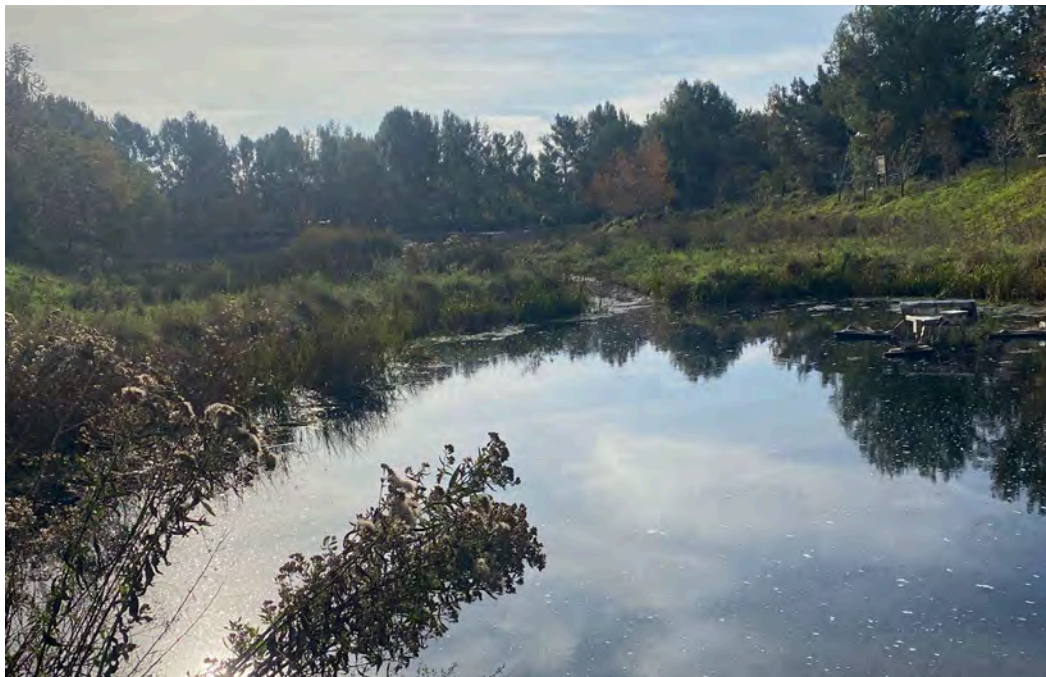
Forge Meadow is a 2.11-acre NTS basin adjacent to Portola Parkway in north Irvine. This basin consists of two ponds connected by a long channel. Forge Meadow is characterized primarily by annual and biennial species, including western ragweed, marsh fleabane, annual saltmarsh aster, and mugwort. Relative to other NTS sites, Forge Meadow is particularly low in native diversity. Endemic advised various manual removal methods to reduce and maintain the cover of non-native & invasive species. The most prevalent species were bristly oxtongue, curly dock, smilo grass, and umbrella sedge. Other non-native species advised for maintenance included Bermuda grass, barnyard grass, burr clover, clustered dock, common purslane, common sowthistle, common stork's bill, dallisgrass, English plantain, flax-leaved horseweed, hairy crabgrass, Italian rye, jungle rice, Mexican fan palm, Mexican primrose, prickly lettuce, prostrate pigweed, spotted spurge, Spanish false fleabane, tropical horseweed, umbrella sedge, wall barely, white sweetclover, and yellow sweetclover.

Figure 2. Forge Meadow Site Overview as of December 2024.

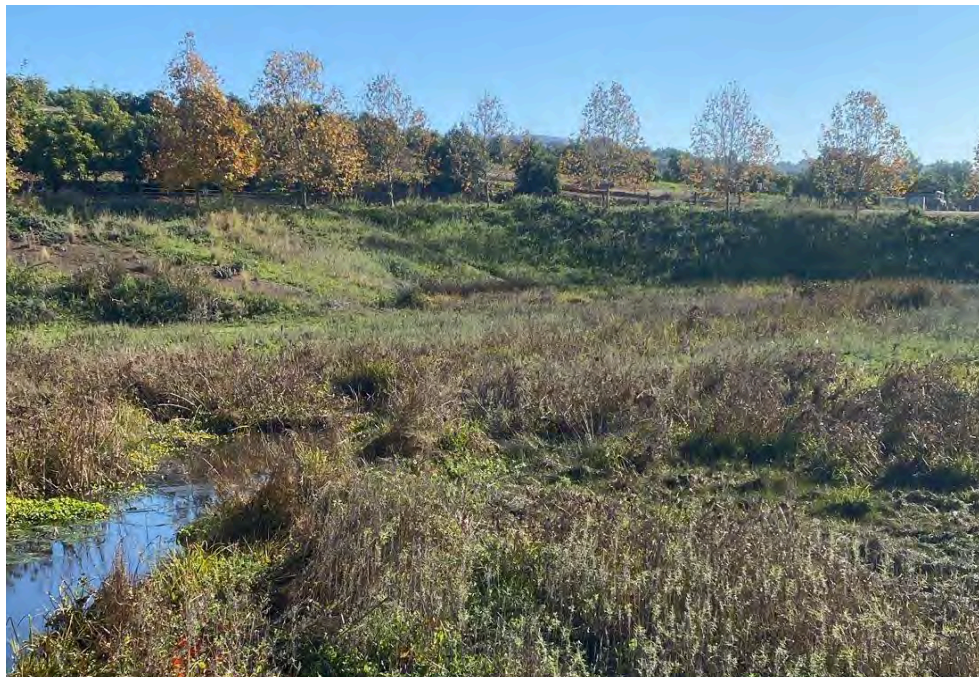
Port Culver is a 3.40-acre basin north of Portola Parkway, adjacent to a large agricultural area in north Irvine. This basin consists primarily of a pilot channel, where water often overflows from the channel and spreads throughout the bottom. Due to its proximity to an avocado plantation, the site experiences high invasion rates for plants that are not particularly characteristic of the NTS sites. As a result, there is particularly low native coverage for existing perennials. Over 400 native plantings (i.e. *Anemopsis californica*, *artemisia douglasiana*, *asclepias fascicularis*, *cyperus eragrostis*, *elymus triticoides*, *elmyus codensatus*, *epilobium canum*, *heliotropium curassavicum*, *mimulus guttatus*, *muhlenbergia rigens*, *salvia mellifera*, *sisyrinchium bellum*, *stipa lepida*, *stipa pulchra*) were planted throughout the basin and slopes at the beginning of the year. Manual hand removal was the primary advised method to reduce and control non-native cover. The most prevalent non-native species on the site included bristly oxtongue, smilo grass, Italian ryegrass, and burr clover, Other non-native species observed included: annual wall-rocket, Brazilian peppertree, bristly oxtongue, common dandelion, common soft brome, common sowthistle, compact brome, english plantain, flax-leaved horseweed, Peruvian peppertree, pickerelweed, prickly lettuce, prickly sowthistle, purple nutsedge, rabbitsfoot grass, red brome, shortpod mustard, spanish false fleabane, tropical horseweed, umbrella sedge, wall barley, wax leaf privet, whorled pennywort, yellow sweetclover.

Figure 3. Overview of Port Culver as of November 2024.

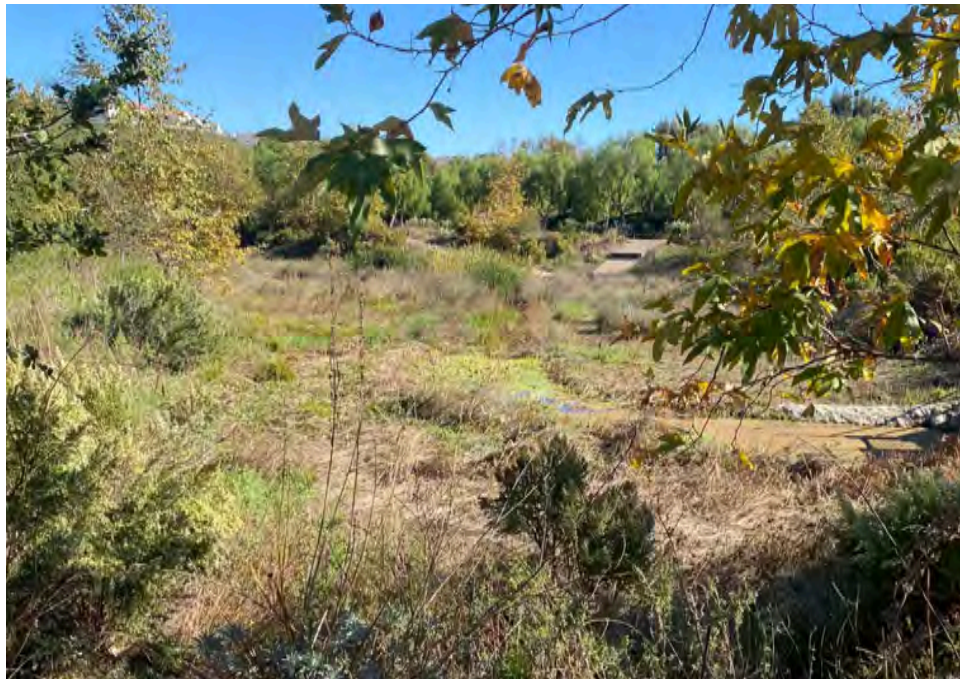
Orchard Meadow is a 1.18-acre basin located north of Portola Parkway and adjacent to a large agricultural area in north Irvine. This basin consists primarily of a pilot channel. Water often overflows from the channel and spreads throughout the bottom of the basin, creating a pond. Compared to other NTS basins in the relative area, Orchard Meadow exhibits minimal invasive slope cover due to the established Coastal Sage Scrub (CSS) vegetation. Due to this, Orchard Meadows is a particularly successful restoration project and likely to see long-term native persistence. Manual hand removal was the primary method prescribed for management. The most prevalent species included bristly oxtongue, curly dock, shortpod mustard, and Spanish false fleabane. Other non-native species observed included African asparagus, burr clover, common cattail, common sowthistle, flax-leaved horseweed, great brome, Peruvian peppertree, prickly lettuce, rabbitsfoot grass, rescuegrass, scarlet pimpernel, slender wild oats, Taiwanese firethorn, tropical horseweed, water beard grass, water smartweed, white sweetclover, yellow sweetclover.

Figure 4. Overview of Orchard Meadow as of November 2024.

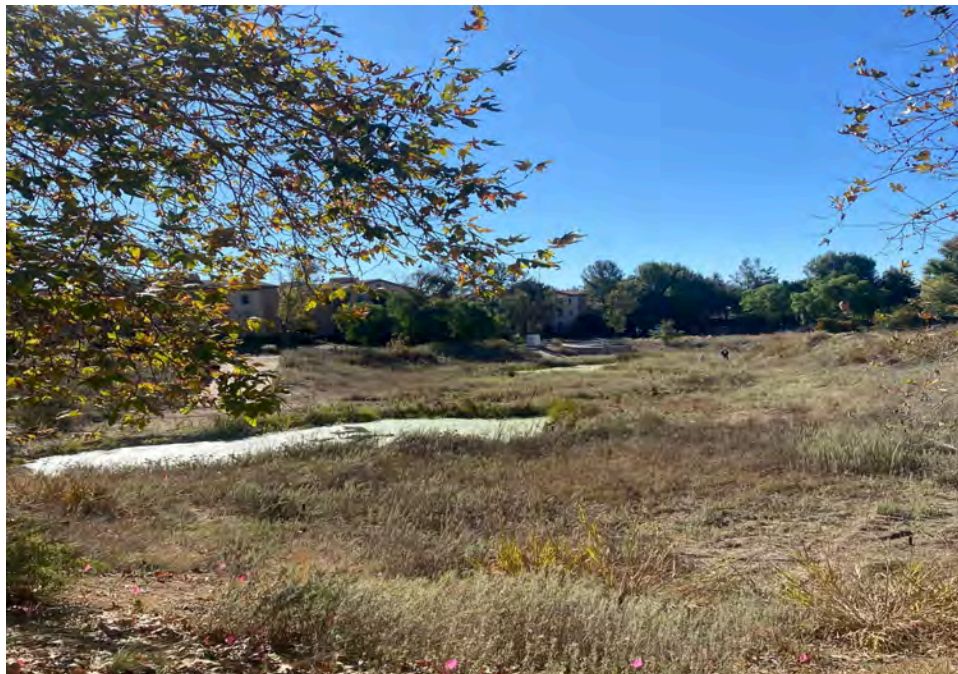
Lower Eastfoot is a 1.62-acre basin north of Portola Parkway adjacent to residential housing and the 261 freeway in north Irvine. The site basin consists primarily of a pilot channel connected with two ponds on each side. Due to the high desiccation rate in warm months and low existing native cover, this site exhibits consistent cover of annual non-native and invasive species. This site harbors a relatively new species to the county [marking the third county detection (white-stem filaree (*Erodium malacoides*))]. This species is featured on the review board for the California Native Plant Society as potentially invasive. Over 400 plantings (i.e. *Anemopsis californica*, *artemisia douglasiana*, *asclepias fascicularis*, *cyperus eragrostis*, *elymus triticoides*, *elmyus codensatus*, *epilobium canum*, *heliotropium curassavicum*, *mimulus guttatus*, *muhlenbergia rigens*, *salvia mellifera*, *sisyrinchium bellum*, *stipa lepida*, *stipa pulchra*) were planted throughout the basin and slopes at the beginning of the year. The overall most prevalent non-native species observed included bristly oxtongue, burr clover, and smilo grass. Various non-native brome species densely covered the slopes during the spring. All other non-native species observed included Bermuda grass, blue water speedwell, cheeseweed, common sowthistle, compact brome, curly dock, dallisgrass, field bindweed, flax-leaved horseweed, fountain grass, hairawn muhly, Italian rye, jungle rice, musky stork's bill, oat sp., rabbitsfoot grass, rescuegrass, Russian thistle, Spanish false fleabane, and yellow sweetclover. Regarding tree health, minor symptoms characteristic of potential Invasive Shot Hole Borer infestation (ISHB) were demonstrated by a sycamore tree on site.

Figure 5. Overview of Lower Eastfoot as of November 2024.

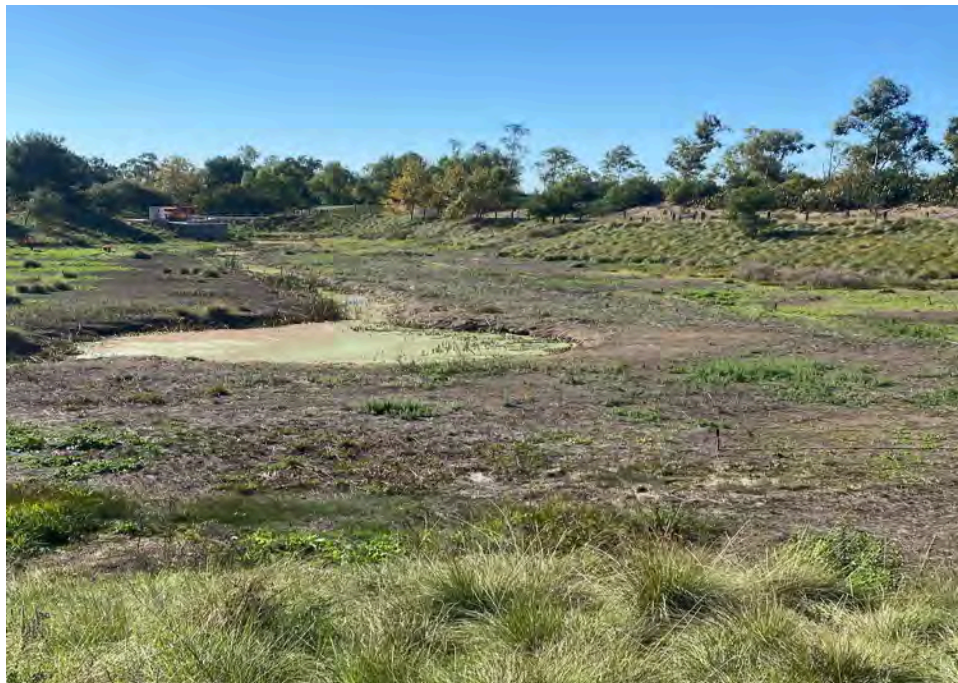
Middle Eastfoot is a 3.82-acre basin located north of Settlers Road in north Irvine. This basin is adjacent to residential housing, the 261 freeway, and agricultural land. The basin consists primarily of a pilot channel, which often overflows. Water spreads throughout the bottom of the basin and creates a pond. Similarly to Lower Eastfoot, there are high rates of non-native and invasive recruitment throughout the year. The basin in particular didn't have any emerging natives this year. The most diverse portions of this basin are along the peripheries of the basin, where water from irrigation is caught and held; here native bioswale vegetation can be found, such as spikerush (*Eleocharis sp.*), false daisy (*Eclipta prostrata*), alkali bulrush (*Bolboschoenus maritimus ssp. paludosus*), fragrant flatsedge (*Cyperus odoratus*), tall flatsedge (*Cyperus eragrostis*), and California loosestrife (*Lythrum californicum*), Mexican Sprangletop (*Leptochloa fusca ssp. uninervia*). The total coverage of this habitat has undergone impacts due to the encroachment of invasive vegetation and disturbance from trampling. In terms of prevalence, the most dominant non-native species included bristly oxtongue, Bermuda grass, burr clover, curly dock, and Mexican primrose. Other non-native species observed included, bristly oxtongue, common sowthistle, dallisgrass, English plantain, fountain grass, hyssop loosestrife, Maltese star thistle, ngaio, prickly sowthistle, rabbitsfoot grass, smilo grass, Spanish false fleabane, watercress, white sweetclover, and yellow sweetclover.

Figure 6. Overview of the Middle Eastfoot as of December 2024.

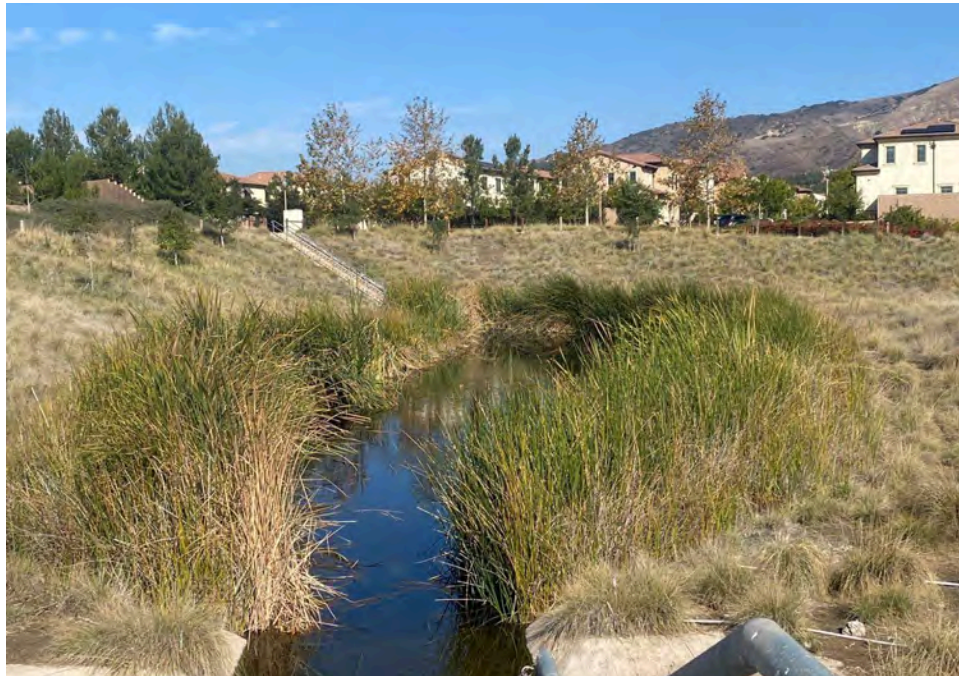
Upper Eastfoot is a 1.41 acre basin located east of the 261 freeway in north Irvine. The basin is adjacent to residential housing and consists primarily of a pond at the base of the slope. Upper Eastfoot remains only vernal wet and thus is almost barren of all non-planted vegetation for a large portion of the year. Due to this, problem areas were within the small corners of the site with consistent irrigation, and no particular non-native species dominated. Throughout the year, hand removal and hula hoe were primarily advised to manage non-native cover. Non-native species observed included yellow sweetclover, rabbitsfoot grass, Bermuda grass, bristly oxtongue, common lantana, matted sandmat, flax-leaved horseweed, hairawn muhly, hyssop loosestrife, prickly sowthistle, and scarlet pimpernel.

Figure 7. Overview of Upper Eastfoot as of December 2024

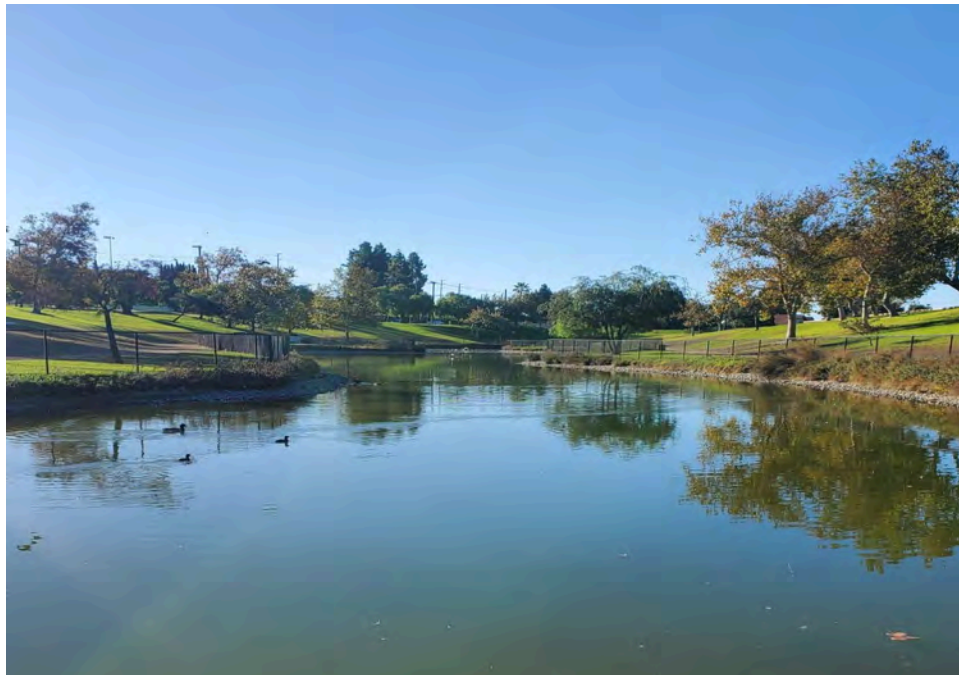
El Modena is a 2.37-acre basin located adjacent to S. Hewes Street in north Irvine. The basin is adjacent to residential housing and consists of a single pond. Non-native plant species advised for maintenance included birdsfoot trefoil, black-jack, bristly oxtongue, burr clover, cheeseweed, common flax, common sowthistle, compact brome, Italian rye, lesser swinecress, Mexican primrose, pineappleweed, rescuegrass, shamel ash, smilo grass, and Spanish false fleabane; birdsfoot trefoil and Mexican primrose were the most prevalent. Non-native plant species were primarily removed by hand.

Figure 8. Overview of El Modena as of November 2024.

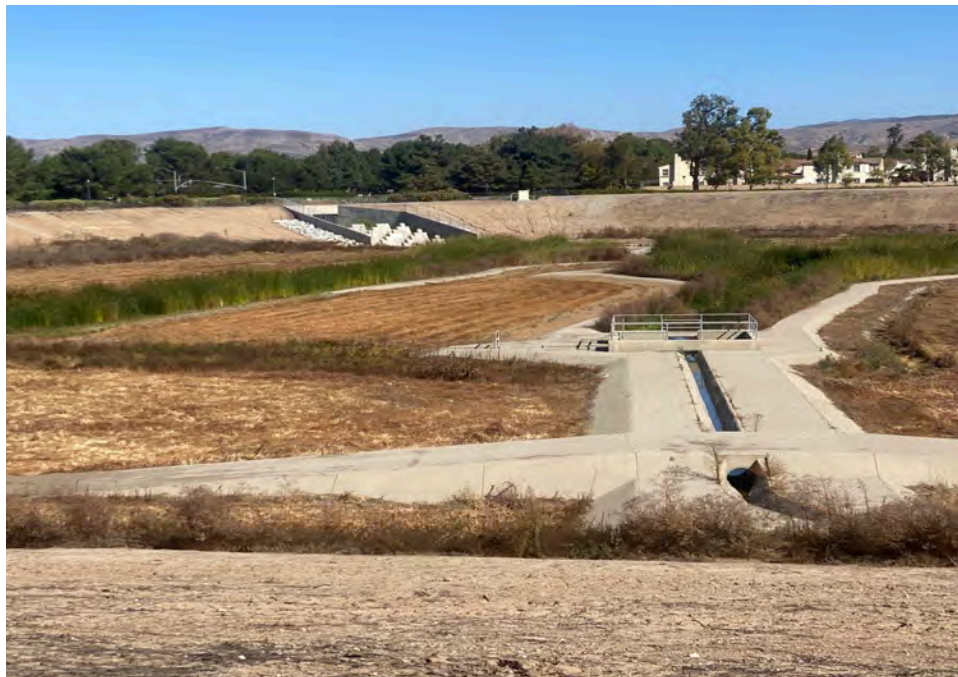
Trabuco is an 18.06-acre basin located north of Trabuco Rd in north Irvine. The basin is adjacent to residential housing. Trabuco consists of three ponds connected by two pilot channels. Characteristic of the flood basin sites, invasive cover remained relatively constant throughout the year, including on slopes, in basin waterways, and the basin bottom. Hand Removal and hula hoeing were the primary methods advised to manage the non-native cover. Following a directive from IRWD, Endemic biologists sought only to order the removal of invasives within 15 feet of the waterways in the latter half of the year. Spanish false fleabane, curly dock, and Italian rye were the most prevalent non-native species. Other non-natives advised for maintenance included: blue water speedwell, brass buttons, bristly oxtongue, burr clover, cheeseweed, Chinese elm, flax-leaved horseweed, lesser swinecress, prickly lettuce, rescuegrass, Shepherd's purse, shortpod mustard, stinknet,, water speedwell, white sweetclover, and yellow sweetclover.

Figure 9. Overview of Trabuco as of November 2024.

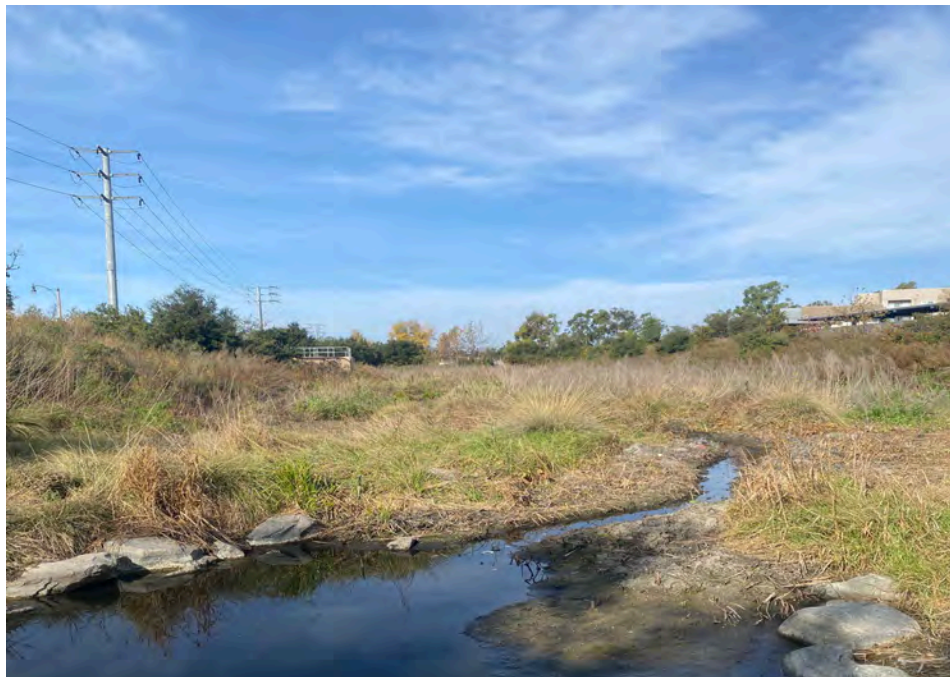
Parasol Park is a 2.07-acre site located north of Great Park Boulevard. It consists mainly of a pilot channel, with water often overflowing into the basin bottom. The site's primary spring and summer cover remains the non-native tropical horseweed (*Erigeron sumatrensis*). Despite its dense appearance, the native cover is relatively low compared to similarly seeded sites, and the waterways remain consistently weedy. Bare patches on the ground populate the site with heavy and compacted fill soil. These empty patches consistently foster Spanish false fleabane and brass buttons, with no opportunities for natives to recruit. Throughout the year, hand removal and digging were the primary methods advised to reduce total invasive cover. Tropical horseweed, curly dock, and Spanish false fleabane were the most prevalent species on site. Other non-natives advised for maintenance included black mustard, Brazilian peppertree, buffelgrass, bull thistle, carrotwood, crape myrtle, fountain grass, hairawn muhly, lindheimer's muhly, prickly lettuce, prickly sowthistle, shamel ash, stalked bulbine, and tropical milkweed.

Figure 10. Overview of Parasol Park as of December 2024.

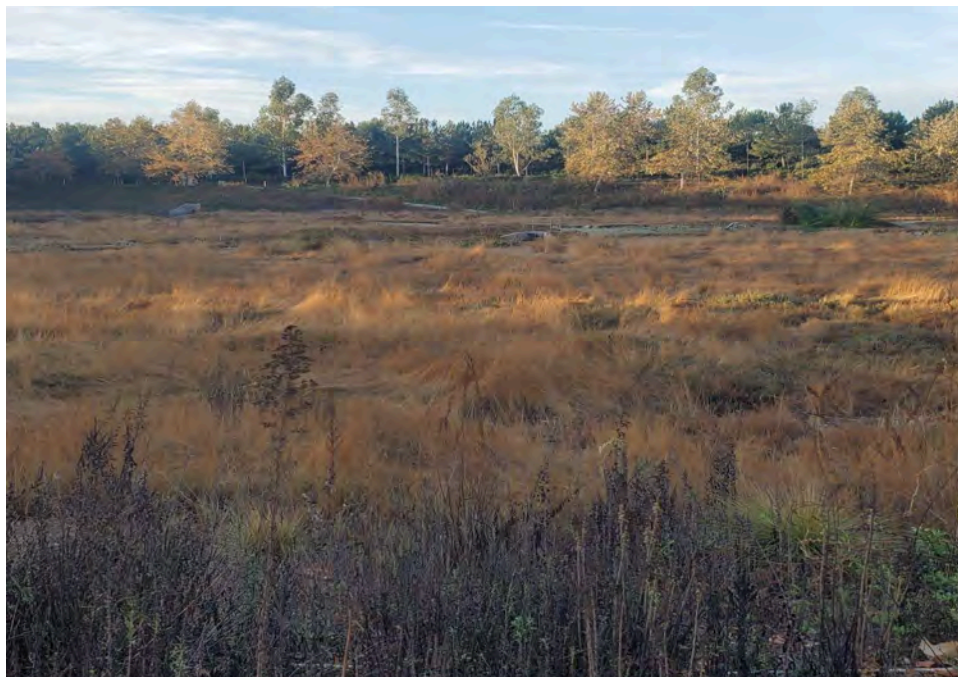
Cypress Meadow A is a 6.77-acre basin north of the 5-freeway and adjacent to residential housing in north Irvine. This basin consists primarily of three pilot channels connected by a pond at the bottom. During wet months, the slopes and basins exhibited high cover by non-native species. However, during the dry season, almost all plant cover (including non-native) senesced in the basin, leaving major bare patches throughout the site the majority of the year. Slopes consistently harbored non-native and invasive growth along the drip lines of trees and on the edge of sites, where moisture was present year-round. Due to high foot traffic, low moisture, and disturbance, there has been a notable reduction of native diversity in the already disturbed basin. Large patches of creeping wild rye (*Leymus triticoides*) and alkali heath (*Frankenia salina*) have disappeared, along with a moderate loss of wetland vegetation cover on the western portion. Native species of interest in this site include Scarlet toothcup (*Ammannia coccinea*) and Narrowleaf milkweed (*Asclepias fascicularis*). Hand Removal, hula hoeing, and digging were the primary methods advised for reducing the non-native cover. The most prevalent species included Spanish false fleabane and Mexican primrose. Other non-native species advised for maintenance included Brazilian peppertree, bristly oxtongue, camphor tree, carrotwood, Chinese elm, common stork's bill, creeping myoporum, curly dock, fountain grass, Japanese cheesewood, Mexican feathergrass, pampas grass, panic veldtgrass, perennial pepperweed, Peruvian peppertree, prickly sowthistle, St. Augustine grass, sticky snakeroot, Taiwanese firethorn, and yellow sweetclover.

Figure 11. Overview of Cypress Meadows A as of November 2024.

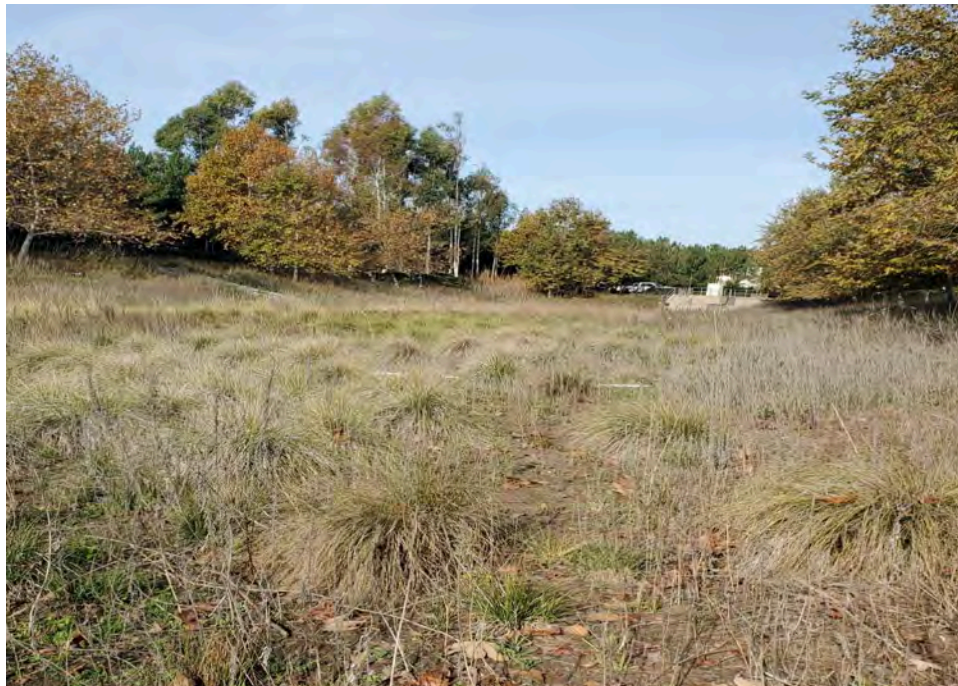
Cypress Meadow B is a 2.29-acre basin located north of the 5 freeway and adjacent to residential housing in north Irvine. This basin consists primarily of a pilot channel that runs throughout the bottom. Hand removal and hula hoeing were the primary methods advised to decrease invasive cover. The most prevalent non-native species documented included bristly oxtongue, common sowthistle, prickly sowthistle and prickly lettuce. Other non-native species advised for removal included Bermuda grass, black medic, burr clover, Chinese elm, common mugwort, great brome, Japanese honeysuckle, Jersey cudweed, Mexican fan palm, Mexican primrose, Peruvian peppertree, pyracantha, rabbitsfoot grass, rat-tail fescue, scarlet pimpernel, smilo grass, Spanish false fleabane, Taiwanese firethorn, wax-leaf privet, and yellow sweetclover.

Figure 12. Overview of Cypress Meadows B as of November 2024.

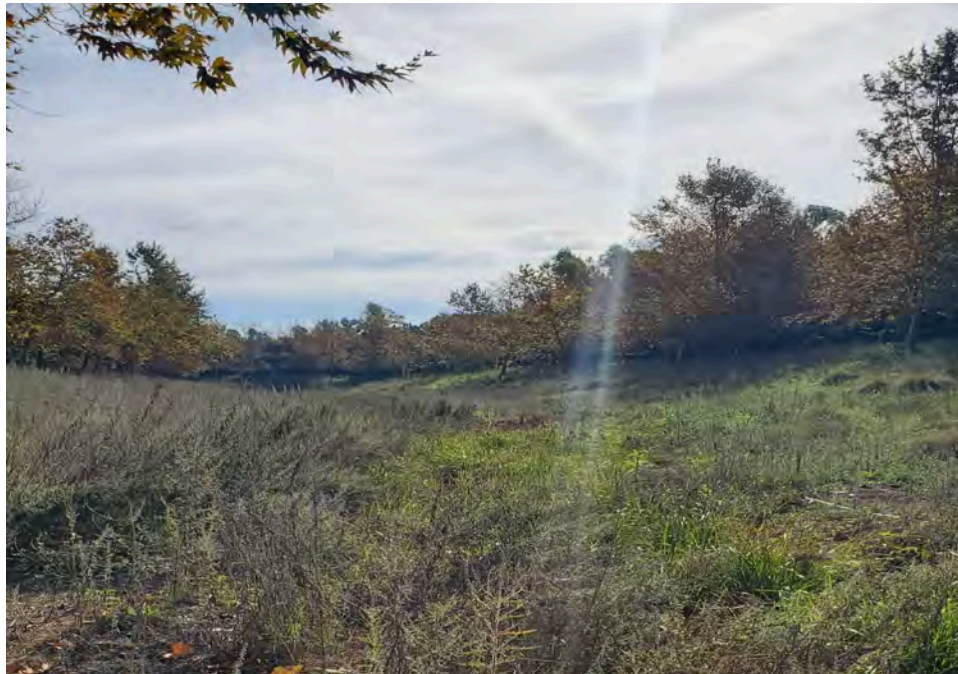
Cypress Meadow C is a 2.92-acre basin located north of the 5 freeway and adjacent to residential housing in north Irvine. This basin consists primarily of a pilot channel that runs along the bottom. Digging and hand removal were the primary methods advised to minimize native cover. Common sowthistle, yellow sweet clover, burr clover, and bristly oxtongue were the most prevalent non-native species on site. Other non-natives species include Asian mustard, Brazilian peppertree, camphor tree, Chinese elm, common stork's bill, compact brome, flax-leaved horseweed, fountain grass, Japanese honeysuckle, Lindheimer's muhly, Mexican fan palm, Mexican primrose, musky stork's bill, pampas grass, prickly lettuce, prickly sowthistle, rabbitsfoot grass, rescuegrass, shepherd's purse, smilo grass, trumpet flower.

Figure 13. Overview of Cypress Meadows C as of November 2024.

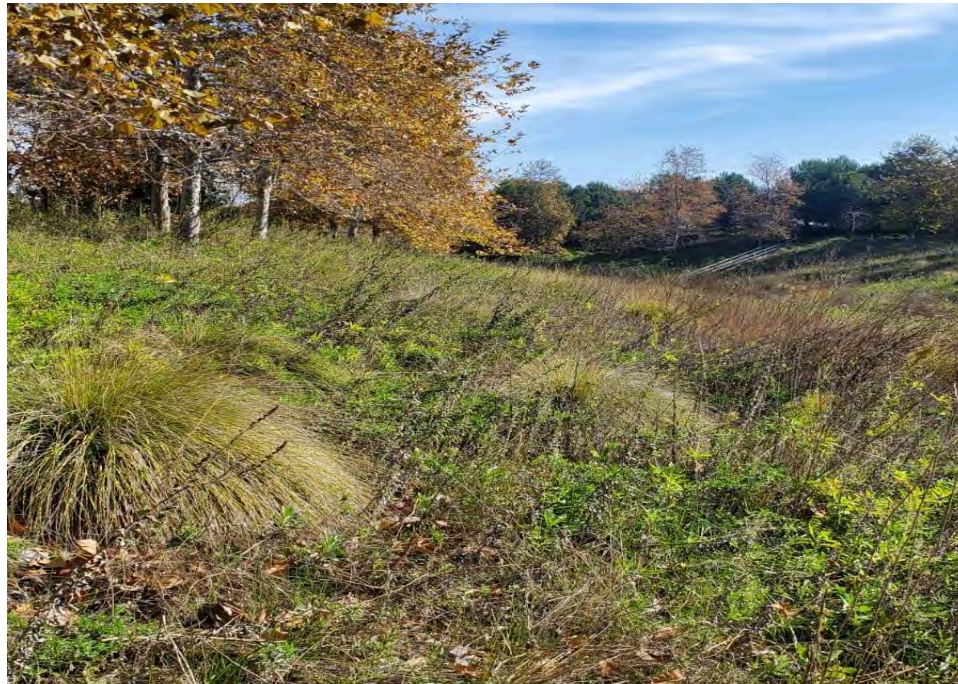
Cypress Meadow D is a 3.44-acre basin located north of the 5 freeway and adjacent to residential housing in north Irvine. This basin consists primarily of a pilot channel that runs throughout the bottom. Hand removal, hula hoeing, and digging were the primary methods advised to reduce non-native plant cover. Bristly oxtongue, Mexican primrose, and prickly sowthistle were the most prevalent species. Other native plants advised for removal included annual bluegrass, bermuda grass, Brazilian peppertree, brass buttons, bull thistle, burr clover, carrotwood, common sowthistle, floating primrose-willow, jersey cudweed, Mexican fan palm, Peruvian peppertree, prickly lettuce, scarlet pimpernel, Spanish false fleabane, Taiwanese firethorn, tropical horseweed, tropical milkweed, willow dock, and yellow sweetclover.

Figure 14. Overview of Cypress Meadows D

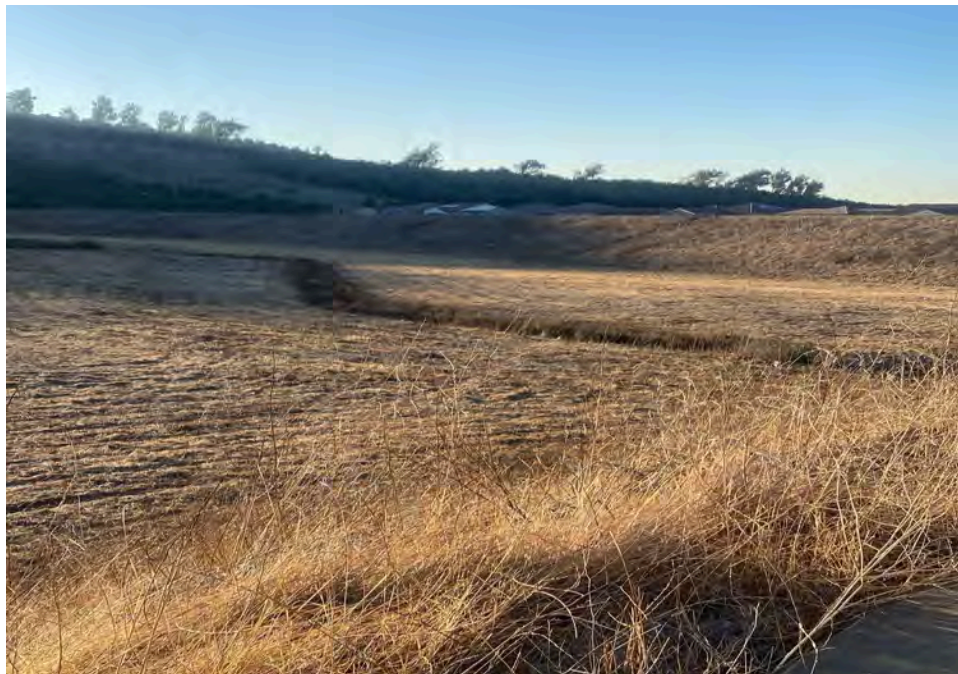
Eastfoot Retarding Basin is a 14.82-acre basin located east of Leafy Pass in north Irvine. The basin is adjacent to agricultural land and residential housing. It consists primarily of a pilot channel connected to three ponds along the basin bottom. Since this site is not under the direct management of IRWD and must primarily function as a flood basin, mowing efforts were the default weed maintenance measure required. To prevent non-native seeds from spreading into the waterway, only non-native individuals within 15 feet of the channels were advised for removal. Hand removal and hula hoeing were the primary advised maintenance methods, with shortpod mustard, Maltese star thistle, common sowthistle, bristly oxtongue, and cheeseweed being the most prevalent. Other non-native species observed on the site included Australian saltbush, bermuda grass, cheeseweed, common stork's bill, compact brome, prickly lettuce, red brome, ripgut brome, Russian thistle, slender wild oats, smilo grass, smooth barley, Spanish false fleabane, stork's bill sp., wall barley, and white sweetclover.

Figure 15. Overview of Eastfoot Retarding Basin as of November 2024.

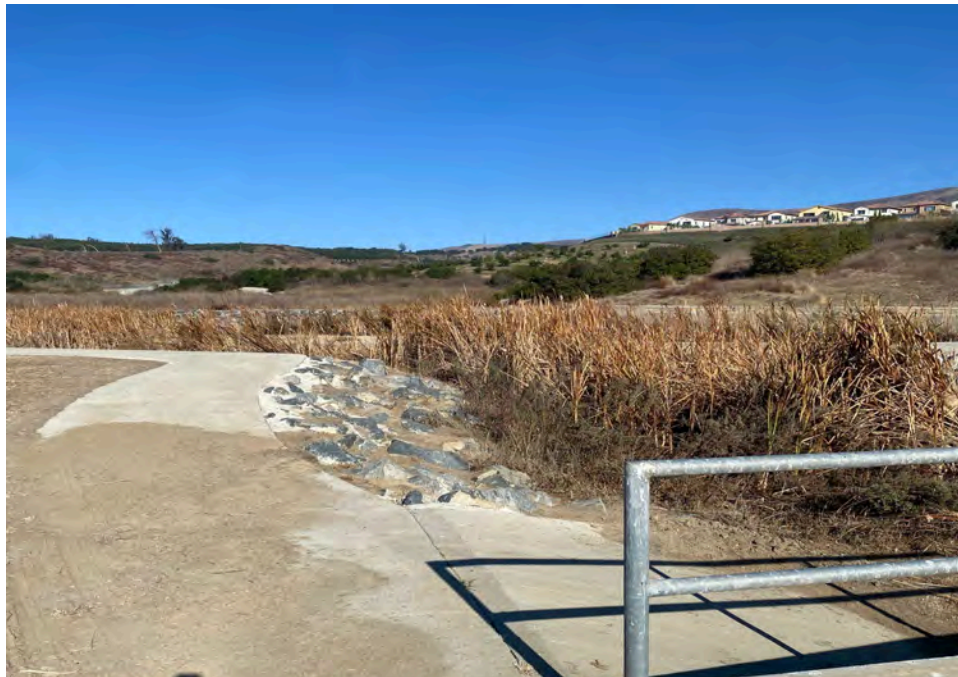
Quail Springs is a 8.38 acre basin located south of the I-405 freeway in north Irvine. The basin is adjacent to a large open field area and residential housing. Quail Springs consists primarily of a pilot channel connected to four ponds. For this site to primarily function as a flood basin, mowing efforts were the default weed maintenance measure required. However, to prevent non-native seeds from spreading into the waterway, non-native individuals within approximately 15 feet of the channels were advised for removal. Hand removal and hula hoeing were the most frequent removal methods advised for decreasing non-native cover, with curly dock, Spanish false fleabane, and burr clover being the most prevalent species to address. Other non-native species observed include the following: African sumac, black mustard, black willow, bristly oxtongue, castor bean, Chinese elm, common fennel, common purslane, common sowthistle, dallisgrass, fountain grass, Italian rye, Maltese star thistle, musky stork's bill, mustard sp., perennial ryegrass, prickly sowthistle, rat-tail fescue, Russian thistle, shepherd's purse, shortpod mustard, tamarisk, wall barley, watercress, white horehound, white sweetclover, wild radish, and yellow sweetclover.

Figure 16. Overview of Quail Springs as of November 2024.

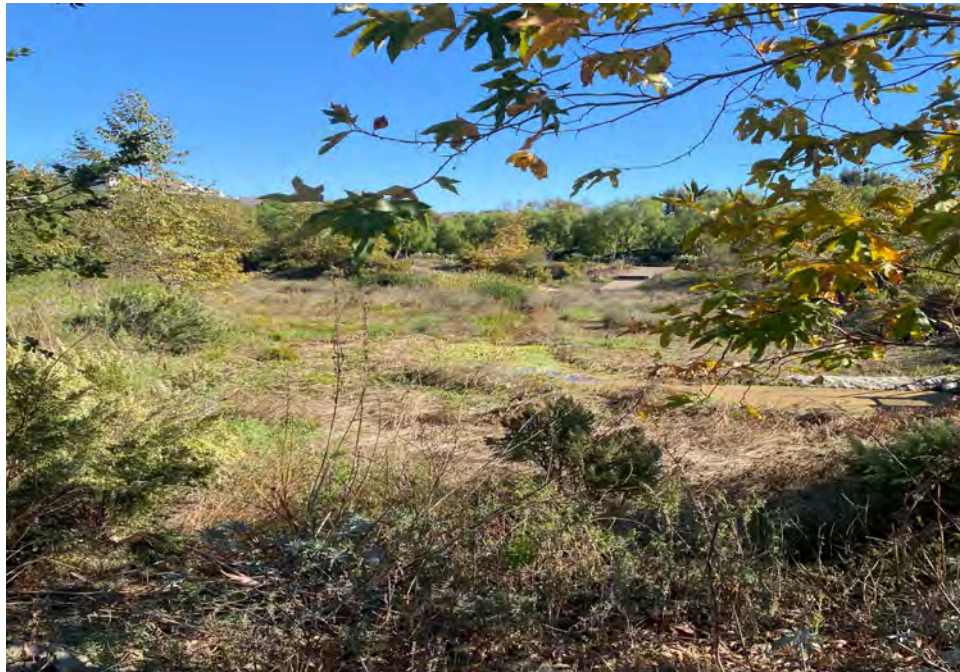
Orchard Retarding Basin is a 0.97-acre basin located adjacent to a housing development and the Orchard Hills Staging Area. The area consists of a basin connected to a channel with a paved walkway around the basin's edge. For this site to primarily function as a flood basin, mowing efforts were the default weed maintenance measure required. However, to prevent non-native seeds from spreading into the waterway, non-native individuals within approximately 15 feet of the channels were advised to remove them. As a flood basin, Orchard Retarding Basin remains relatively barren for the large majority of the year. Due to the lack of supplemental irrigation, seed bank, and foot traffic, little to no colonization of any species is present. Hula hoeing, hand removal, and digging were the primary advised methods for addressing non-natives bordering the channels, of which bristly oxtongue, Spanish false fleabane, shortpod mustard, and flax-leaved horseweed were the most prevalently observed. Other non-native species observed included common fennel, flax-leaved horseweed, Maltese star thistle, Mediterranean grass, prostrate pigweed, rabbitsfoot grass, ripgut brome, slender wild oats, and wall barley.

Figure 17. Overview of Orchard Retarding Basin as of December 2024.

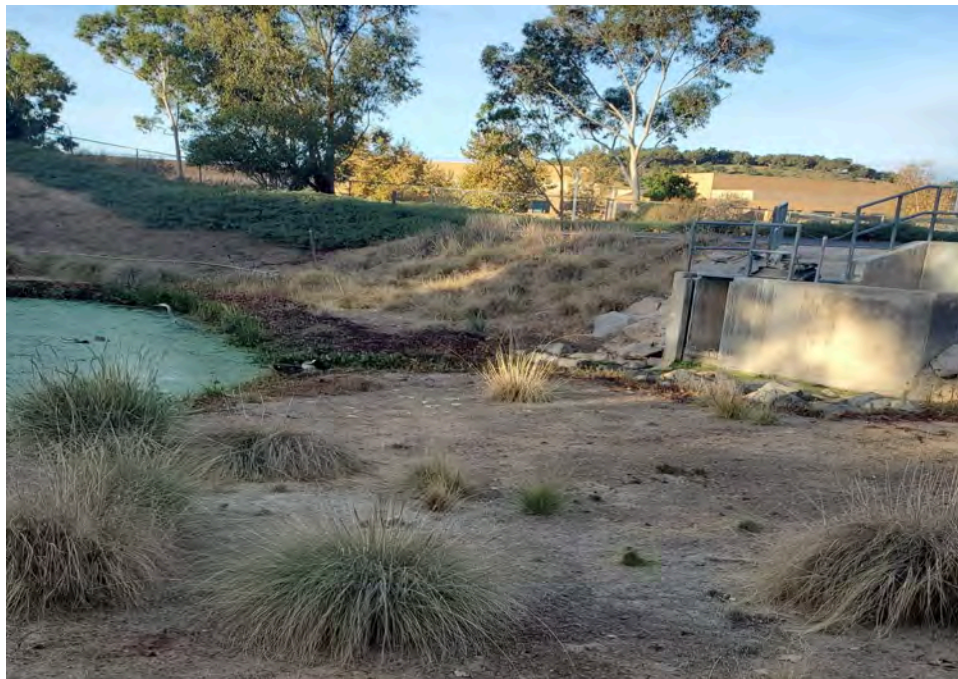
Twisted Oak is a 0.40-acre basin located northeast of Northwood High School. It consists of one circular pond. This site does not have access to a controller or irrigation system. Consequently, a large bareground area occupies the majority of the basin's bottom. Hand removal and hula hoeing were the primary methods recommended to manage the sparse non-natives occupying the disturbed areas. Due to the highly exposed soil, there was no particularly dominant species. In the waterway, the dominant non-native was floating primrose-willow; Bristly oxtongue and floating primrose-willow were the most prevalent non-native species; other non-natives observed in the site include Bermuda grass, burr clover, cheeseweed, common sowthistle, flax-leaved horseweed, prickly sowthistle, rabbitsfoot grass, scarlet pimpernel, sharpleaf cancerwort, and yellow sweetclover. In December, a grade-A mulch was distributed onto the barren areas. Follow-up restoration was advised to seed the bank conjunctly with planting. However, this plan should be reconsidered once a more readily available irrigation system has been secured on-site. Additionally, plant choices should be vetted to ensure proper nativity. Among the remaining planted vegetation at Twisted Oak, a plant native to Northern California (*Leymus mollis*) was detected. Only two plants were present, and the health of the individuals appeared to indicate no invasive risks. However, caution should be taken due to the capacity of seed distribution through the waterway.

Figure 18. Overview of Twisted Oak with bareground in the basin as of November 2024.

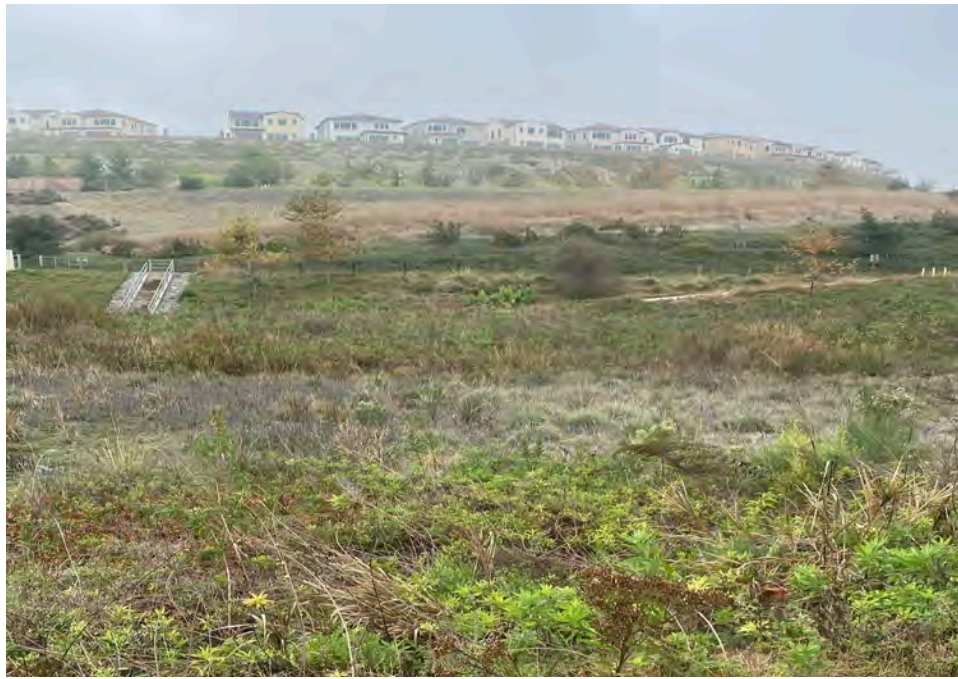
Agua Chinon A is a 2.10-acre basin located near a housing development off Portola Springs Road and adjacent to SR-241. Hand removal was the primary method advised to reduce the non-native cover. Fountain grass and Spanish false fleabane were the most prevalent species observed. Due to its proximity to other weedy areas, the basins often receive ‘tumbleweeds’ from nearby senesced Russian thistle. Other non-natives advised for removal included bristly oxtongue, bull thistle, common sowthistle, marsh celery, pampas grass, prickly sowthistle, rabbitsfoot grass, scarlet pimpernel, shorthpod mustard, stork’s bill sp, and tamarisk..

Figure 19. Overview of (Upper) Agua Chinon A as of November 2024.

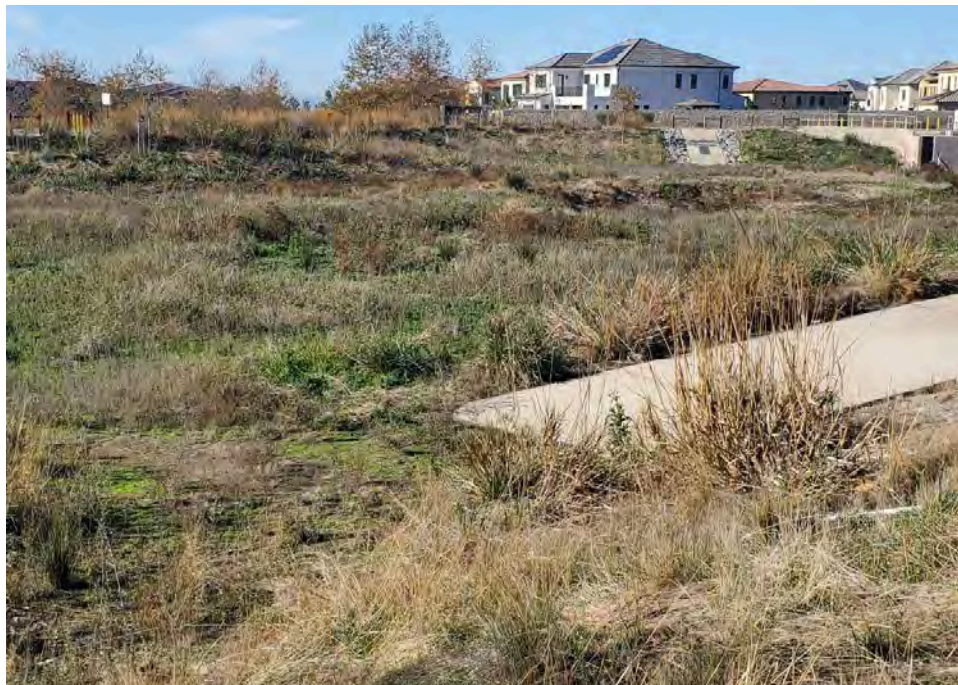
Aqua Chinon B is a 2.36-acre basin located near a housing development off Portola Spring Road and adjacent to SR-241. Hula hoeing and hand removal were the primary methods advised to decrease non-native cover. Spanish false fleabane was the most prevalent and problematic non-native species on site. Additionally, a polygon of newly germinating smilo grass was allowed to seed in the center of the site, which will be an issue to anticipate in the wet season. Other non-natives observed include bristly oxtongue, burr clover, common sowthistle, curly dock, fountain grass, golden wreath wattle, prickly sowthistle, rabbitsfoot grass, shortpod mustard, smilo grass, stinknet, tamarisk, and yellow sweetclover.

Figure 20. Overview of (Upper) Aqua Chinon B as of December 2024.

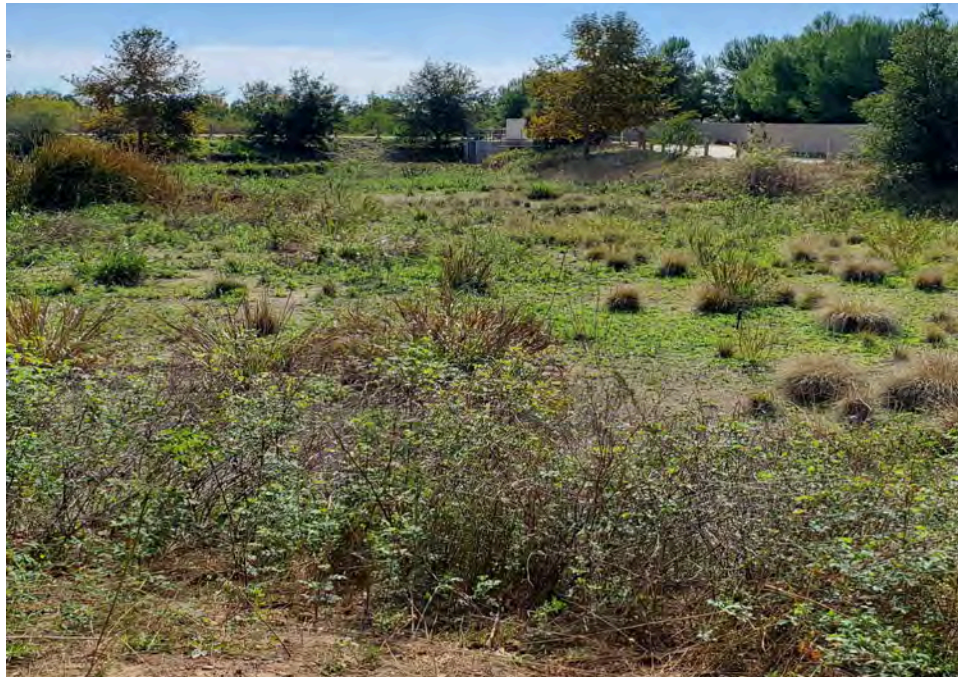
Aquila Springs is a 1.19-acre basin located in the Altair Community development east of Irvine Boulevard. The basin consists of one channel, which frequently floods. Once characterized by its high native cover, excessive foot traffic and invasive encroachment have significantly reduced native recruitment. While most slopes have retained a relatively high native cover, the basins and the west slope are in the process of degradation. Furthermore, large bare patches of rocky soil populate the site, which are only colonized by ephemeral natives and annual non-natives. Hand removal and digging were the primary methods advised for reducing non-native cover. Prevalent non-natives were Spanish false fleabane, horseweed spp. (flax-leaved and tropical), yellow sweet clover, and lesser swinecress. Other non-natives advised for removal included canary island date palm, common sowthistle, common stork's bill, fountain grass, garland daisy, hairawn muhly, lesser swinecress, lindheimer's muhly, Mexican fanpalm, milk thistle, prickly sowthistle, rabbitsfoot grass, Saharan mustard, scarlet pimpernel, shortpod mustard and yellow sweetclover.

Figure 21. Overview of Aquila Springs as of November 2024.

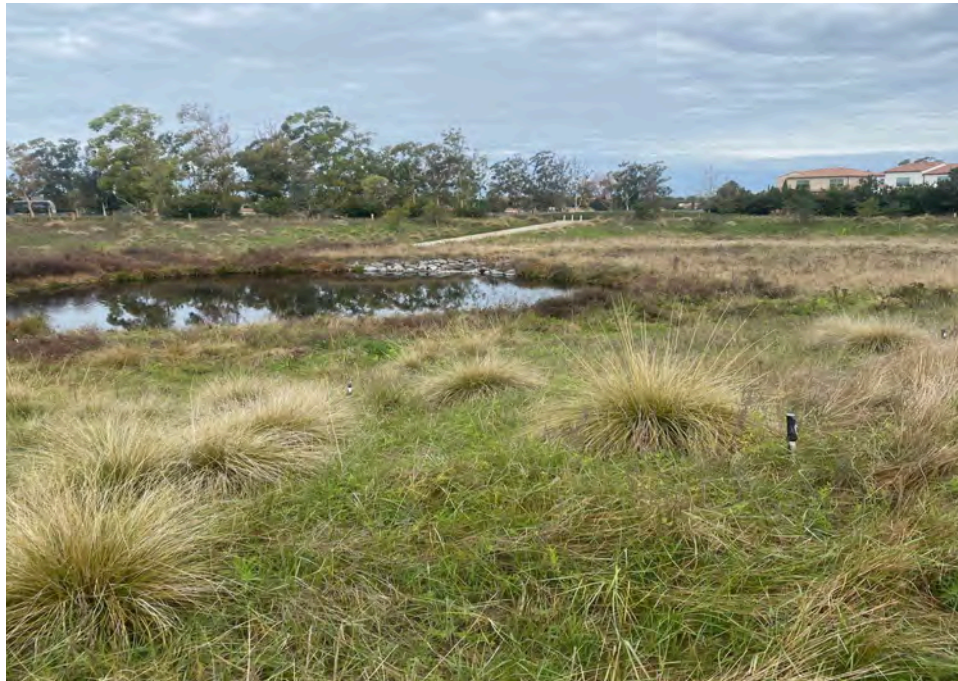
Floral View is a 2.49-acre basin located east of SR-133 and west of Floral View. It consists of one channel leading to a circular pond. The site had a moderate amount of annual non-native plants. Furthermore, large stands of Tall Fescue (*Festuca arundinacea*) were detected onsite, particularly on the Northeast slopes. Tall fescue is designated as a Moderate on the Cal-IPC rating system, indicating a substantial and apparent impact on the ecosystems it invades. Most of these plants have left large holes on the slopes upon removal. As a supplementary recommendation, Endemic suggests a replanting effort upon eradicating all of the Tall Fescue stands. Hand removal and hula hoeing were the primary methods advised to reduce general non-native cover. The most prevalent species observed were Spanish false fleabane, Mexican primrose, and rescuegrass. Other non-natives advised for removal include bay laurel, black mustard, bull thistle, burr clover, common fig, common sowthistle, compact brome, Italian thistle, Jersey cudweed, Mexican fan palm, Mexican primrose, poison hemlock, red brome, rescuegrass, ripgut brome, slender thistle, tall fescue, tropical milkweed, and sweetclover spp. (white and yellow). Lastly, Floral View appears to have a notable decline in tree health, with all Coast live oaks undergoing significant stress, pest damage, and stunting.

Figure 22. Overview of Floral View as of November 2024.

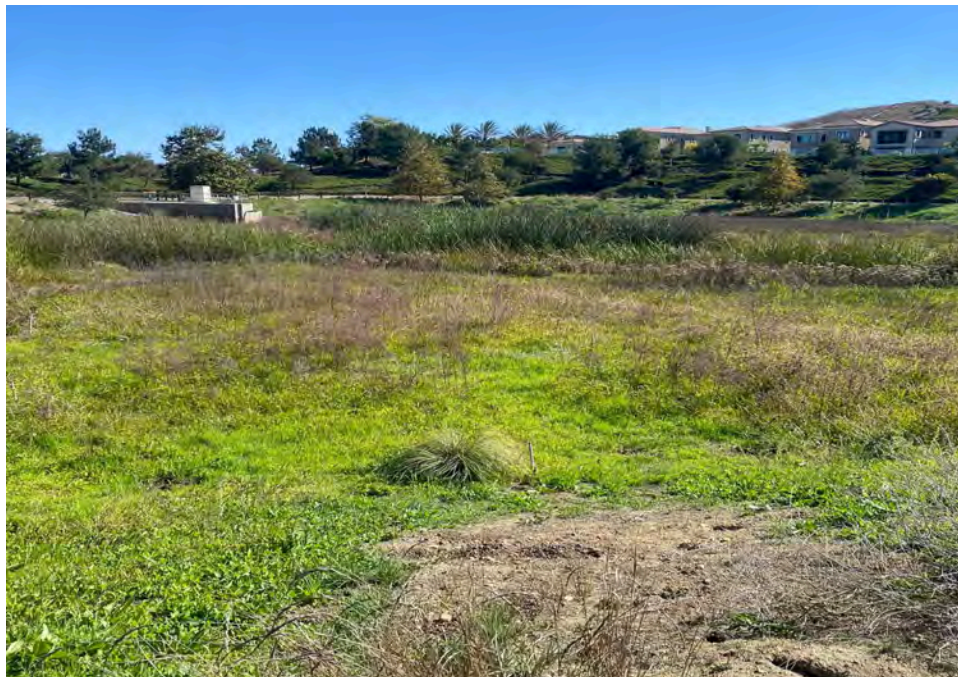
Hidden Canyon is a 2.89-acre basin located south of Lake Forest Drive and adjacent to the Hidden Canyon residential development. The basin consists of two inlets which flow into one pond. Due to high rates of flooding and perennial moisture, this basin exhibits high non-native species cover throughout the bottom and the south-facing slopes. Additionally, the site's presence in the formerly agrarian dominated San Joaquin Hills strongly influences the presence of weeds within. Thus, despite the moisture presence, invasives oriented towards high disturbance are plentiful onsite year-round. Hand removal, hula hoeing, and digging were the primary methods advised to reduce the non-native cover on site. Curly dock, bristly oxtongue, Bermuda grass, and smilo grass were among the most prevalent and problematic invasive and non-native species on site. Other non-natives observed included black mustard, bull thistle, burr clover, cheeseweed, common fennel, common sowthistle, creeping saltbush, creeping wood sorrel, flax-leaved horseweed, goosegrass, knotroot bristlegrass, musky stork's bill, prickly lettuce, prickly sowthistle, rabbitsfoot grass, rescuegrass, scarlet pimpernel, shepherd's purse, Spanish false fleabane, tamarisk, and yellow sweetclover. Oak tree(s) on site were observed experiencing root instability in October. Endemic provided irrigation adjustment recommendations to address this issue.

Figure 23. Overview of Hidden Canyon basin as of November, 2024.
