# Integrated Pest Management Plan for the Irvine Ranch Water District

2024 Annual Report

Provided By:  
Endemic Environmental Services Inc.

Prepared For:  
Irvine Ranch Water District

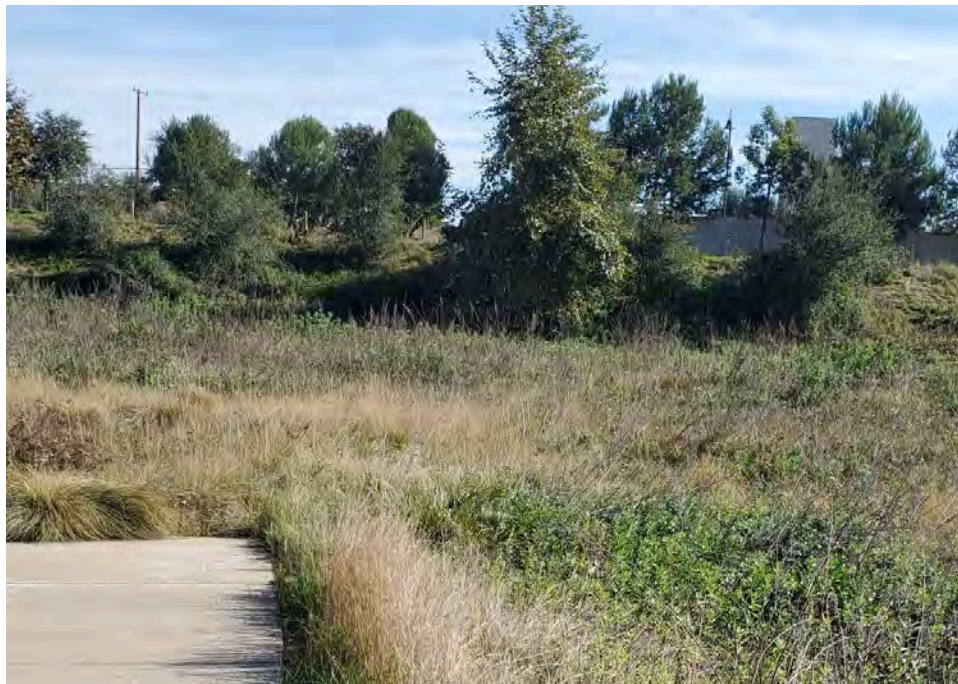
Iluna Springs is a 2.66-acre basin located in the Altair Community development. The development is north of Irvine Boulevard in northeast Irvine. This basin consists of two inlet channels. The basin and surrounding slopes experienced moderate coverage of annual non-native plants throughout the year. Otherwise, large patches of bareground are primarily in the Southeast basin. Uniquely, Iluna Springs remains one of two localities (the other being the San Joaquin Marsh sites) with consistent infestation of castor bean (*Ricinus communis*). Hand removal and digging were the primary methods advised for reducing non-native cover. Prevalent invasive species include curly dock, Spanish false fleabane, and castor bean. Other non-native species observed were annual bluegrass, black mustard, bristly oxtongue, Chinese elm, common sowthistle, field bindweed, fountain grass, lesser swinecress, Mexican primrose, shortpod mustard, and tree tobacco.

Figure 24. Overview of Iluna Spring as of November 2024

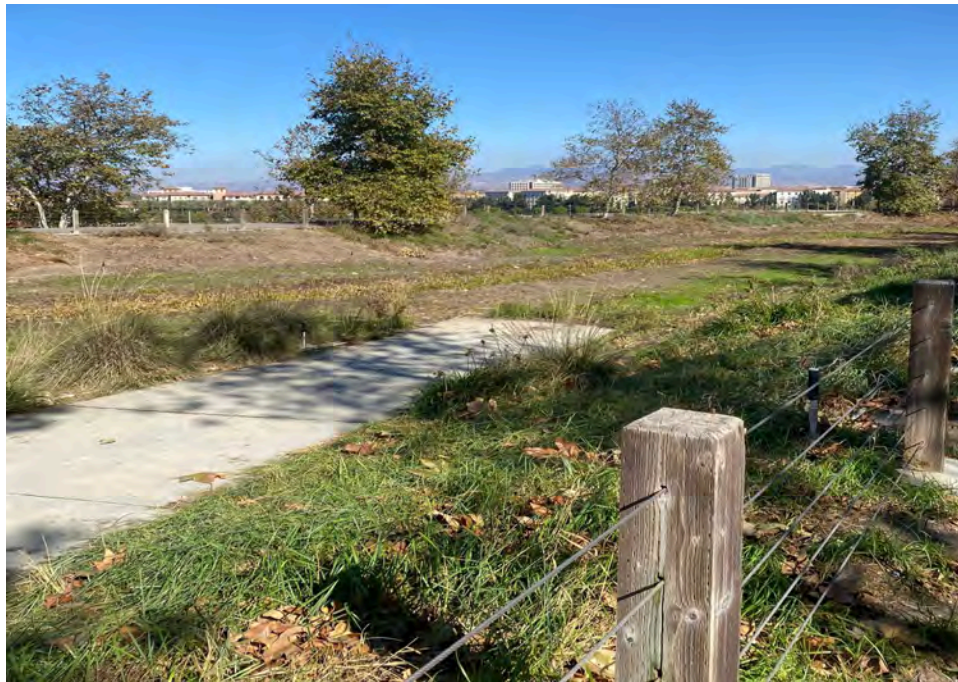
Laguna Altura North is a 1.53-acre basin north of the Laguna Altura housing development and south of I-405. Once characterized by a high level of native recruitment onsite, high rates of desiccation during the warm season have led to senescence and perennial mortality, creating patches of bareground. Hand removal and digging were the primary advised methods to reduce the non-native cover on site. Non-native species, such as common sowthistle, smilo grass, burr clover, and bristly oxtongue were most prevalent throughout the year. Other non-native species observed were castor bean, cheeseweed, compact brome, curly dock, field bindweed, fountain grass, hyssop loosestrife, Italian rye, lesser swinecress, Mexican primrose, Oak-leaved goosefoot, panic veldtgrass, prickly lettuce, prickly sowthistle, rabbitsfoot grass, rat-tail fescue, red brome, rescuegrass, scarlet pimpernel, tropical horseweed, wall barley, and water beard grass.

Figure 25. Laguna Altura North as of November, 2024.

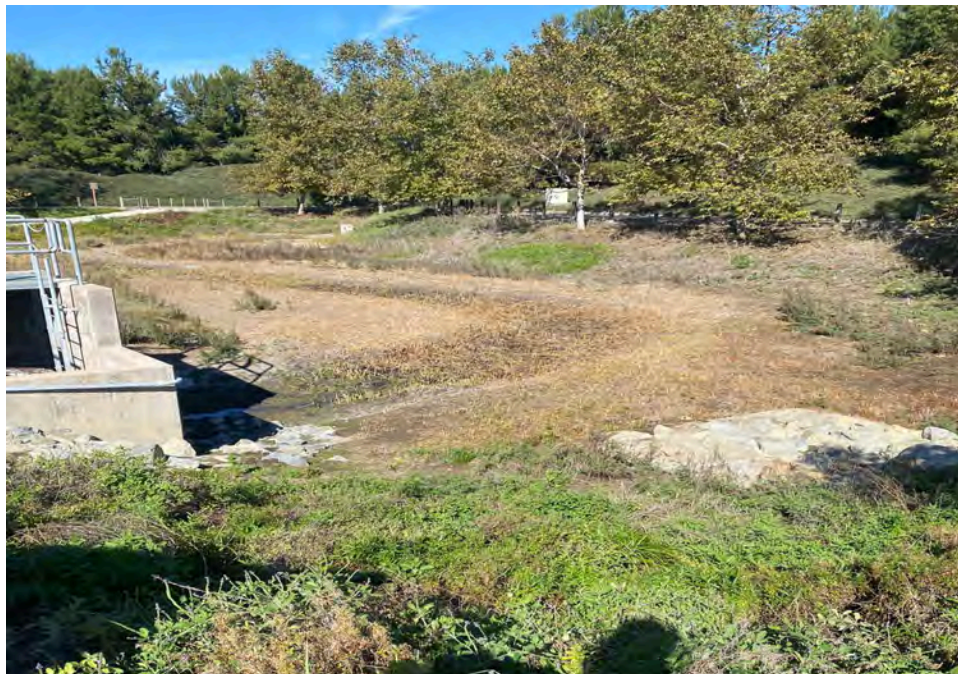
Laguna Altura South is a 0.92-acre basin located west of the Laguna Altura housing development and east of SR-133. While hand removal and hula hoeing were the primary methods advised to reduce non-native cover, solarization and herbicide were also prescribed. Laguna Altura South is another site that only remains wet during winter months. As a result, similar to other sites experiencing these conditions, bareground in the basin is present for the entirety of the warm season. Prevalent invasive species include rabbitsfoot grass and Bermuda grass. Other non-native species were as follows: bristly oxtongue, bull thistle, burr clover, common stork's bill, curly dock, field bindweed, Mexican primrose, petty spurge, prickly lettuce, prickly sowthistle, rabbitsfoot grass, rescuegrass, scarlet pimpernel, Spanish false fleabane, Taiwanese firethorn, tamarisk, and yellow sweetclover. Manual solarization was proposed in May for Bermuda grass and successfully executed later that month; to further address Bermuda, herbicide treatment was advised and reported in December, 2024.

Figure 26. Laguna Altura South as of November 2024.

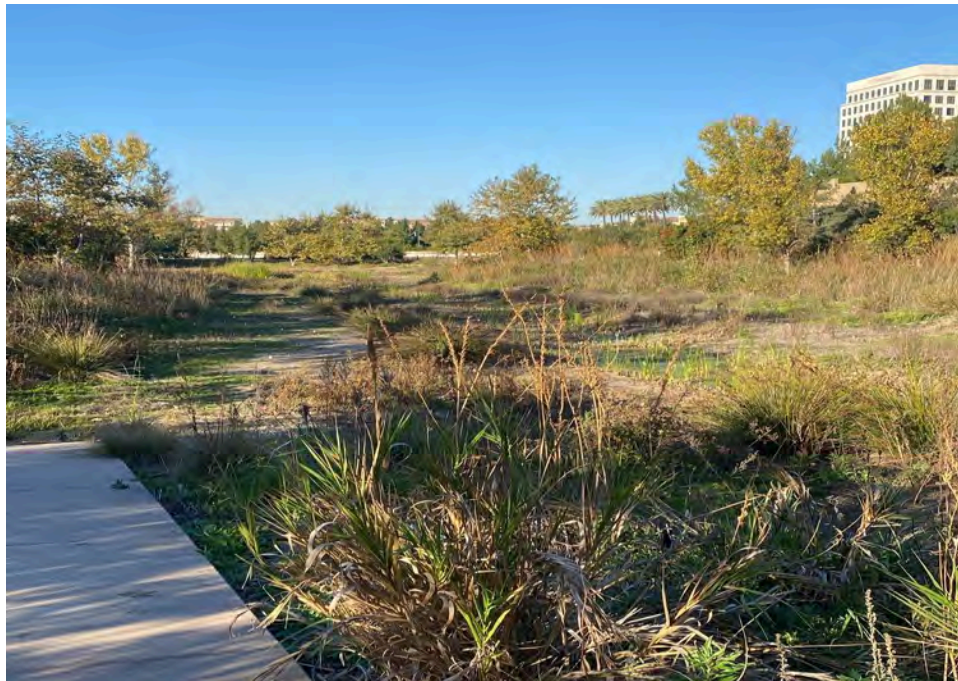
Los Olivos is a 3.78-acre basin located east of San Diego Creek and adjacent to the Los Olivos housing development. This basin has two inlet channels that flow into one pond. Los Olivos Meadows is one of the sites addressed by both Endemic and LC. Thus, vegetation cover is consistently managed, with the caveat that disturbance and plant mortality are more prevalent. Without careful restoration efforts, invasive colonization will continue to pose an issue on this site. To promote native biodiversity and cover, over 400 individuals (i.e. *Anemopsis californica*, *artemisia douglasiana*, *asclepias fascicularis*, *cyperus eragrostis*, *elymus triticoides*, *elmyus codensatus*, *epilobium canum*, *heliotropium curassavicum*, *mimulus guttatus*, *muhlenbergia rigens*, *salvia mellifera*, *sisyrinchium bellum*, *stipa lepida*, *stipa pulchra*) were planted throughout the slopes and basin at the begging of the year. The non-native cover was controlled primarily by hand removal, hula hoeing, and digging. Prevalent invasive species included bristly oxtongue and Spanish false fleabane. Other non-natives advised for maintenance included the following: black mustard, Brazilian peppertree, burr clover, common sowthistle, common stork's bill, curly dock, prickly sowthistle, rabbitsfoot grass, tamarisk, and yellow sweetclover.

Figure 27. Overview of Los Olivos Meadow as of November 2024.

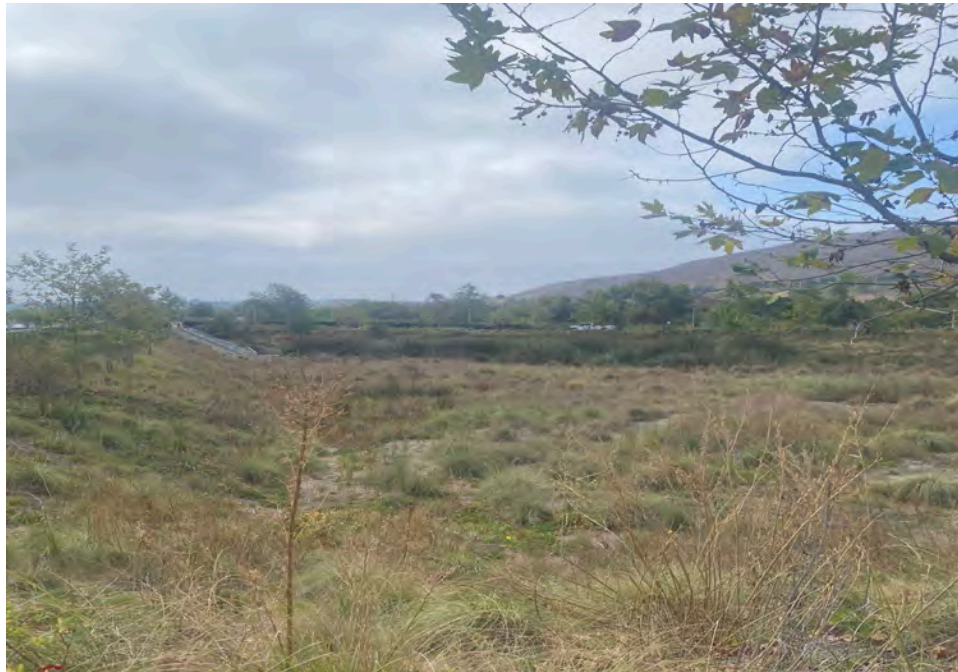
Los Olivos South is a 2.86-acre basin located east of SR-133 and adjacent to the Laguna Altura housing development. High flooding conditions and hard soil lead to notable expansion of creeping non-natives. Compounding this issue, natives of interest are syntopic and often grow intermixed. Notable natives include Saltgrass (*Distichlis spicata*) and California Dock (*Rumex californicus*). Otherwise, hand removal, digging, and hula hoeing were the primary methods to reduce non-native cover on site. The prevalent naturalized species included Bermuda grass, Spanish false fleabane, and creeping saltbush. Other non-natives advised for maintenance included the following: bristly oxtongue, burr clover, common sowthistle, curly dock, lesser swinecress, pampass grass, prickly sowthistle, seashore paspalum, St. Augustine grass, tamarisk, and yellow sweetclover. Manual solarization was proposed to treat a large patch of Bermuda grass in June and was successfully executed. Herbicide was prescribed for Spanish false fleabane and curly dock in February and Bermuda grass in May. However, no chemical pesticide applications were reported at this site between January and December 2024.

Figure 28. Overview of Los Olivos South as of November 2024.

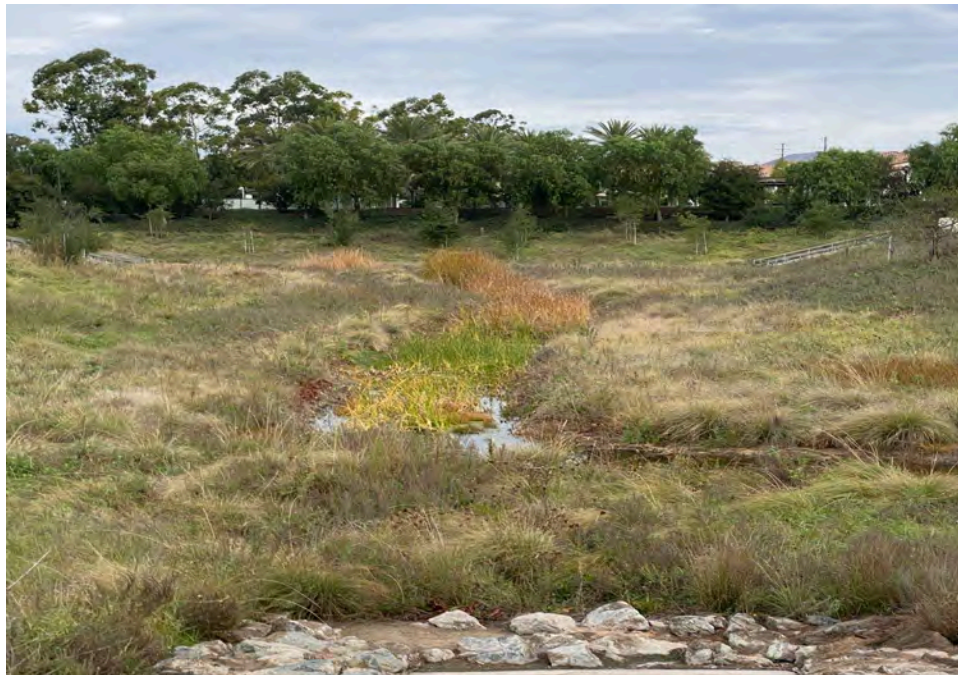
Marine Meadows is a 1.72-acre basin located west of the SR-133 and I-5 highways. The basin is adjacent to Great Park and a housing development. With the high bunchgrass cover on slopes and in the basin, non-native expansion and presence are almost non-existent. However, as a result, the site itself provides minimal habitat and utility as a wildlife resource. Here, plant diversity is incredibly low, with no more than 10 different native species in total. Hand removal and digging were the primary recommended treatments to reduce invasive plant species, with the prevalent species being common sowthistle, bristly oxtongue, and yellow sweetclover. Other non-natives observed included the following: black medic, burr clover, common soft brome, common sowthistle, hairawn muhly, Jersey cudweed, Spanish false fleabane, yellow sweetclover, and rescuegrass.

Figure 29. Overview of Marine Meadows as of November 2024.

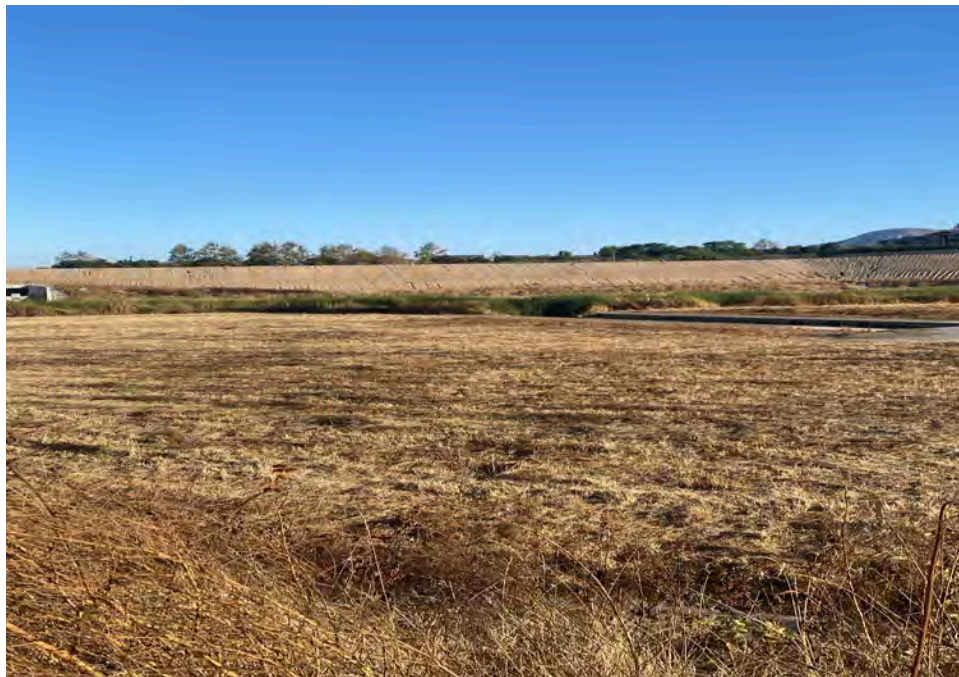
Marshburn is a 11.74-acre basin located at the intersection of Irvine Boulevard and Ridge Valley in Irvine. This basin also serves as a flood retention basin. Marshburn consists of two channels that flow into one large pond. Hand removal and digging were the primary methods advised to reduce invasive cover. The most prevalent species included curly dock and Spanish false fleabane. Other non-natives observed included the following: barnyard grass, bindii, blackwood acacia, carrotwood, castor bean, cheeseweed, Chinese flame tree, common sowthistle, everblooming acacia, flax-leaved horseweed, floating primrose-willow, Italian rye, Italian thistle, narrow-leaved goosefoot, red brome, slender wild oats, white sweetclover, and wild radish.

Figure 30. Overview of Marshburn in November, 2024.

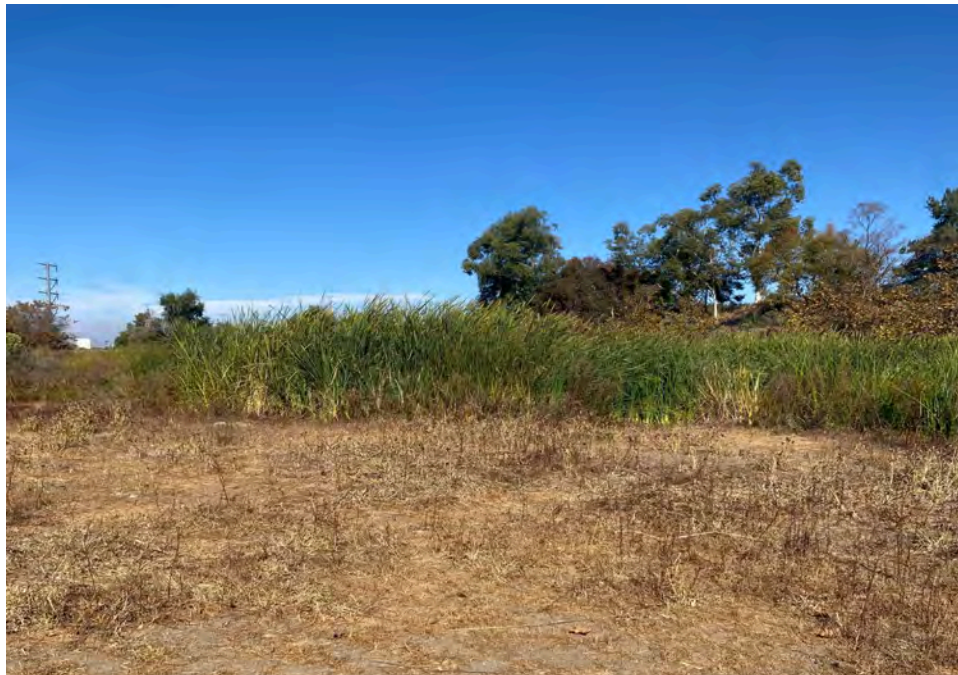
Old Laguna is a 2.95-acre basin located west of Laguna Canyon Road and south of I-405. This basin consists of two small channels that flow into one large pond. The slopes and basin exhibited a relatively high diversity of non-native cover. Hand removal and hula hoeing were the primarily advised methods to reduce the total cover of non-native and invasive plants. Prevalent non-native species included, Spanish false fleabane, curly dock, and English plantain. Other non-native species advised for removal included the following: Bermuda grass, blue water speedwell, brass buttons, bristly oxtongue, burr clover, carrotwood, common sowthistle, common stork's bill, compact brome, floating primrose-willow, marsh parsley, Mexican fan palm musky storks bill, prickly lettuce, prickly sowthistle, rabbitsfoot grass, rat-tail fescue, shortpod mustard, watercress, and yellow sweetclover.

Figure 31. Overview of Old Laguna as of November, 2024.

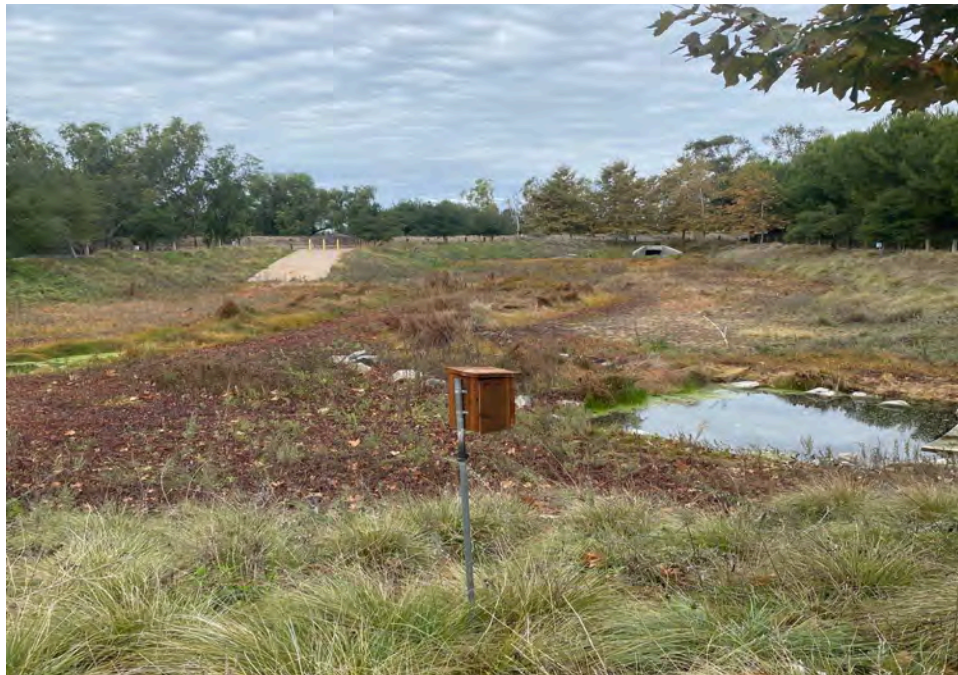
Portola Springs Meadow is a 1.01-acre basin located north of Irvine Boulevard and east of SR-133. This basin consists of two inlets. Throughout the year, the site had primarily native cover on slopes and relatively moderate non-native cover in the basin. Dense patches of naturalized plants are within the high moisture areas along the slope. Hand removal and hula hoeing were the primary methods advised to control non-native cover. Prevalent species included Mexican primrose, Spanish false fleabane, and common sowthistle. Other non-natives included the following: Bermuda grass, common purslane, common sowthistle, compact brome, creeping lantana, curly dock, flax-leaved horseweed, golden wattle, golden wreath wattle, great brome, musky stork's bill, panic veldtgrass, prickly sowthistle, rabbitsfoot grass, red brome, ripgut brome, shoestring acacia, soft chess, water beard grass, and yellow sweetclover.

Figure 32. Overview of Portola Springs as of November 2024.

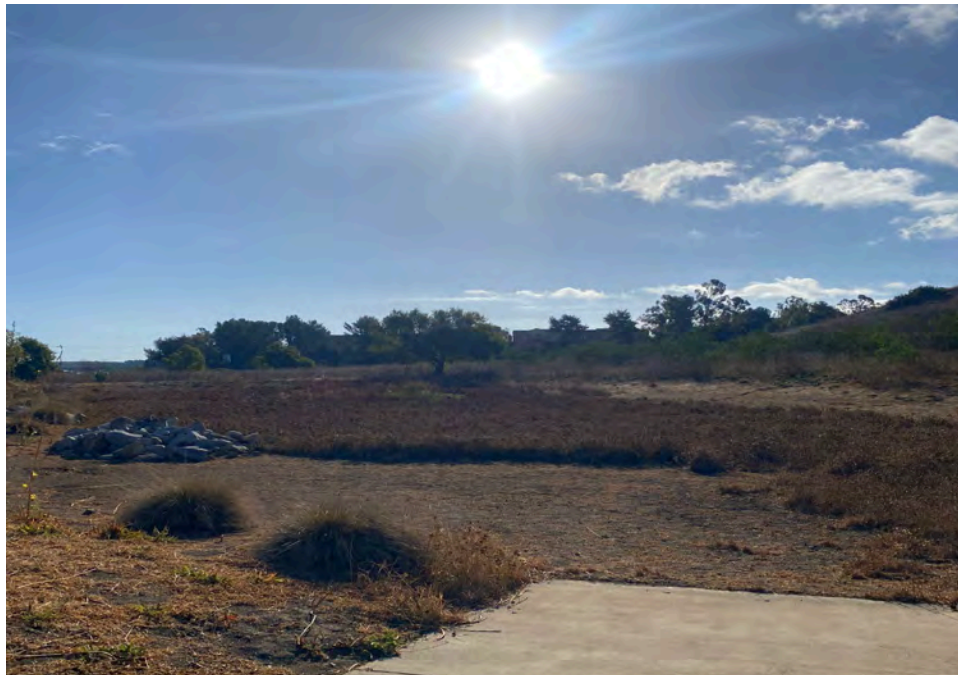
Quail Meadow is a 1.19-acre basin north of Quail Hill Shopping Center in Irvine. This basin consists of a small sediment catchment pond at the inlet, after which water percolates into the ground. Overall, there was low non-native cover in the basin and along the slopes. Hand removal and hula hoeing were the primary methods to reduce the abundance of non-native cover. The most prevalent species were Spanish false fleabane, prickly lettuce, prickly sowthistle, and burr clover. Other non-native species advised for removal include the following: brass, buttons, bristly oxtongue, burr clover, cheeseweed, common sowthistle, common stork's bill, curly dock, English plantain, hooker's evening primrose, musky stork's bill, prickly lettuce, prickly sowthistle, rat-tail fescue, ripgut brome, slender wild oats, wall barley, wild barley, and yellow sweetclover.

Figure 33. Overview of Quail Meadow as of November 2024.

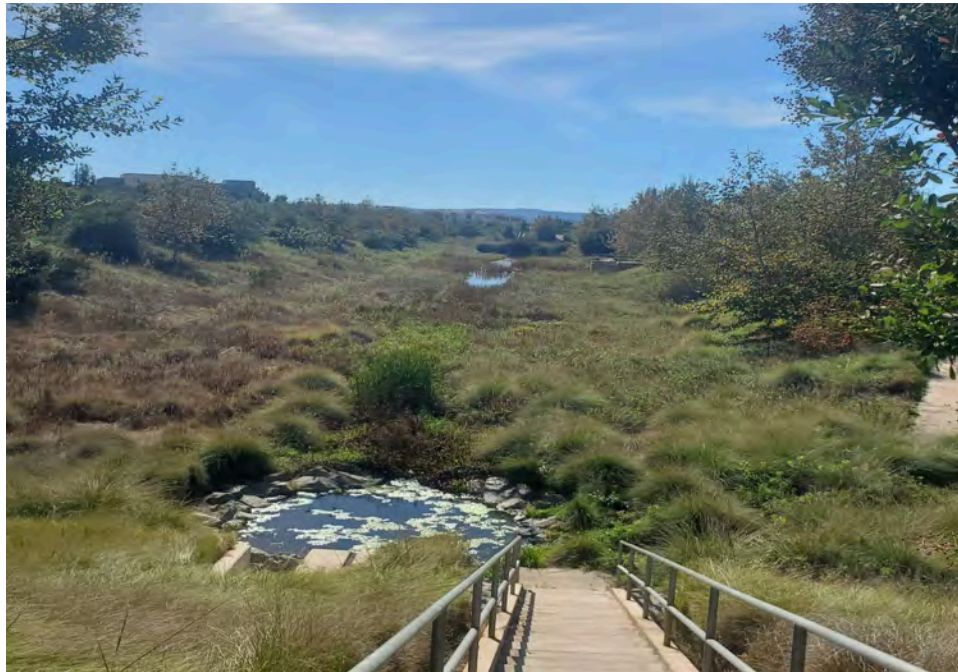
Ridge Valley A is a 6.9-acre basin located east of SR-133. It consists of two inlets that flow into one pond. High non-native cover persisted throughout the year, with fewer non-native species present during winter. Hand removal and hula hoeing were the primary advised methods to reduce non-native cover. Bristly oxtongue, curly dock, and rabbitsfoot grass were the most prevalent observed. Other non-native species advised for removal included the following: African sumac, Brazilian peppertree, bull thistle, burr clover, camphor tree, carrotwood, cheeseweed, Chinese elm, Chinese flame tree, Chinese privet, common lantana, common sowthistle, compact brome, field burrweed, flax-leaved horseweed, flaxleaf paperbark, floating primrose-willow, fountain grass, Japanese honeysuckle, jersey cudweed, Lindheimer's muhly, Mexican fan palm, Mexican primrose, moth vine, musky stork's bill, perennial pepperweed, prickly lettuce, prickly sowthistle, rescuegrass, ripgut brome, shortpod mustard, Spanish false fleabane, stork's bill, tussock paspalum, water beard grass, and yellow sweetclover.

Figure 34. Overview of Ridge Valley A as of November, 2024.

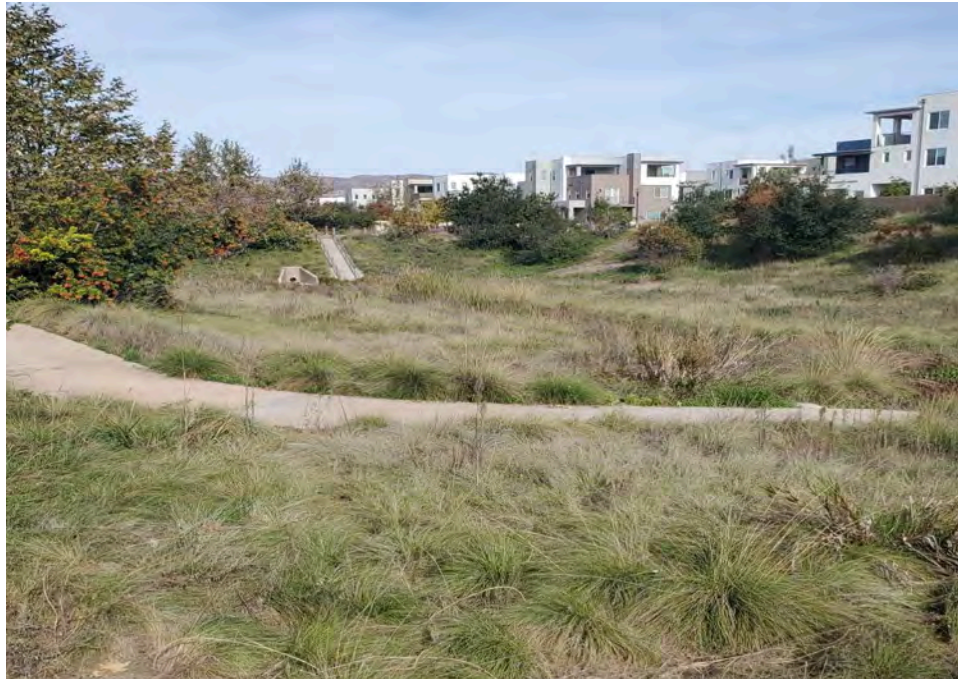
Ridge Valley B is a 1.78-acre basin located east of SR-133 and adjacent to Ridge Valley A NTS basin. Ridge Valley B consists of a channel that flows into Ridge Valley A. The northern half of the site exhibits moderate non-native cover, while the southern basin slopes and basin exhibit healthy native cover. Similar to Marine Meadows, Ridge Valley B provides poor wildlife habitat and plant diversity. Hand removal and hula hoeing were the primary removal methods advised to decrease non-native cover. Prevalent species were bristly oxtongue and Mexican primrose. Other non-natives observed included the following: bird of paradise, Brazilian peppertree, burr clover, common sowthistle, Jersey cudweed, Lindheimer's muhly, Mexican primrose, perennial pepperweed, prickly lettuce, prickly sowthistle, rabbitsfoot grass, rusty fig, scarlet pimpernel, Spanish false fleabane, tropical horseweed, tussock paspalum, watercress, and yellow sweetclover.

Figure 35. Overview of Ridge Valley B in November, 2024.

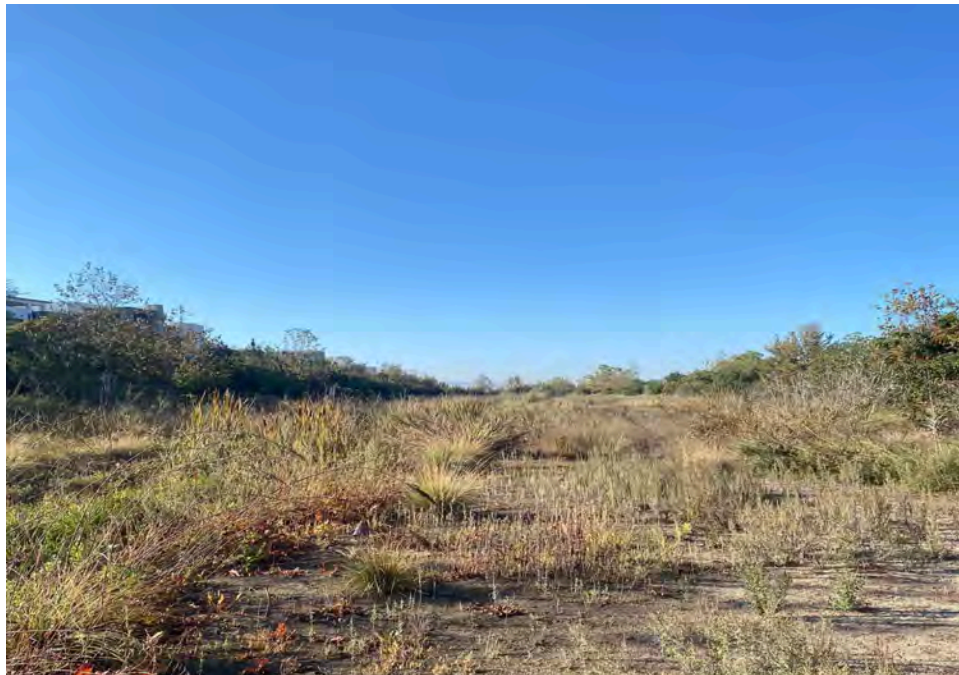
Ridge Valley C is a 4.90-acre basin located east of SR-133 and adjacent to Ridge Valley B. The basin consists of one long channel with a pond in the center. Throughout the year, most non-native coverage was along the eastern & northern aspects of the basin. Hand removal, hula hoeing, and digging were the primary removal methods advised to decrease non-native cover. Prevalent species were Spanish false fleabane, common sowthistle, and curly dock. Other non-natives observed included the following: African sumac, Brazilian peppertree, bristly oxtongue, bull thistle, burr clover, Canary Island date palm, cheeseweed, common lantana, compact brome, fountain grass, jersey cudweed, Lindheimer's muhly, Mexican primrose, pampas grass, perennial pepperweed, prickly lettuce, prickly sowthistle, shortpod mustard, snow-in-summer, water beard grass, yellow sweetclover.

Figure 36. Overview of Ridge Valley C in November, 2024.

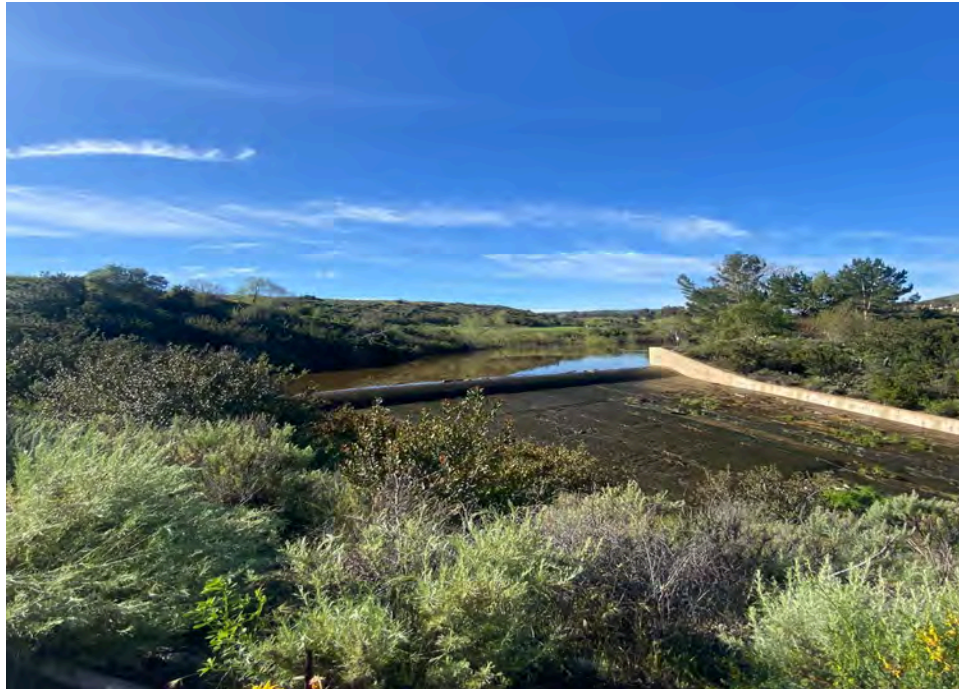
Sand Canyon is a 43.50 acre basin located east of Ridgeline Drive in north Irvine. The basin is adjacent to a golf course and primarily consists of a large pond. Sand Canyon has dense riparian habitat to the south of the pond. This site is considered both an NTS and a Recycled Water Reservoir. It was not surveyed by Endemic in 2024 and no chemical herbicide use was reported.

Figure 37. Overview of Ridge Valley C in November, 2024.

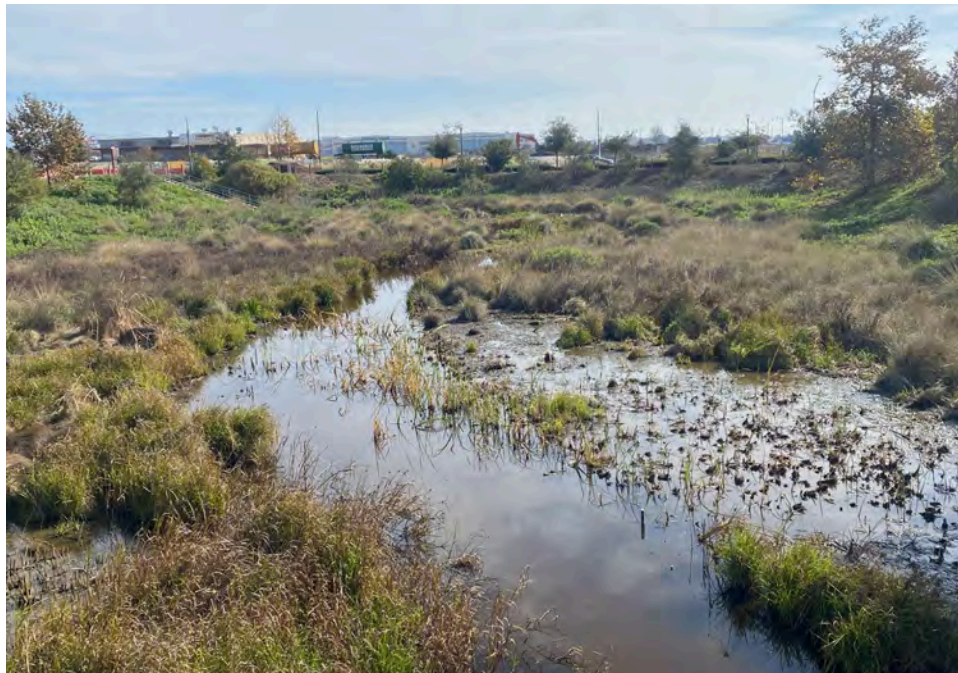
Sports Park is a 2.20-acre basin located north of the I-5 freeways at the corner of Marine Way and Skyhawk. The site exhibited relatively high annual non-native cover, especially in the spring and summer. Hand removal and digging were the primary methods advised to reduce non-native cover. Prevalent species were curly dock, Spanish false fleabane, bull thistle, and Italian thistle. Other non-native species included the following: black mustard, Brazilian peppertree, bristly oxtongue, carrotwood, castor bean, Chinese elm, Chinese flame tree, common cattail, common fig, common lantana, common sowthistle, fountain grass, hairawn muhly, Maltese star thistle, Mexican fan palm, Mexican primrose, prickly lettuce, prickly sowthistle, scarlet pimpernel, shortpod mustard, tree tobacco, vanilla scented wattle, yellow sweetclover.

Figure 38. Overview of Sports Park as of December 2024.

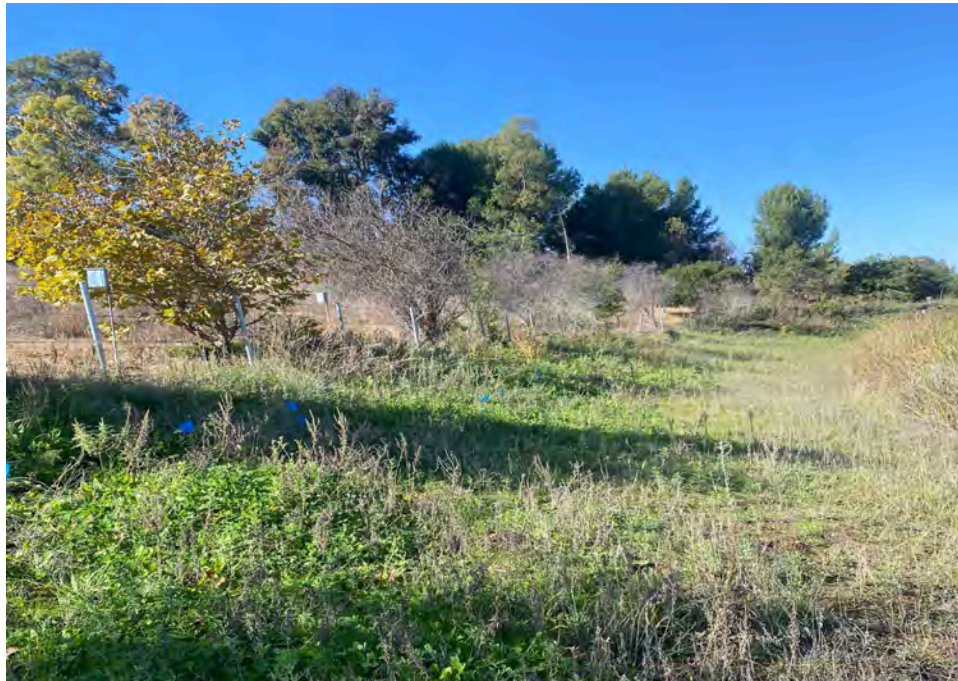
Turtle Ridge is a 1.82-acre basin located south of Shady Canyon Drive. It is adjacent to an open field and residential housing and consists of a pond surrounded by vegetated slopes. Its proximity to weedy slopes has led to significant degradation. In its current state, Turtle Ridge suffers from high competition between native and naturalized annuals, leading to difficulty addressing interspersed non-natives without risking trampling and extirpating the few remaining natives. The lack of native perennials relative to other sites has exacerbated this issue. Hand removal and tilling were the primary methods advised to reduce non-native cover. Prevalent species were prickly sowthistle, bristly oxtongue, and compact brome. Other non-natives advised for maintenance included the following: African asparagus, blue water speedwell, Brazilian peppertree, bulrush, burr clover, common soft brome, common sowthistle, Italian rye, Mexican primrose, Peruvian peppertree, prickly lettuce, rabbitsfoot grass, rat-tail fescue, red brome, ripgut brome, scarlet pimpernel, slender wild oats, Spanish false fleabane, watercress, yellow sweetclover

Figure 39. Overview of Turtle Ridge in November, 2024.

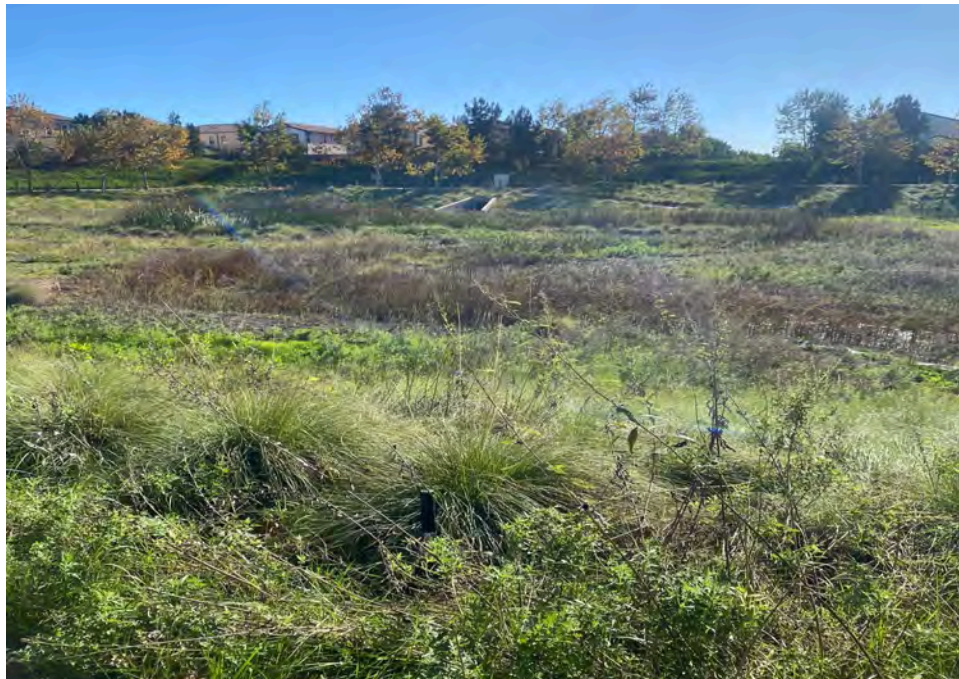
Eastwood Meadow is a 1.87-acre basin located east of Ridgeline Drive. The site exhibited high non-native cover in open patches of the basin. Hand removal, digging, and hula hoeing were the primary methods advised to reduce non-native cover. Prevalent species include Spanish false fleabane, English plantain, and Mexican primrose. Other non-natives observed were as follows: Bermuda grass, black medic, Brazilian peppertree, bristly oxtongue, broadleaf plantain, burr clover, cheeseweed, Chinese elm, clustered dock, common cattail, common celery, common purslane, common stork's bill, curly dock, flax-leaved horseweed, goose grass, Jersey cudweed, Lindheimer's muhly, Mediterranean love grass, Mexican fan palm, mexican primrose, prickly lettuce, prostrate pigweed, rabbitsfoot grass, Shepherd's purse, smilo grass, thorny olive, tussock paspalum, white stem filaree, white sweetclover, yellow sweetclover.

Figure 40. Overview of Eastwood as of November 2024.

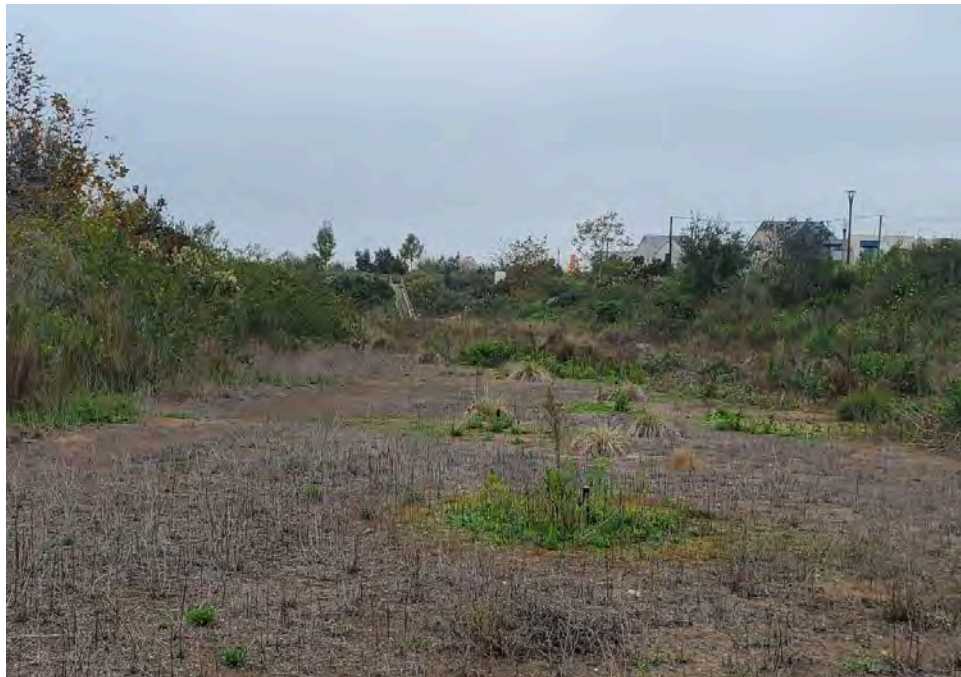
Lower Agua Chinon A is a 3.48-acre site located southeast of the Great Park Sports Complex and northeast of the I-5 freeway. During the wet months, high non-native cover persists. Once the warm months approach, the annual cover senesces and leaves large patches of bareground. Hand removal, hula hoeing, and digging were the primary methods advised to reduce non-native cover. Curly dock, umbrella sedge, and Spanish false fleabane were the most prevalent and problematic species observed. Other non-natives advised for removal included the following: annual wall-rocket, bristly oxtongue, flax-leaved horseweed, hairawn muhly, palo verde, prickly sowthistle, rabbitsfoot grass, seashore paspalum, shortpod mustard, St. Augustine grass, wild radish, yellow sweetclover.

Figure 41. Overview of Lower Agua Chinon A as of December 2024.

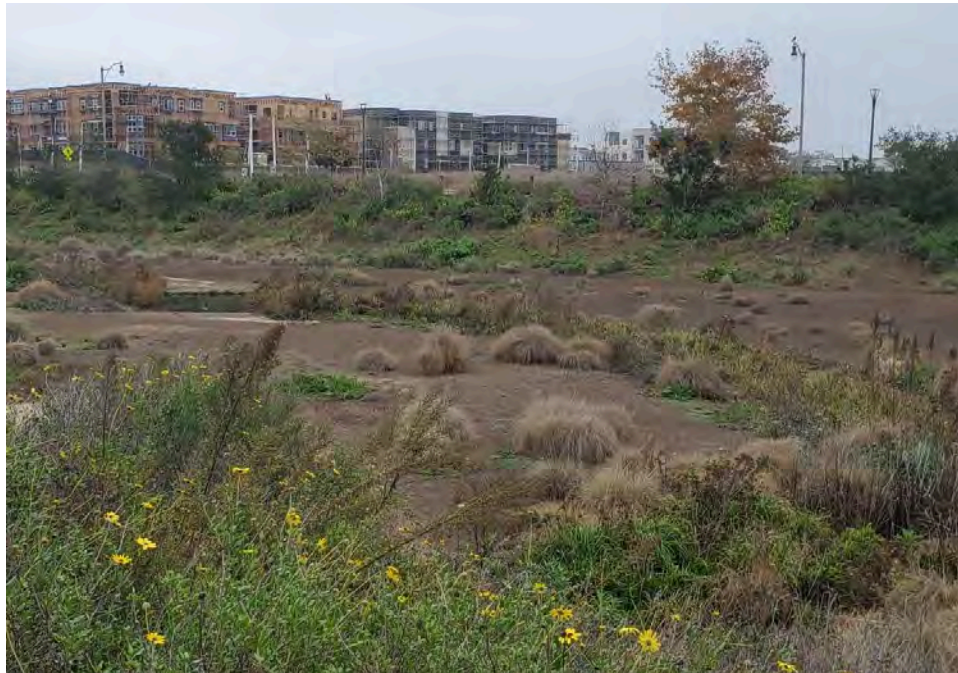
Lower Agua Chinon B is a 2.44-acre site located southeast of the Great Park Sports Complex and is adjacent to District 5A/Lower Agua Chinon A. Non-native cover and persistence more or less resembles Lower Agua Chinon A. Notably, basin slopes seem to have a higher comparative rate of native recruitment and survival. Overall, hand removal and hula hoeing were the primary methods advised to reduce non-native cover. Yellow sweetclover and Spanish false fleabane were the most prevalent non-native species observed. Within the waterways, a new detection has elicited particular concern. Seashore paspalum (*Paspalum vaginatum*), rated by the Orange County CNPS as a high risk of invasiveness, is a relatively new weed in Orange County. This detection is concerning, as it is the farthest north documented instance in the county. The species has formed deep carpets, choking out almost all native growth in the waterways. Herbicide was advised as an early eradication measure to mitigate further range expansion. Other non-natives advised for removal included the following: black mustard, bristly oxtongue, bull thistle, common sowthistle, common stork's bill, curly dock, flax-leaved horseweed, fountain grass, hairawn muhly, Italian thistle, jersey cudweed, lesser swinecress, palo verde, prickly sowthistle, scarlet pimpernel, shortpod mustard, tree tobacco, and white sweetclover.

Figure 42. Overview of Lower Agua Chinon B as of December 2024.

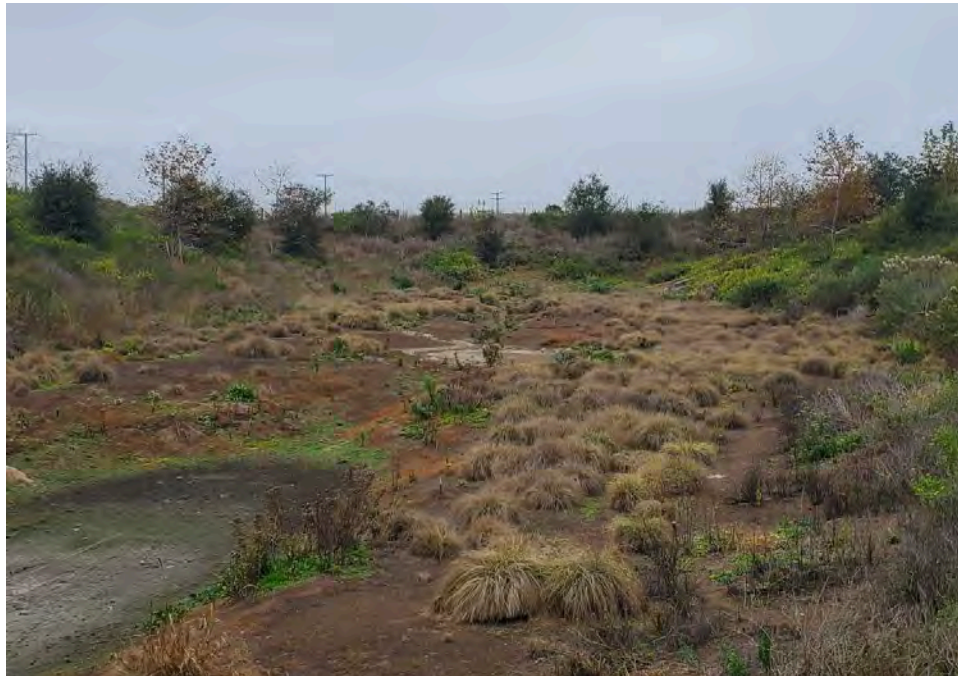
Lower Agua Chinon C is a 3.21-acre site located southeast of the Great Park Sports Complex and adjacent to District 5B. Throughout the year, slopes had high native cover, and the basin bottom had large bare patches. Significant naturalized plant growth only occurred along the margins of the basin where water from the irrigation was available. Hand removal was the primary method advised to reduce non-native cover. Shortpod mustard, Spanish false fleabane, and prickly sowthistle were the most prevalent non-native species observed. Other non-natives advised for removal included the following: black mustard, bull thistle, common fig, curly dock, hairy bittercress, Jersey cudweed, lesser swinecress, prostrate pigweed, tamarisk, tomato plant, tree tobacco, tropical horseweed, yellow sweetclover.

Figure 43. Overview of Lower Agua Chinon C/District 5C as of December 2024.

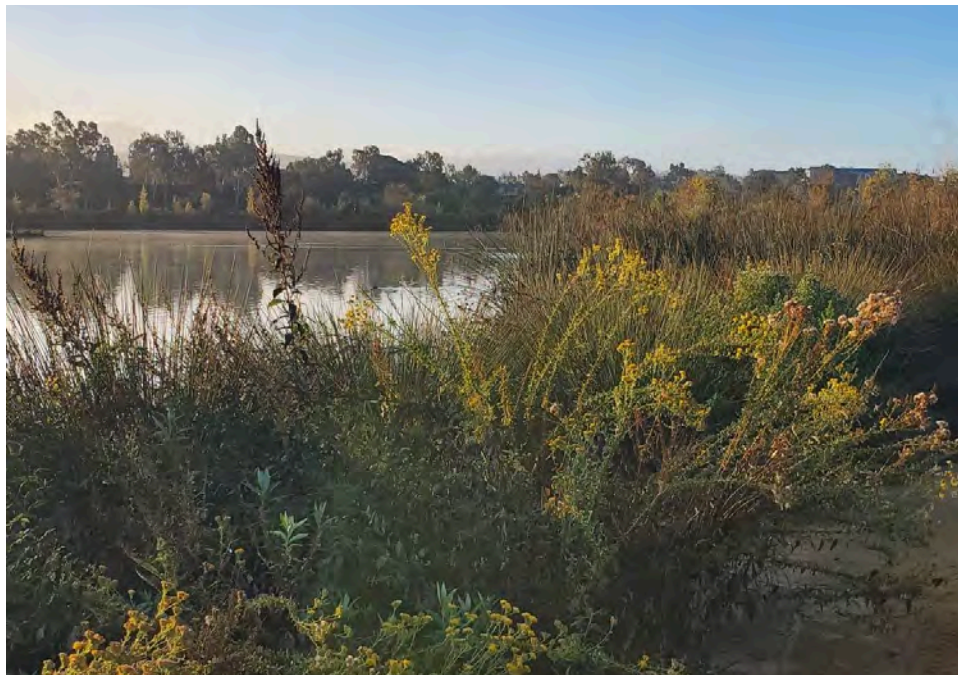
San Joaquin Marsh Landing Zone 1 is a 94.61-acre portion of the San Joaquin Marsh and Wildlife Sanctuary. It serves as a restoration area and natural treatment system for water from San Diego Creek. Hand removal and hula hoeing were the primary methods advised to reduce non-native cover. Spanish false fleabane and perennial pepperweed were the most prevalent non-native species. Other non-natives advised for removal were as follows: African sumac, Bermuda grass, black mustard, Brazilian peppertree, carrotwood, castor bean, common stork's bill, curly dock, dwarf nettle, fern pine, Jersey cudweed, lesser swinecress, Maltese star thistle, Mexican fan palm, poison hemlock, prickly sowthistle, rabbitsfoot grass, shortpod mustard, tomato plant.

Figure 44. Overview of San Joaquin Marsh Zone 1 as of November 2024.

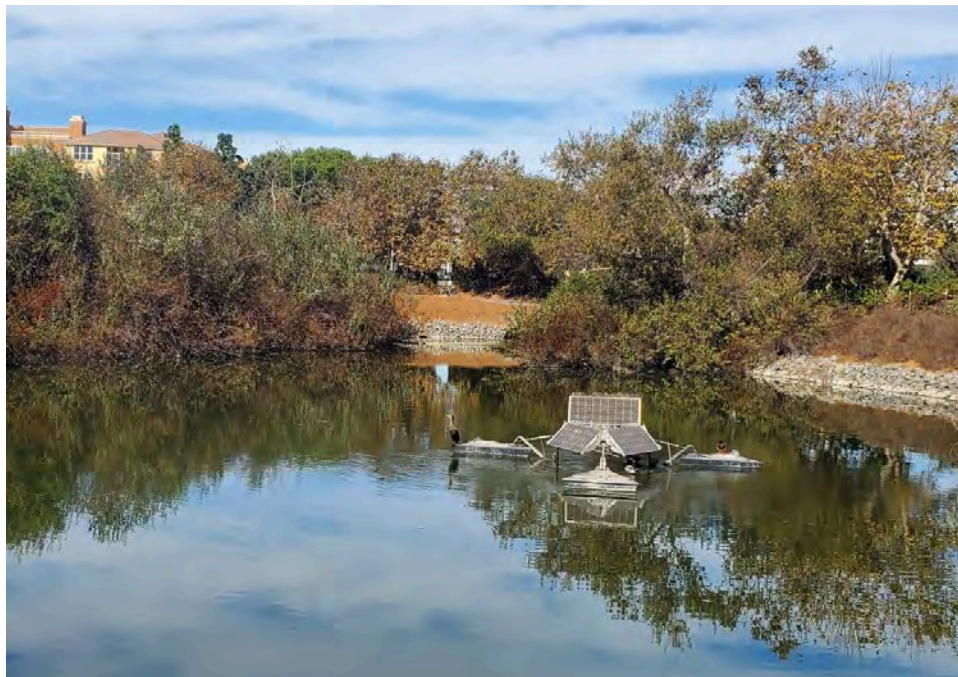
San Joaquin Marsh Landing Zone 2 is a 61.28-acre portion of the San Joaquin Marsh and Wildlife Sanctuary. It serves as a restoration area and natural treatment system for water from San Diego Creek. Relative to the previous year, Zone 2 exhibited a reduced cover of non-native species overall. High-traffic areas along trails yielded the most non-native density, with tree driplines harboring young naturalized saplings. Hand removal and hula hoeing were the primary methods advised to reduce non-native cover. Dwarf nettle and common fig were the most prevalently documented non-native species. Other non-natives advised for removal were as follows: black mustard, bristly oxtongue, butterfly bush, carrotwood, castor bean, cheeseweed, Chinese elm, common fig, common stork's bill, compact brome, curly dock, hairy bittercress, Indian fig opuntia, lesser swinecress, London rocket, poison hemlock, prickly sowthistle, rabbitsfoot grass, silver-dollar gum, Spanish false fleabane, tomato plant, tree tobacco, watercress, and white horehound.

Figure 45. Overview of San Joaquin Marsh Zone 2 as of November 2024.

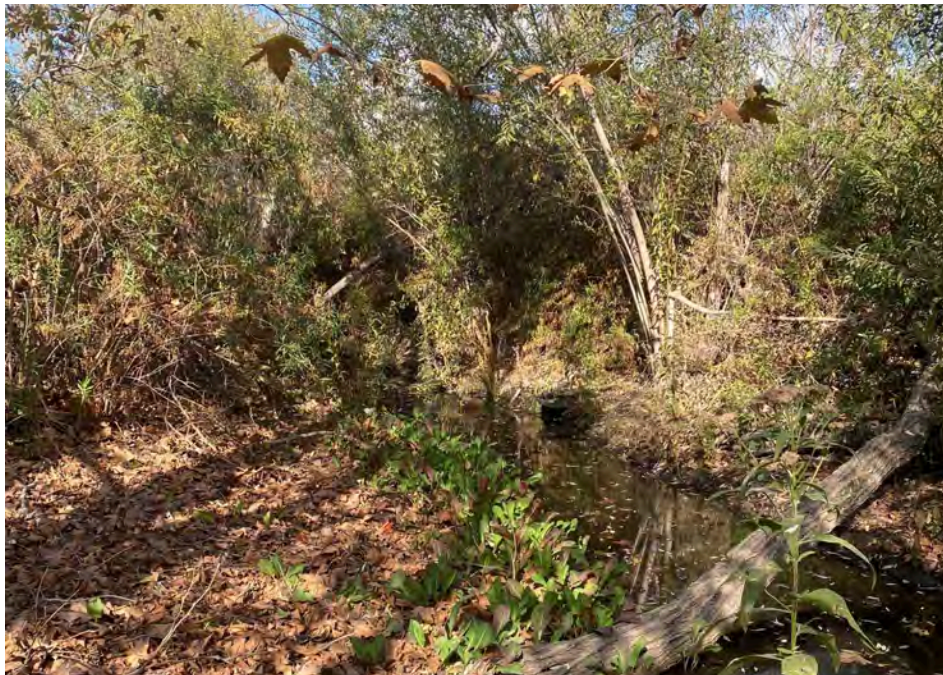
San Joaquin Marsh Landing Zone 4 is a 67.49-acre section of the San Joaquin Marsh and Wildlife Sanctuary. It serves as a restoration area and natural treatment system for the water from the San Diego Creek. Obscure trails and reduced human traffic have aided with the prevention of trail-based invasion. Otherwise, tree canopies harbored large amounts of non-native saplings. Hand removal and hula hoeing were the primary advised methods to control non-native species. Spanish false fleabane, curly dock, and common fig were the most prevalent invasive species. Other non-native species advised for removal included the following: bull thistle, Callery pear, camphor tree, carrotwood, cheesewood, common fig, common sowthistle, common stork's bill, curly dock, dwarf nettle, lesser swinecress, London rocket, Mexican fan palm, petty spurge, poison hemlock, prickly sowthistle, Shamel ash, stork's bill sp., Virginia creeper. The herbicide usage reported indicates a chemical treatment application in April.

Figure 47. Overview of San Joaquin Marsh Zone 4 as of November 2024.
