# Integrated Pest Management Plan for the Irvine Ranch Water District

2024 Annual Report

Provided By:  
Endemic Environmental Services Inc.

Prepared For:  
Irvine Ranch Water District

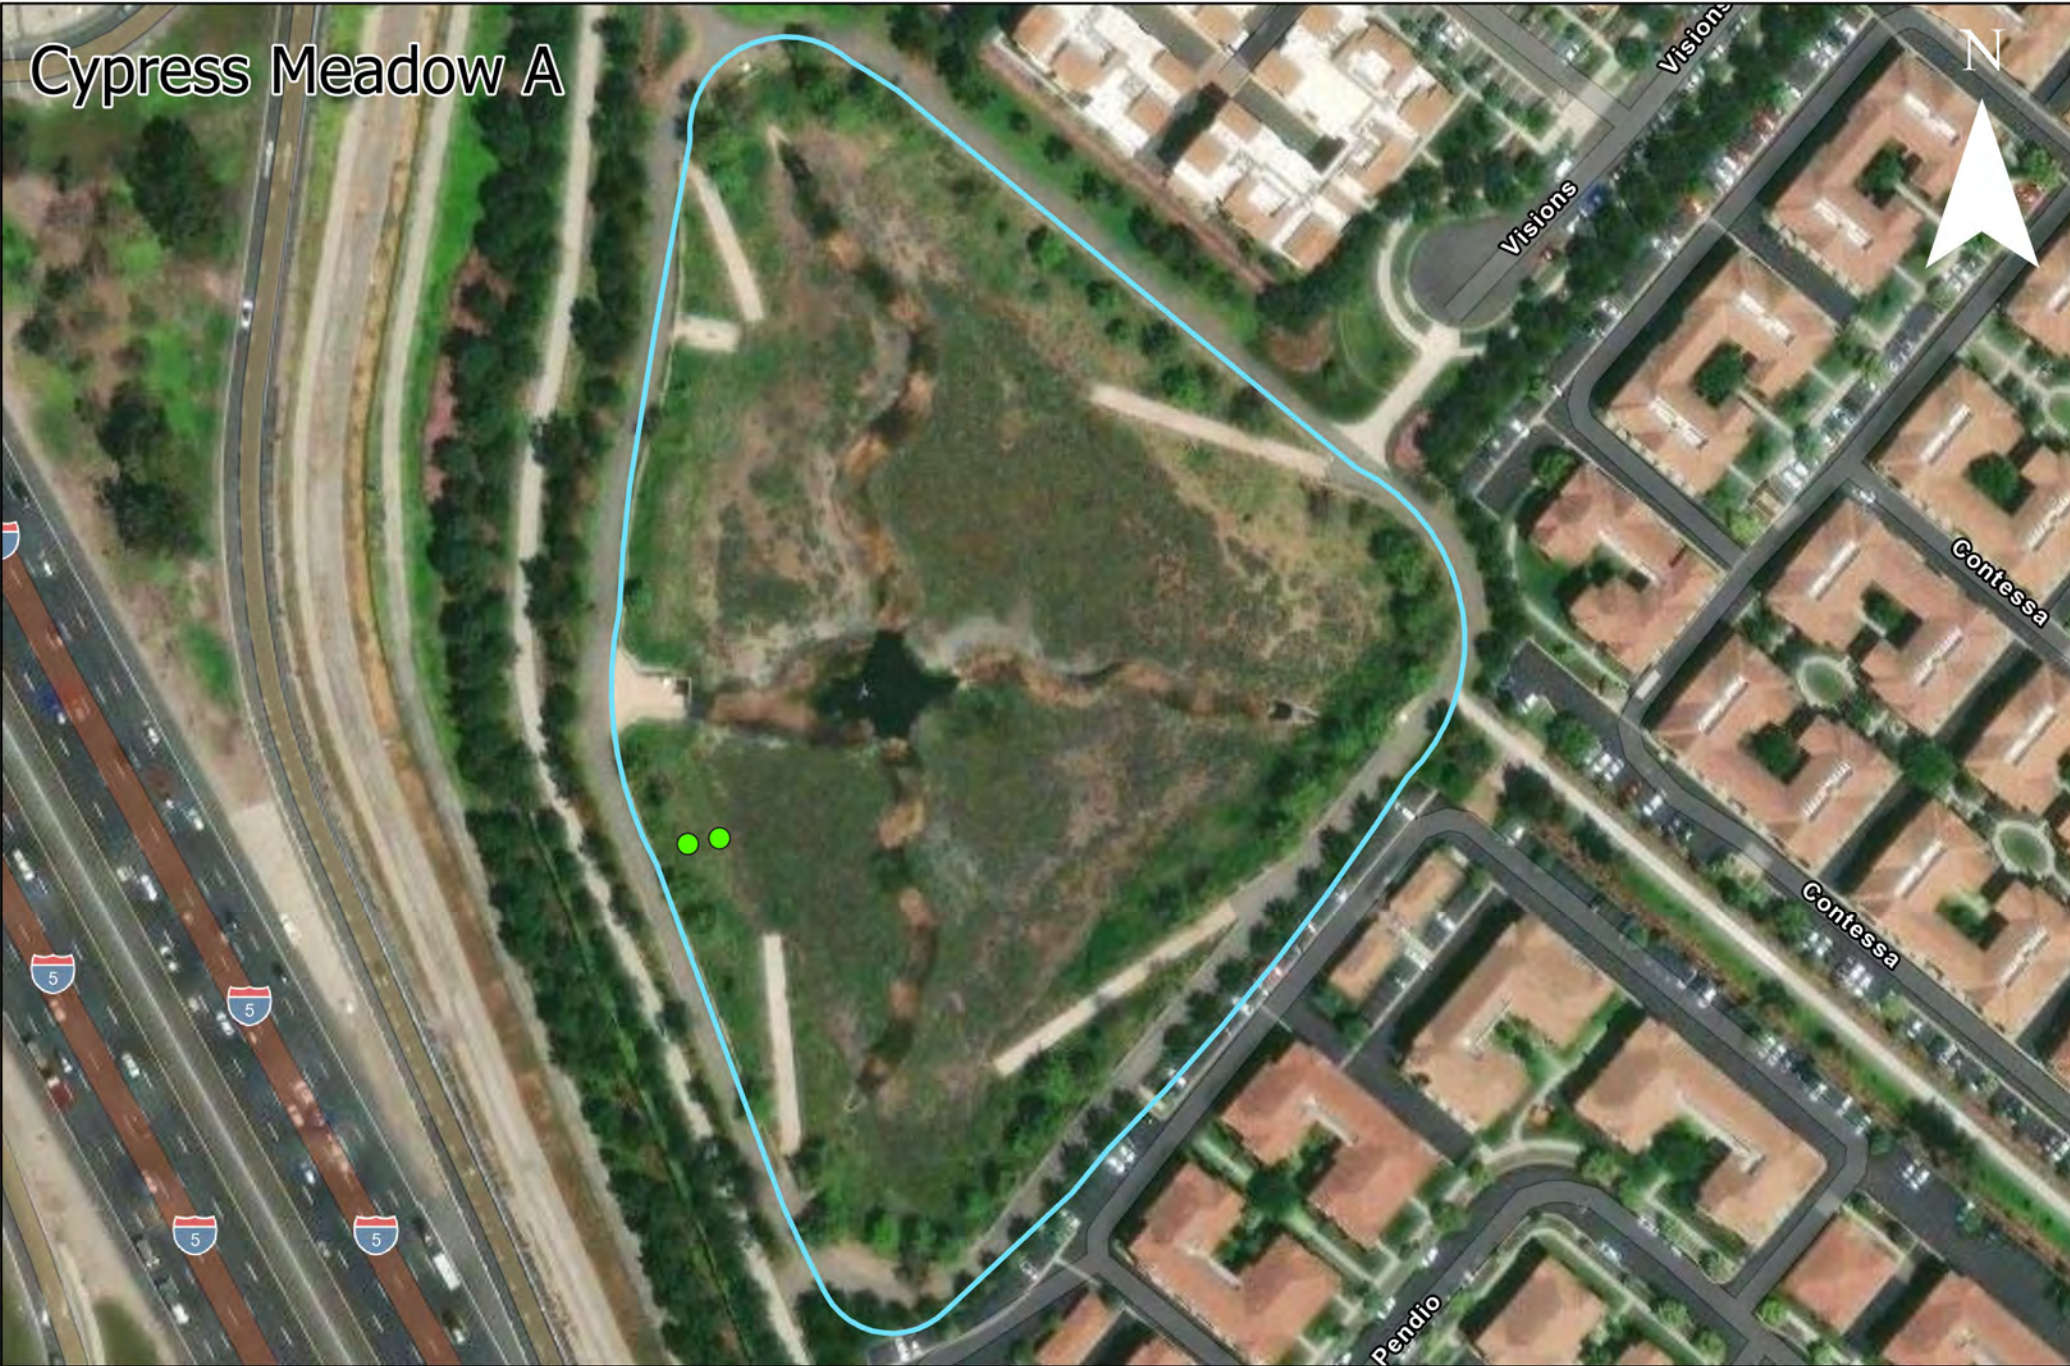
# Cypress Meadow A

● Herbicide Prescribed Point (2)

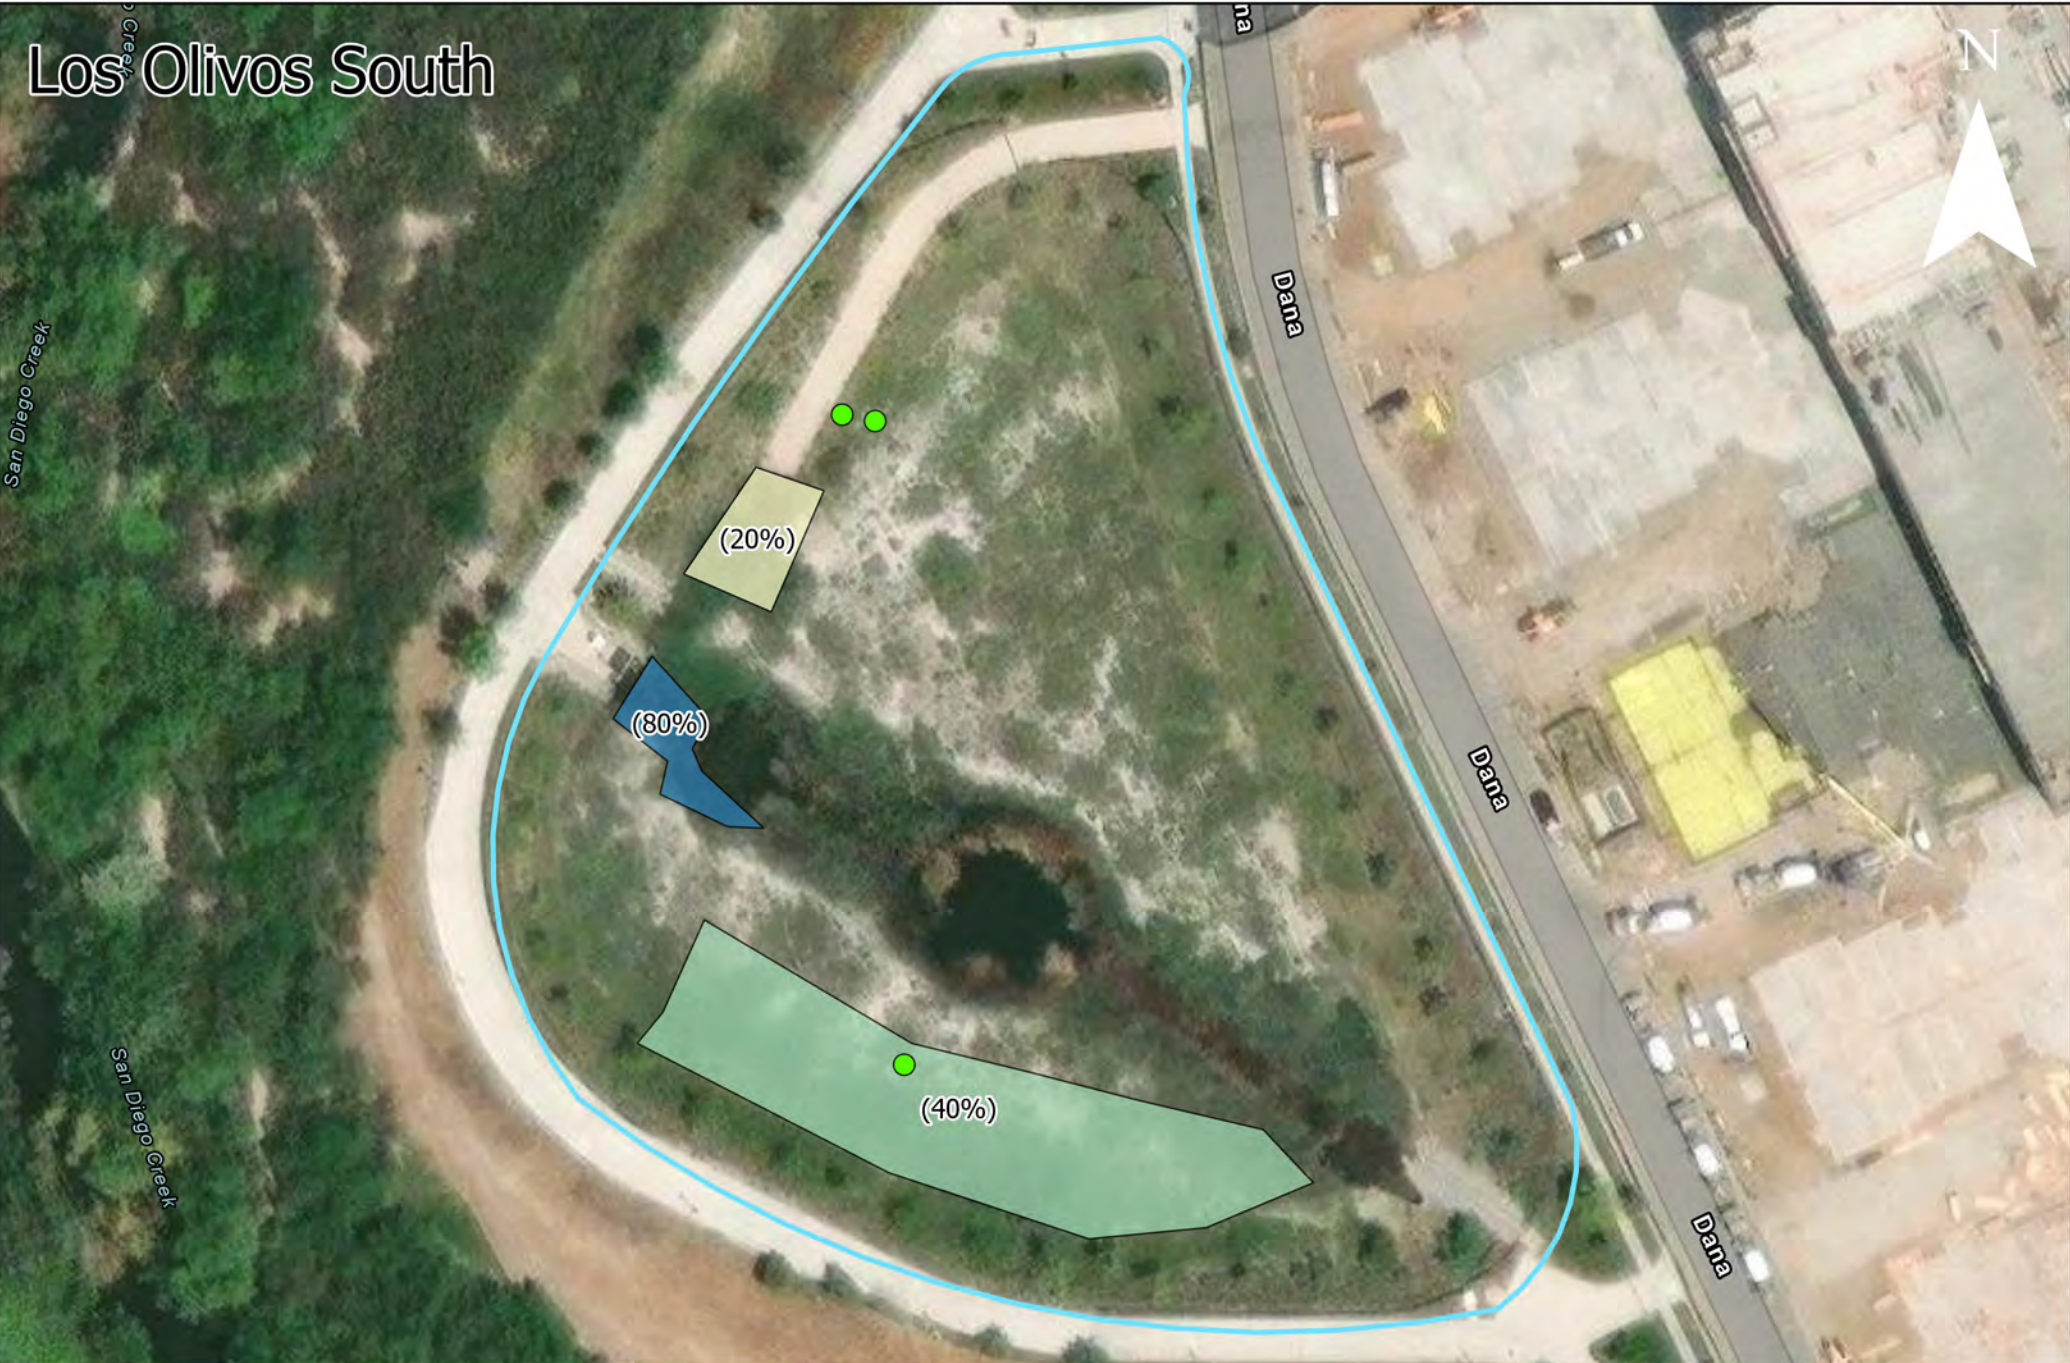
# Los Olivos South

● Herbicide Prescribed Point (3)

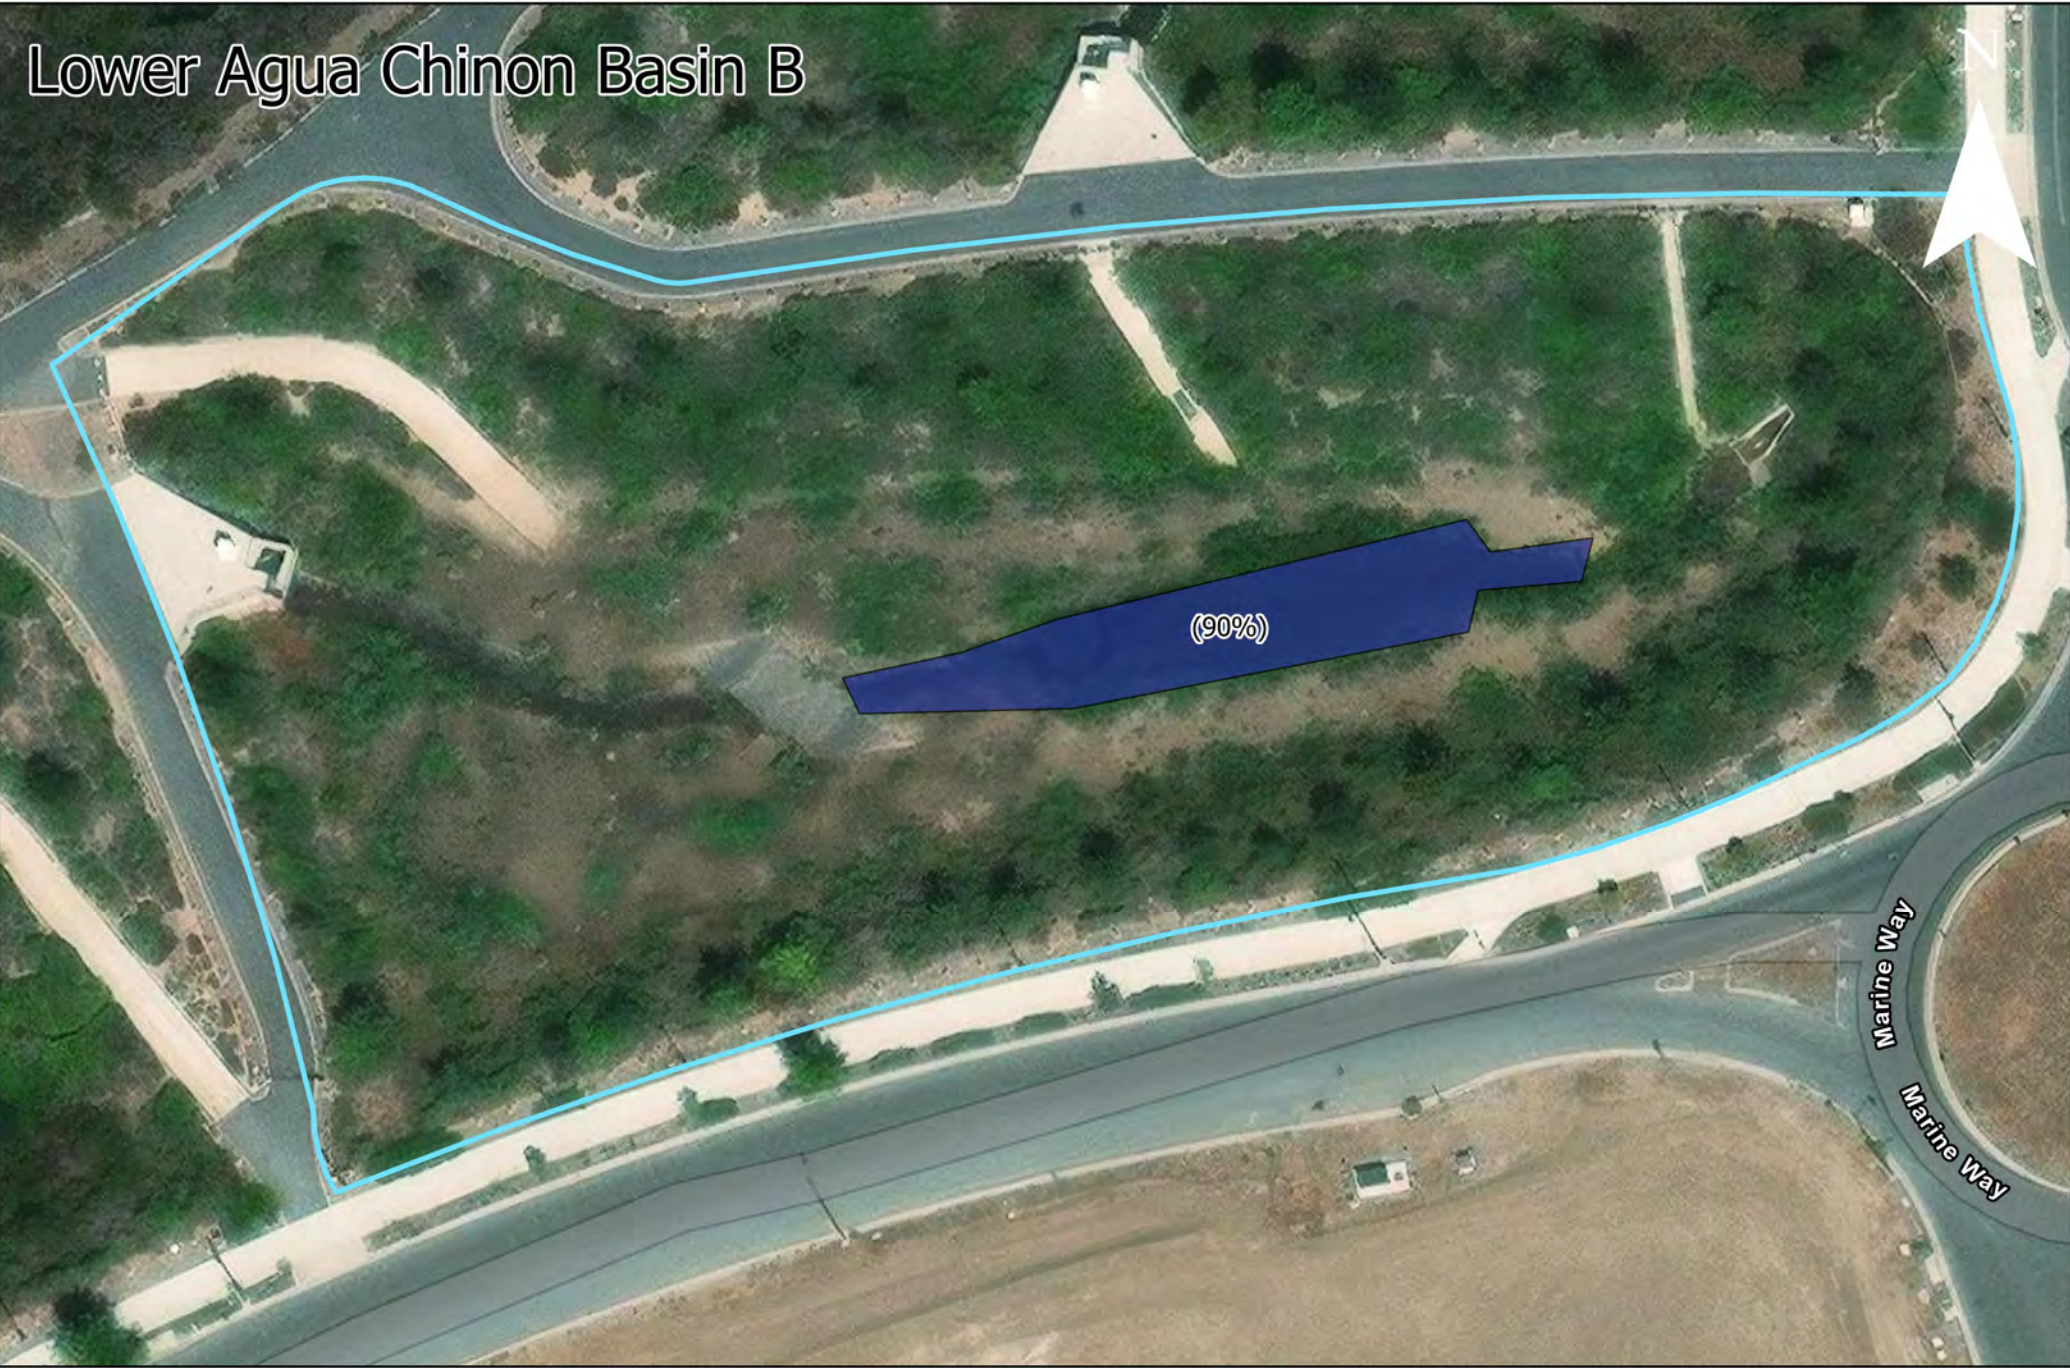
# Lower Agua Chinon Basin B

**Invasive Coverage**  
■ 81% - 100% (1)

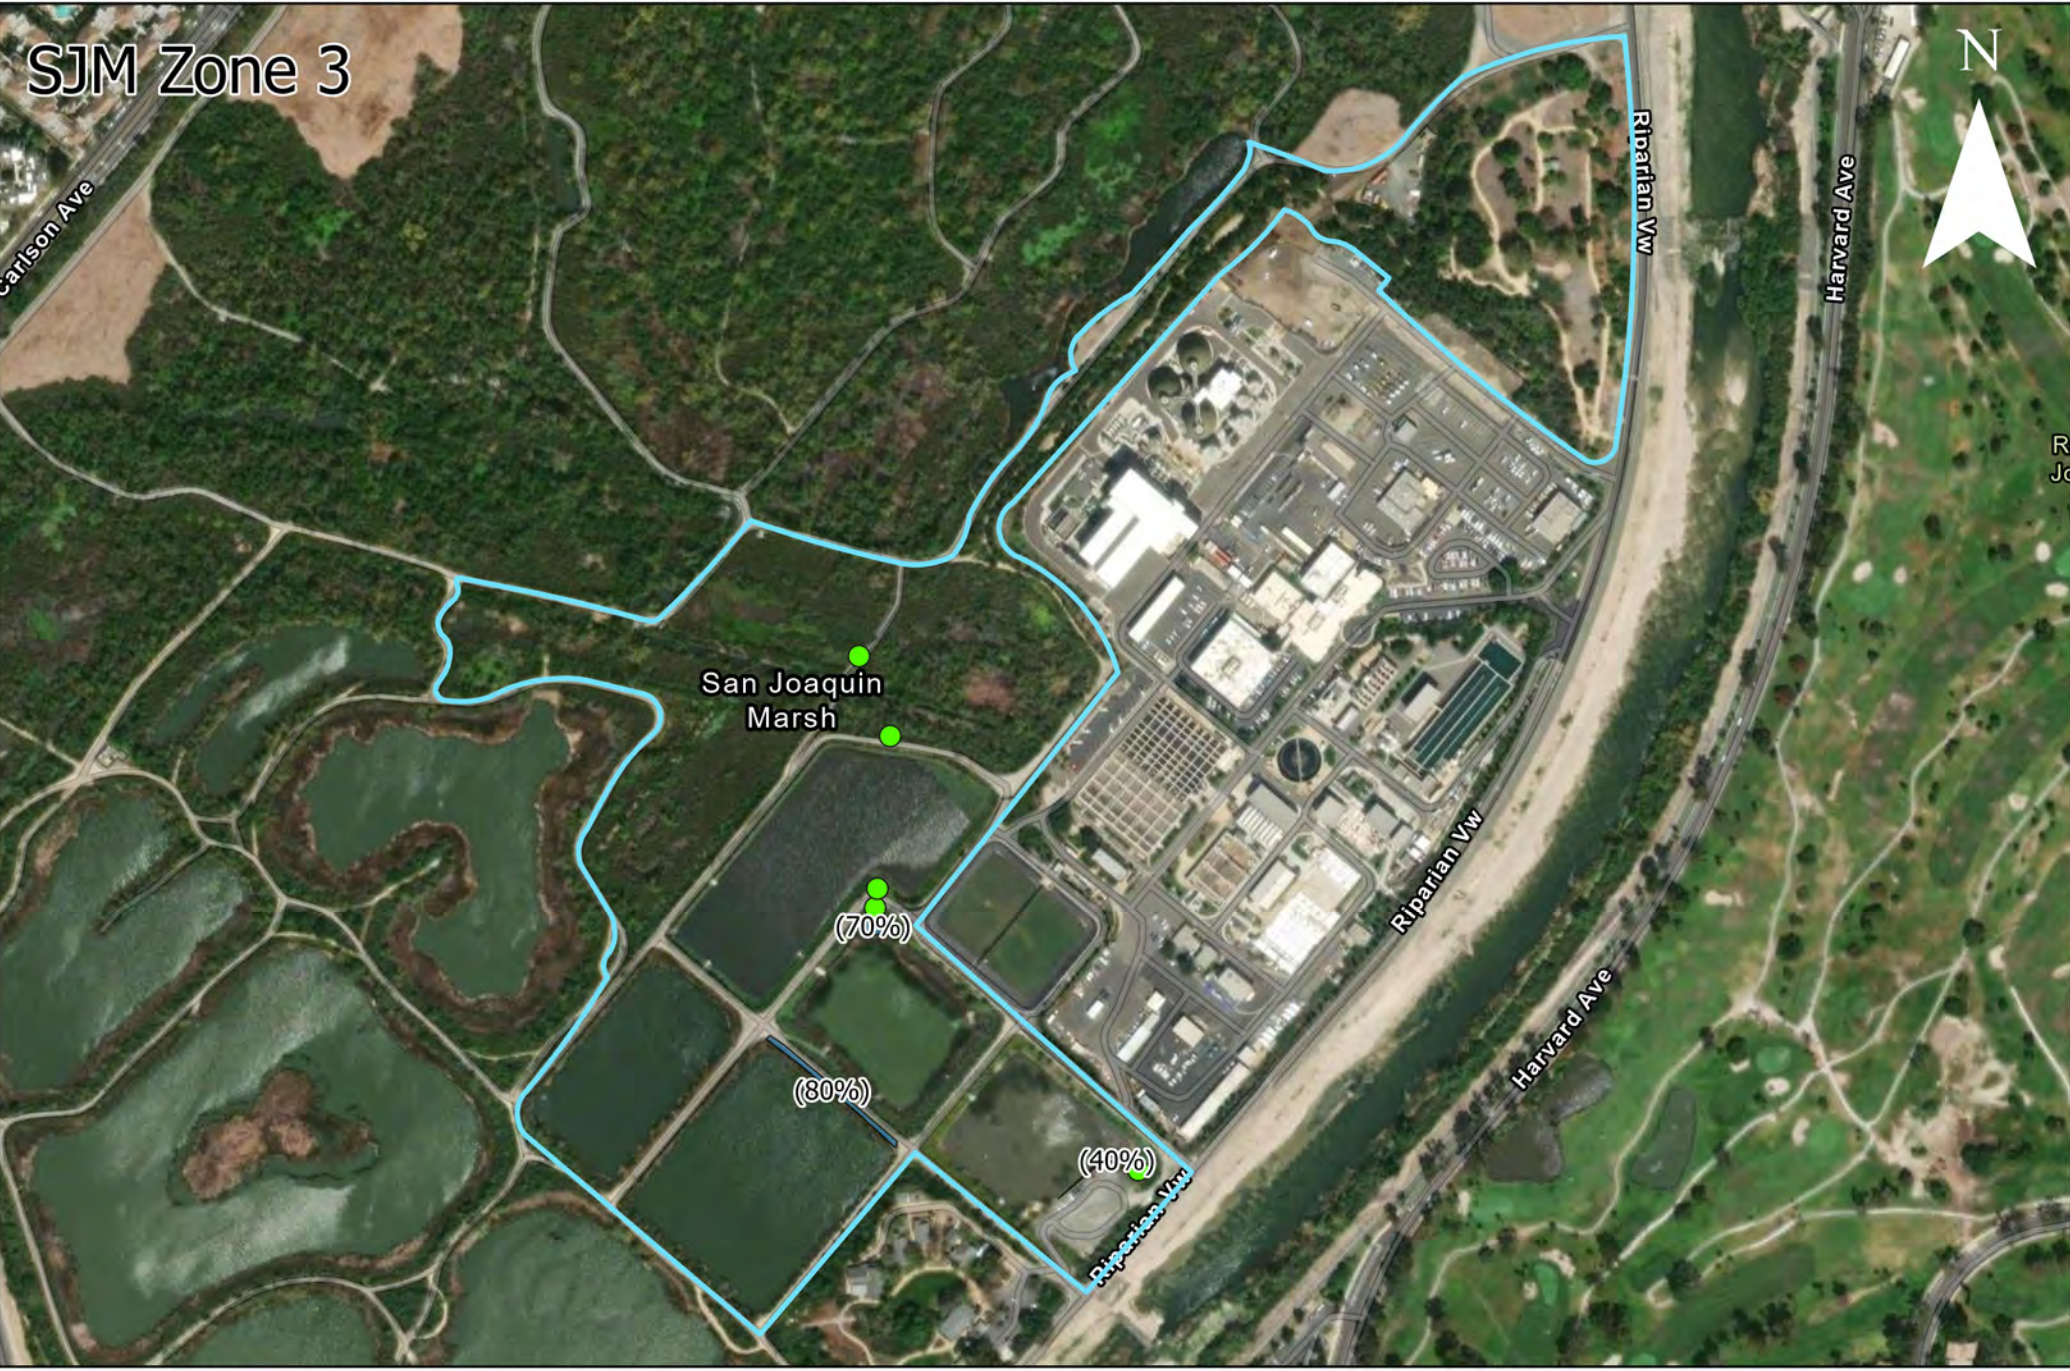
- Herbicide Prescribed Point (5)
- Invasive Coverage**
- 21% - 40% (1)

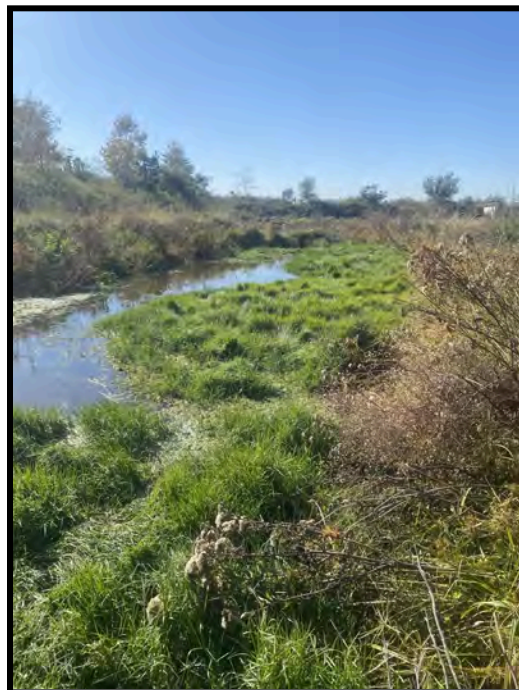
**Figure 1:** *Paspalum vaginatum* covering waterway at Lower Agua Chinon Basin B (LACB B)

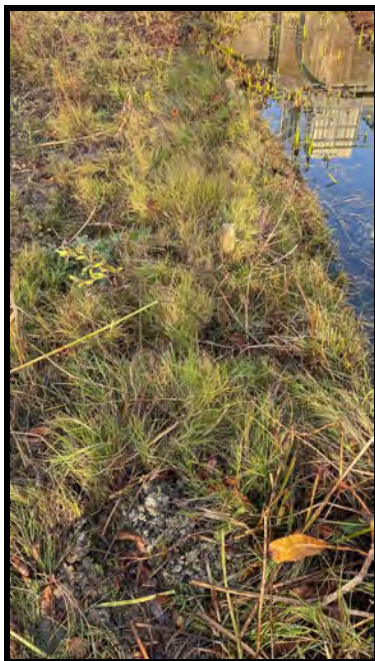
Figure 2: *Paspalum vaginatum* forming smaller, but still prevalent mats at Los Olivos South
