Annual Surveillance Report January 2024 to December 2024 for Sand Canyon Dam DSOD Dam No. 1029-002

Irvine, California

**Re: Sand Canyon Dam, DSOD Dam No. 1029-002,
Annual Surveillance Report from January 2024 to December 2024**

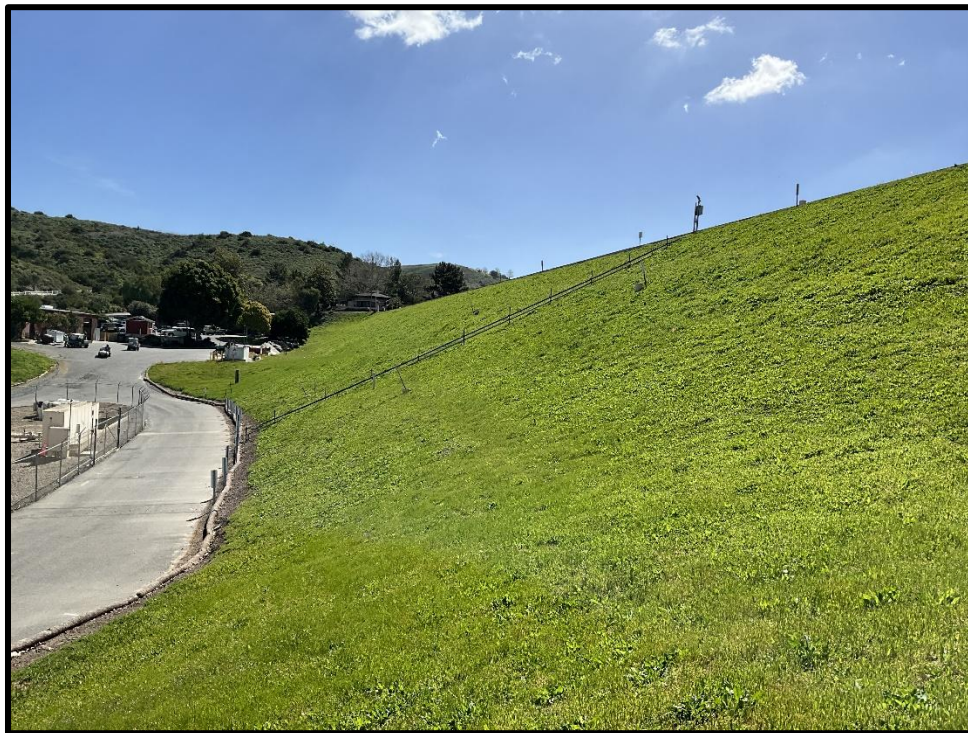
Photo 6) Downstream face of dam. Looking towards right abutment.

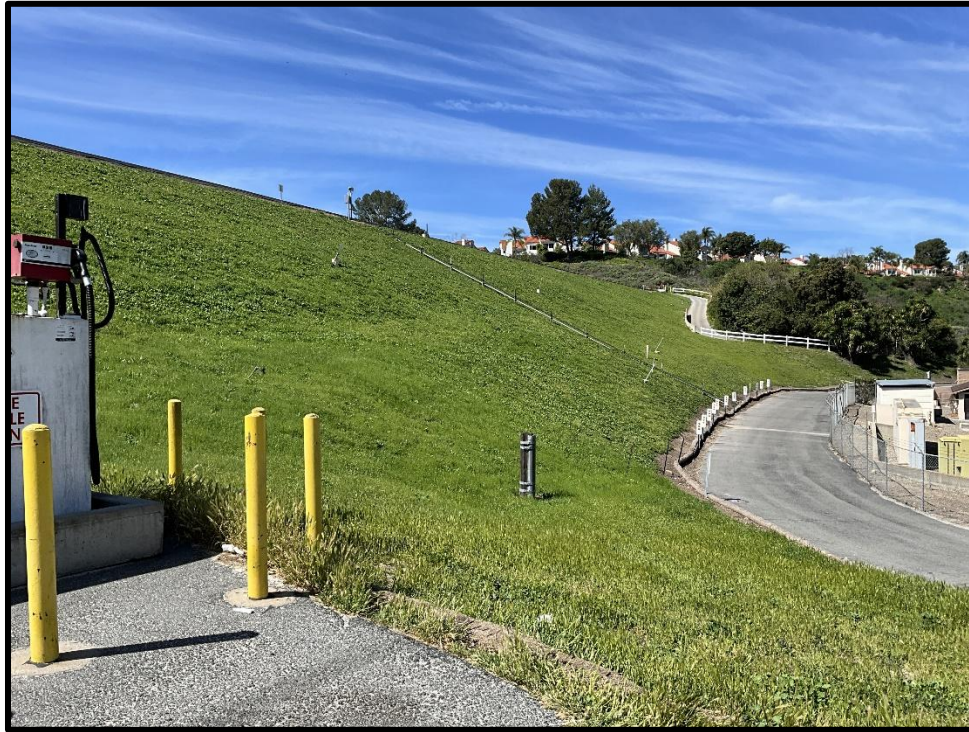
Photo 7) Downstream face of dam. Looking towards left abutment.

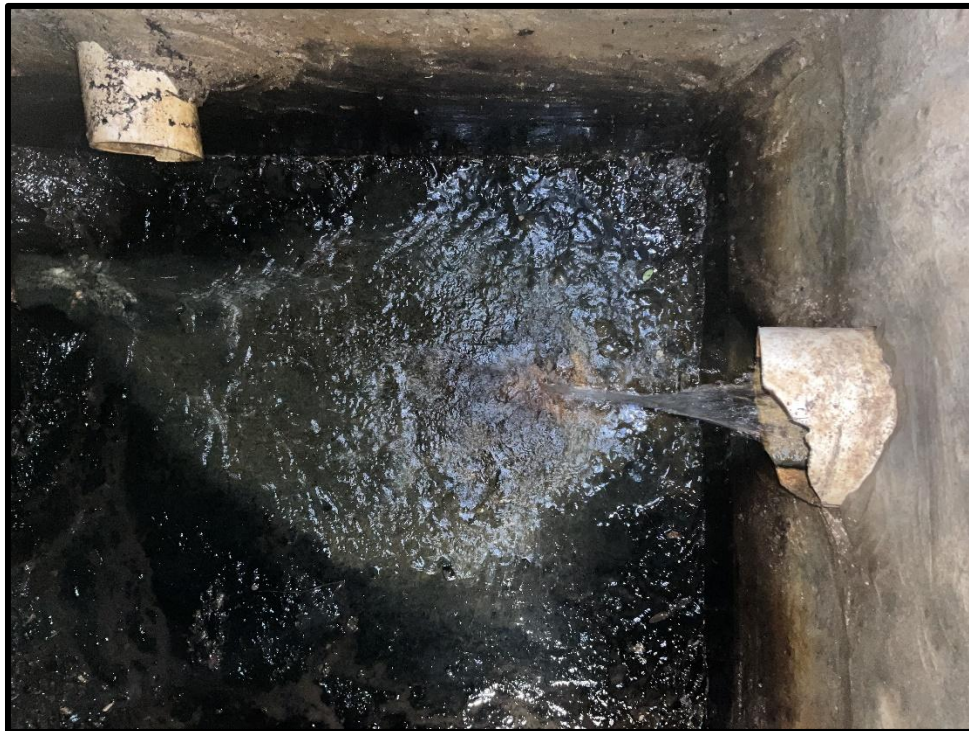
Photo 16) Seepage at left subdrain. Right subdrain was dry.

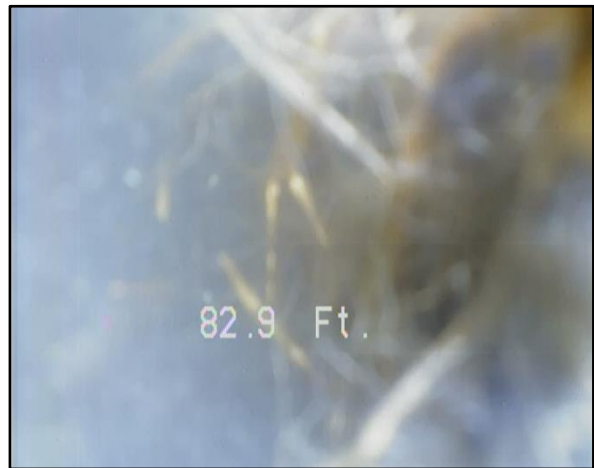
Photo 4 – STA 00+82: Root ball inside pipe.

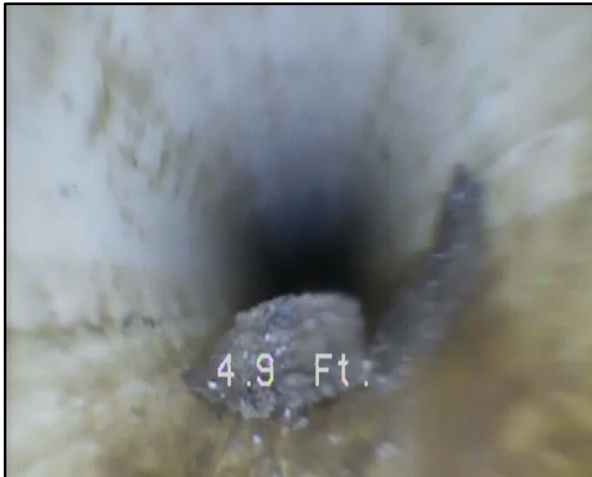
Photo 5 – STA 00+04: Debris in the pipe.

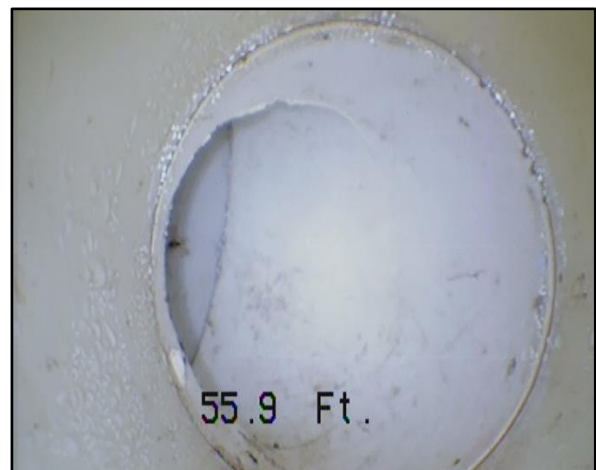
Photo 8 – STA 00+55: 90° bend in the pipe.

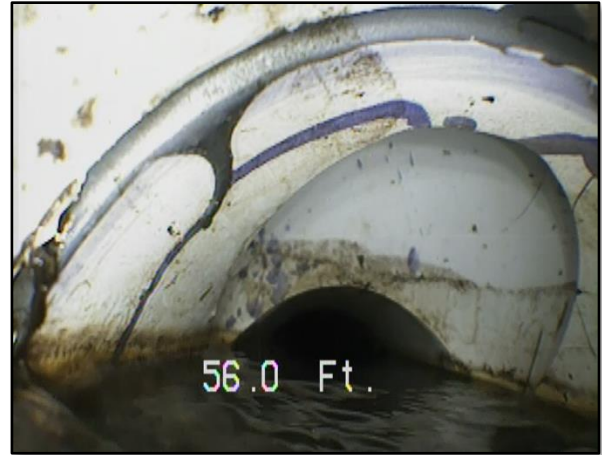
Photo 16 – STA 00+56: Change in the pipe diameter.

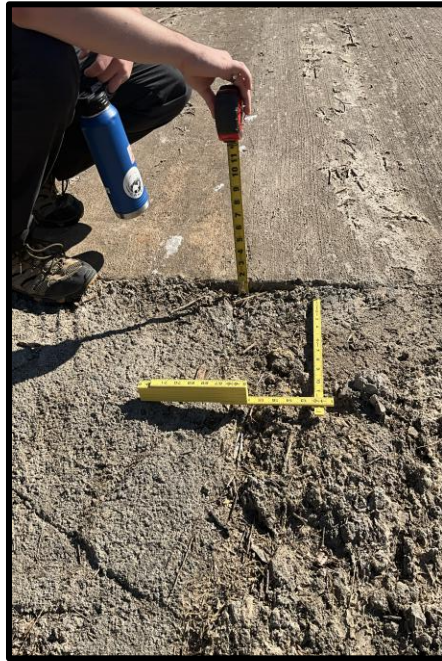
Photo 3) 1" slab joint offset at spillway ogee weir and unlined spillway channel transition.

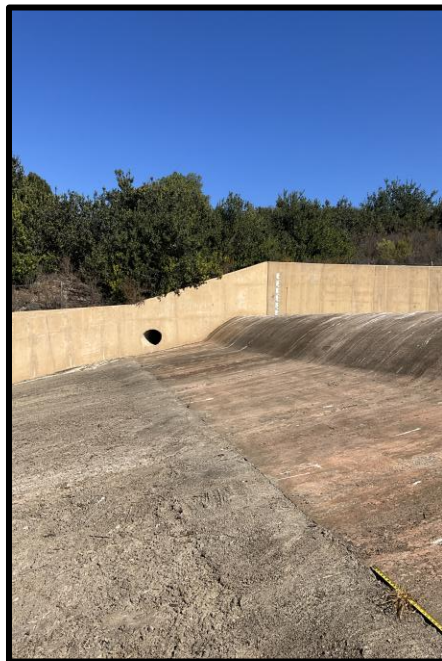
Photo 4) View of spillway ogee weir and unlined spillway channel transition looking northeast. Note 2' diameter corrugated metal pipe.

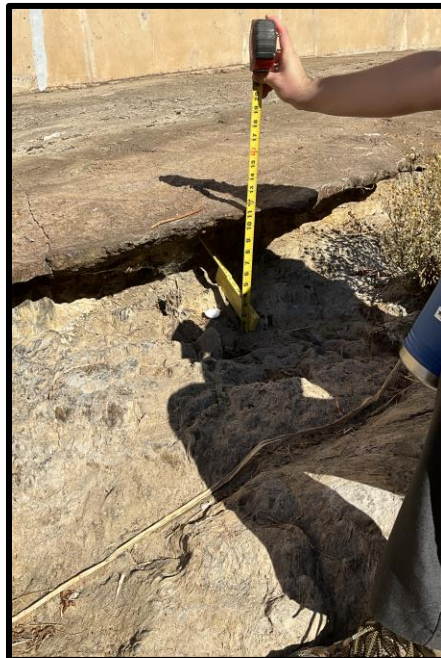
Photo 26) Spillway floor undermining. 11" max height, 12" max depth.

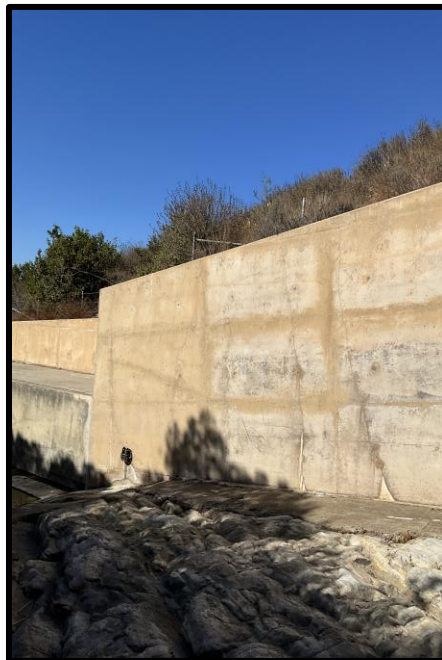
Photo 28) View of spillway wall panel R3 looking downstream. Note spillway drain.

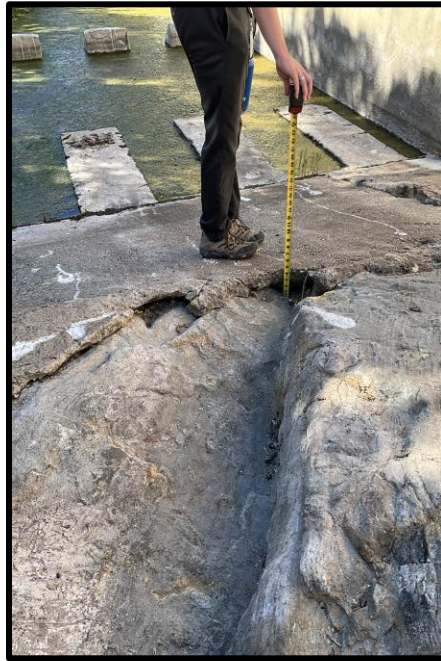
Photo 29) 4.6" downstream slab joint offset at unlined spillway channel and stilling basin transition.

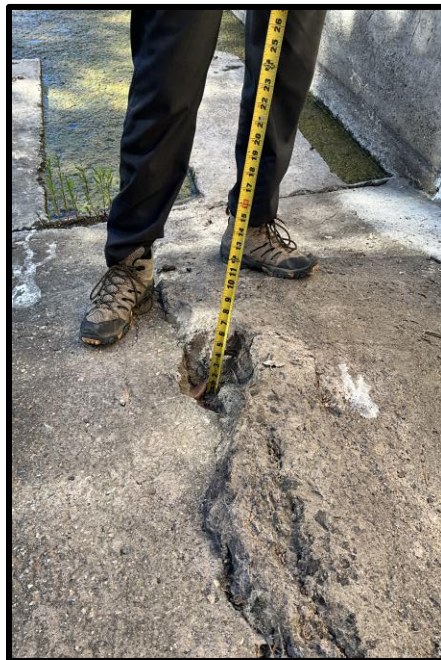
Photo 30) 11" Length (L) x 6" Width (W) x 5" Depth (D) concrete popout at unlined spillway channel and stilling basin transition.

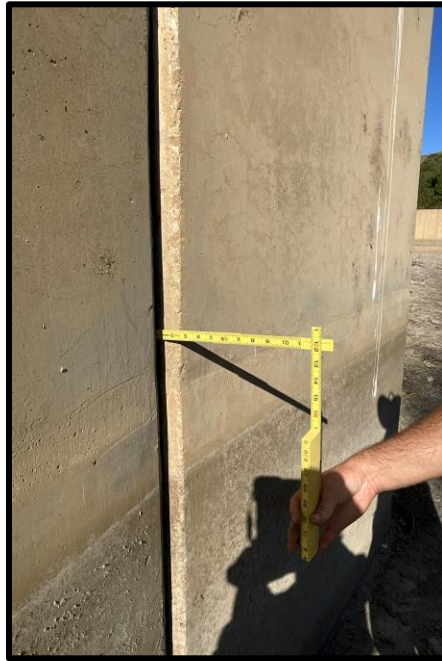
Photo 37) Vertical wall joint $\frac{1}{2}$ " open max with $1\frac{1}{2}$ " max wall joint offset. 1" void in joint.
